Inspection Photos
Remediation Project 15777
Inspection Date: 9/24/2020
All Photos taken by Kris Neidel

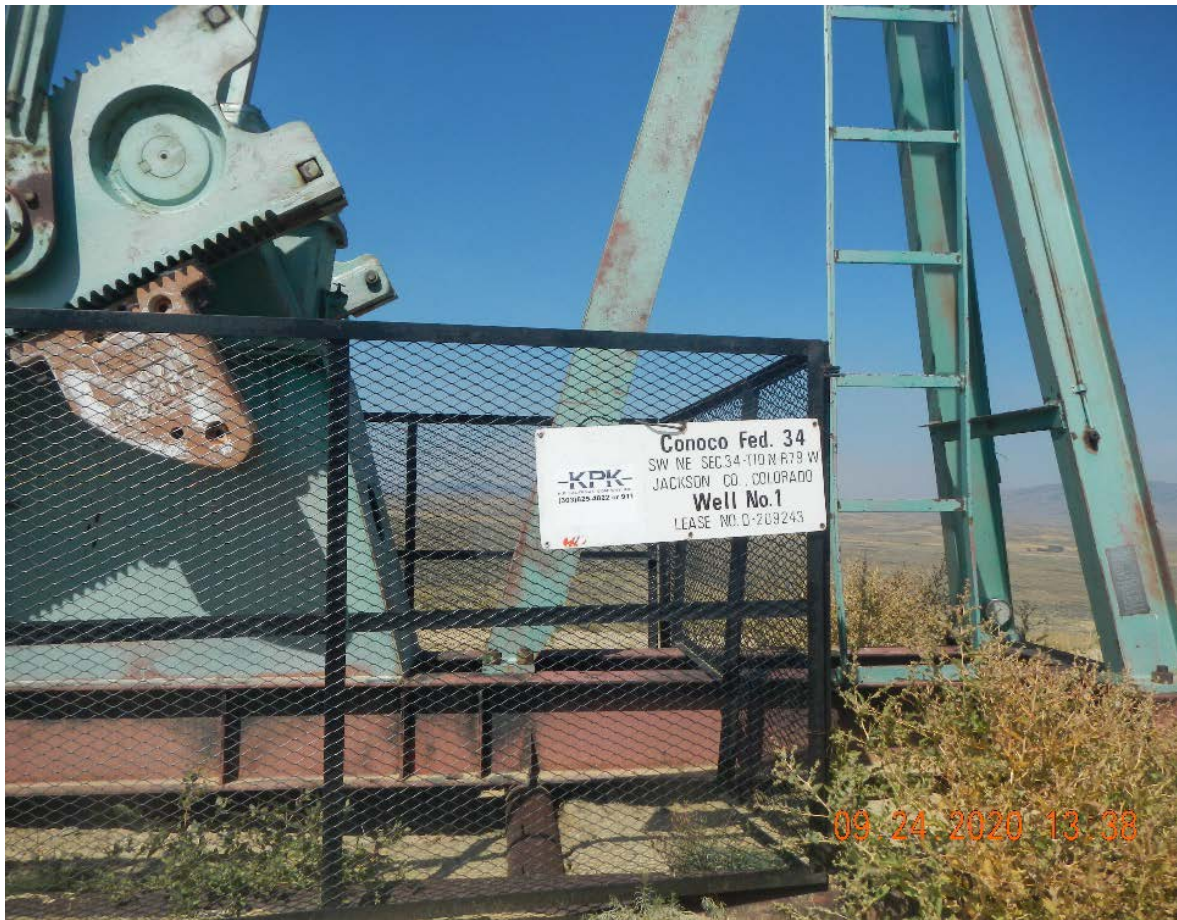
Photo #1 Sign on Pump Jack. Well was PR during inspection.

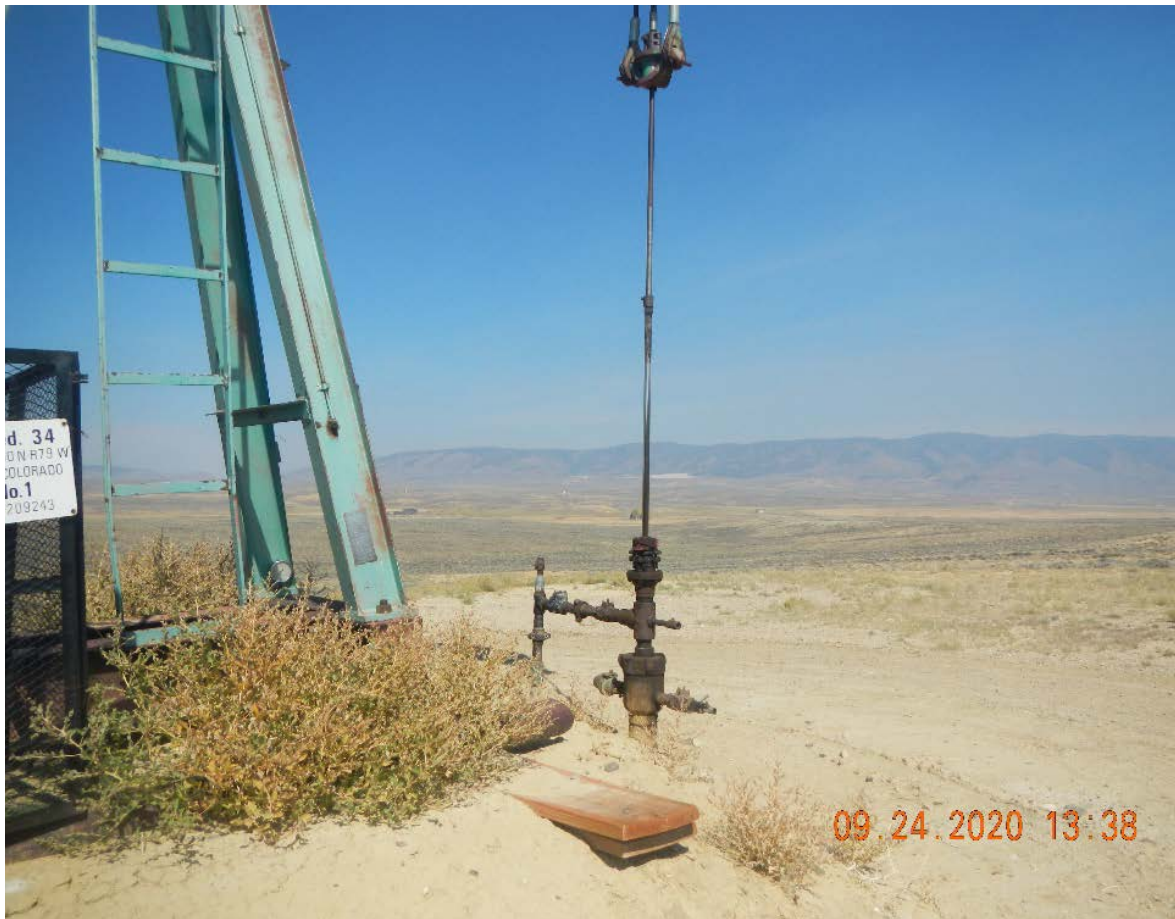
Photo #2 weeds at wellhead.

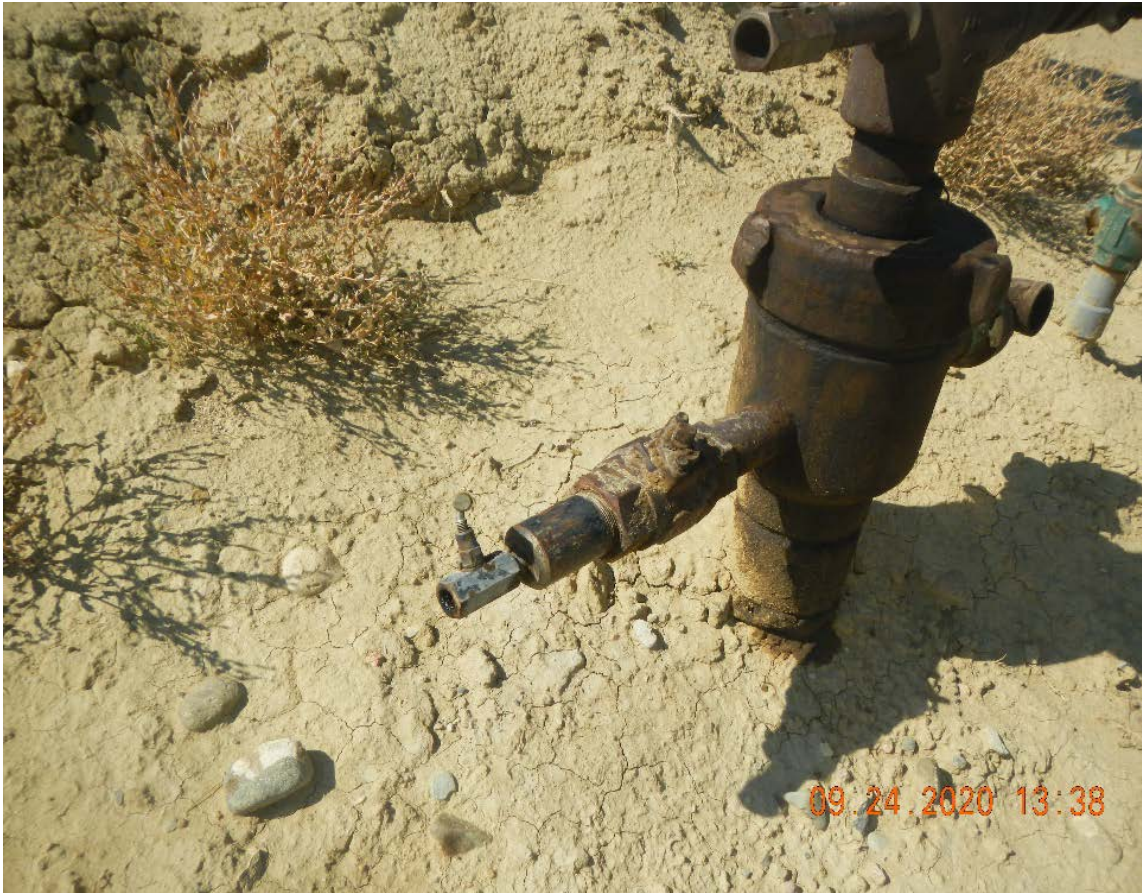
Photo #3 Well was venting out of needle valve. If prior approval to vent gas has not been granted (via Sundry, Form 4), Immediately cease venting. Per COGCC Corrective Action Matrix.

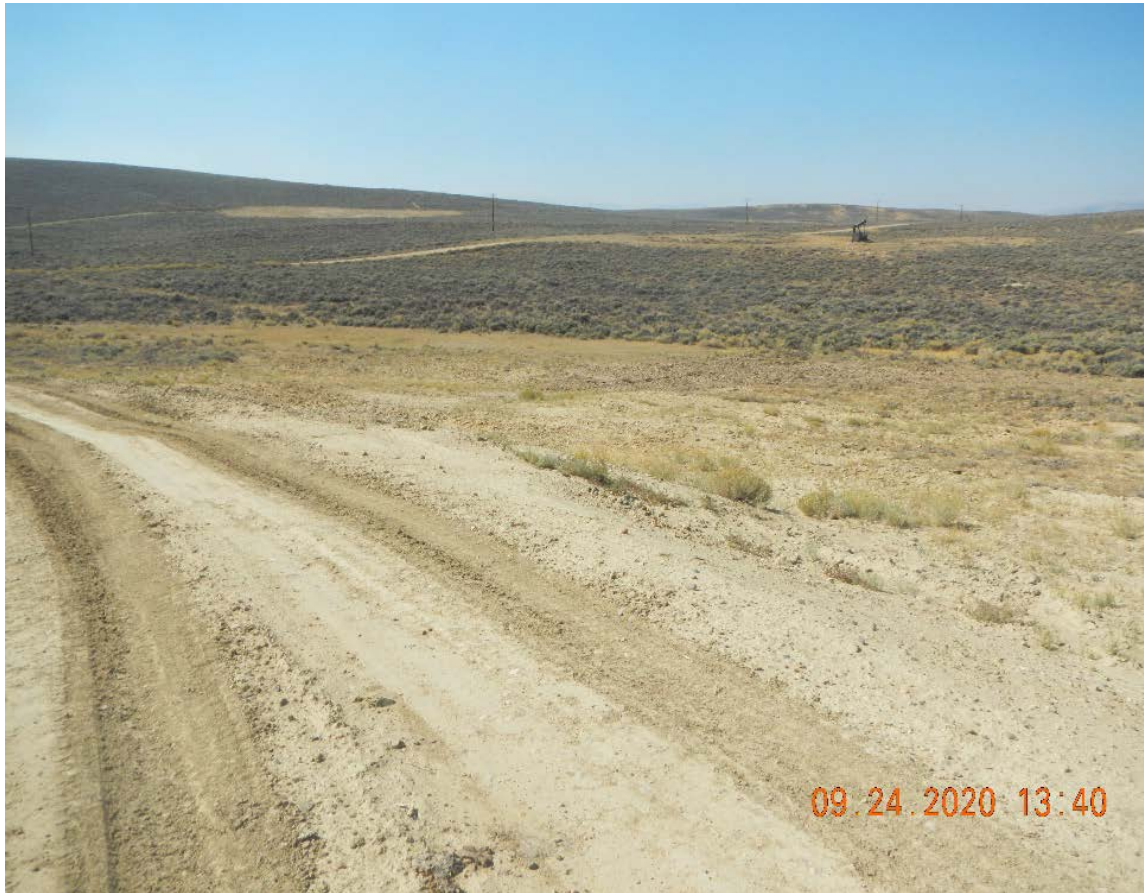
Photo #4 Access road from the #1 well looking toward the area of impact.

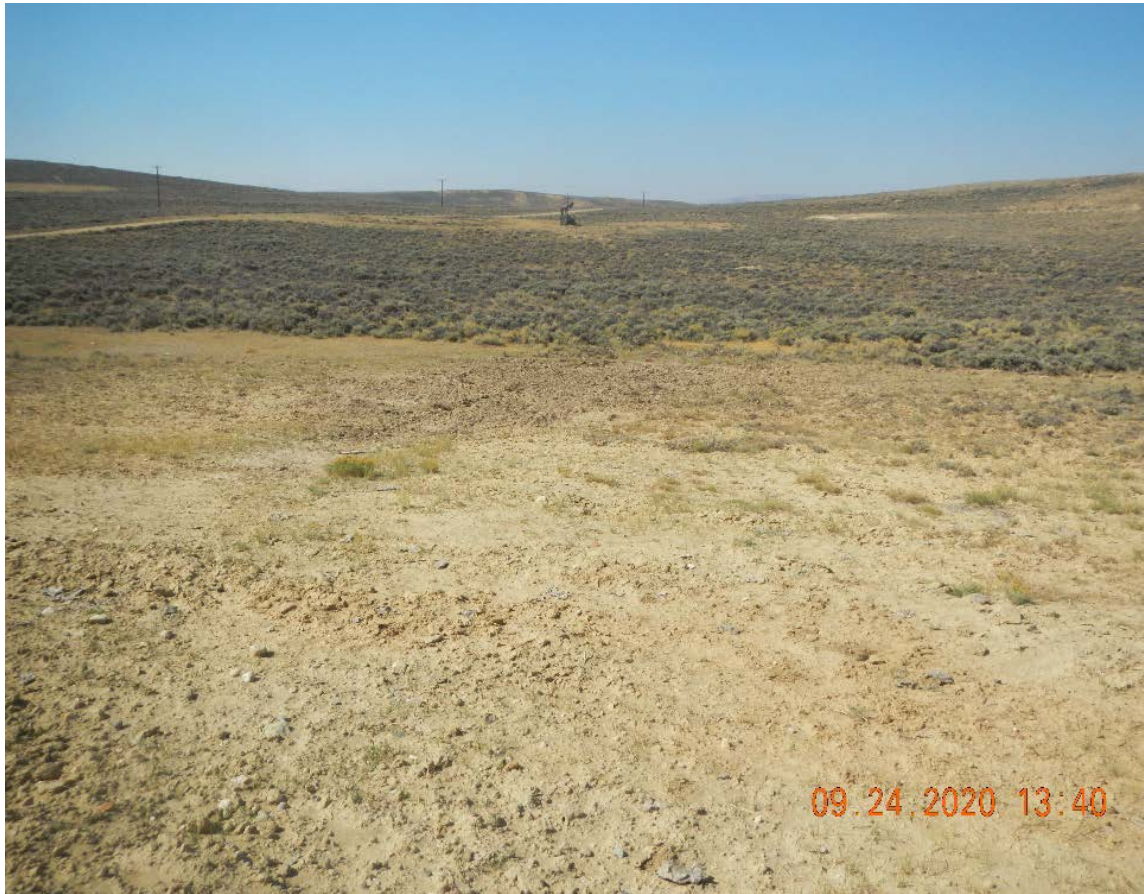
Photo #5. This is the Area identified by COGCC staff on 4/8/2020, where oil staining was observed.

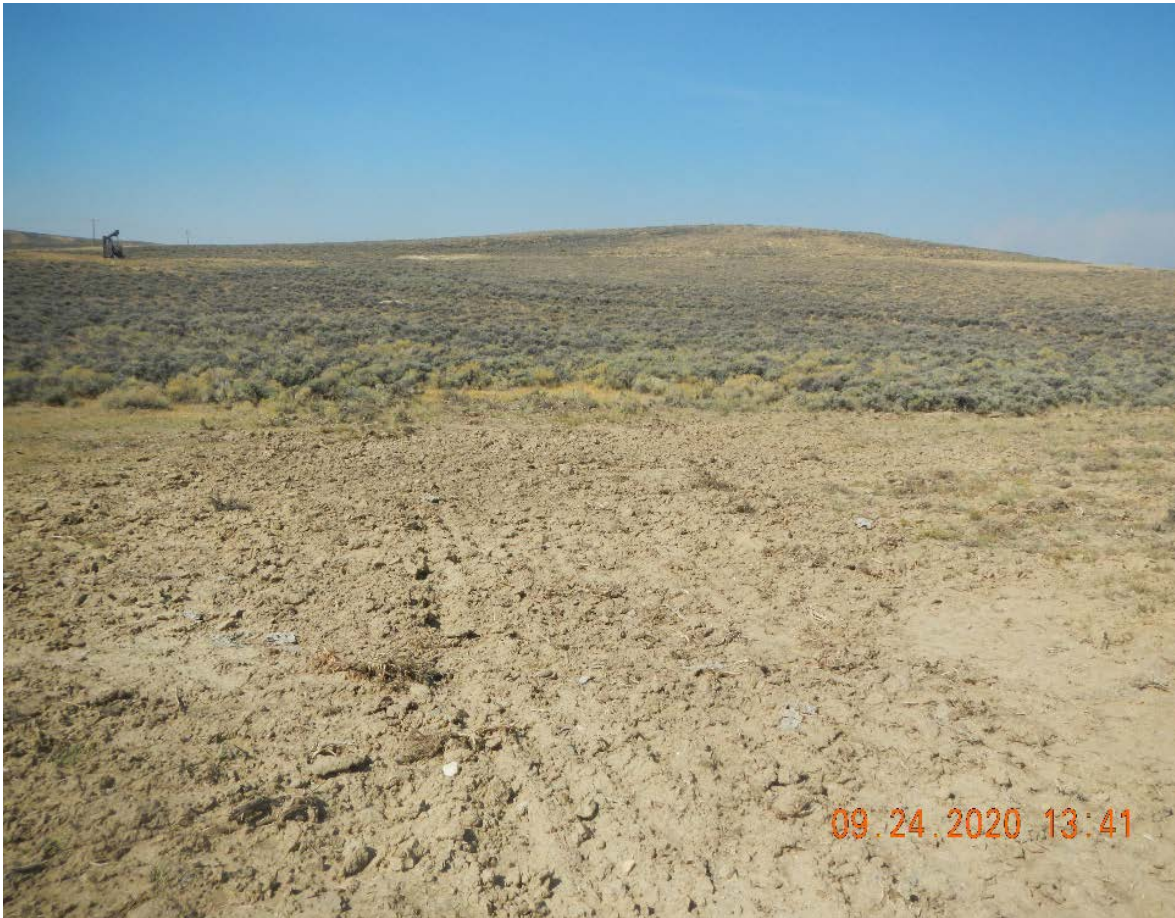
Photo #6 it appeared that the impacted area was tilled.

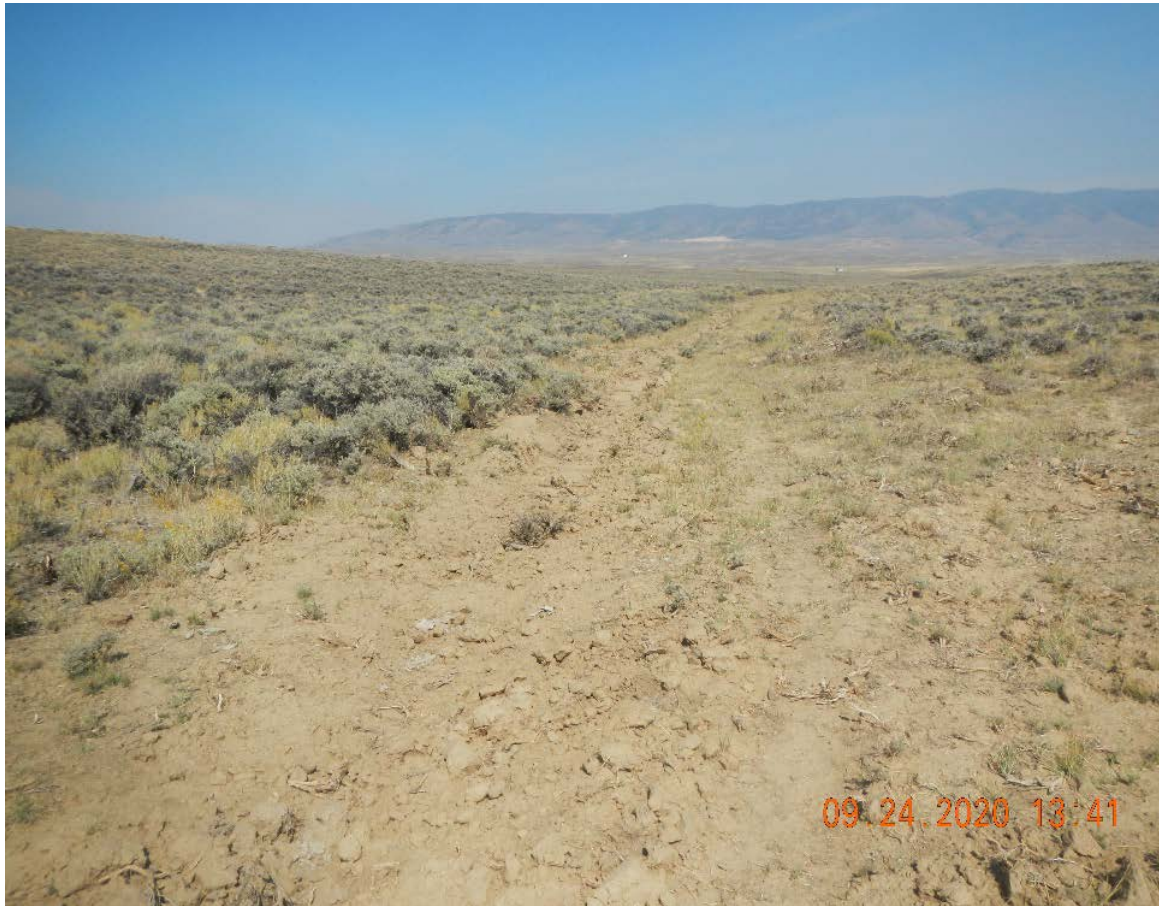
Photo #7 The foreground of photo is where impacts had been previously observed. The area in the background is a game trail (and perhaps a flowline corridor).

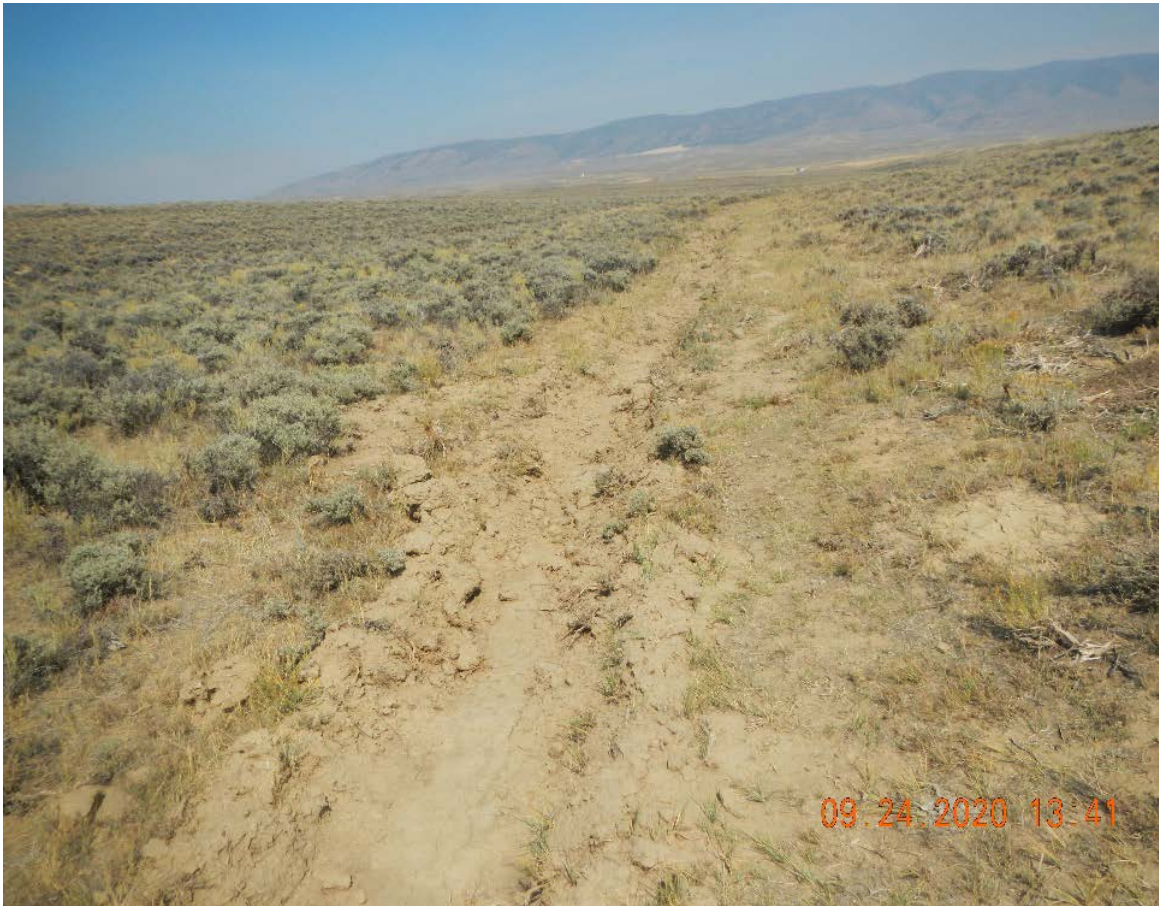
Photo #8 Close up of Game path.
