Inspection Photos

Operator: Hilcorp Energy
API: 067-09069
Date: 10/7/2020

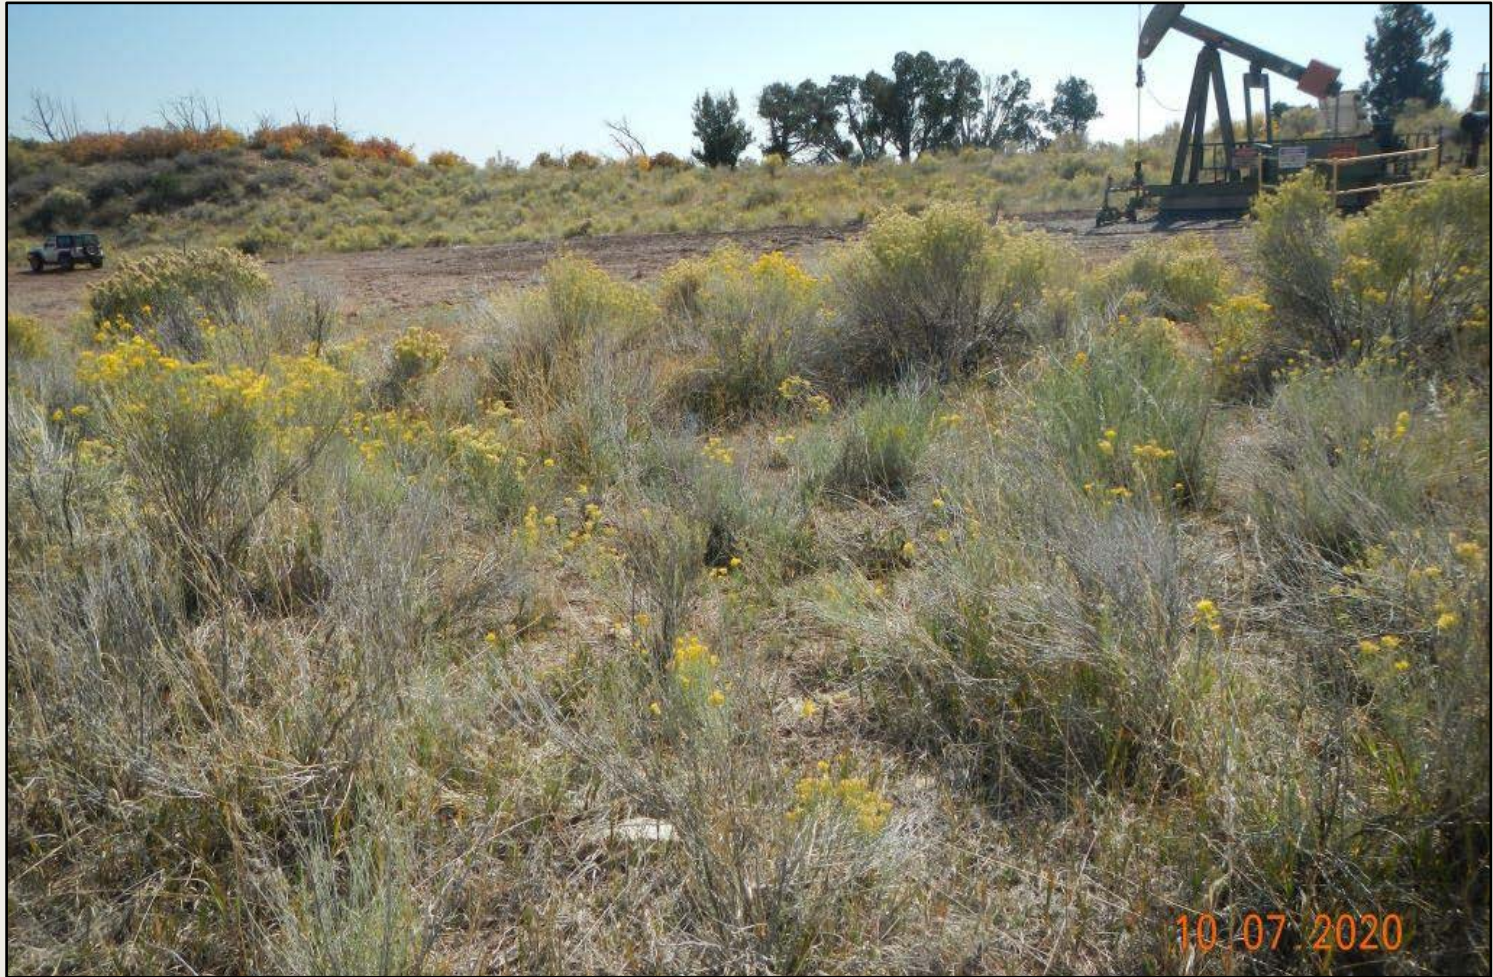
Photo 1. View of the project area from the northwestern corner facing center.

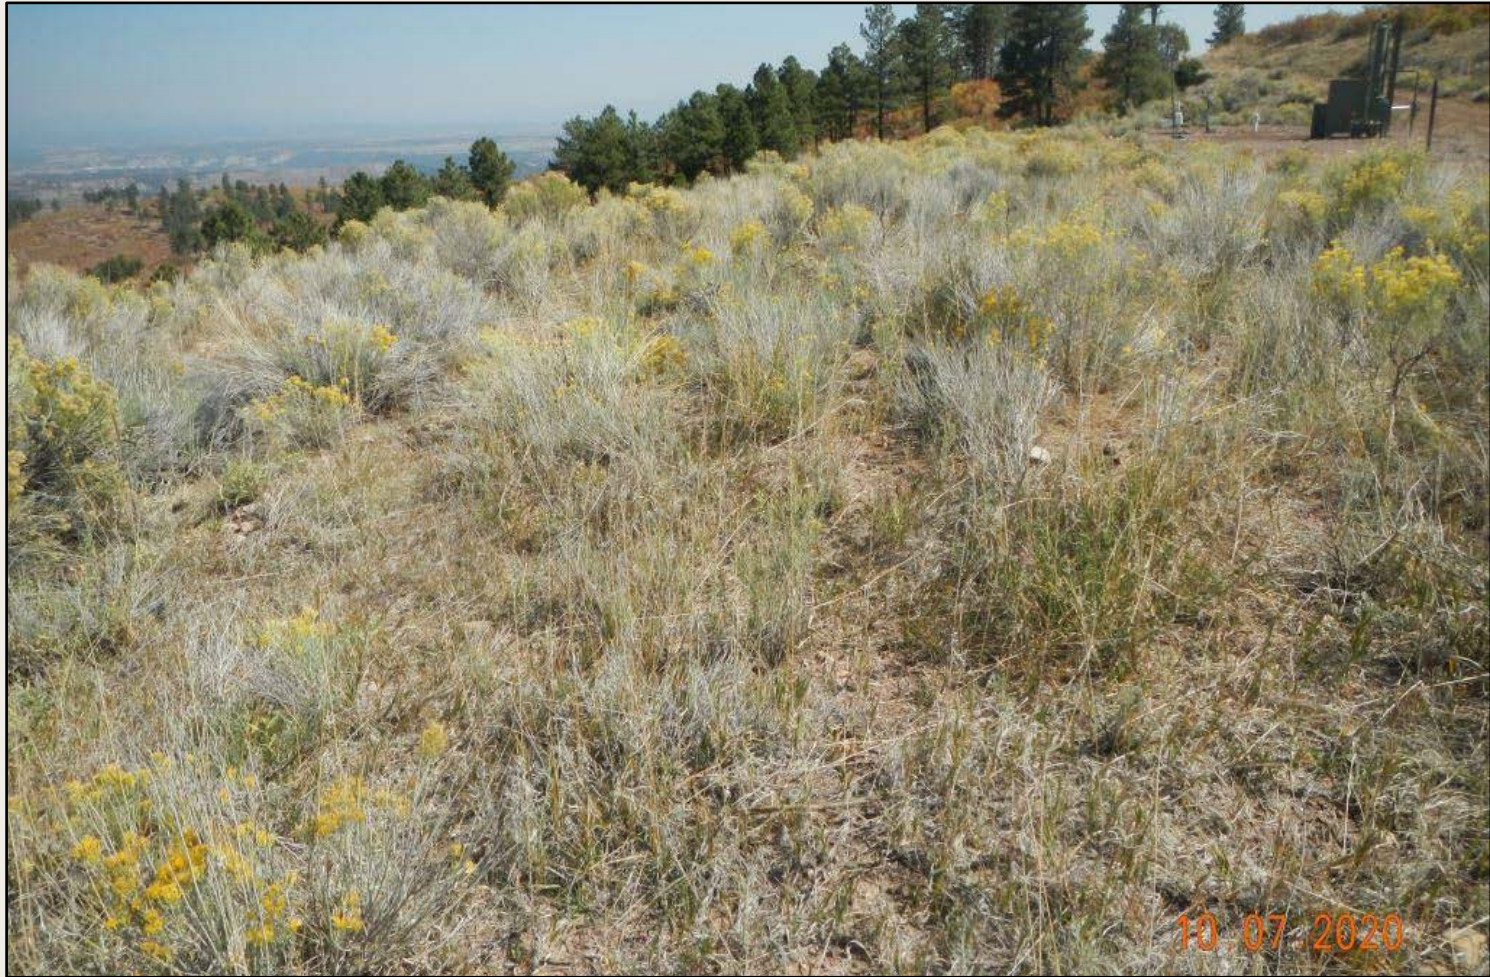
Photo 2. View of the northern fill slope from the northwestern corner facing eastward. Revegetation is progressing with smooth brome, western wheatgrass, and rubber rabbitbrush.

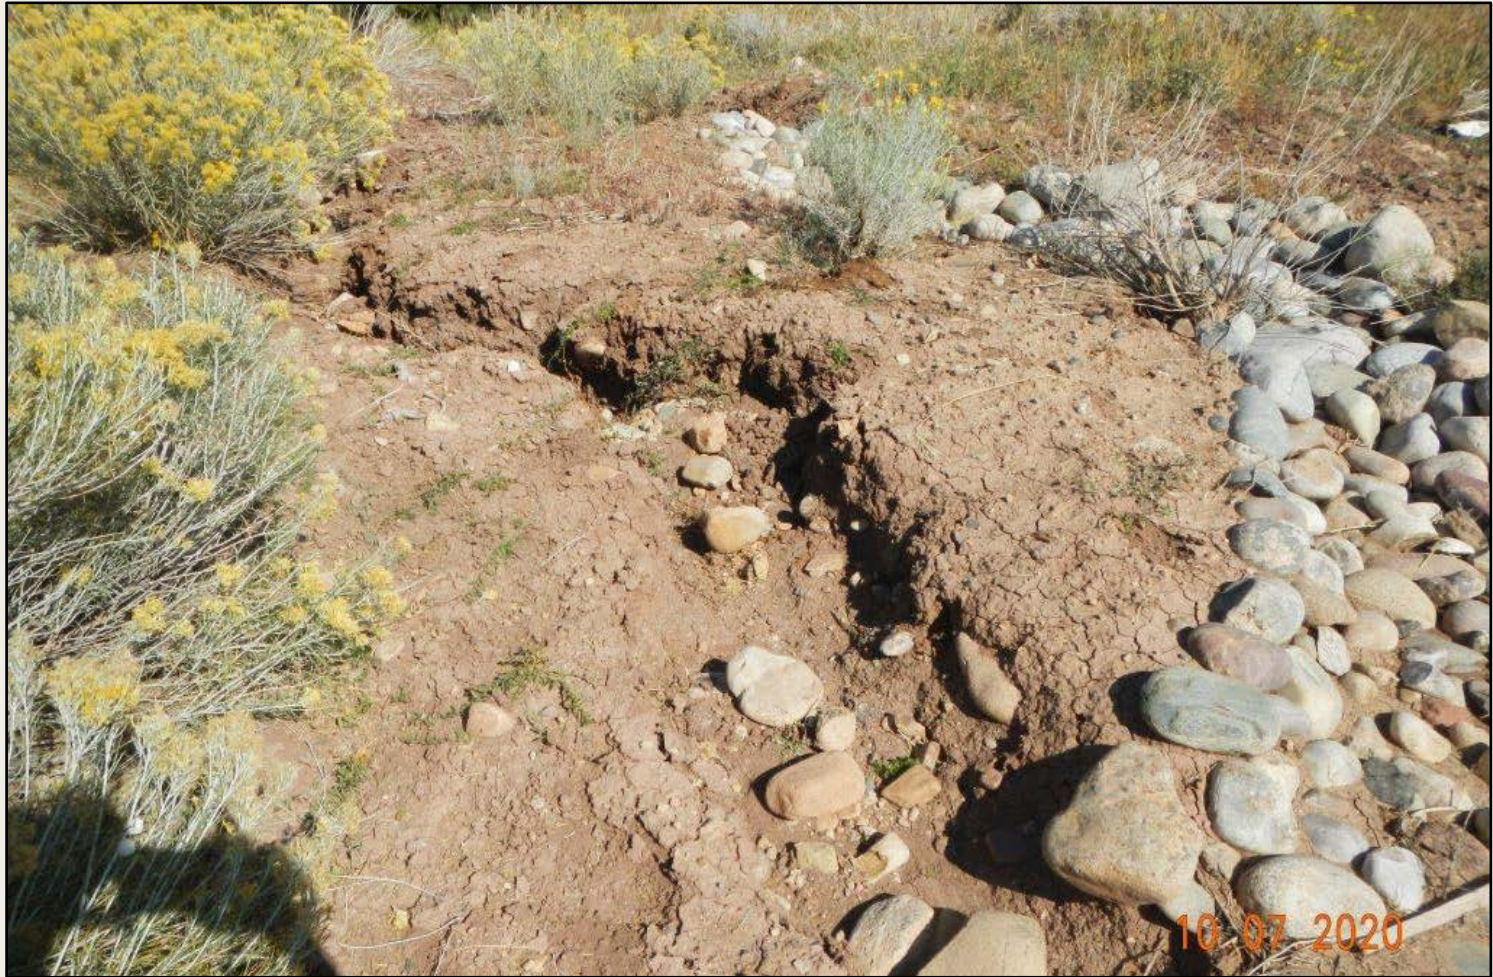
Photo 3. View of erosional channel, approximately 1.5 feet wide and deep, in the northeastern project area.

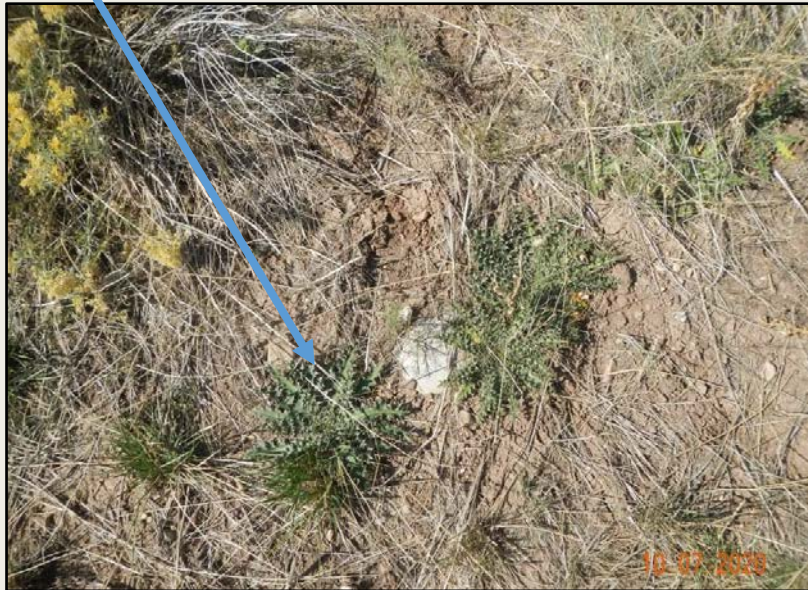
Musk thistle

Photod 4/5. View of musk thistles (on left) and scattered debris (on right) within the project area.

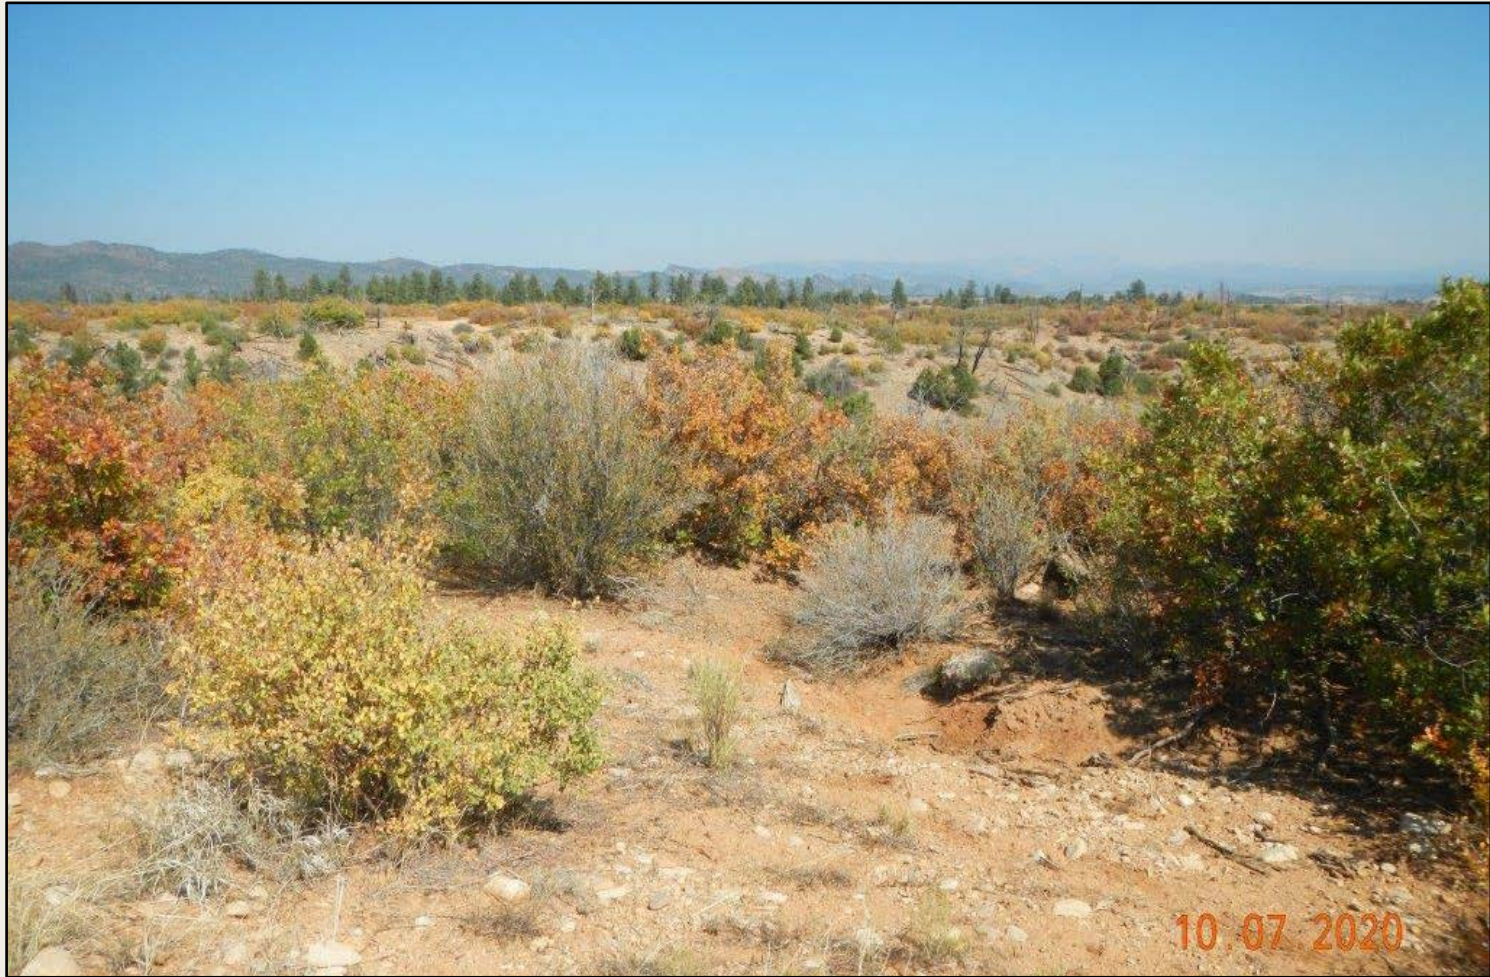
Photo 6. View of reference area vegetation comprised of gambel oak shrubland in a post-fire vegetative condition with other shrubs such as mountain mahogany, serviceberry as well as grasses and forbs such as squirreltail and Colorado rubberplant.
