Inspection Photos

Operator: Epic Energy
API: 067-05624
Date: 10/7/2020

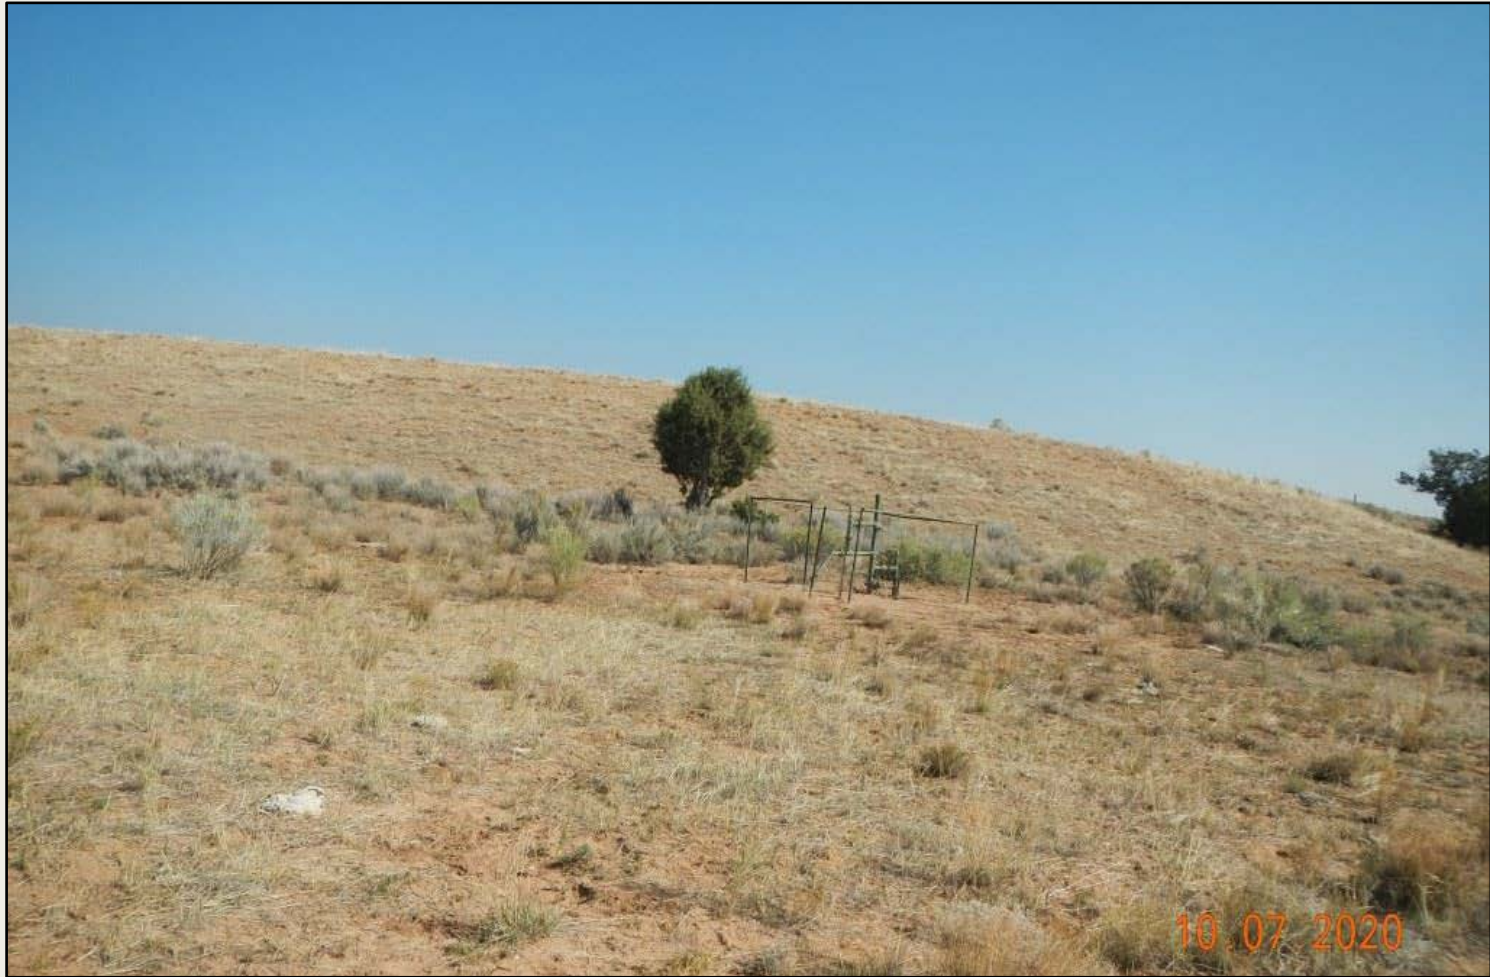
Photo 1. View of project facilities in the eastern project area, facing northeastward from the access road. Revegetation is progressing within the project area with grasses, forbs, and sub-shrubs such as western wheatgrass, Colorado rubberplant, and black sage.

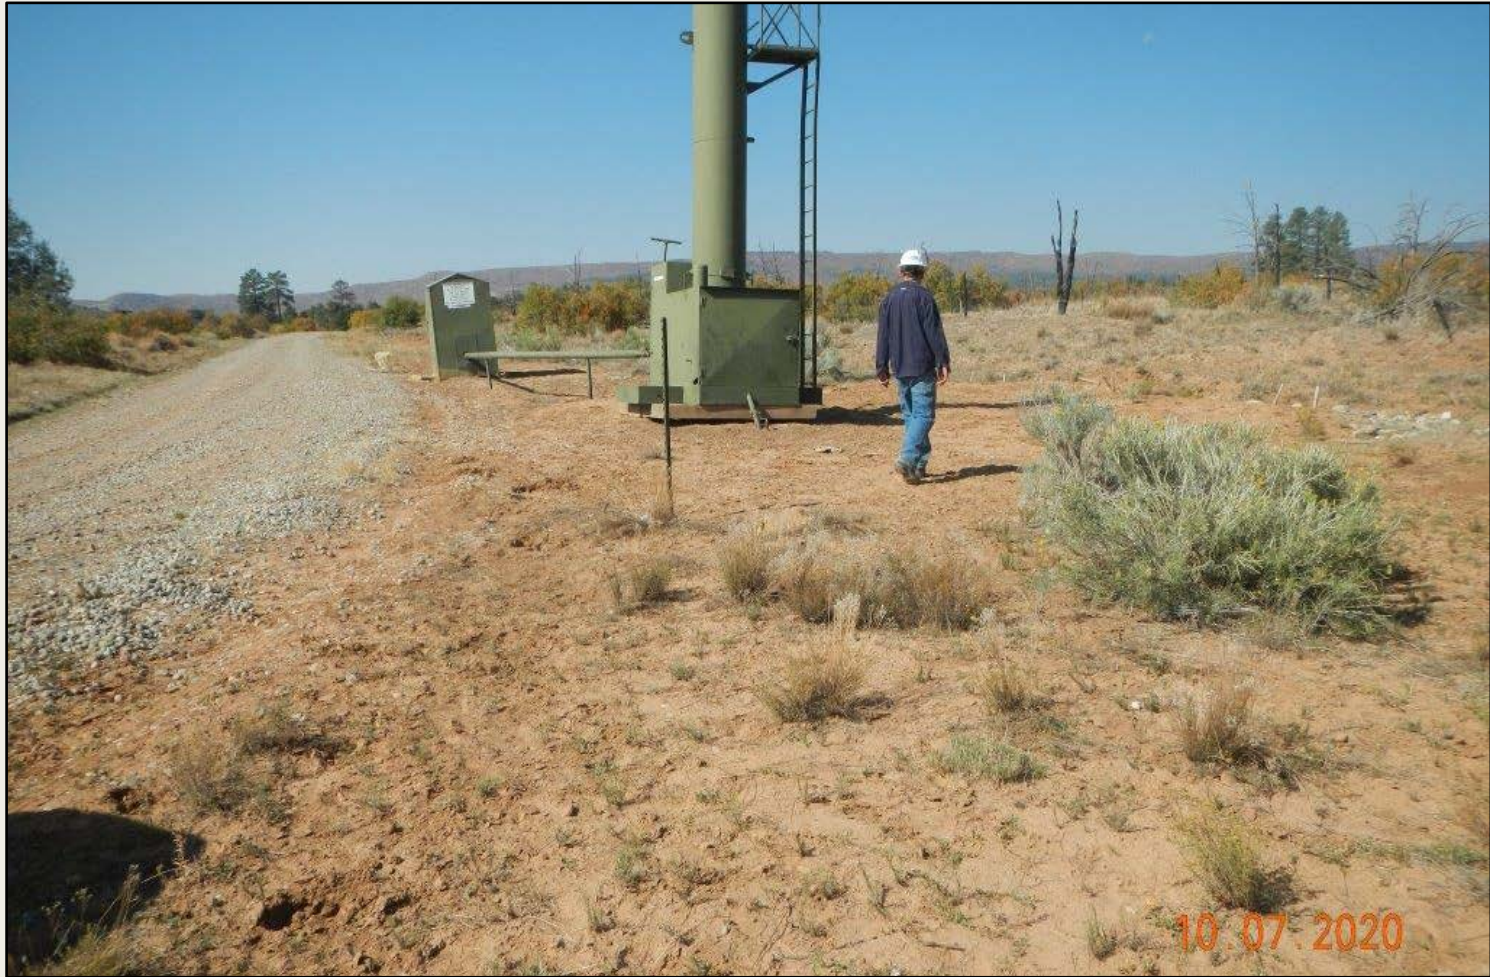
Photo 2. View of project facilities in the western project area facing westward from the access road.

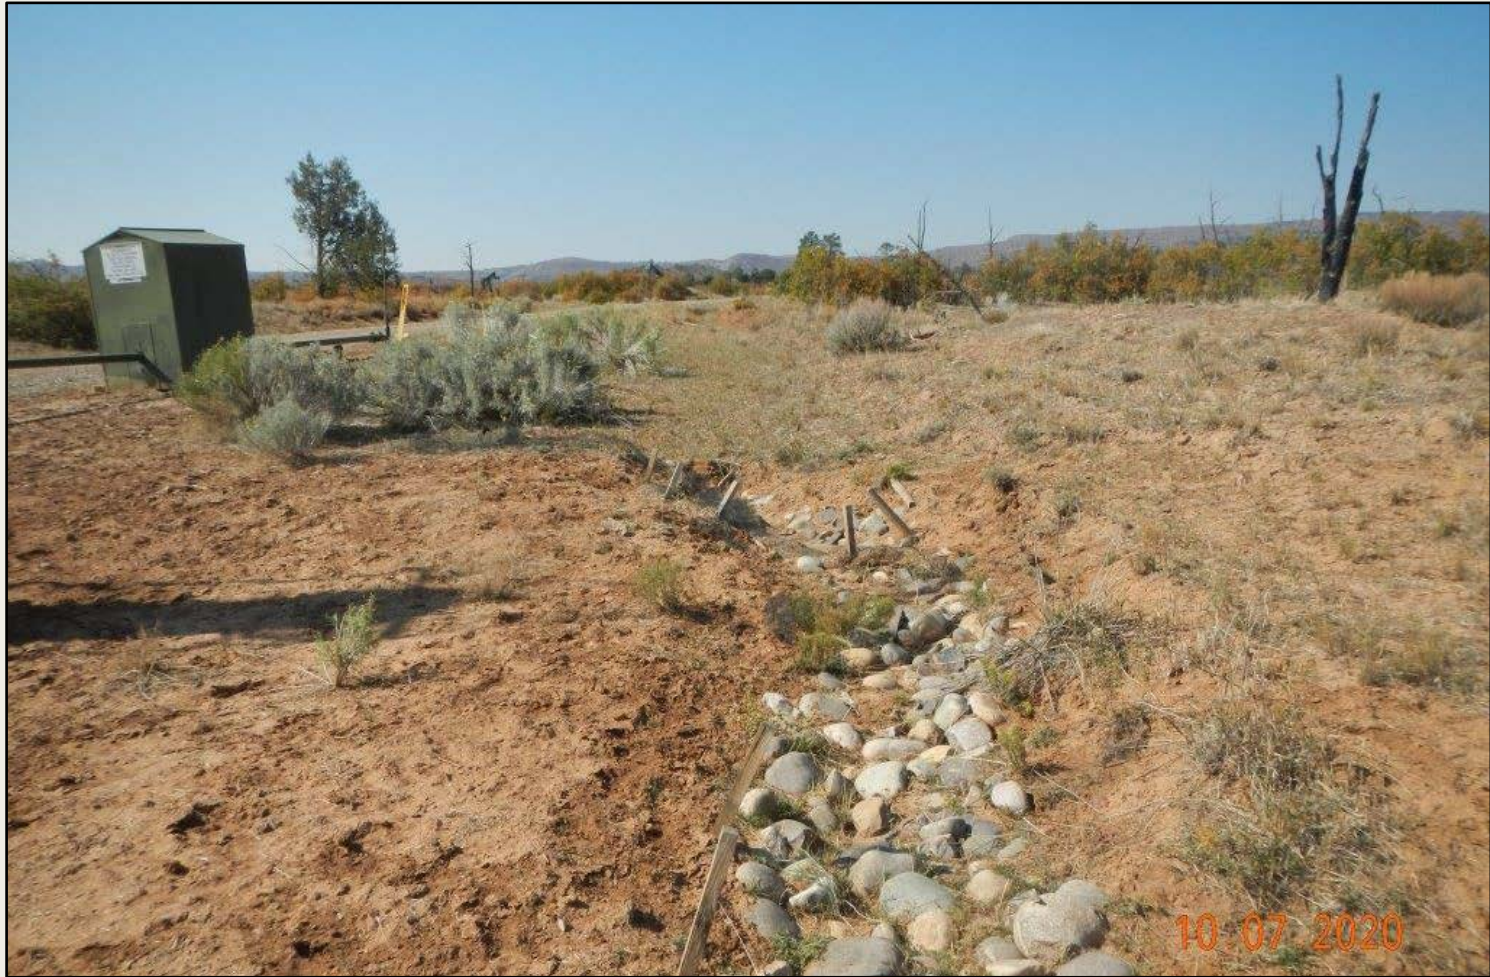
Photo 3. View of erosional channel within the southwestern project area. Cobble is placed in channel. Wattles are degraded and only stakes/plastic netting remain.

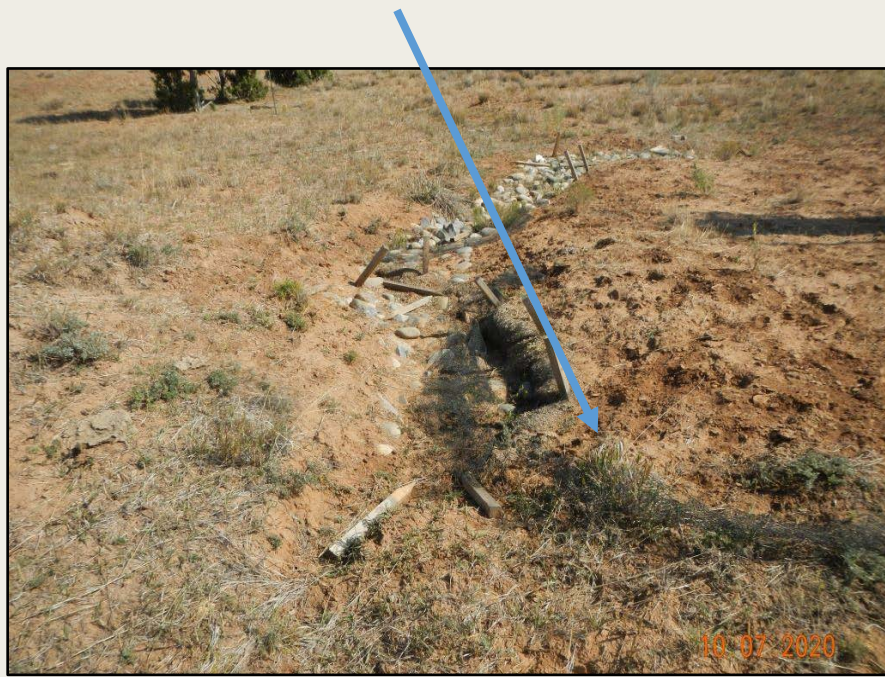
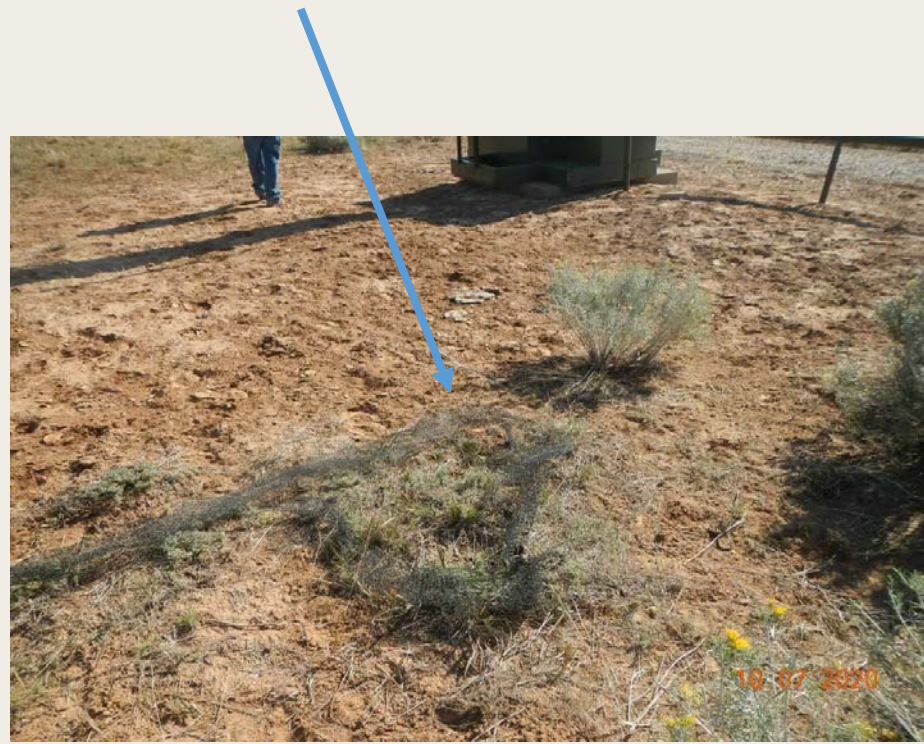
Photos 4/5. View of black netting from degraded wattles within the project area.
