Inspection Photos
Operator: Logos Operating
API: 067-05367
Date: 10/13/2020

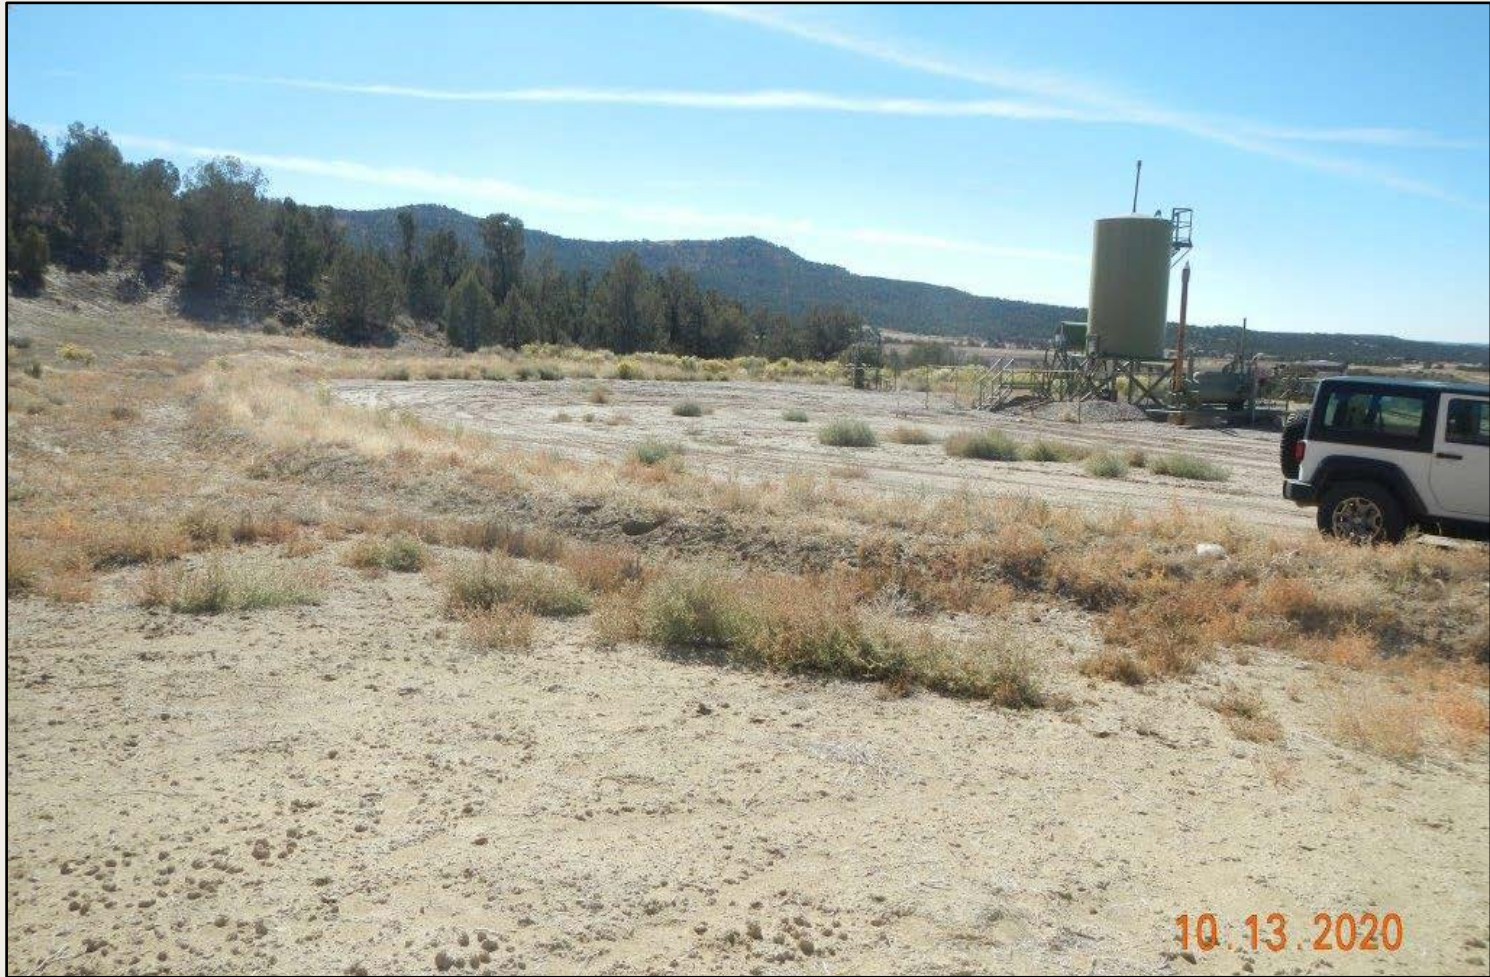
Photo 1. View of the project area from the northeastern corner facing center.

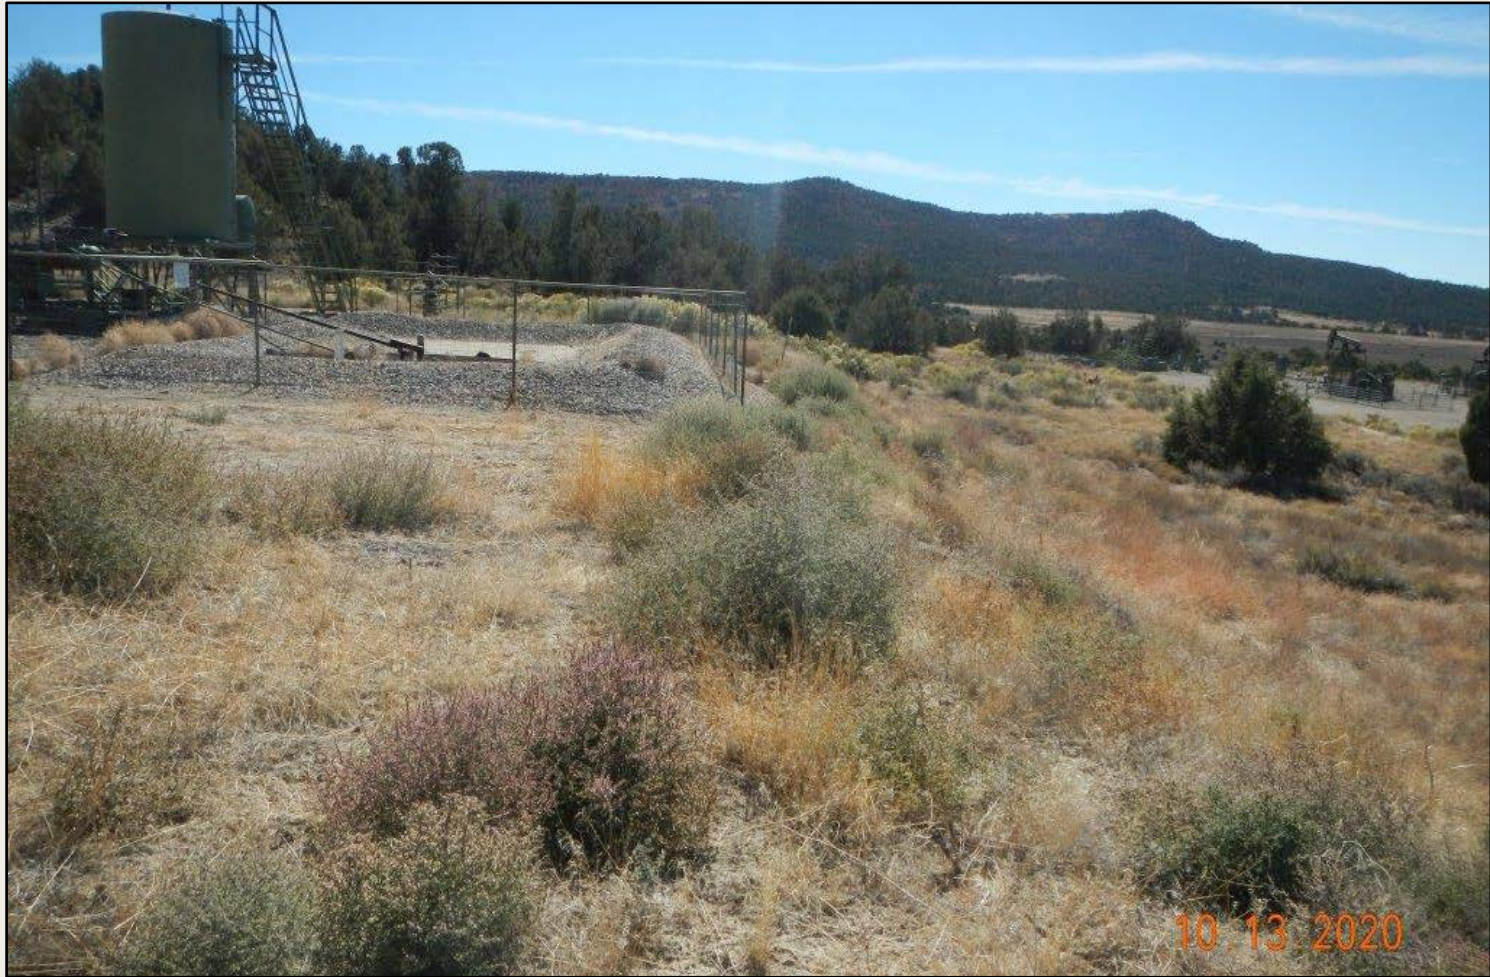
Photo 2. View of the western fill slope from the northwestern corner facing southward. Revegetation is progressing with smooth brome, western wheatgrass, and rubber rabbitbrush. Weeds such as Russian thistle and cheatgrass present. Russian thistle debris needs to be removed.

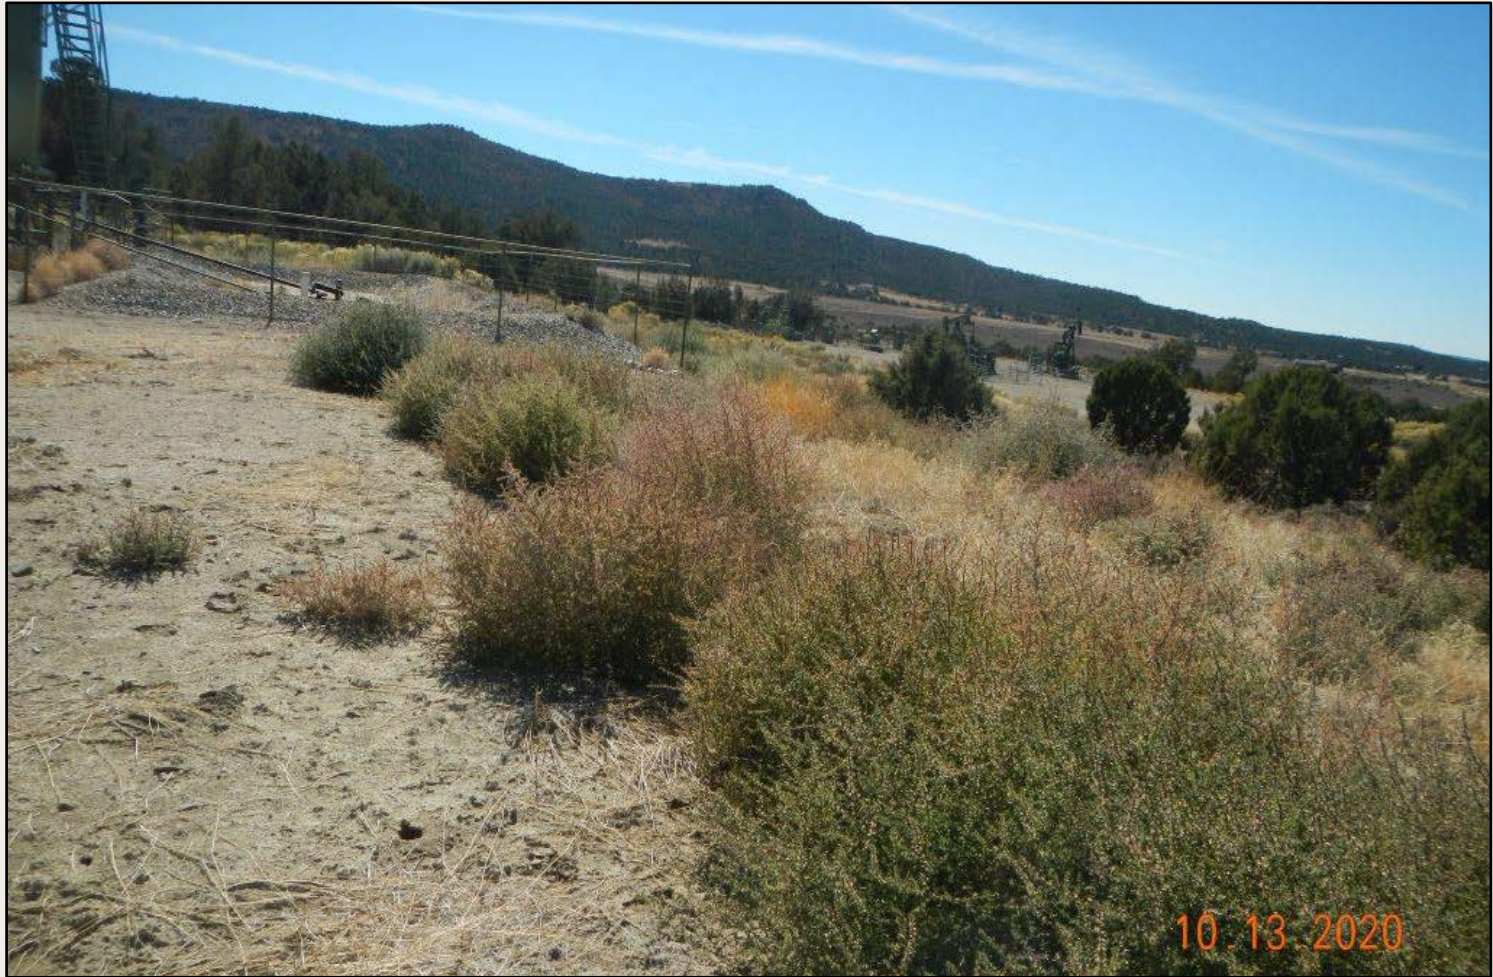
Photo 3. View of Russian thistles approx. 2-3 feet tall within the northwestern project area. Russian thistles will break off and become debris.

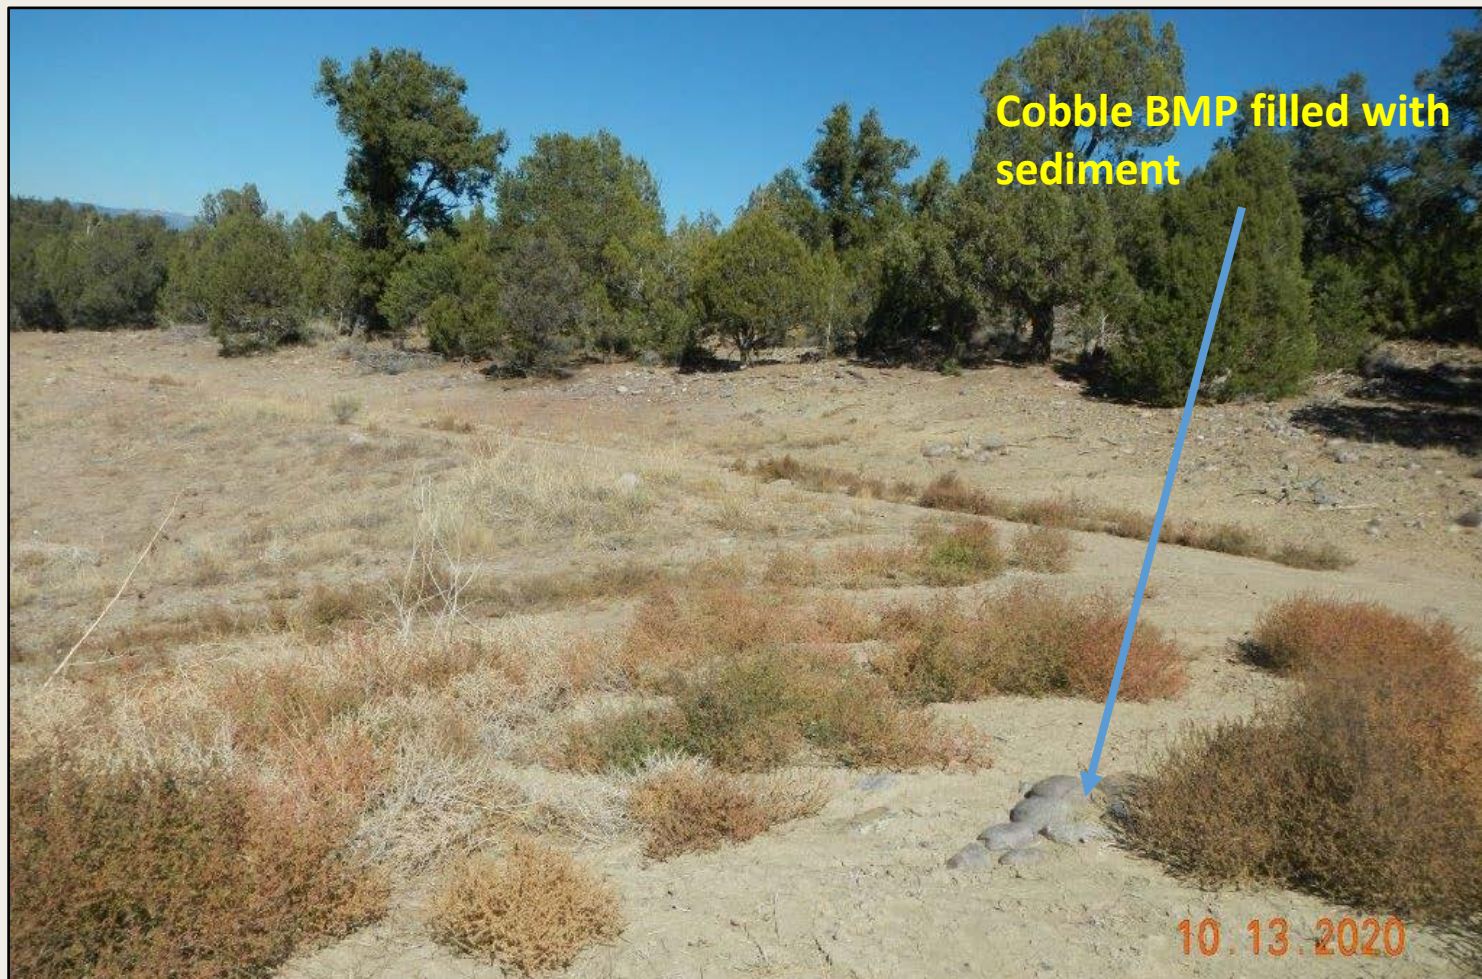
Photo 4. View of area within the northwestern project area where cobble BMP is filled with sediment and no longer functioning. Rilling is also occurring here.

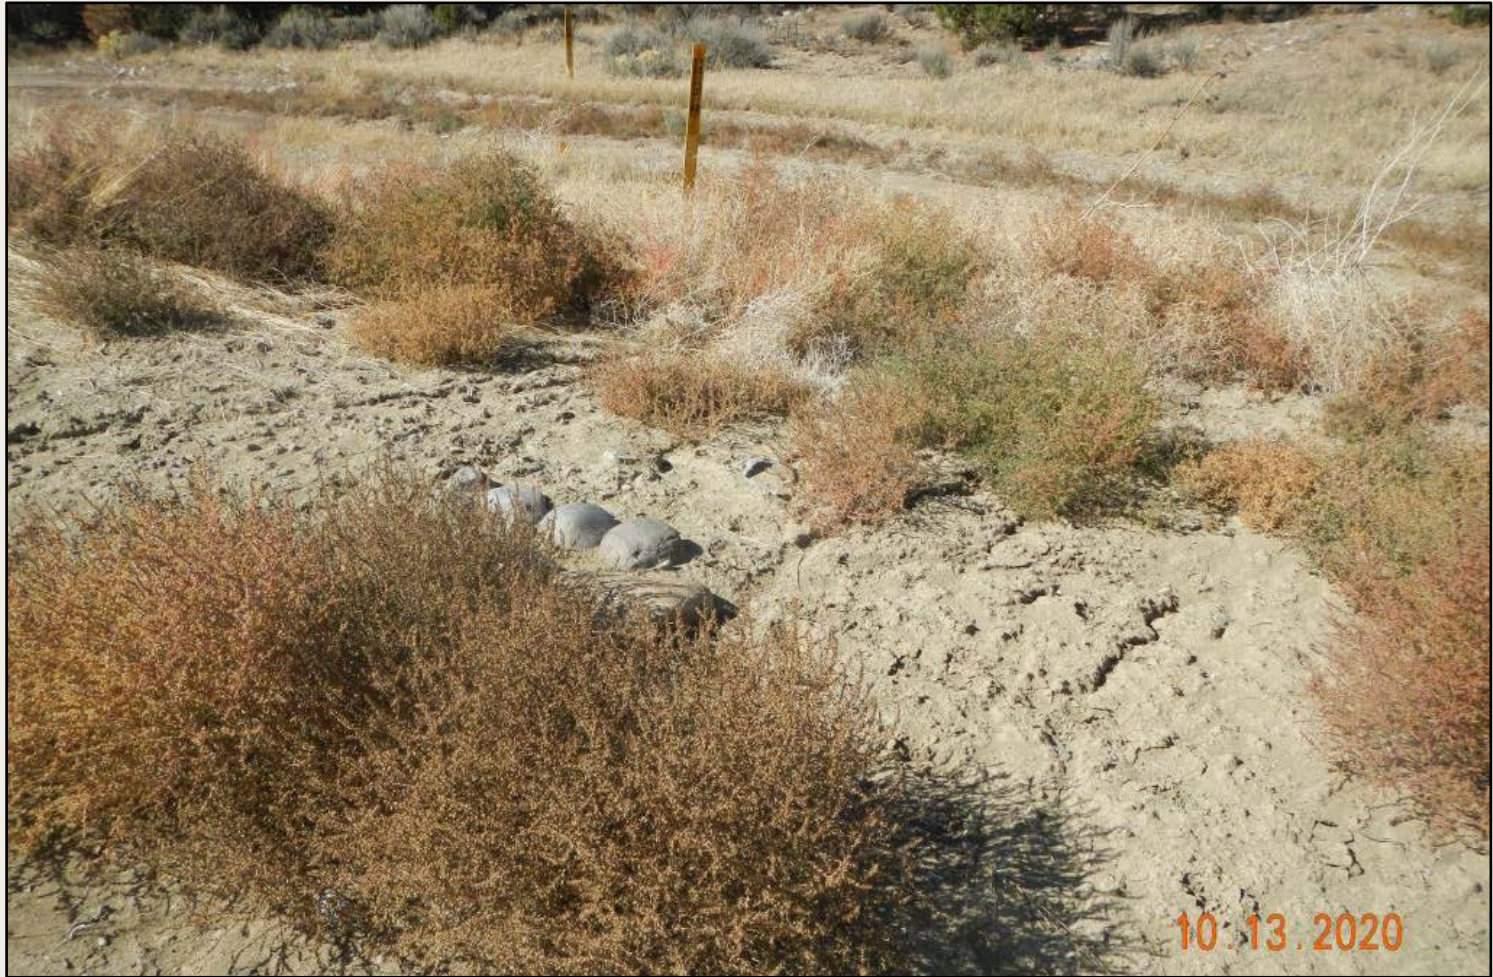
Photo 5. closeup view of erosion and weeds within the northwestern project area.

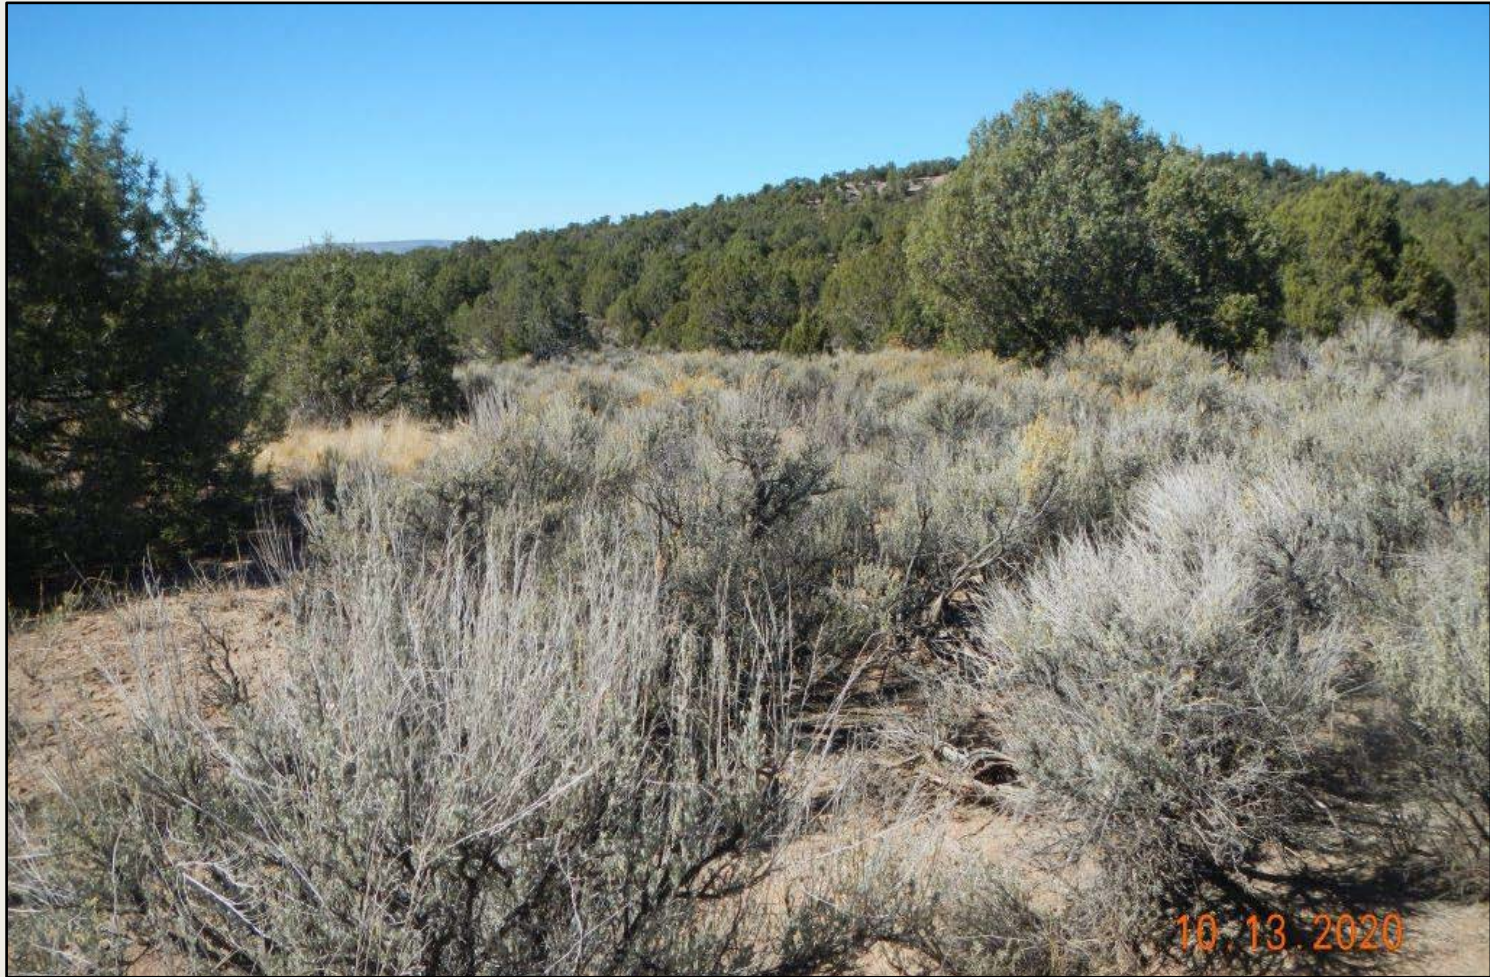
Photo 6. View of reference area vegetation comprised of pinyon and juniper woodland with and understory of sagebrush, squirreltail, Indian ricegrass, and mixed forbs.
