KP Kauffman - COGCC Inspection Photos
Location: John Weigandt Consolidation OLF Release
Spill ID # 465402 Date 10/15/2020

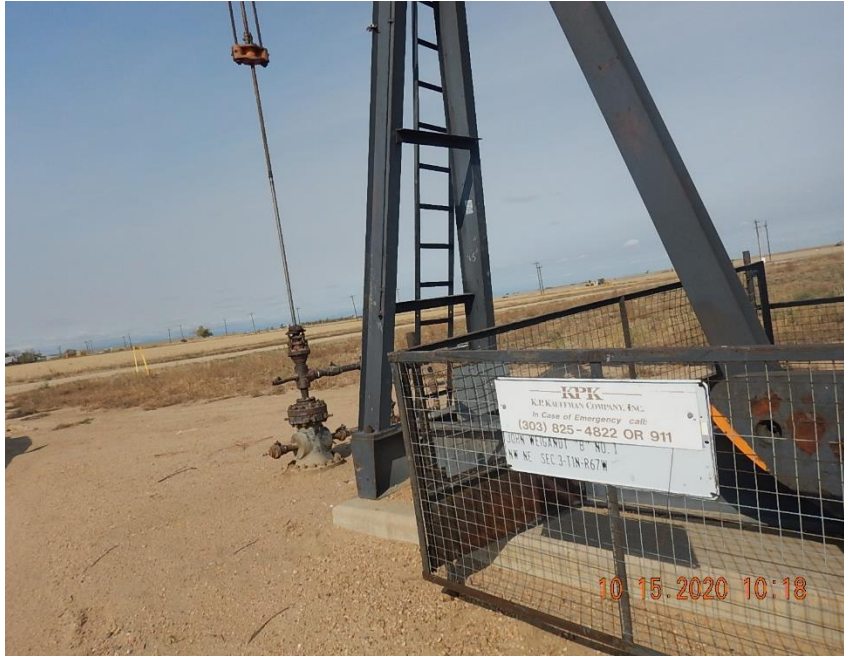
Wellhead and signage; view northwest.

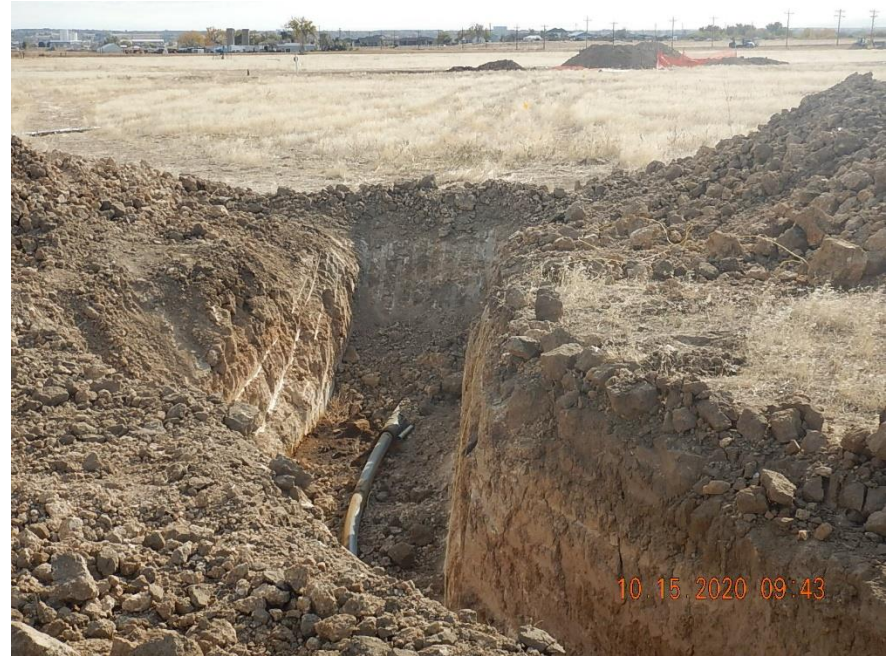
View of NW most bellhole style excavation; looking east toward the excavation at spill release point #465402.

New 3" SDR 11 HDPE pipe stung inside the cut end of the old 4" Consolidation flowline.

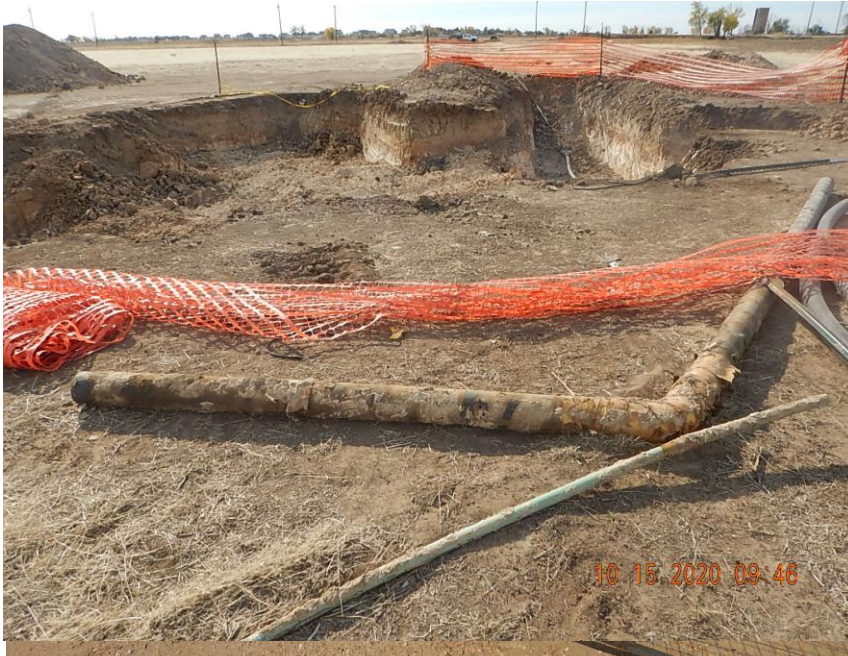
View of excavation at spill release point #465402. Looking South; Compromised section of the old flowline has been cut out and removed.

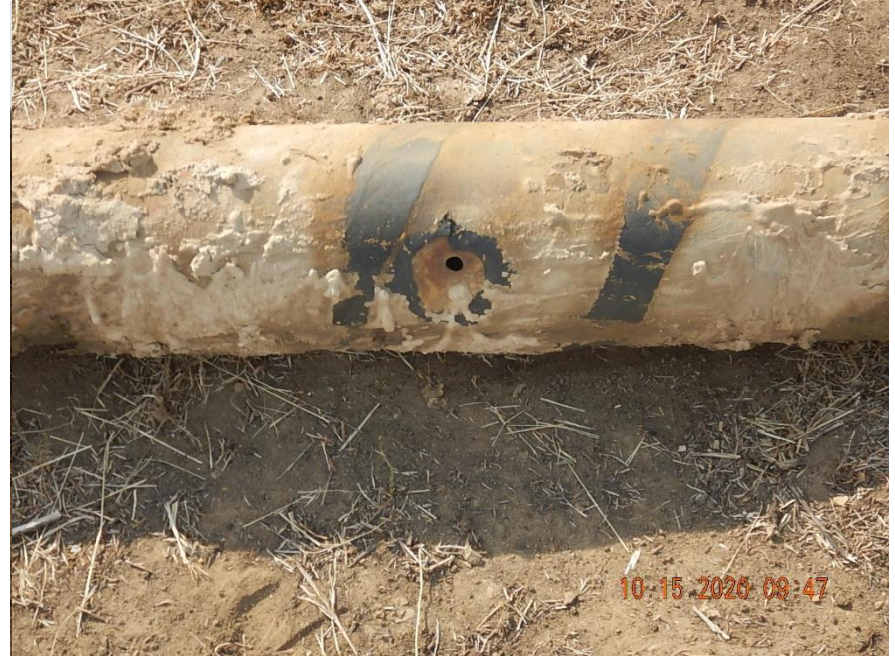
External corrosion hole identified in the side wall of the carbon steel flowline segment removed from the excavation.

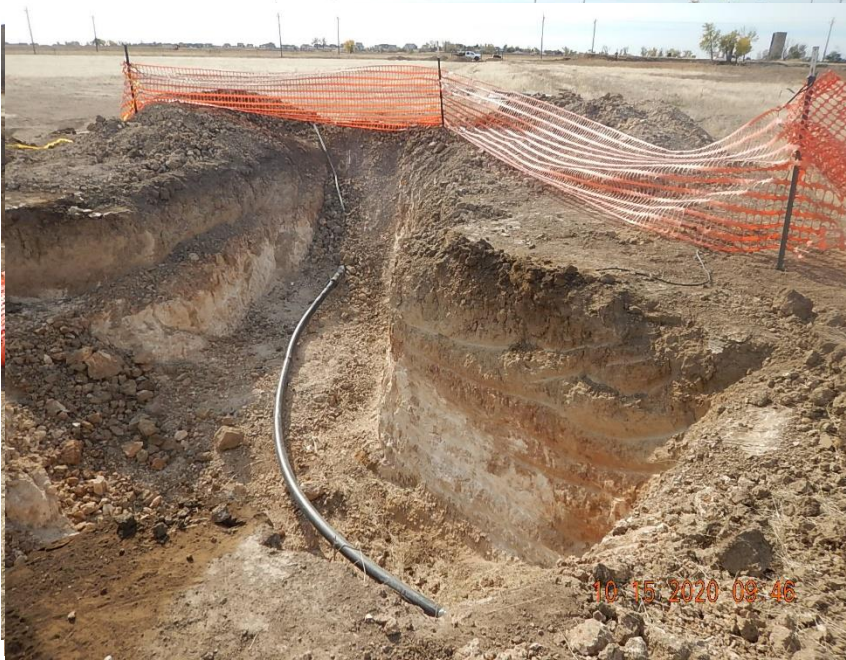
View of excavation at spill release point #465402. Looking South; New 3" SDR 11 HDPE pipe has been stung/ sliplied inside the cut end of the old 4" Consolidation flowline.

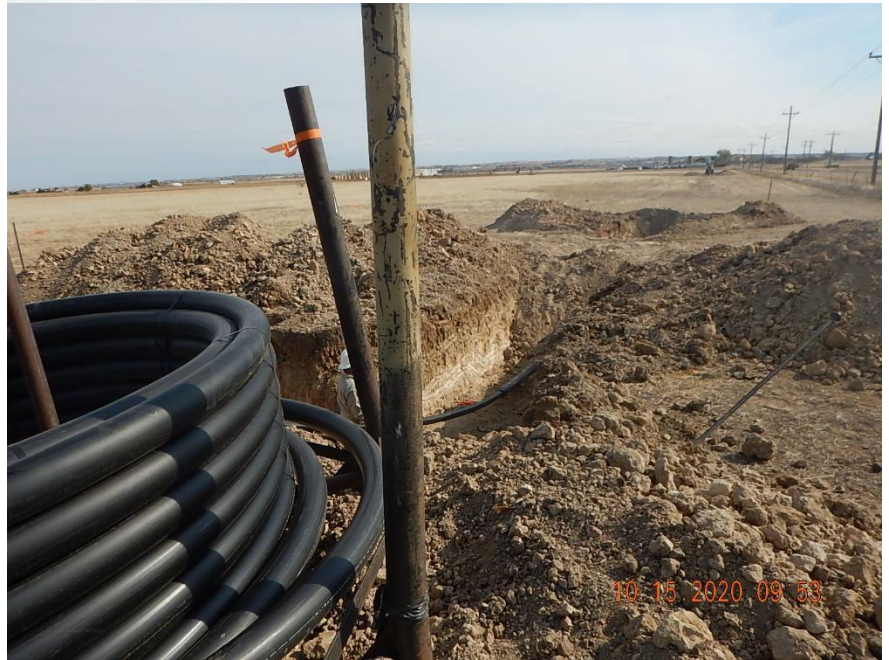
View of SW most excavation; Looking east; New 3" HDPE pipe is being pulled inside the old 4" CS flowline.

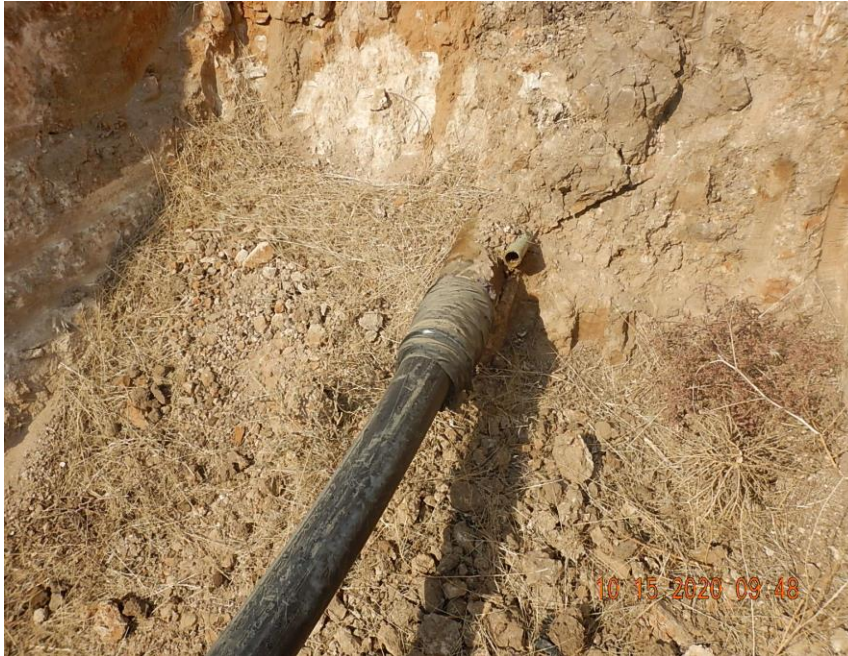
View of 3" HDPE pipe slipline replacement pipe (taped) and the cut end of the out of service 1" CS gas supply line.

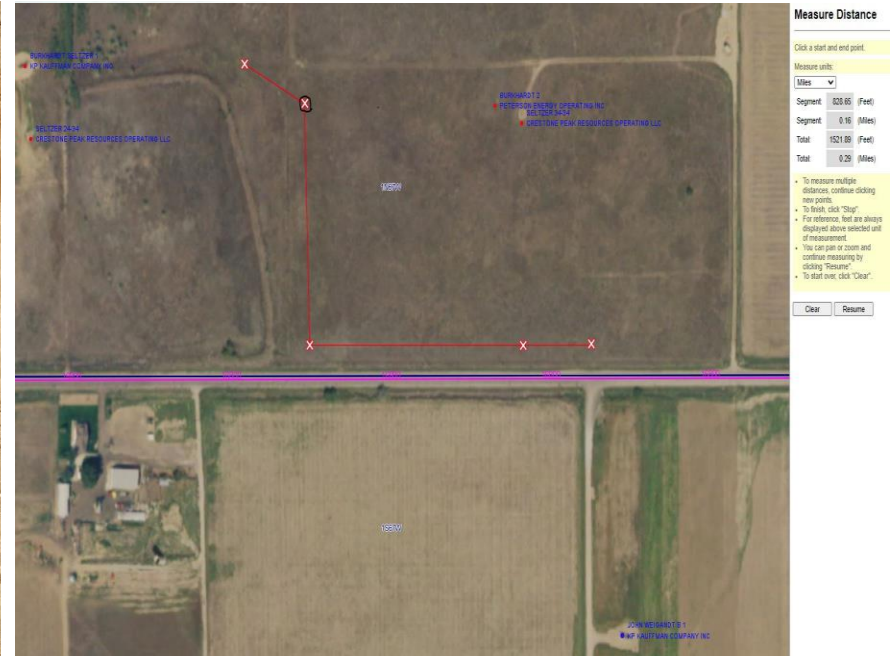
Aerial view of the approximate alignment of the John Weigandt Consolidation slipling project; the X's mark excavations and the location of spill ID 465402 is circled.
