Inspection Photos

API: 071-07766

Operator: EVERGREEN NATURAL RESOURCES

Inspection Date: 10/8/2020

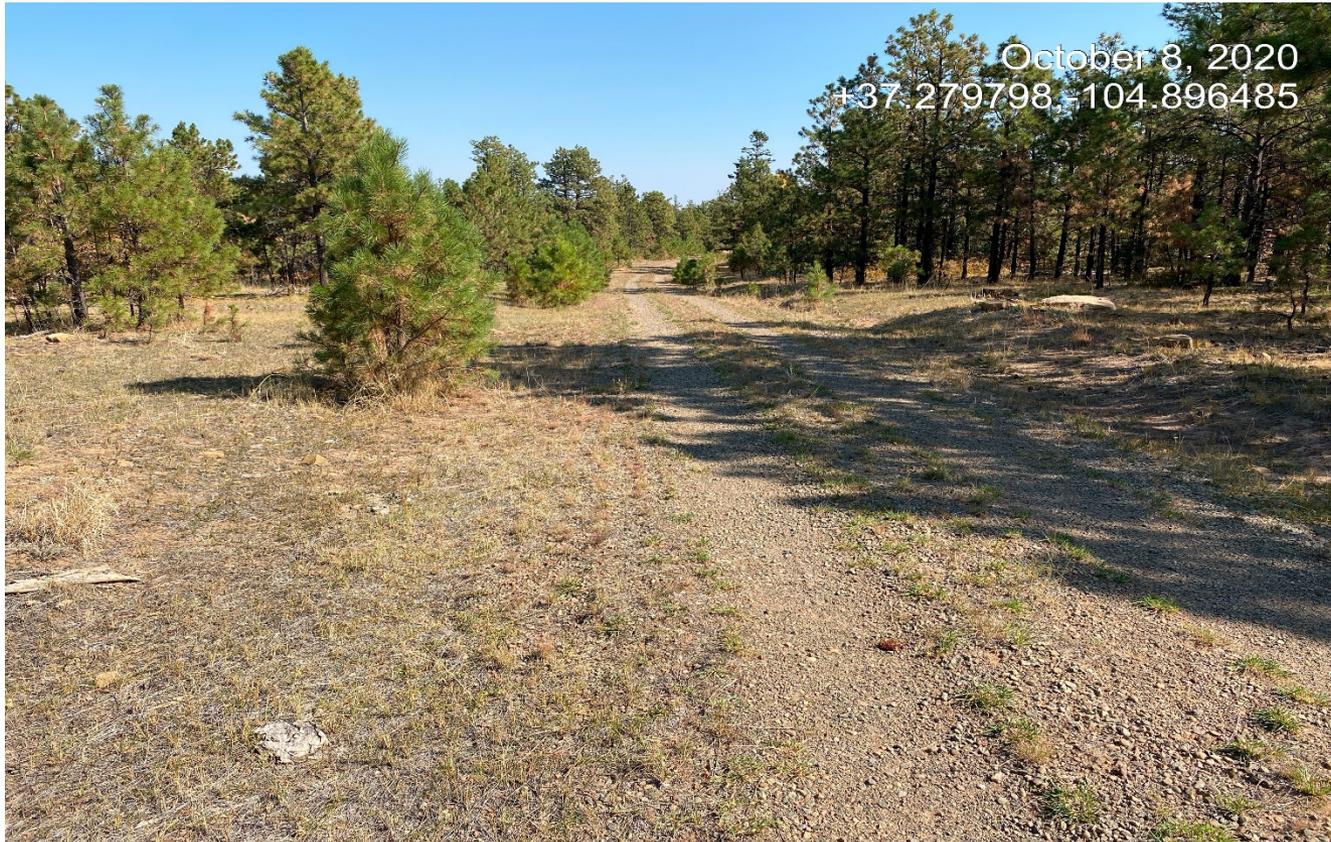
Photo 1. Facing northeast along the access road. The beginning portion of the location is stabilized with gravel and vegetation.

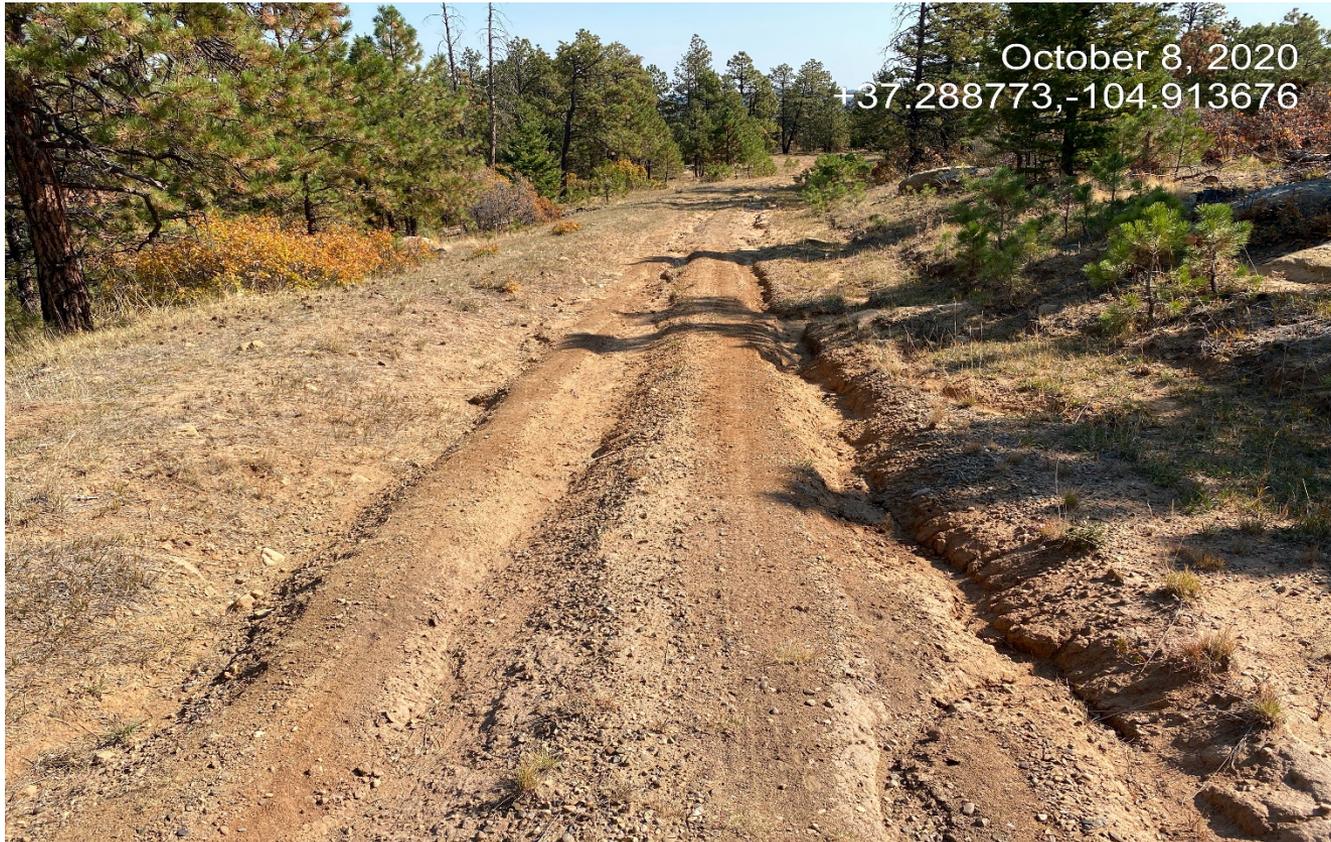
Photo 2. Facing northeast further along the access road. The road is not stabilized and there is erosion channels along the road.

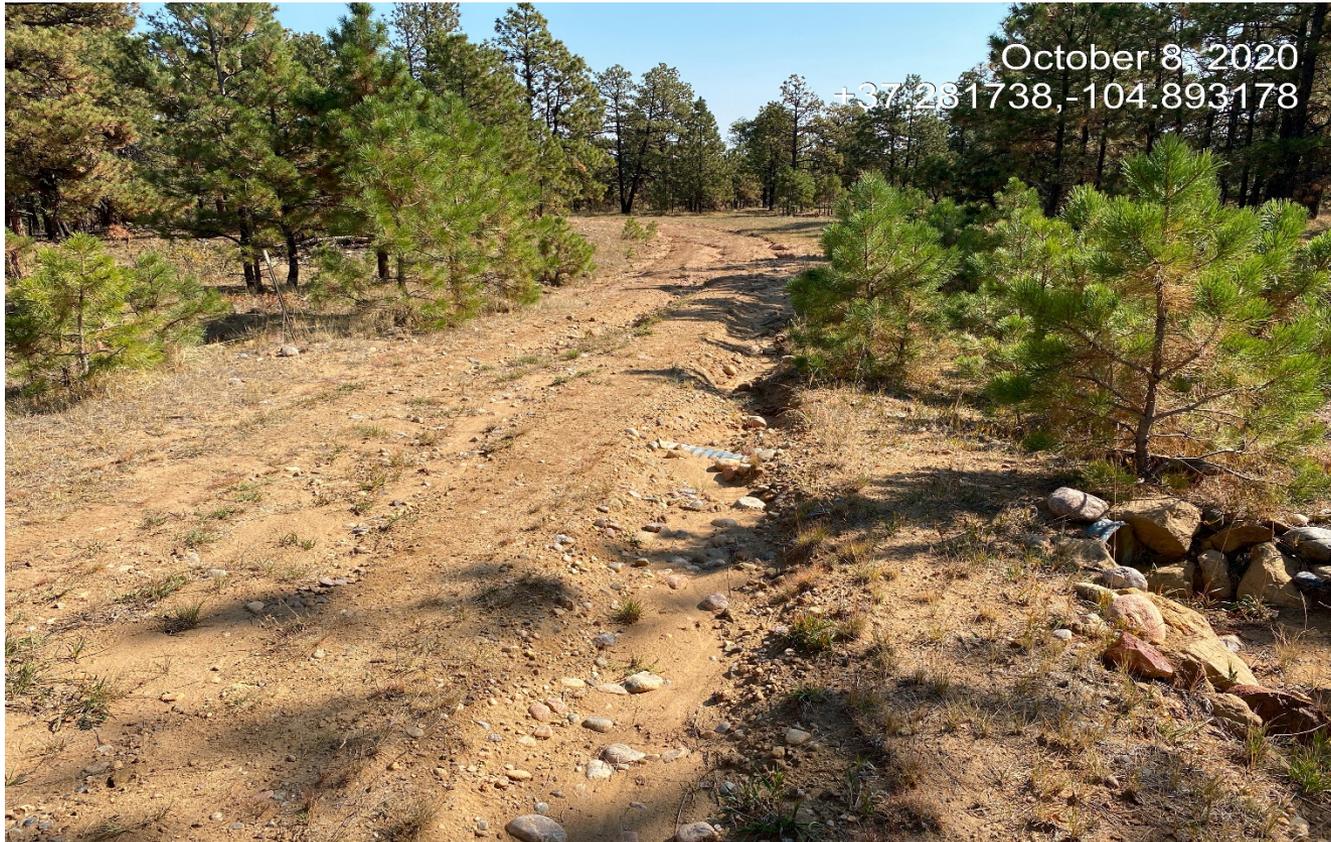
Photo 3. Stormwater is not properly diverted to the culverts along the road.

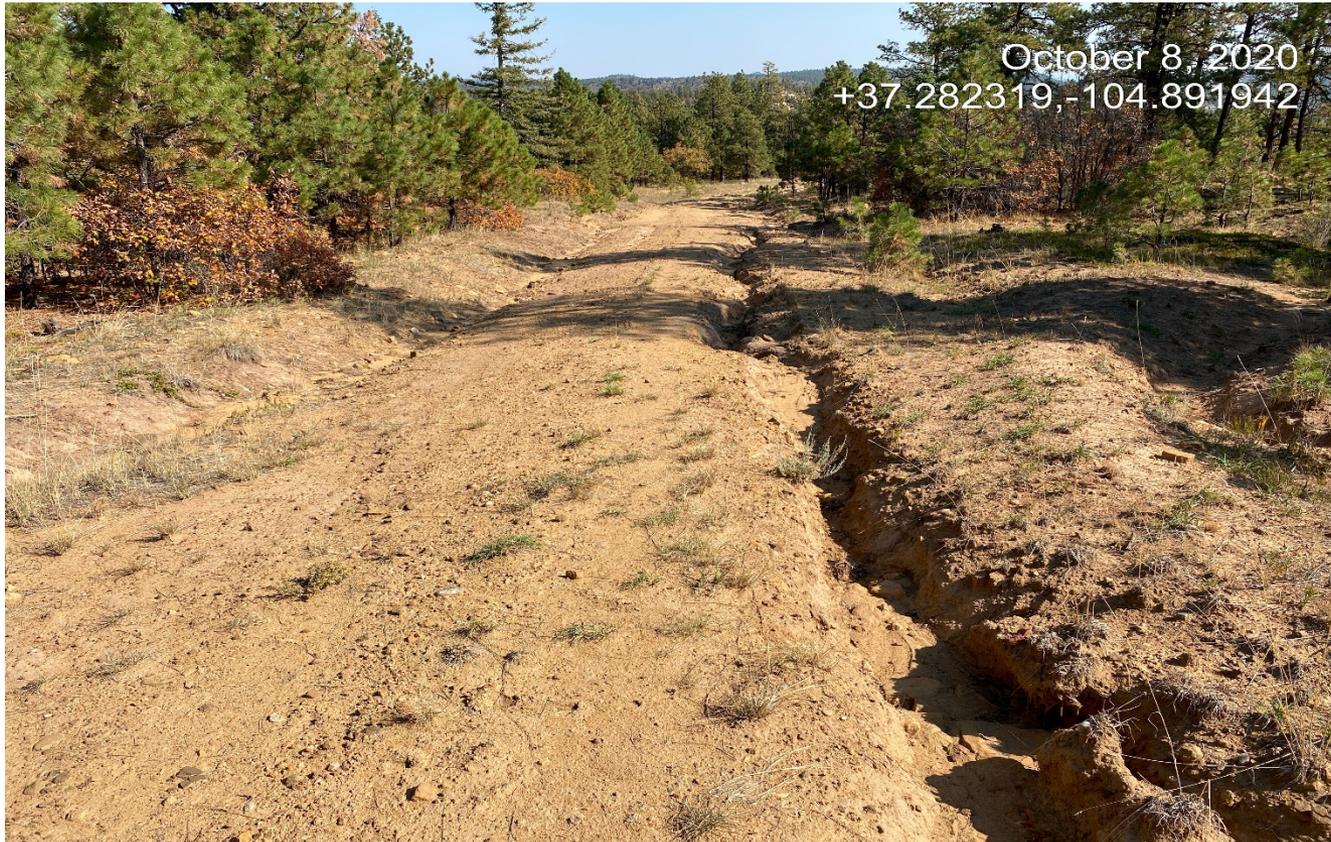
Photo 4. Facing northeast further along the access road. The road is not stabilized and there is erosion channels along the road.

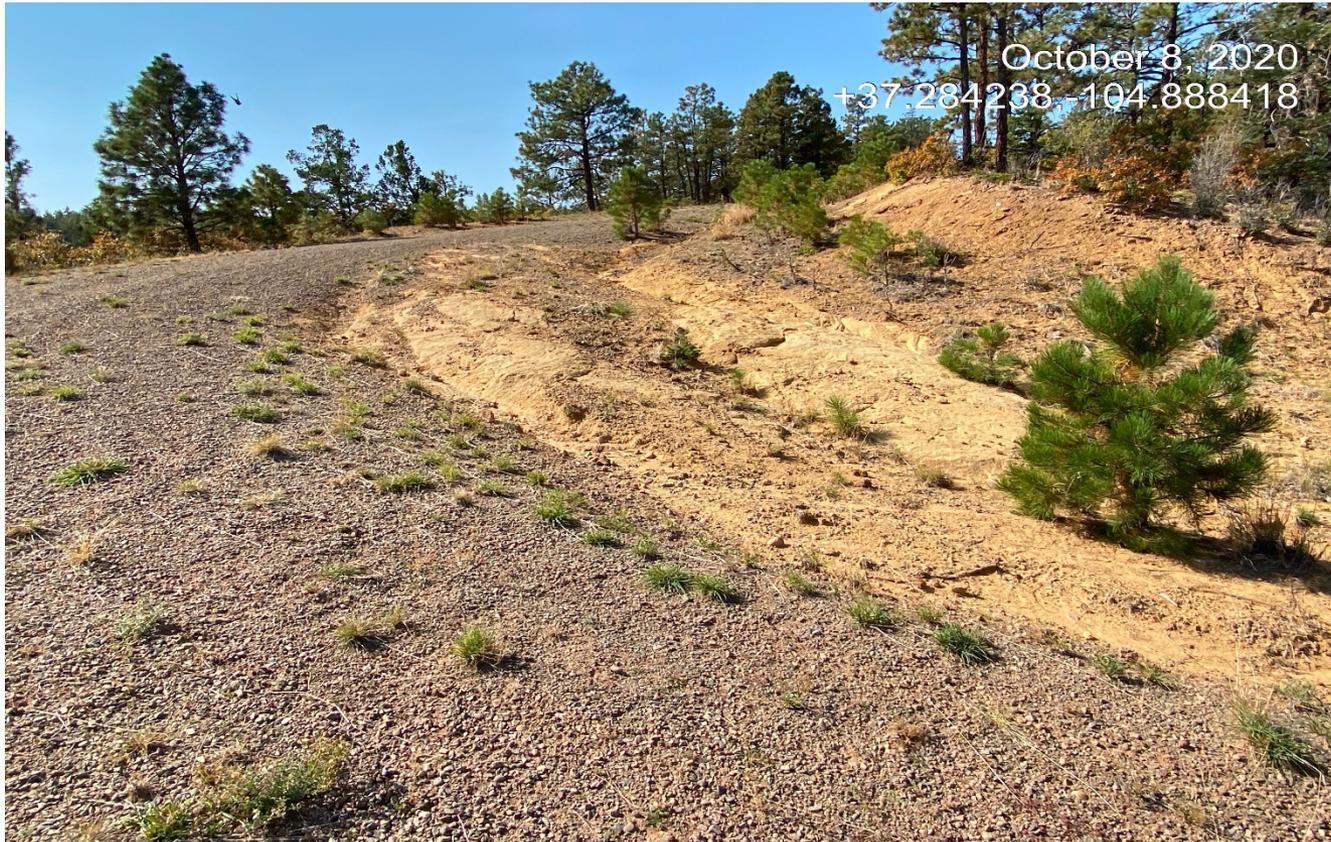
Photo 5. Facing back where the road turns down the hill side into the canyon. The side of the road is not stabilized in this area.

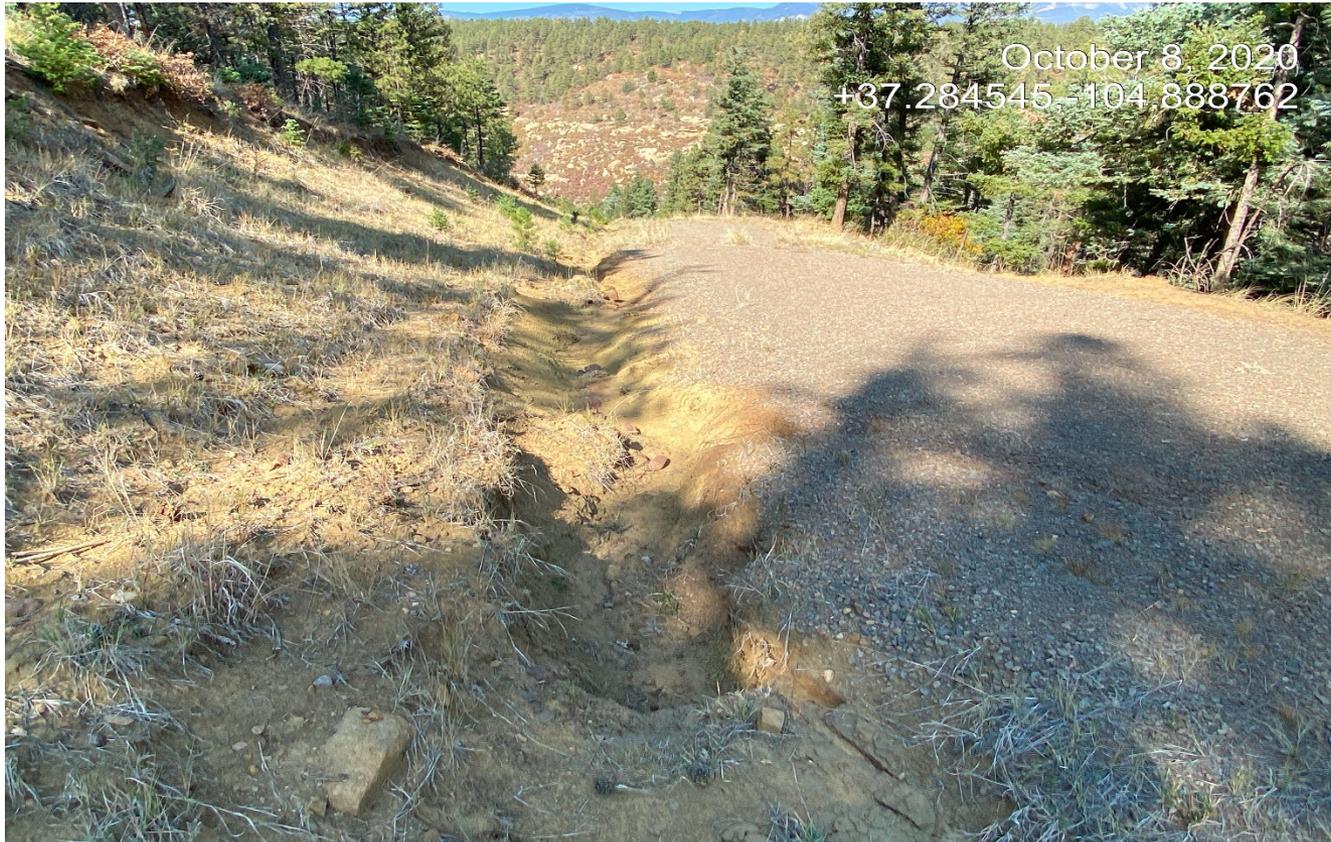
Photo 6. There is erosion occurring along the side of the road and culverts are filled in with sediment.

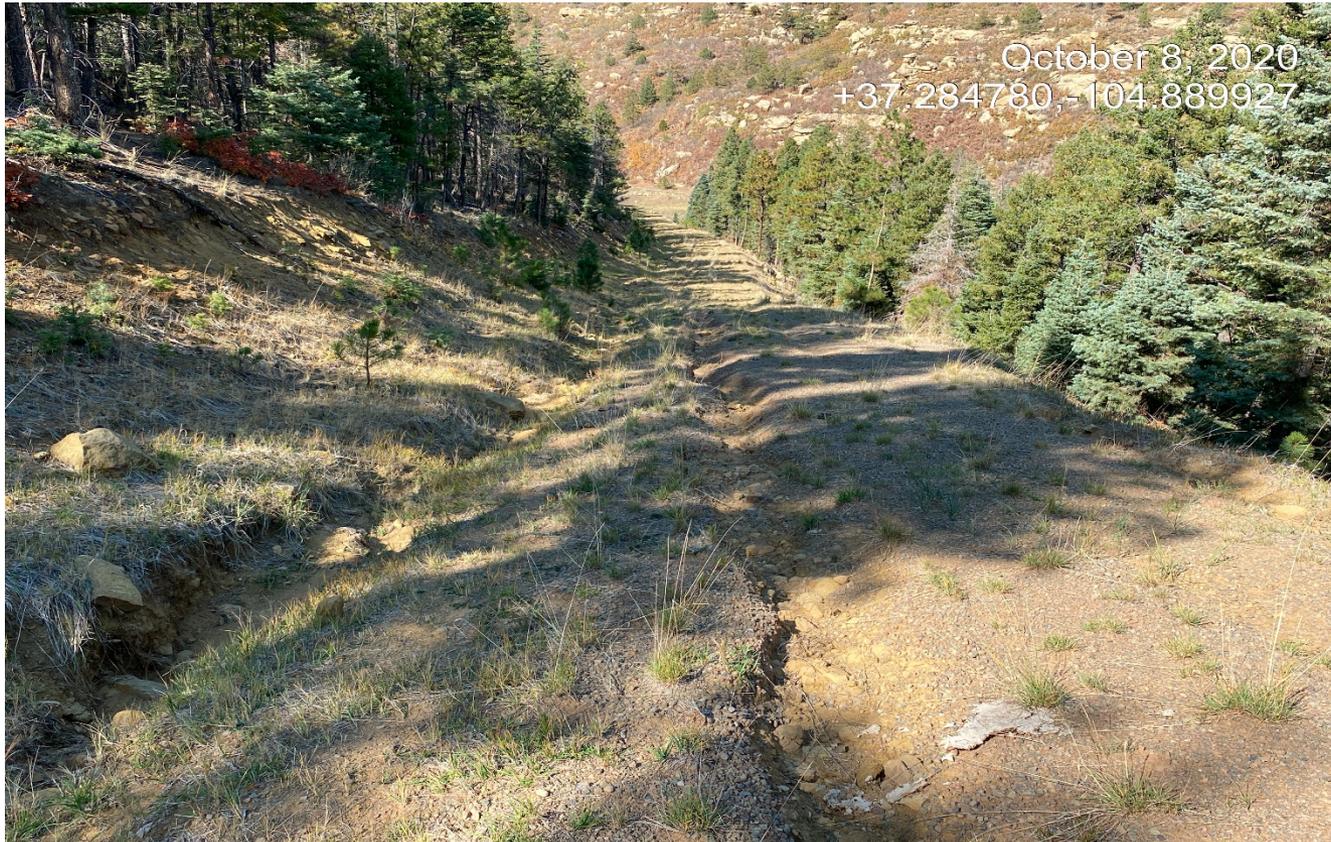
Photo 7. Facing northwest along the access road descending into the canyon. There is erosion along the road all the way down to the canyon bottom.

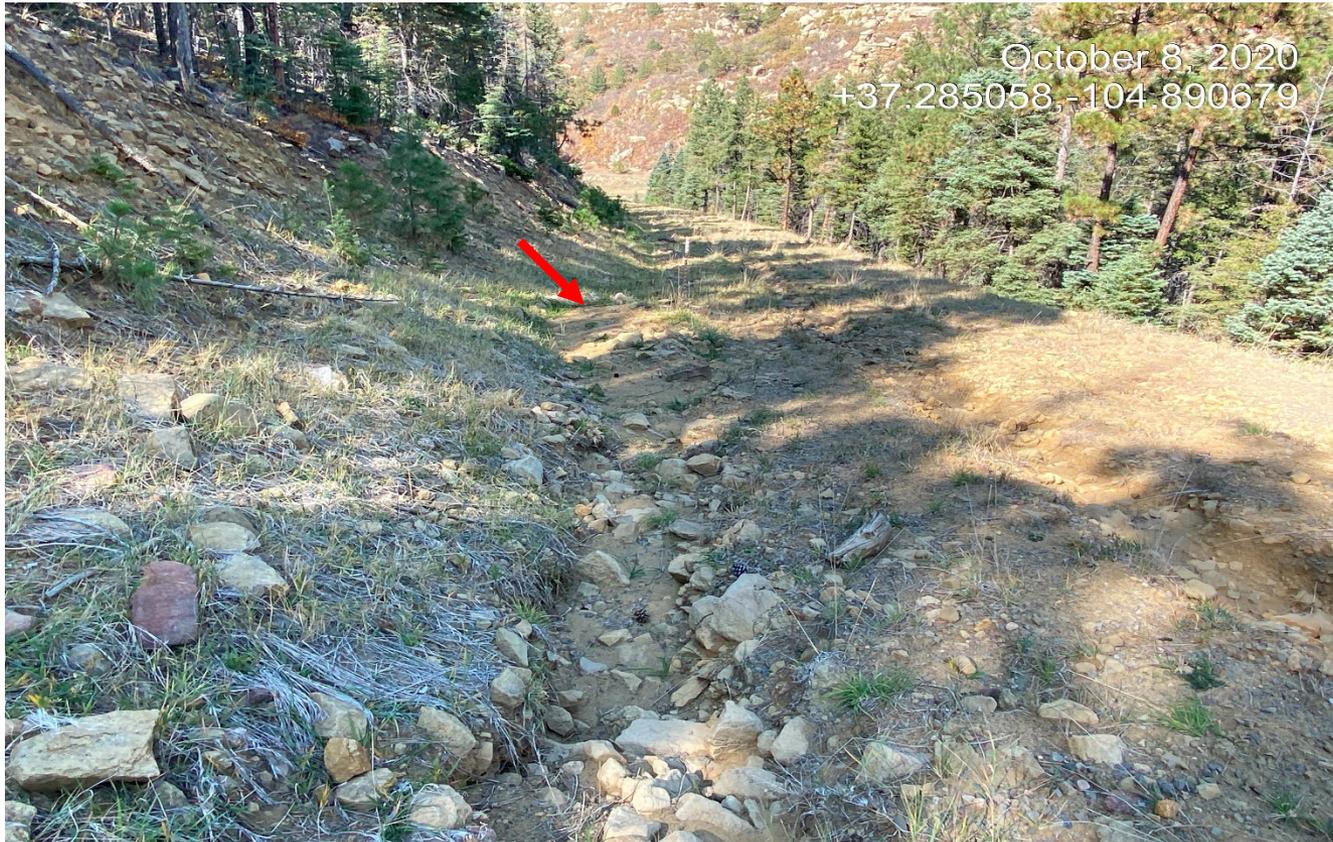
Photo 8. The arrow points to a culvert which is filled in with sediment.

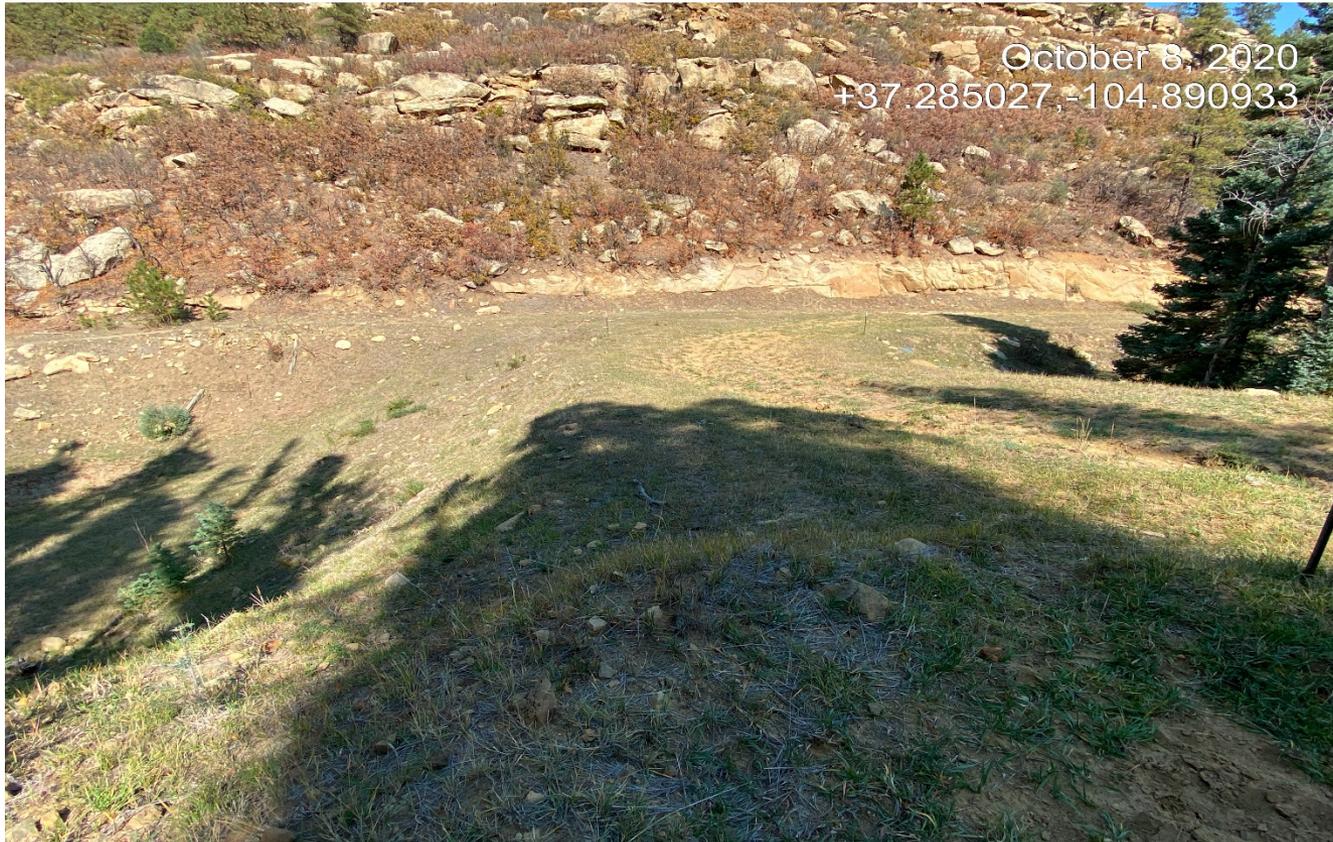
Photo 9. The road crosses the canyon bottom which creates a dam across the canyon.

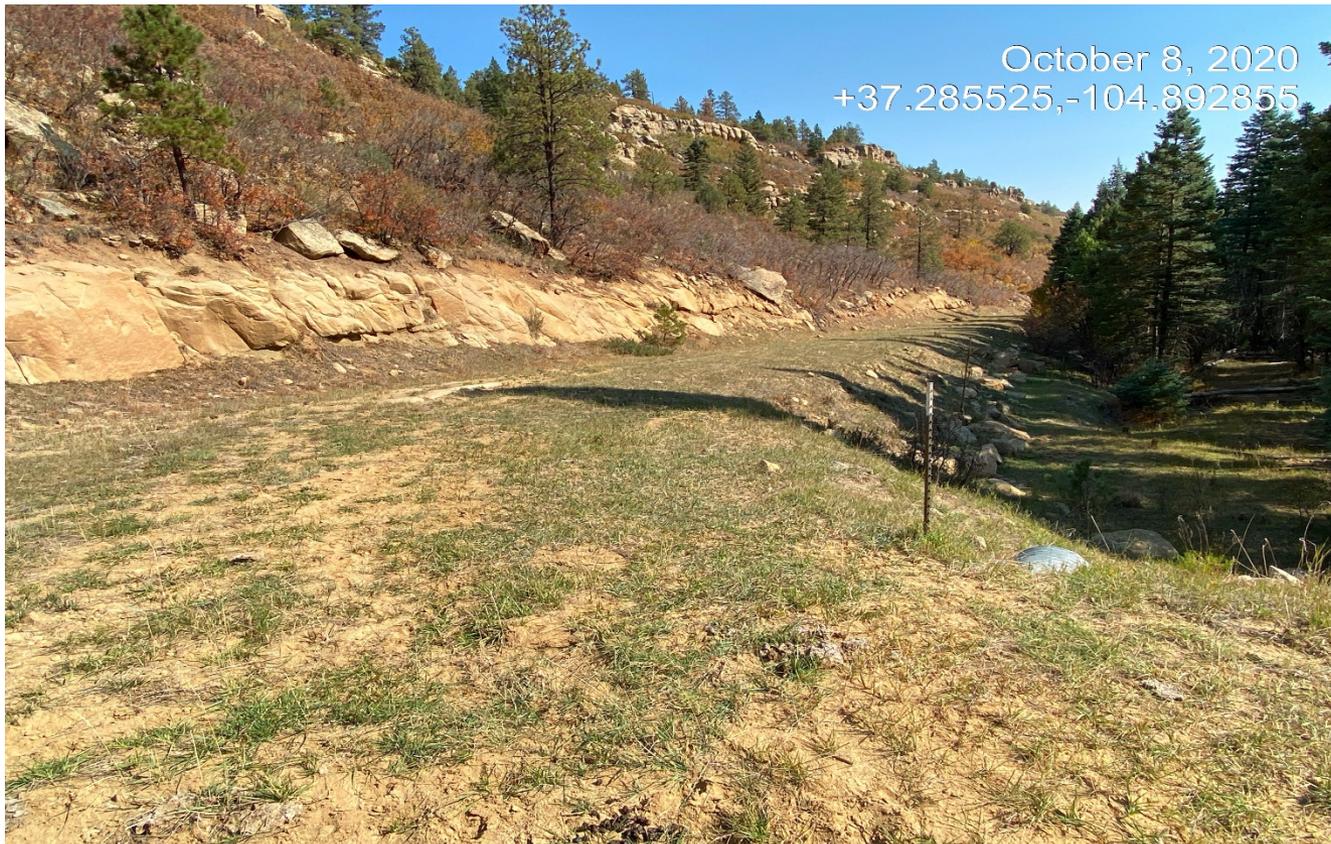
Photo 10. Facing northeast along the access road.

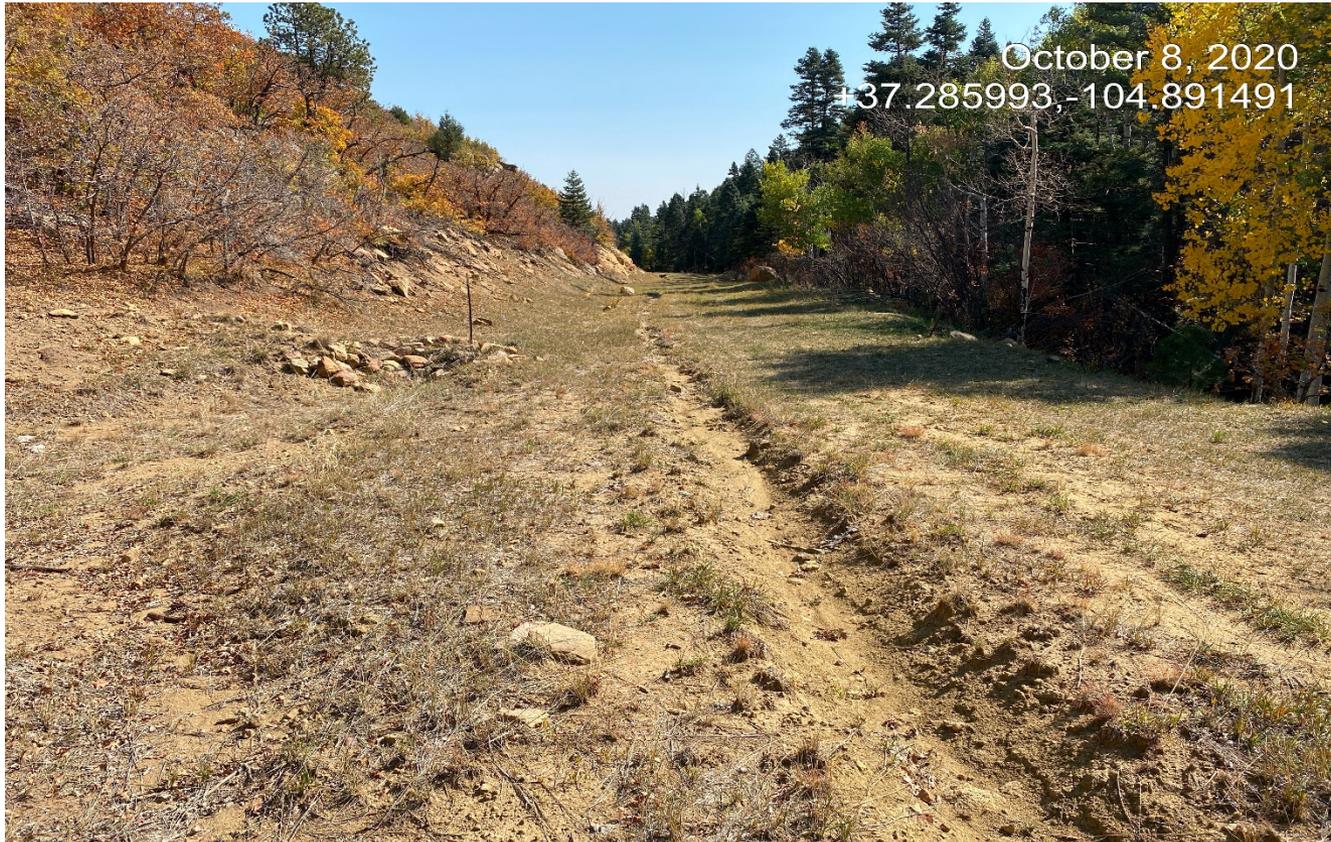
Photo 11. Facing east along the access road. It appears erosion has occurred along the road and stormwater is not diverted toward the culvert.

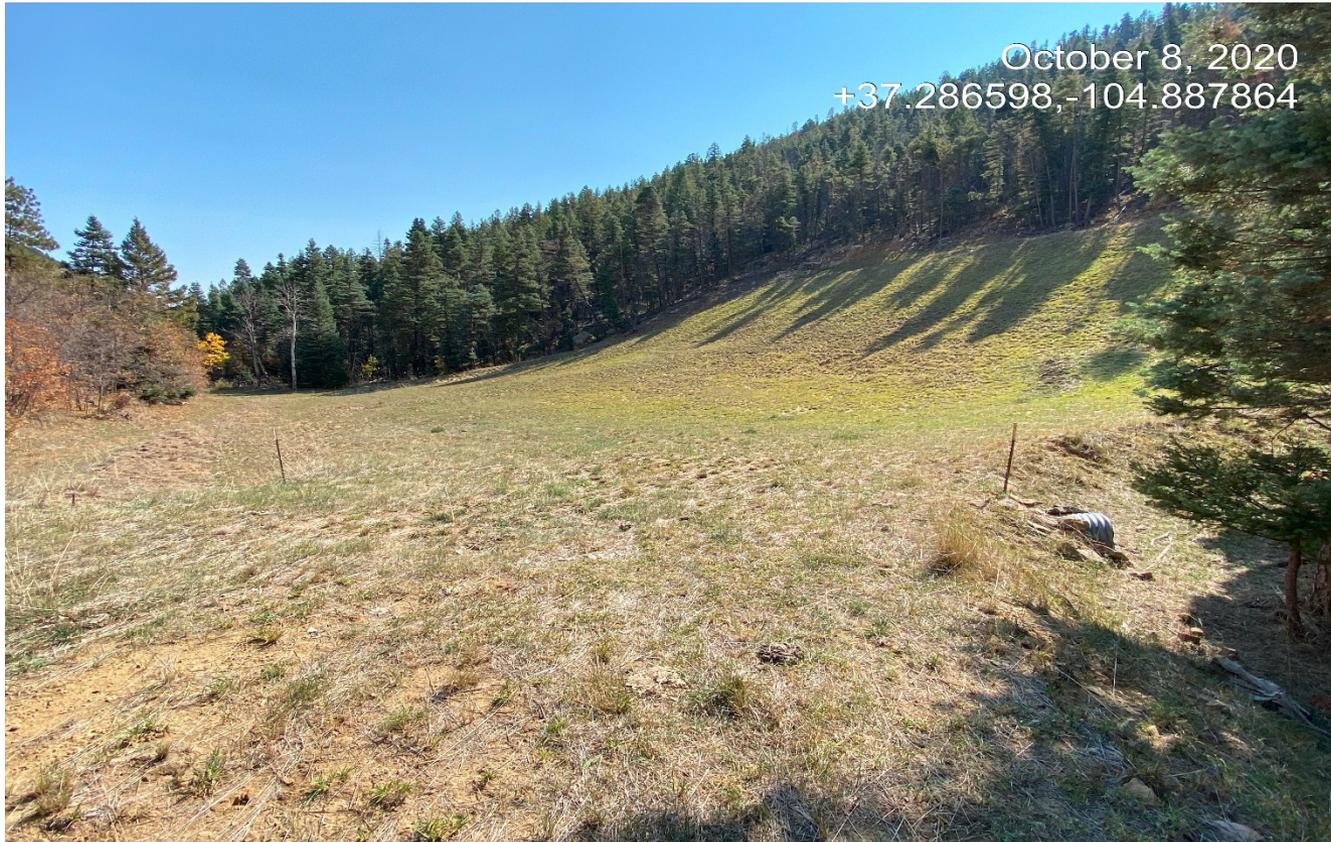
Photo 12. Facing southeast toward the location. There is a culvert that remains at red arrow. The location has been recontoured and reclaimed.

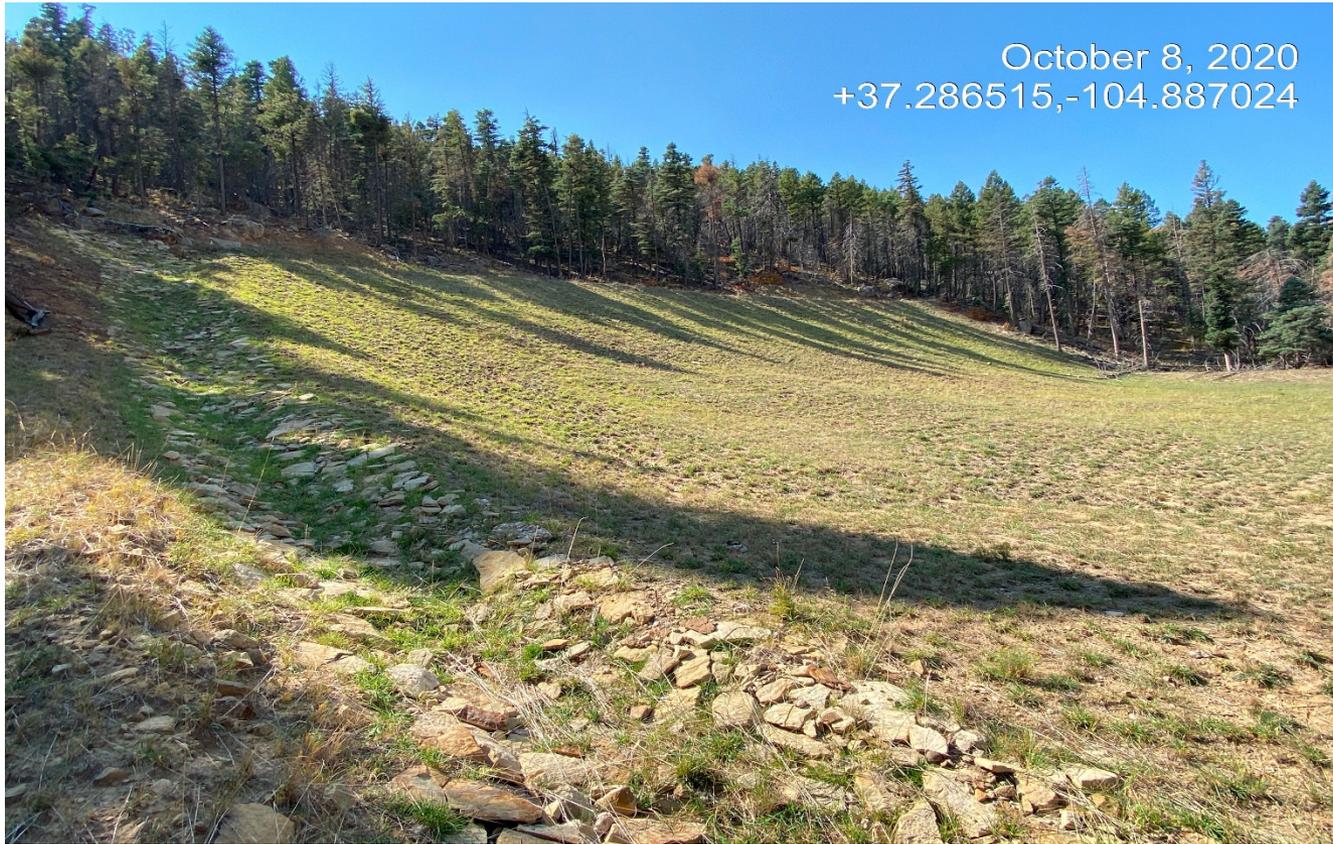
Photo 13. Facing southwest toward the location.

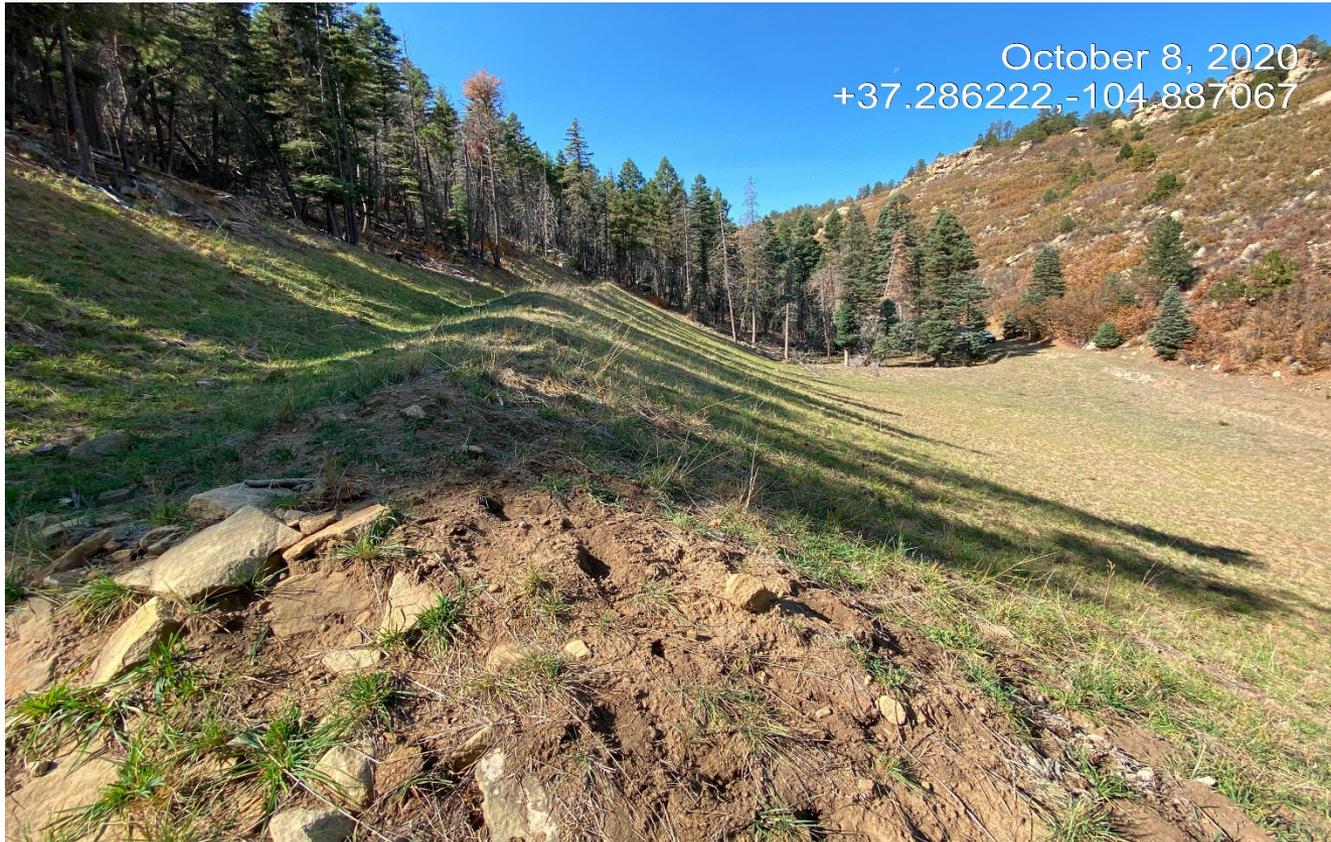
Photo 14. Facing west toward the location. There is a berm along the top portion. The berm has increased the steepness of the slope. Large berms and terracing do not match the contours of the terrain.
