Inspection Photos

Operator: Hilcorp Energy
API: 067-08485
Date: 10/15/2020

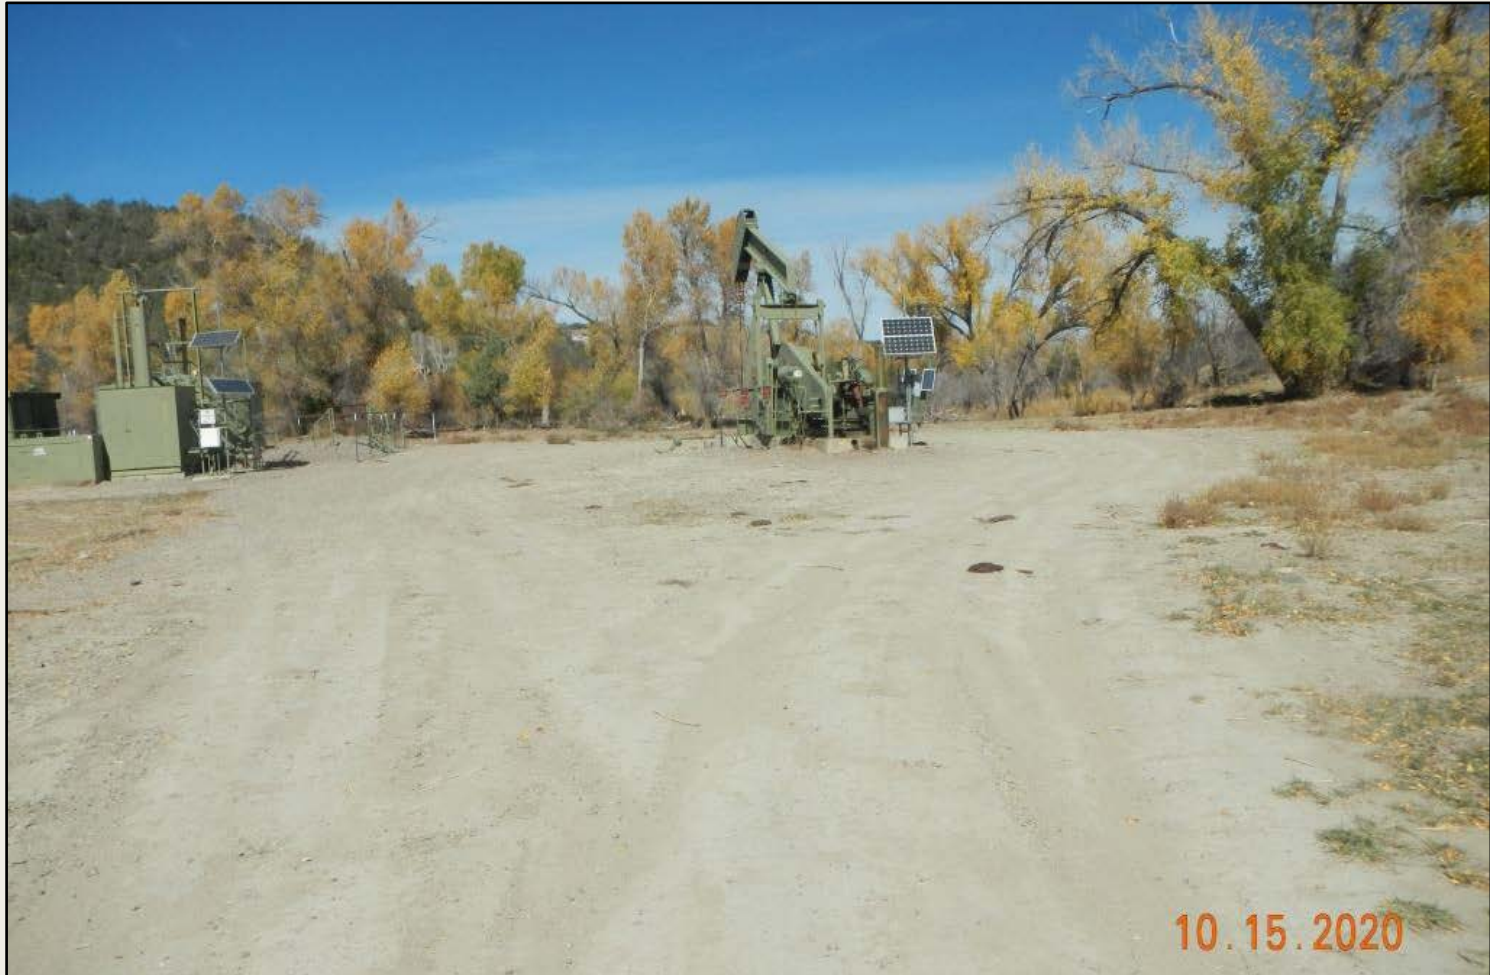
Photo 1. View of the project area from the well pad entrance facing center.

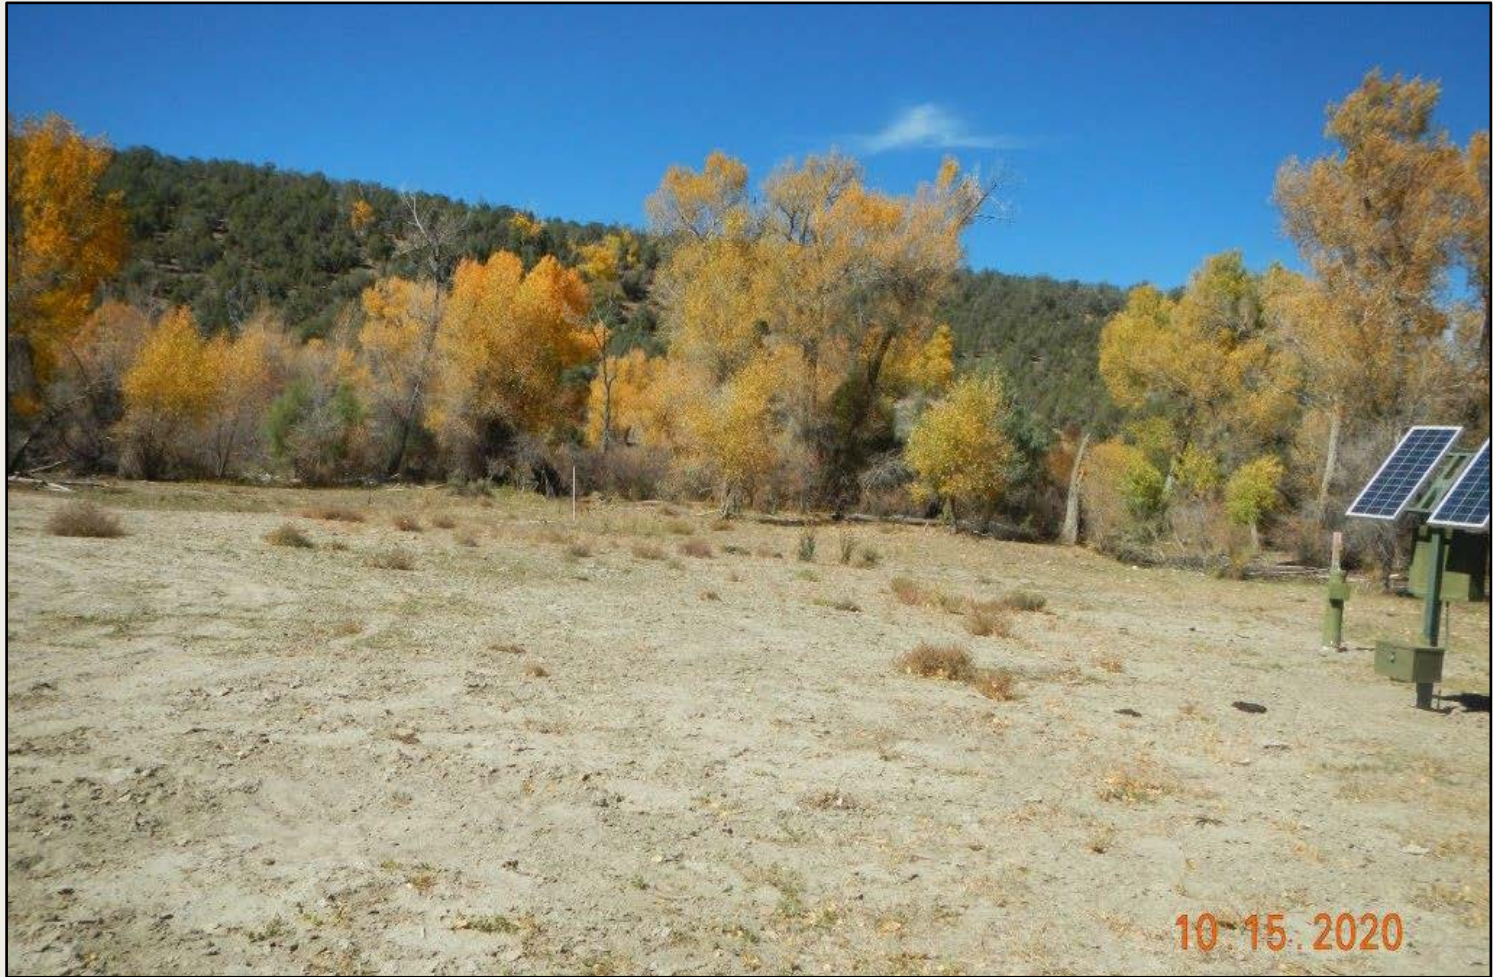
Photo 2. View of the northern project area from the northeastern corner of the working area facing westward. Vegetation is grazed, but appears to be progressing with grasses such as western wheatgrass and sand dropseed.

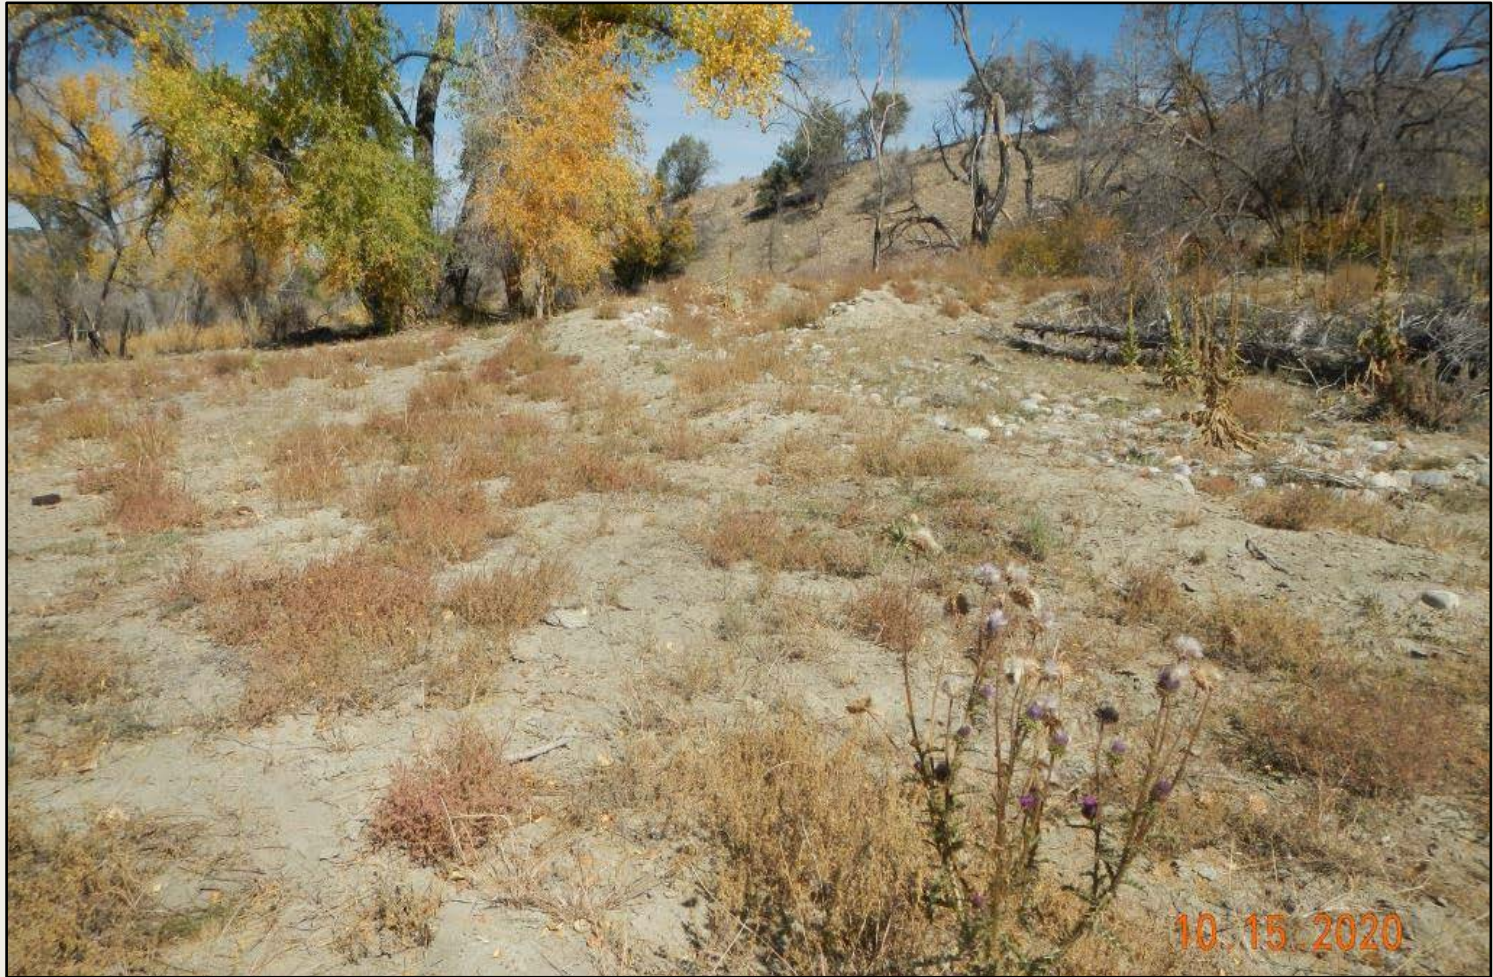
Photo 3. View of the eastern project area from the southeastern corner facing northward. Drainage diversion is cobble-lined. Scattered musk thistles and Russian thistles need to be removed and properly disposed of.

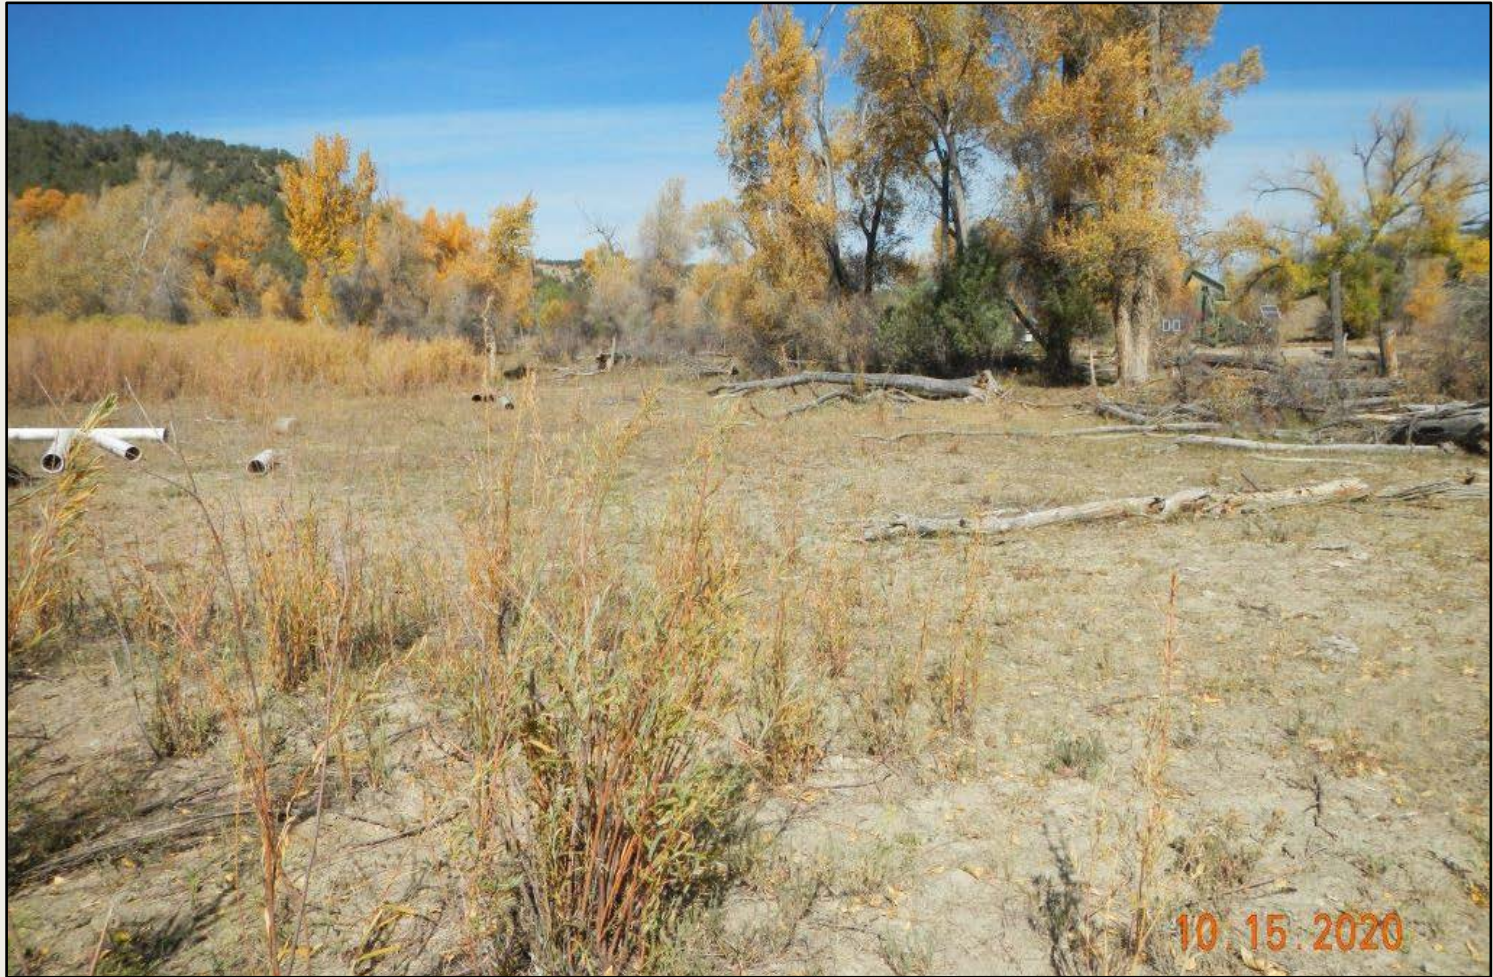
Photo 4. View of reference area vegetation comprised of sand bar willow, western wheatgrass, smooth brome, and narrowleaf cottonwood.
