Stormwater Inspection Report

Operator:	Laramie Energy, LLC
Project:	Collbran
Location:	McDaniel 2-1
Date:	Monday, October 19, 2020
Weather:	Partly Cloudy, Light Breeze, High 61° Lo 28°

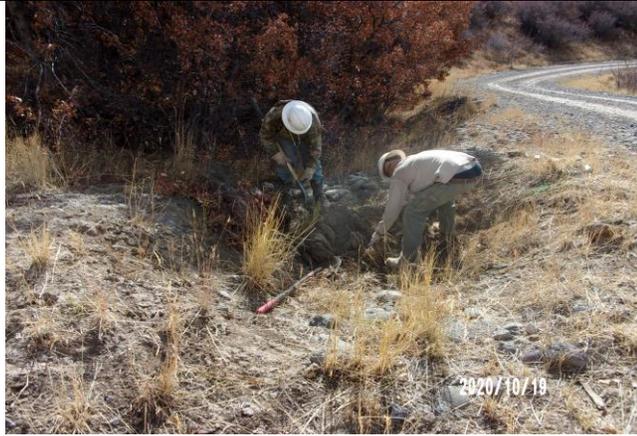
Photo 1

Corrective Actions on the McDaniel 2-1 Pad

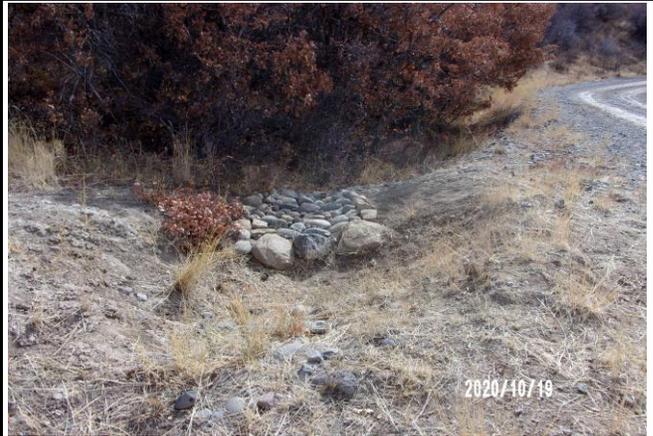
Photo 2

Corrective Actions on the McDaniel 2-1 Pad

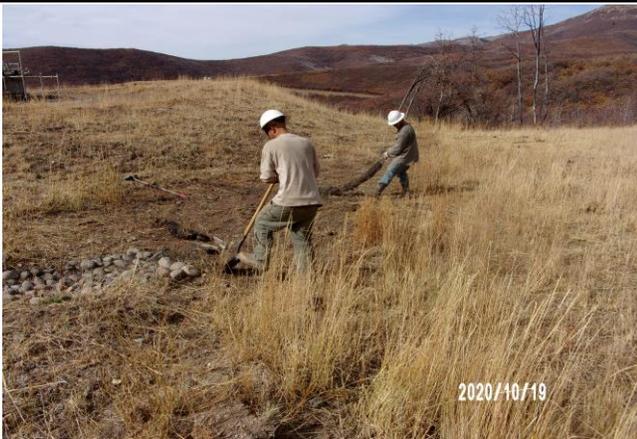
Photo 3

Corrective Actions on the McDaniel 2-1 Pad

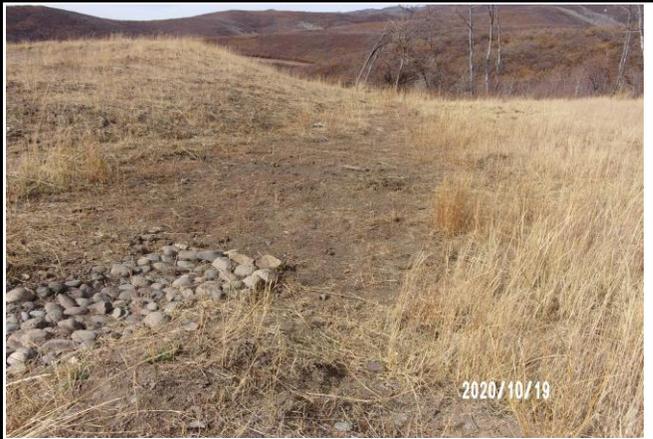
Photo 4

Corrective Actions on the McDaniel 2-1 Pad
