# Inspection Photos

API: 043-06196

Operator: JAVERNICK OIL

Inspection Date: 10/19/2020

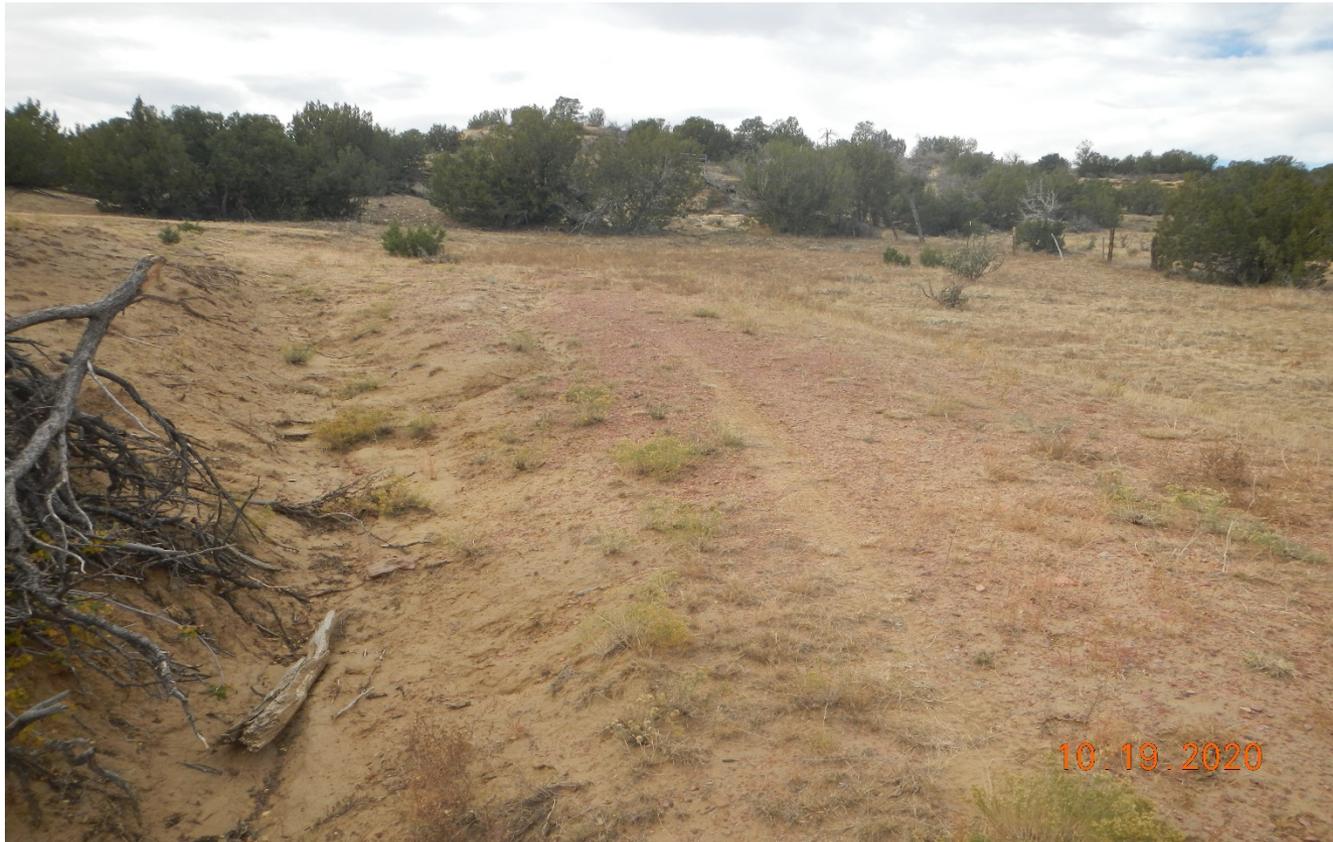
**Photo 1.** Facing southwest along the access road. The access road has not been reclaimed.

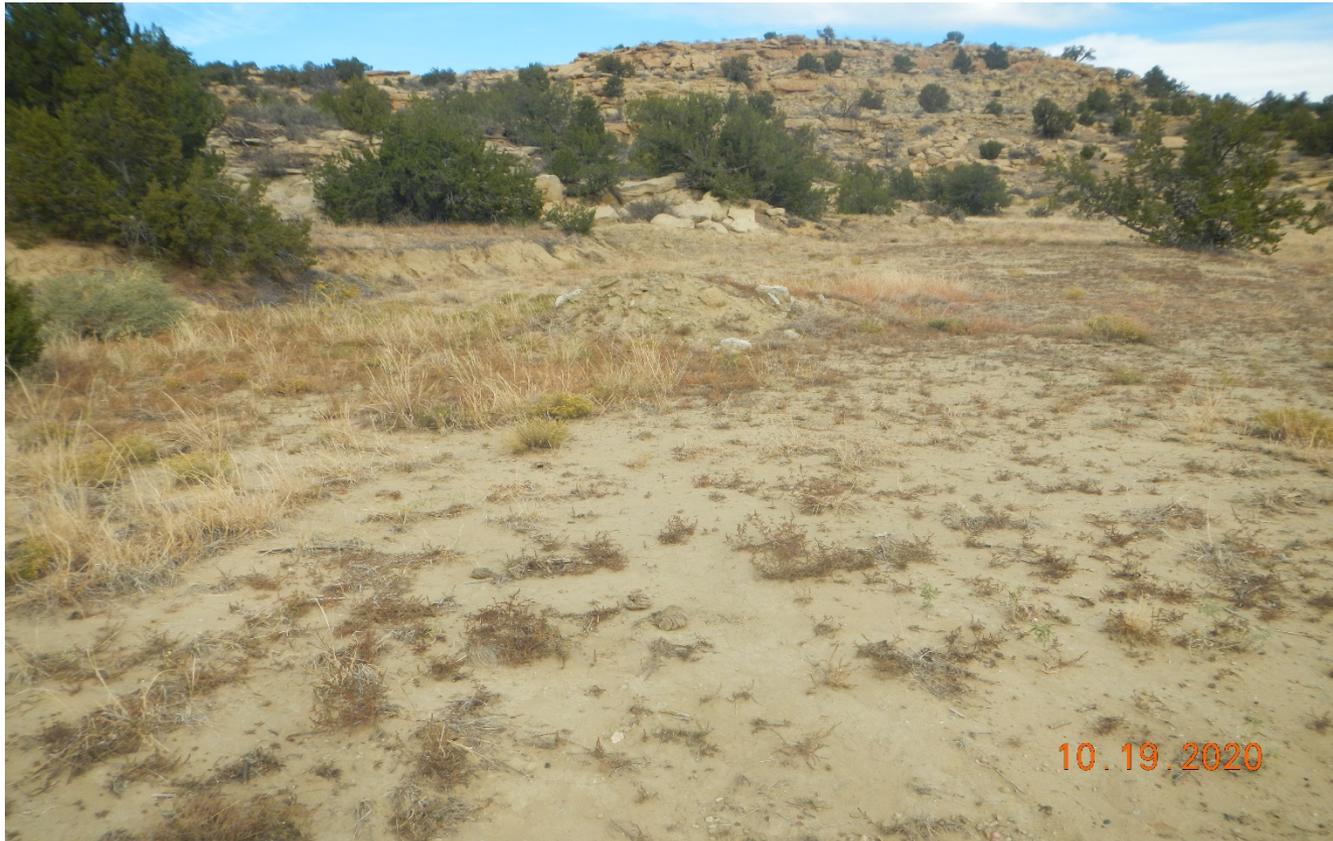
**Photo 2.** Facing northwest toward the location. The location has not been recontoured and reclaimed. There is an open hole and soil pile at the center of the location.

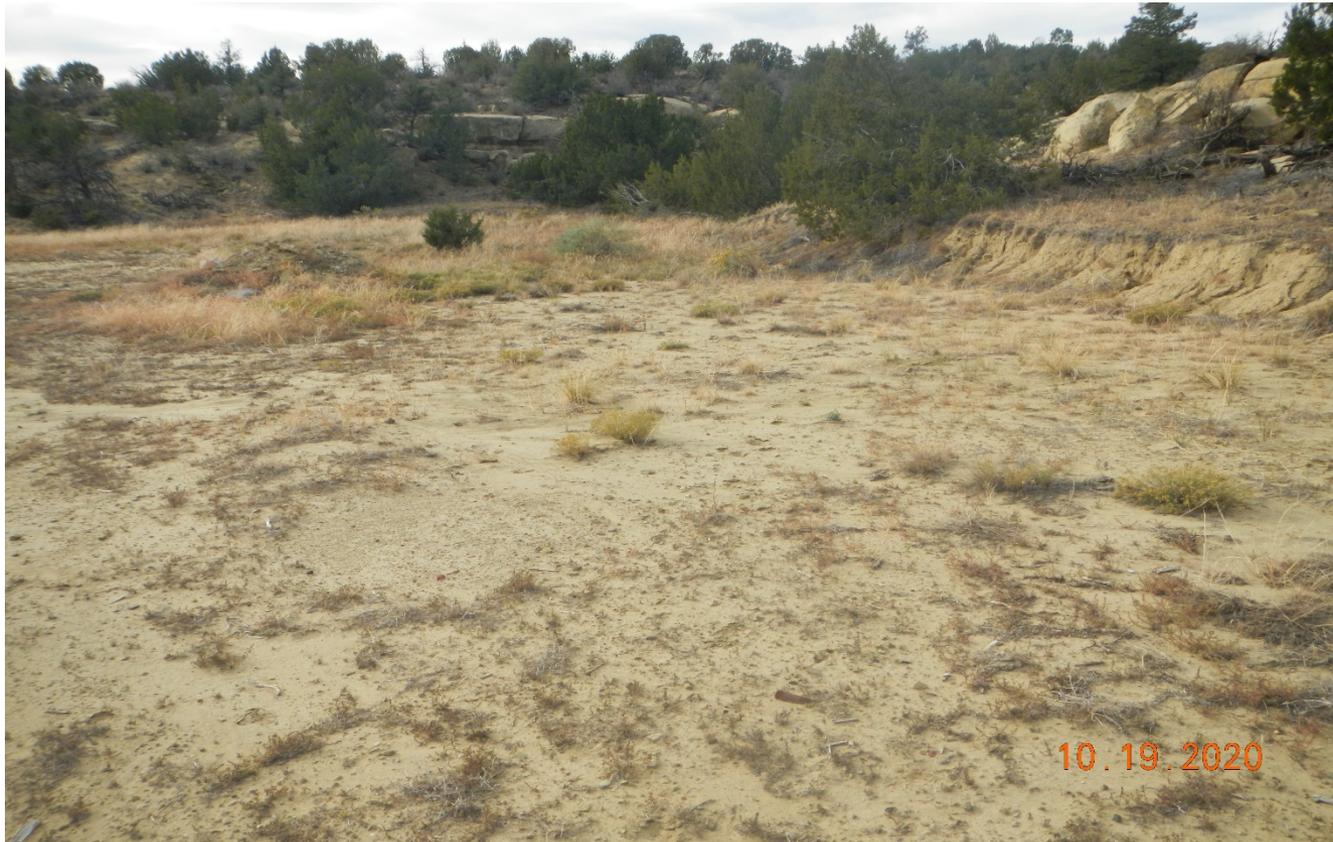
**Photo 3.** Facing southwest at the location. The cut slope is shown in the right side of the o. The location will need to be recontoured and reclaimed.

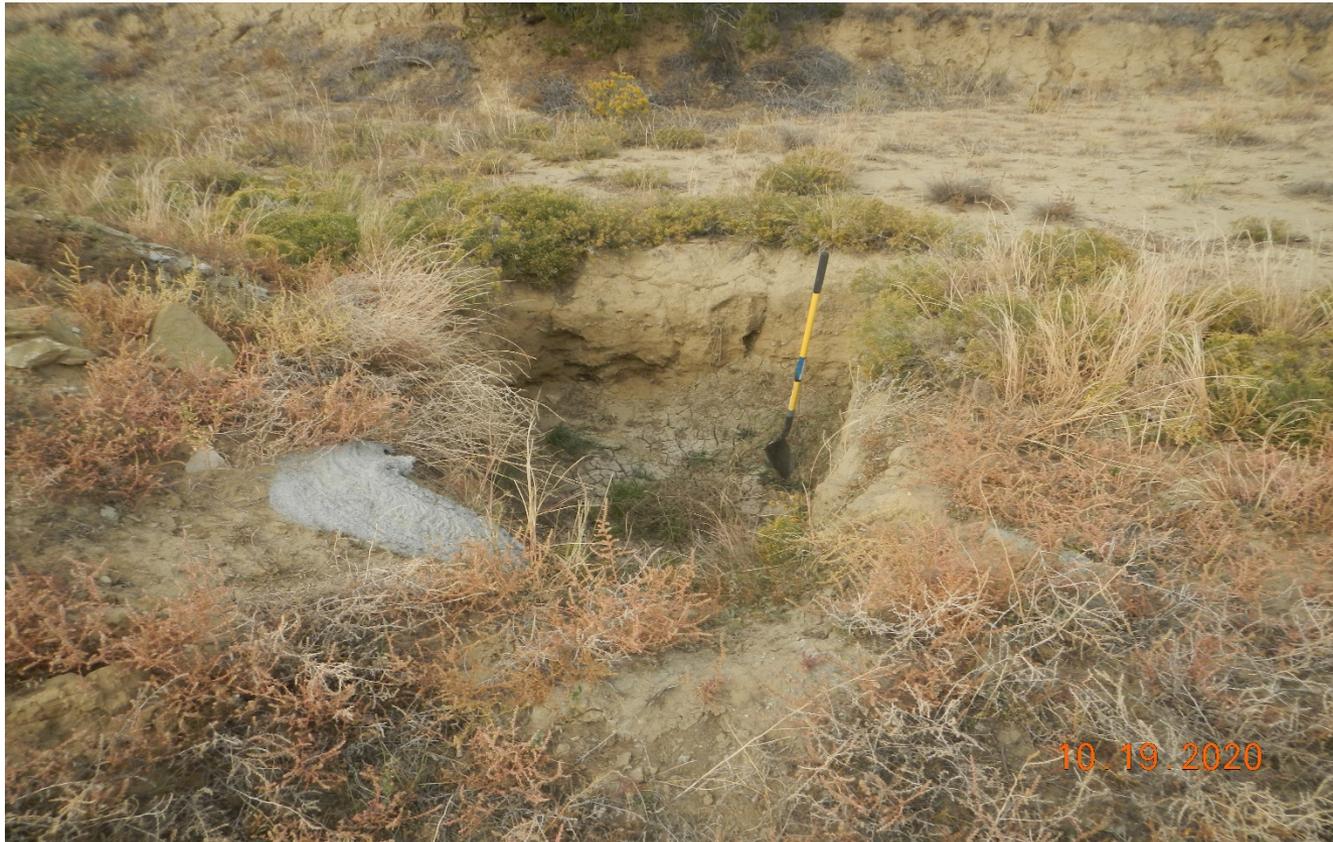
**Photo 4.** There is an open hole which is about 4.5 ft. deep shown by shovel placed in the hole. There is cement debris next to the hole which appears to be from plugging the well.
