Inspection Photos

Location Name: CAERUS PICEANCE LLC LINDAUER-68S96W /3SWSE

Location ID: 334105

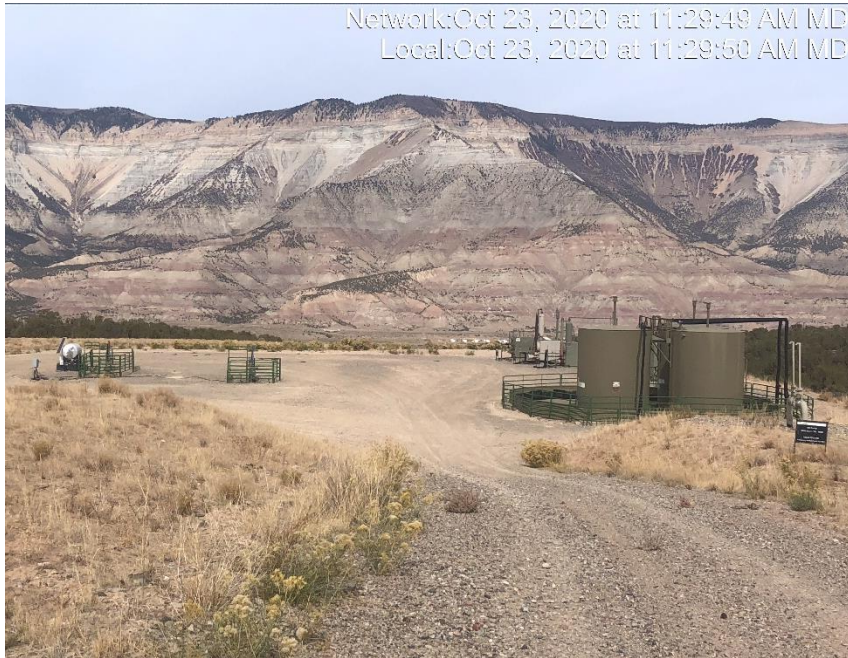
Photo #2091 from entrance to location.

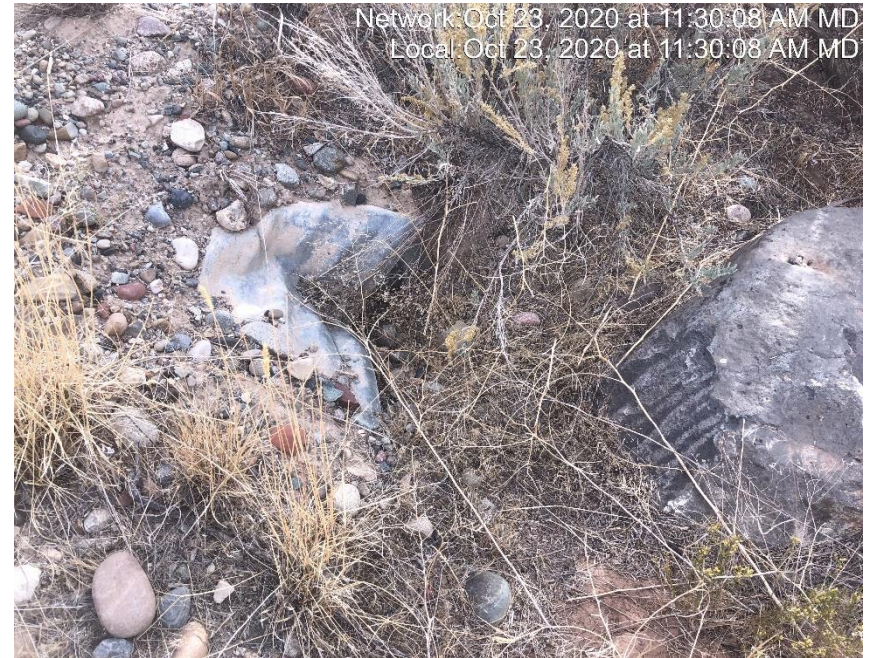
Photo #2092 Culvert inlet collapsed and sediment accumulation.

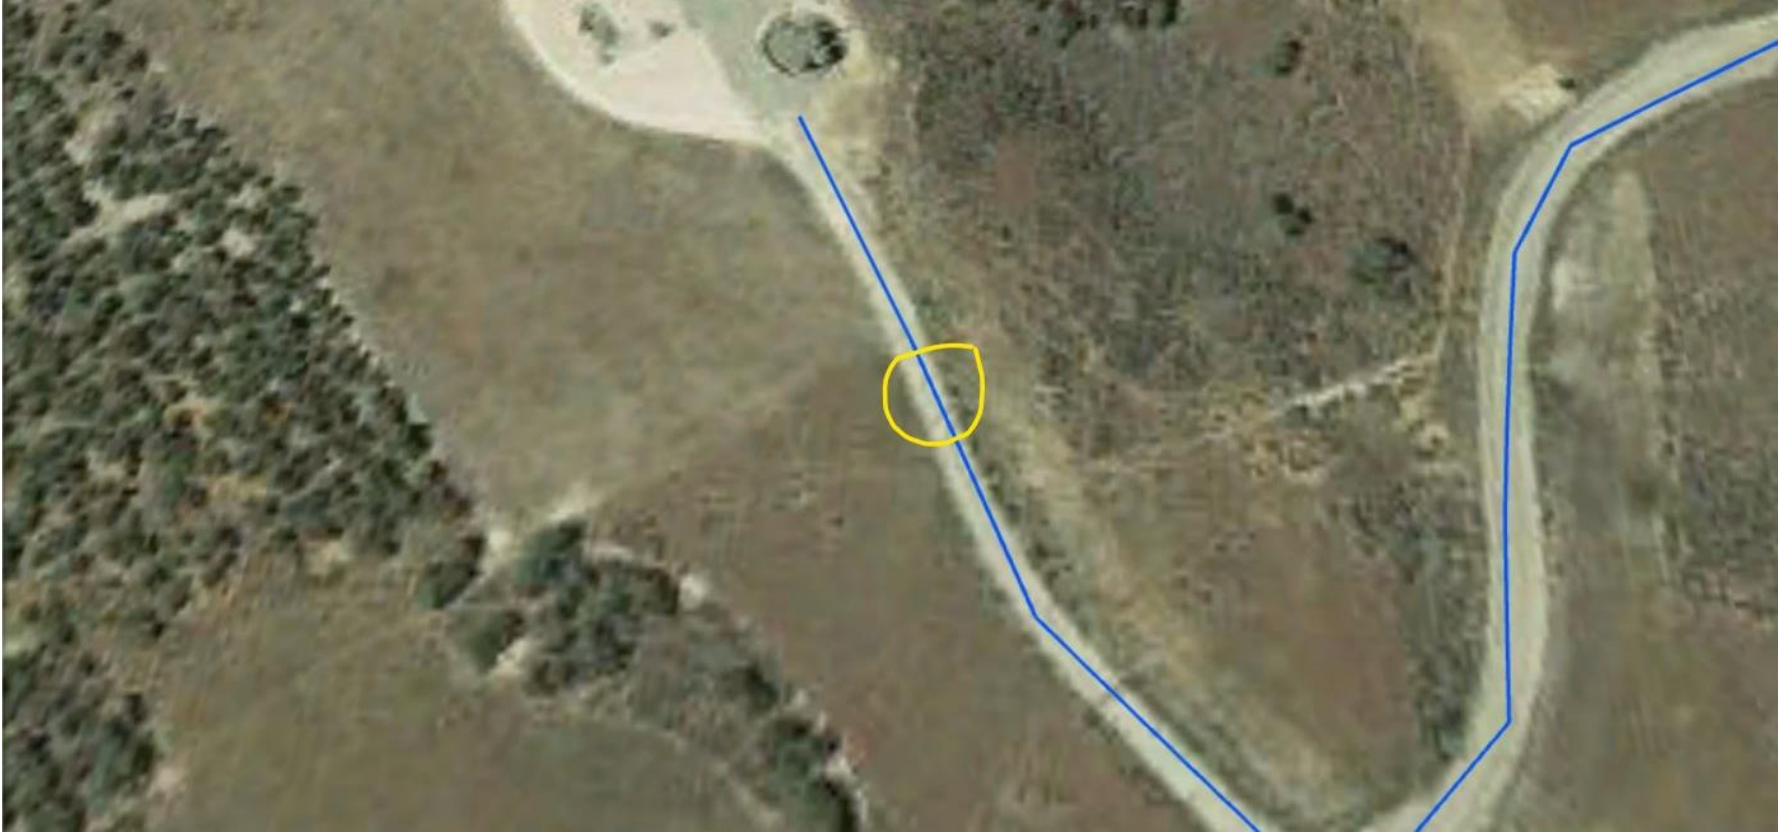
Photo #2089 approximate culvert location.

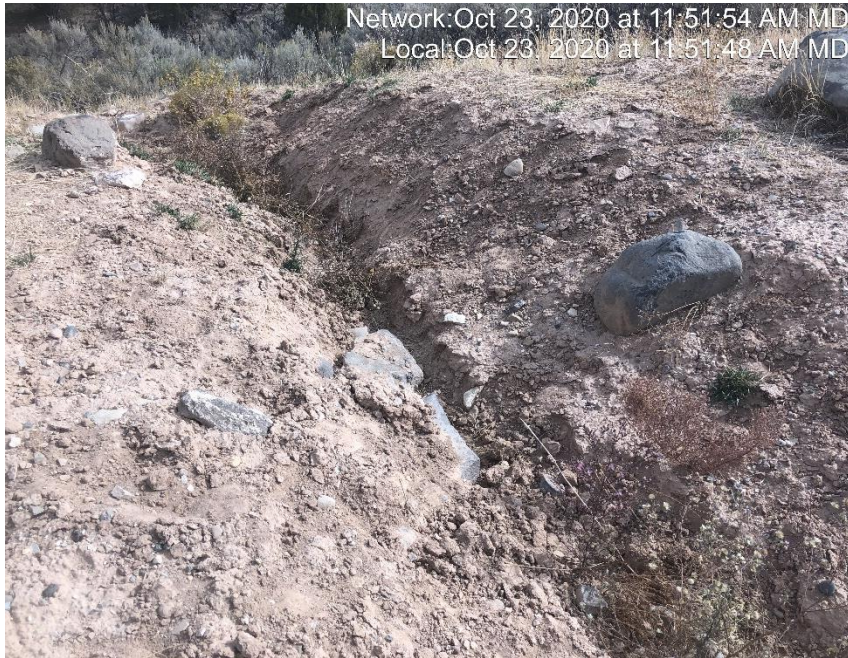
Photo #2094 Gully erosion.

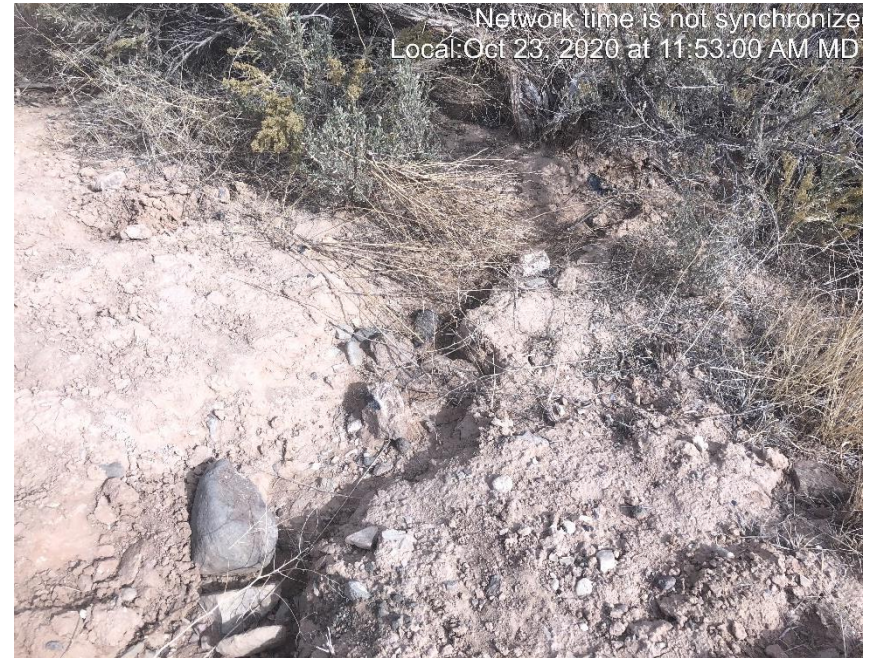
Photo #2097 rill erosion.

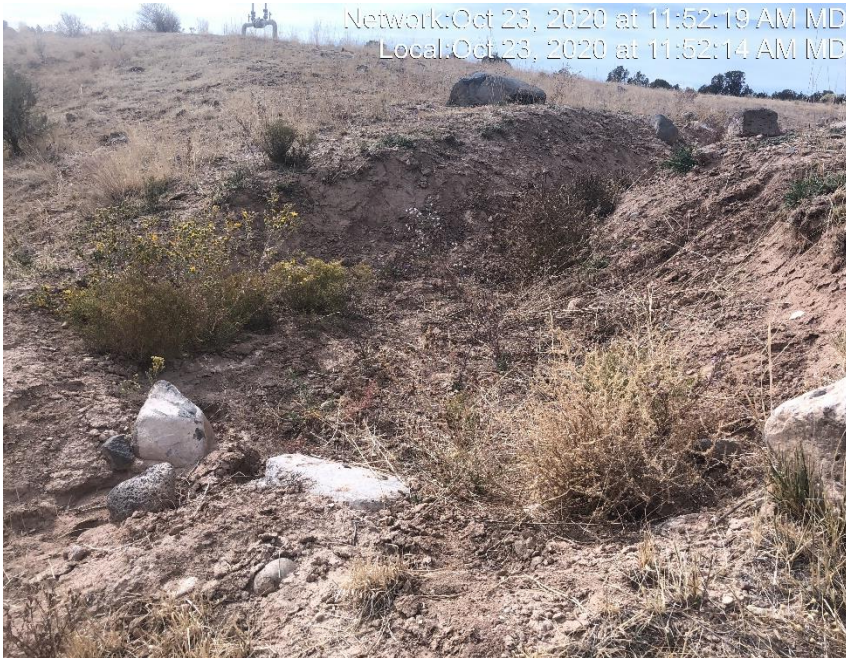
Photo #2095 sediment trap.

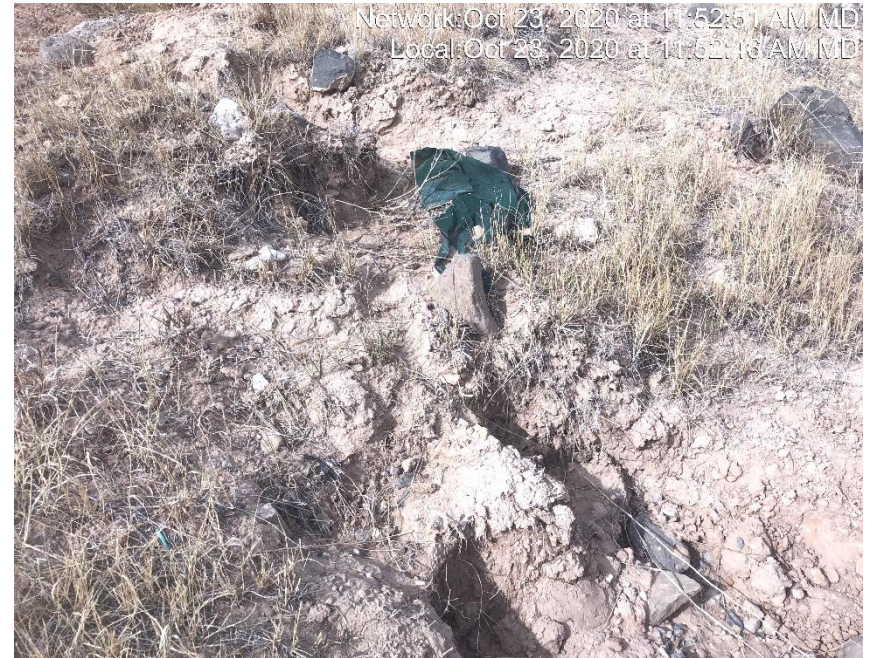
Photo #2096 sediment migrating off of location.
