Issue Report

Chaplin Limon 2-19, 073-06163

Report created on October 26, 2020

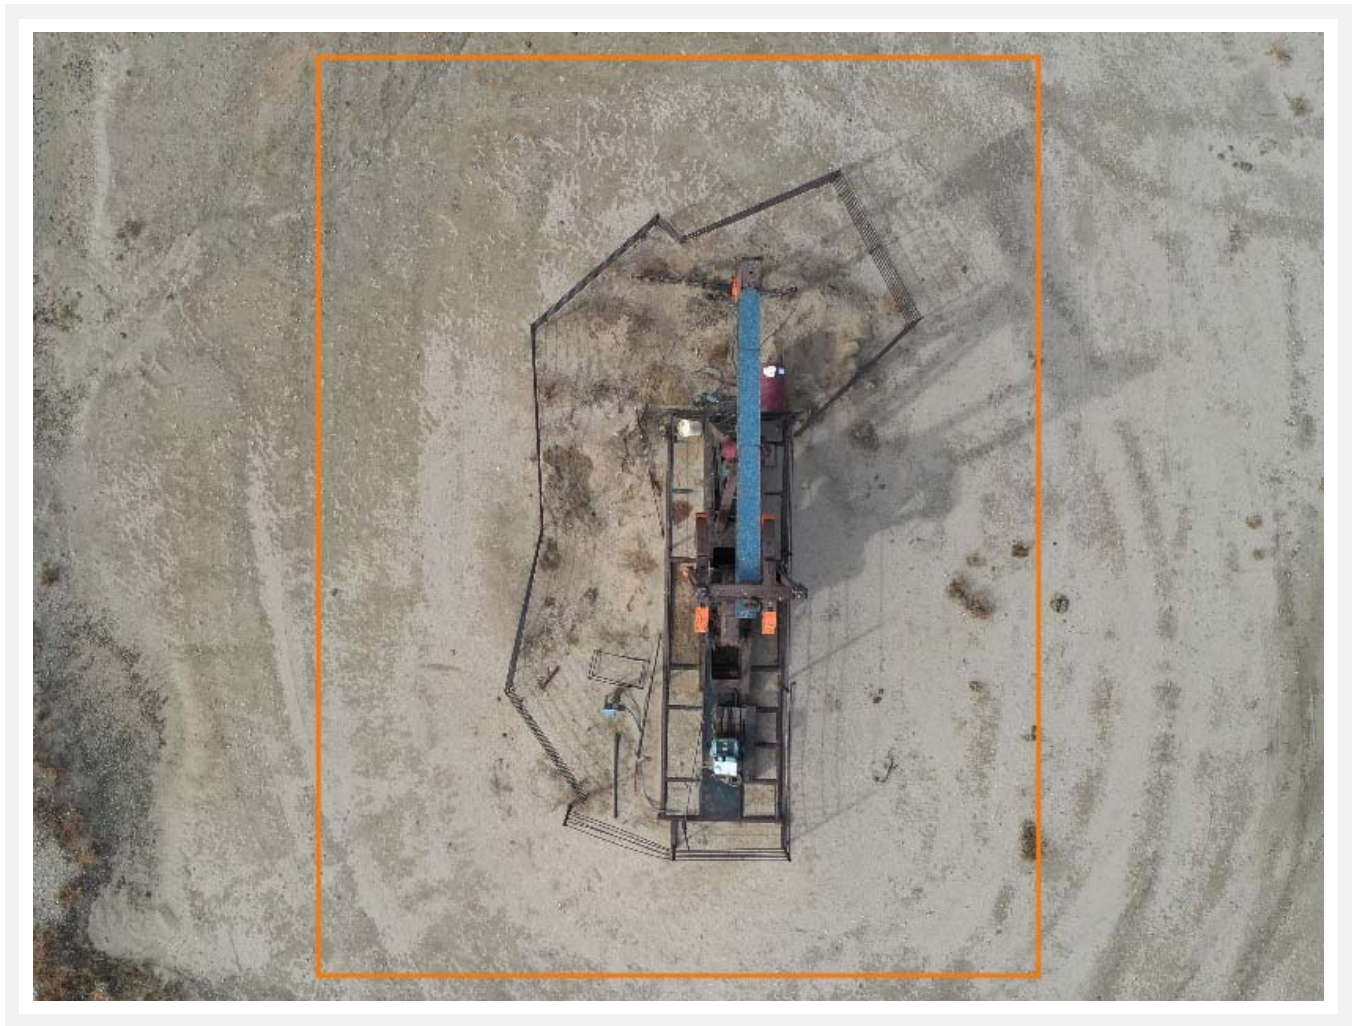
No. 1 OPEN**Captured:** Oct 20, 2020 at 11:12am

**Type**
Other**Lat/Long**
39.25329, -103.71228**Summary**
Pumping unit fenced with steel panels**Created**
Oct 26, 2020 at 6:37pm by Craig Quint

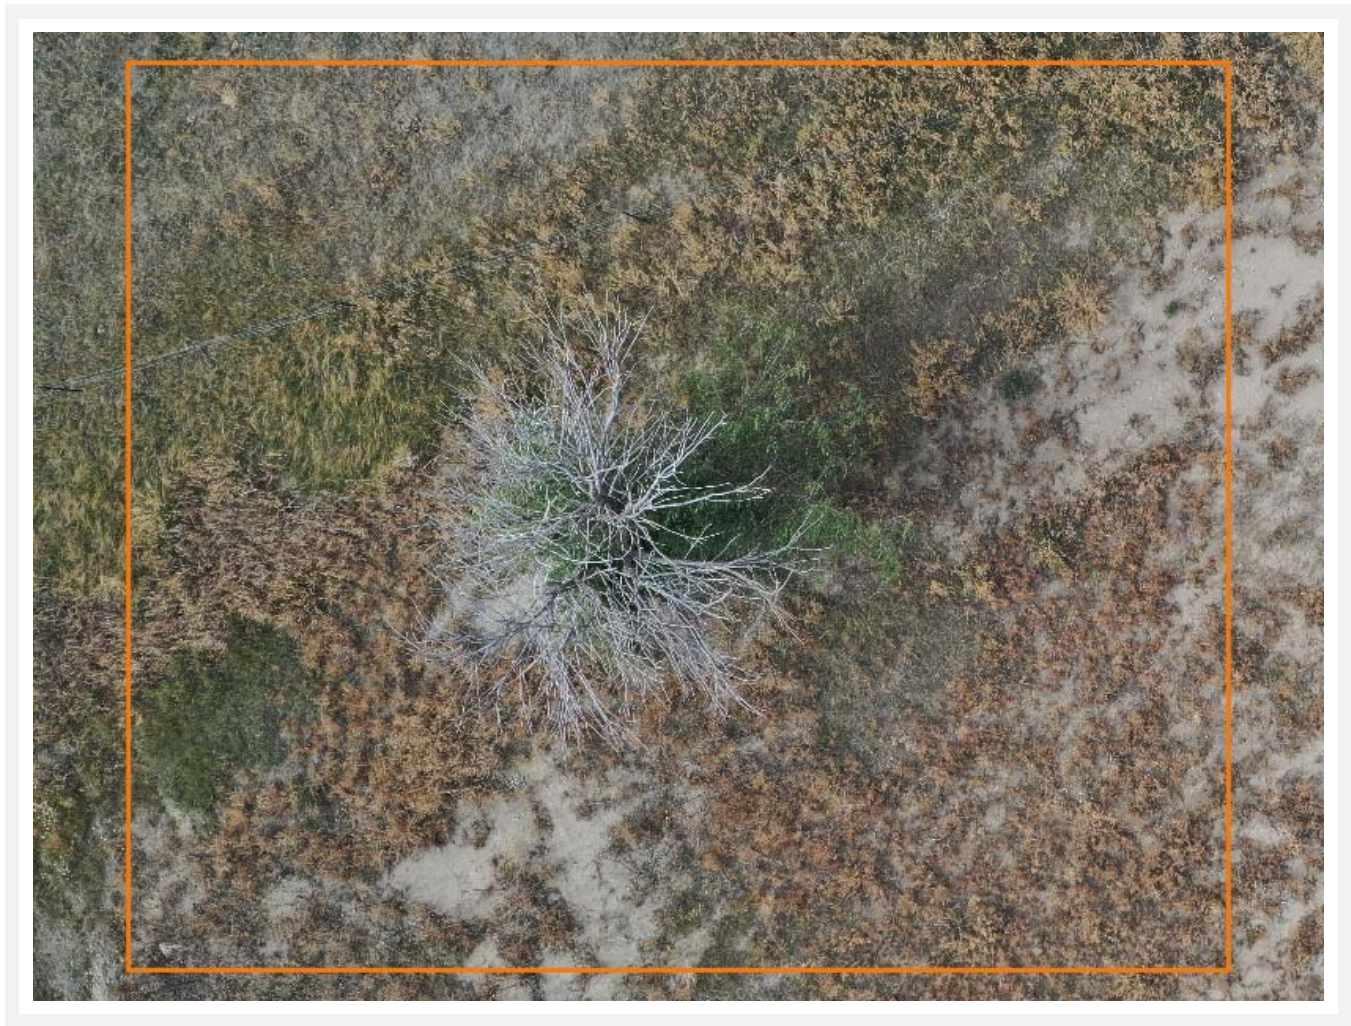
No. 2 OPEN**Captured:** Oct 20, 2020 at 11:12am

**Type**
Other**Lat/Long**
39.25311, -103.71217**Summary**
Tree growing on south side of location**Created**
Oct 26, 2020 at 6:39pm by Craig Quint

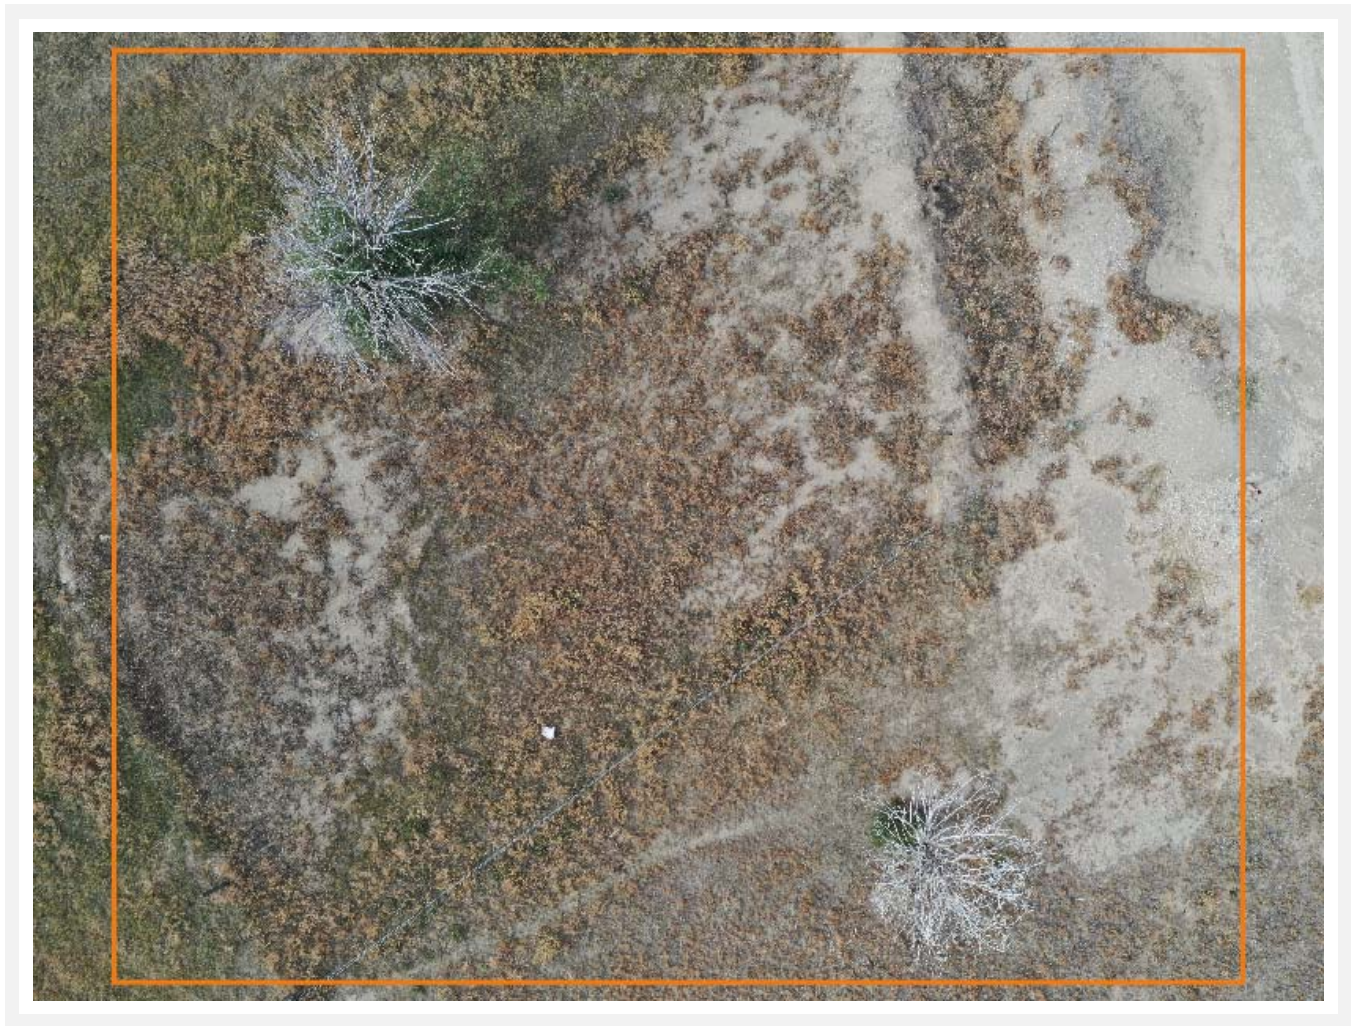
No. 3 OPEN**Captured:** Oct 20, 2020 at 11:12am

**Type**
Other**Lat/Long**
39.25311, -103.71211**Summary**
Tree's growing on south side of location with some stressed vegetation all fenced in.**Created**
Oct 26, 2020 at 6:40pm by Craig Quint
