**COLORADO**  
Oil & Gas Conservation  
Commission  
Department of Natural Resources

**BCU 42-31-198**

**API: 05-103-10874**

**Inspection: 700403936**

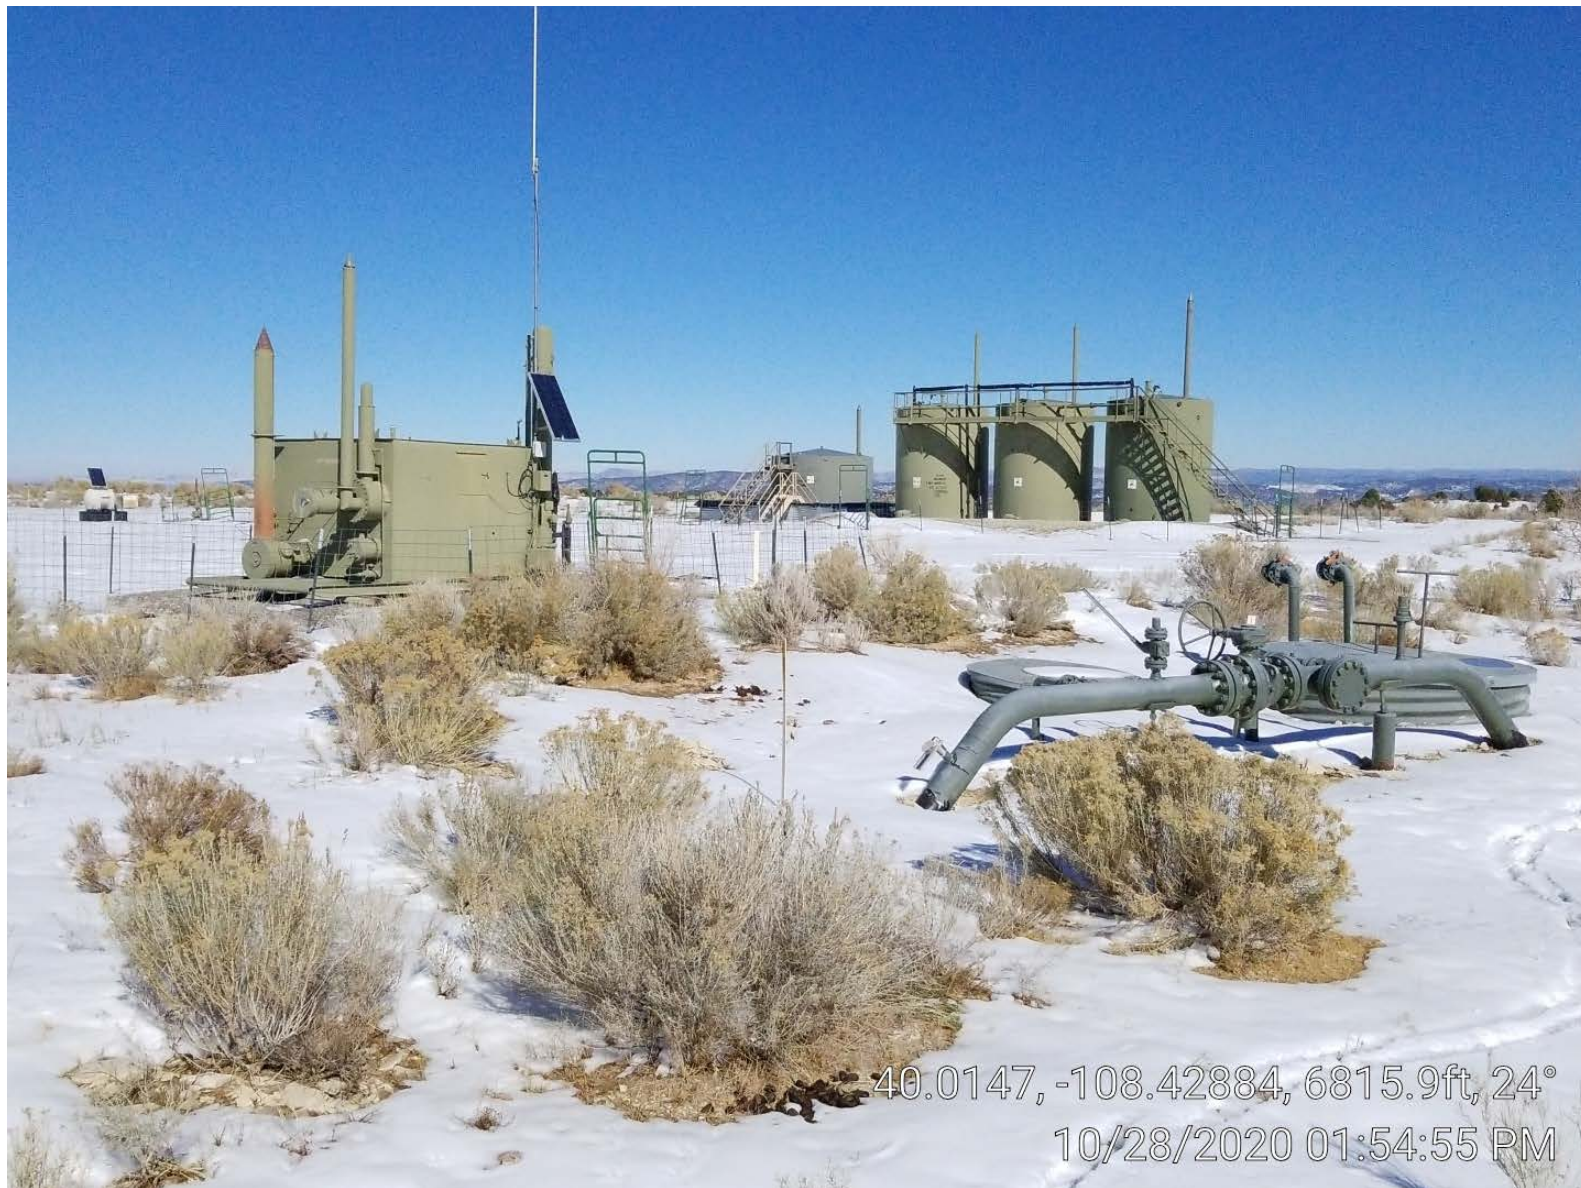
**Photo 1. Location.**

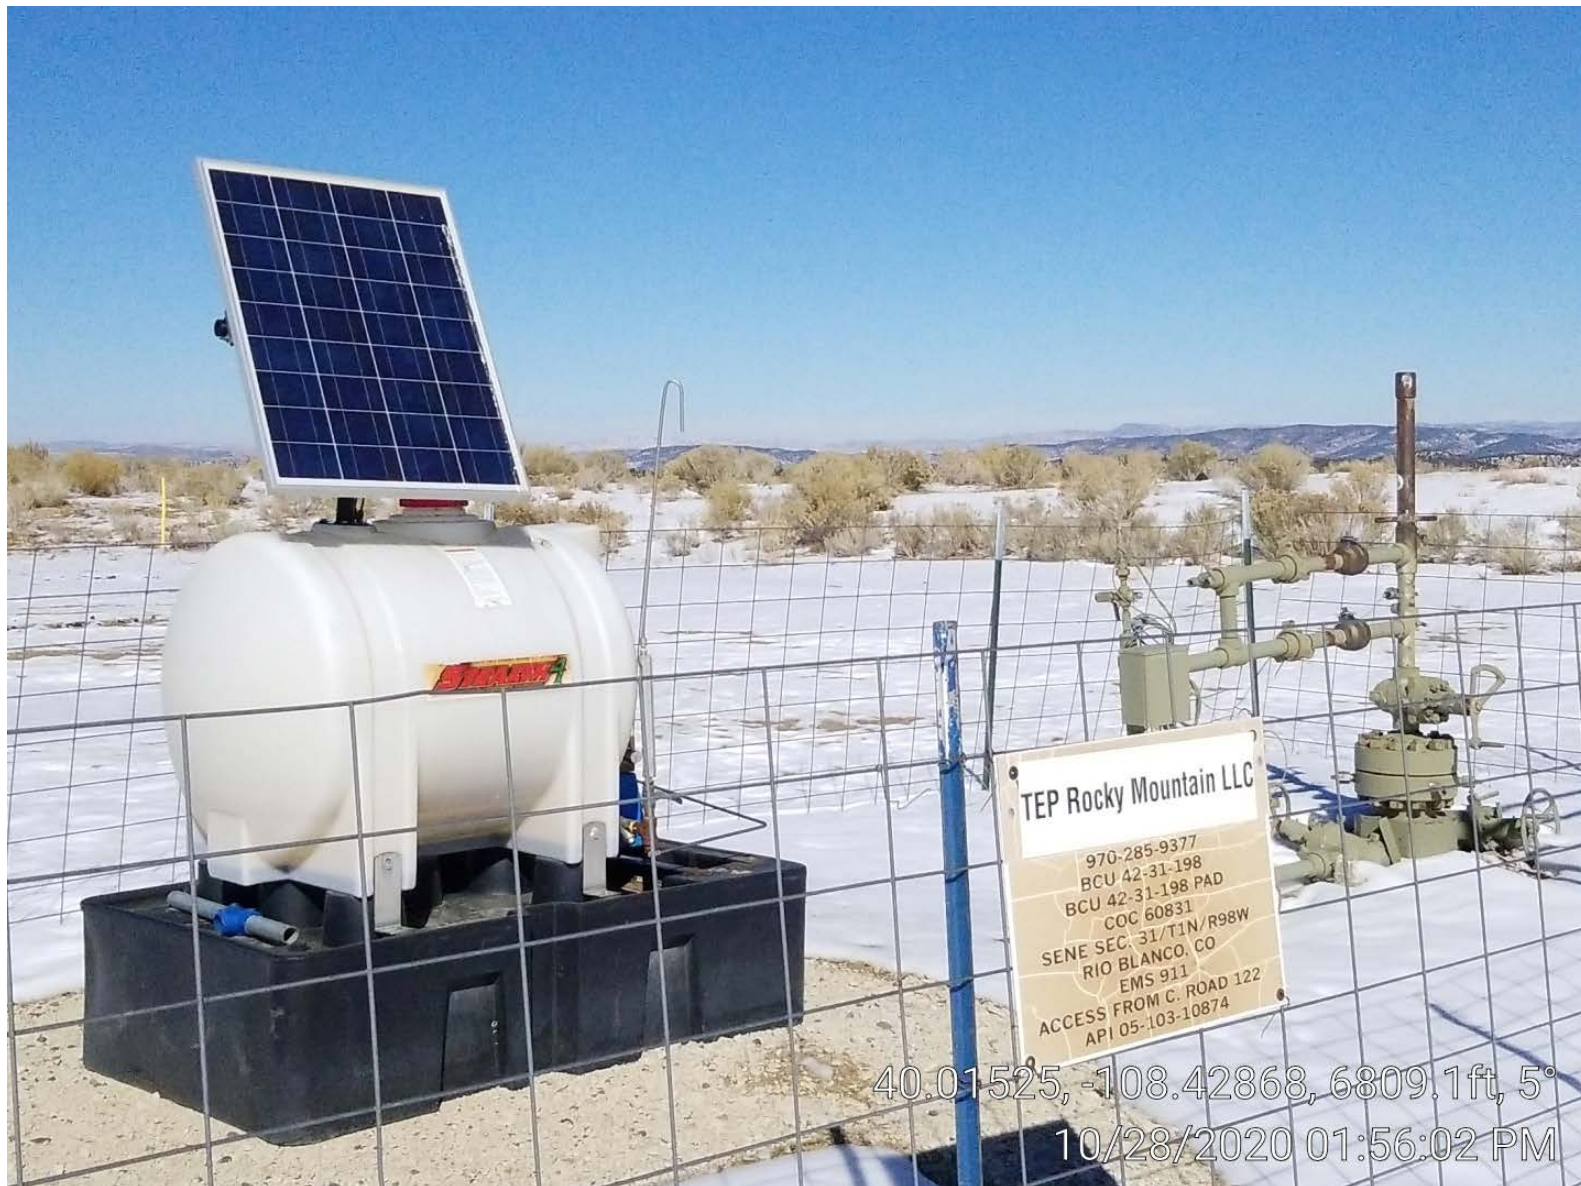
**Photo 2. Well.**

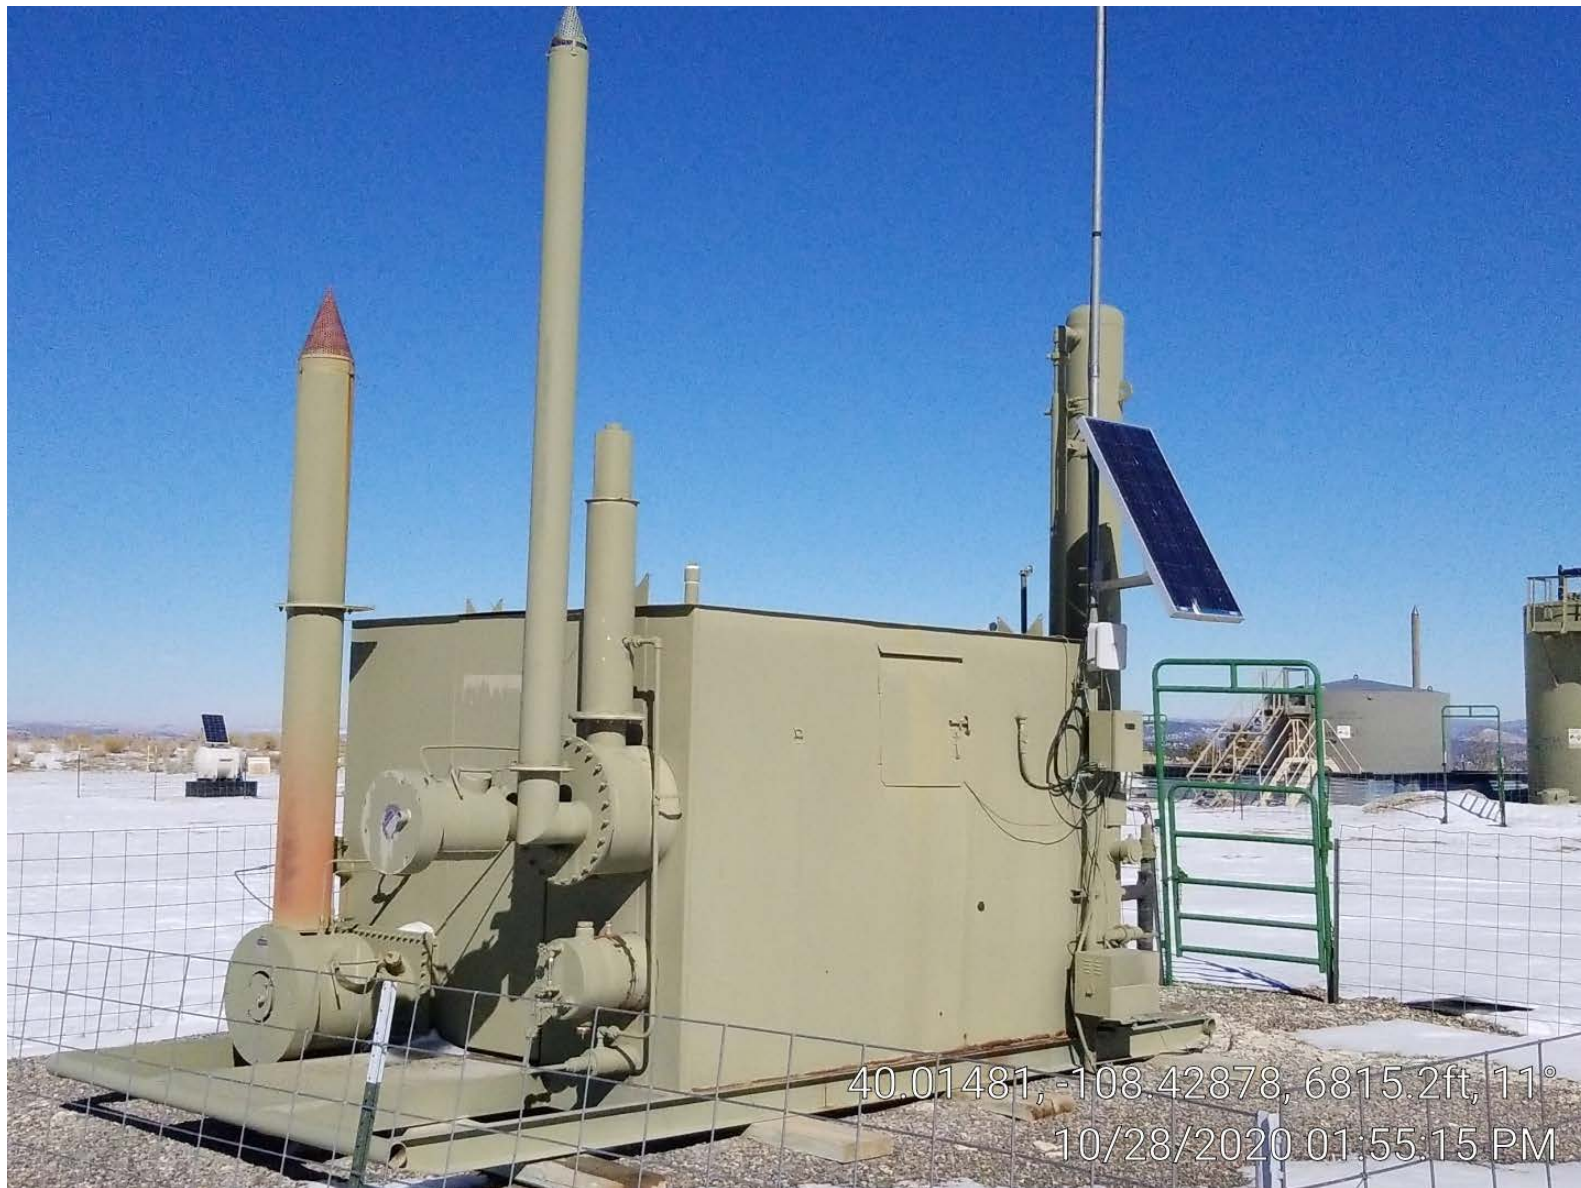
**Photo 3. Separator.**

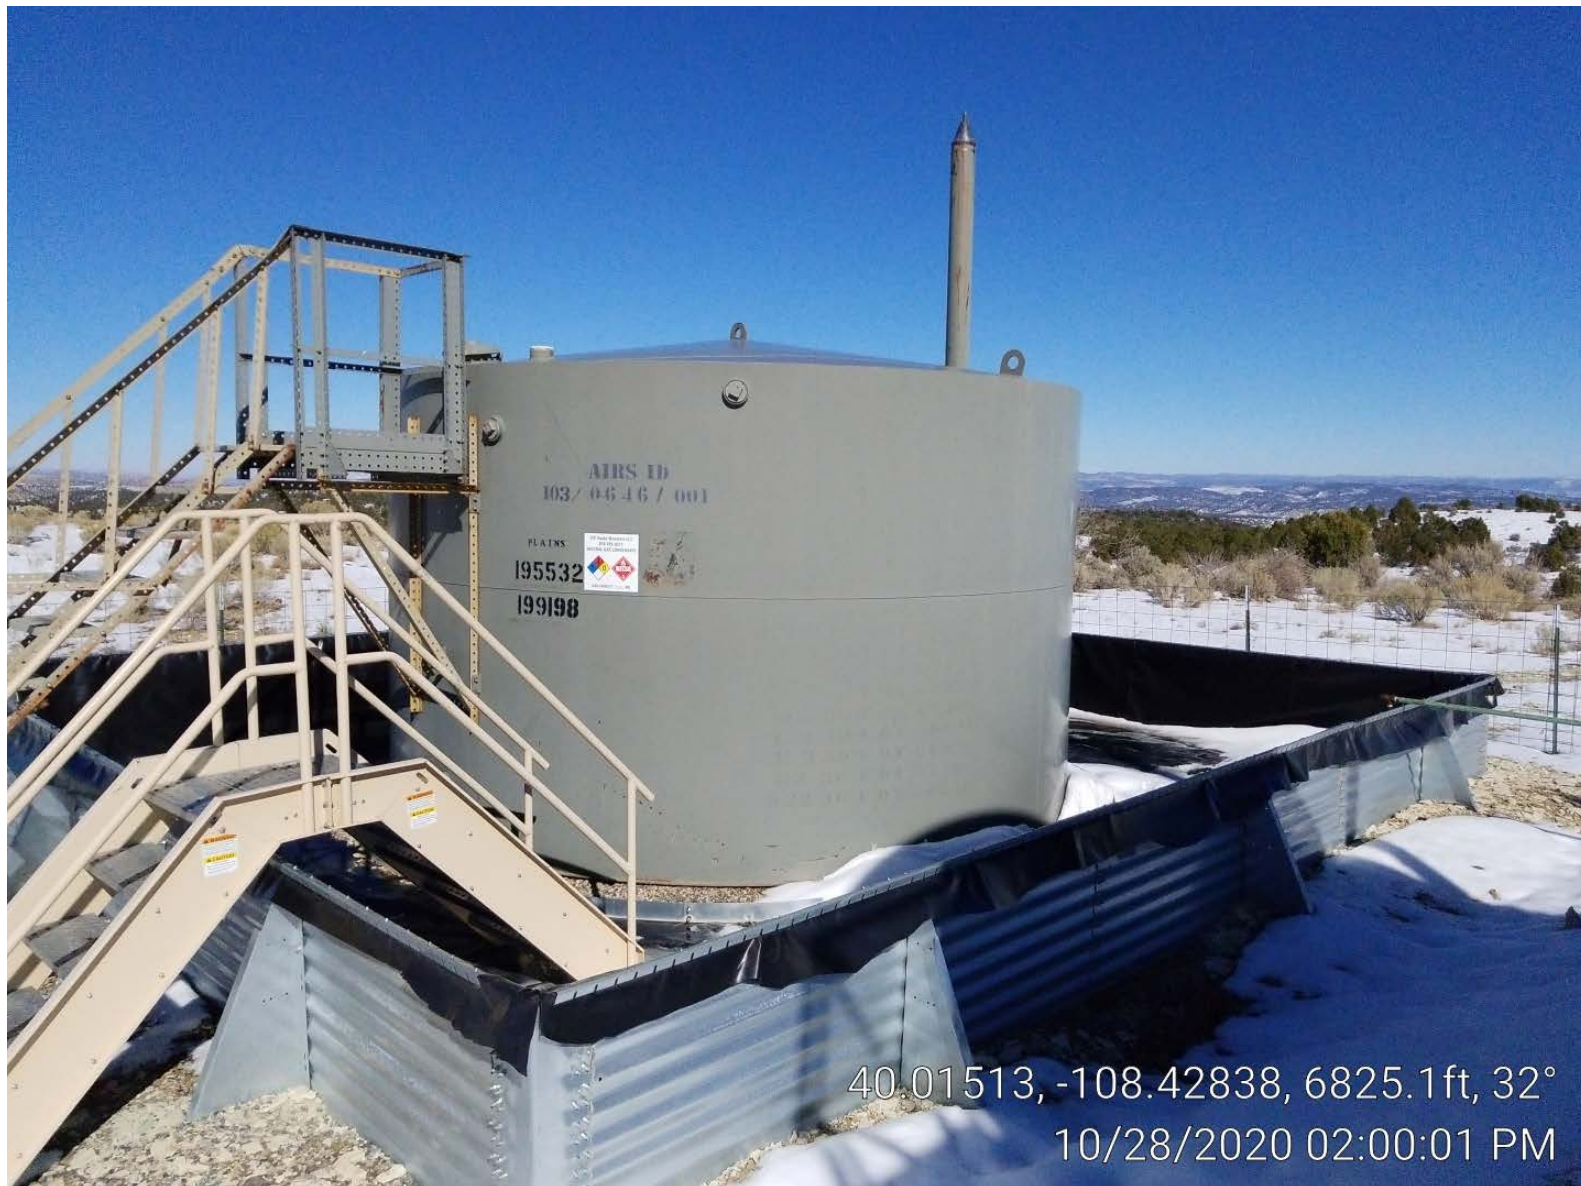
**Photo 5. Tank with secondary container liner holes.**

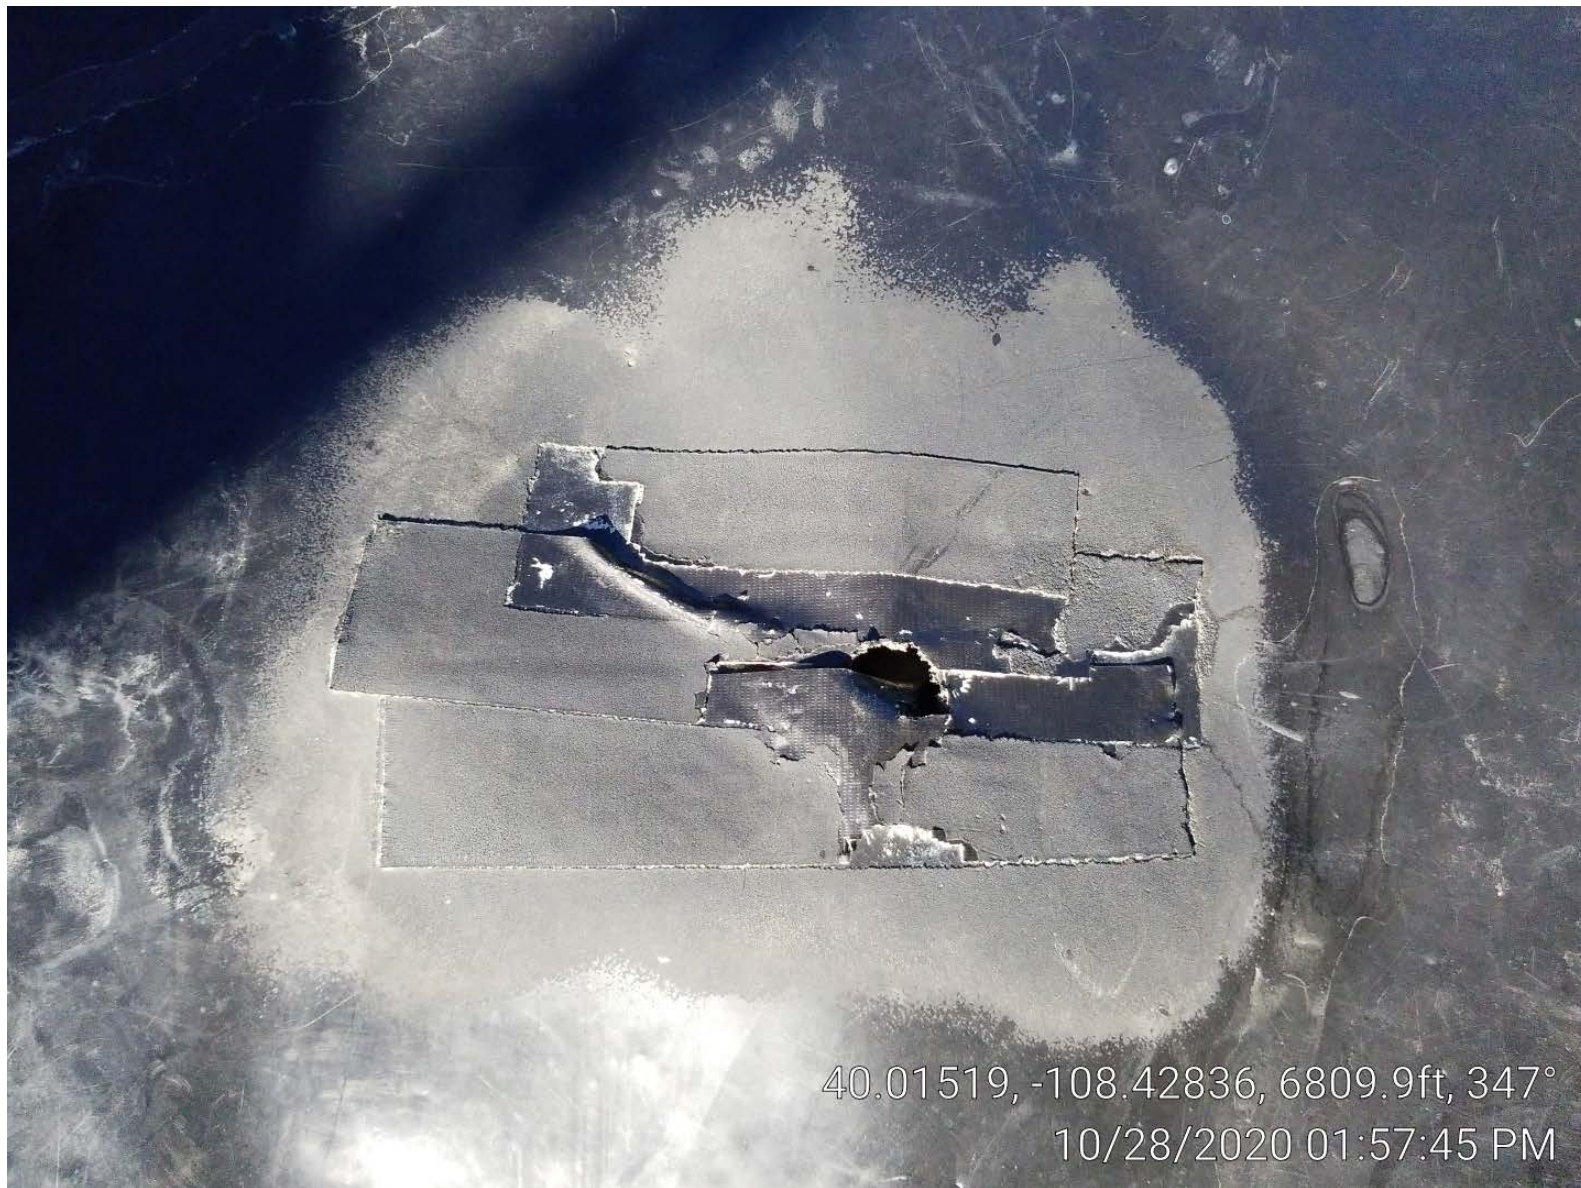
**Photo 6. Hole in tank liner.**

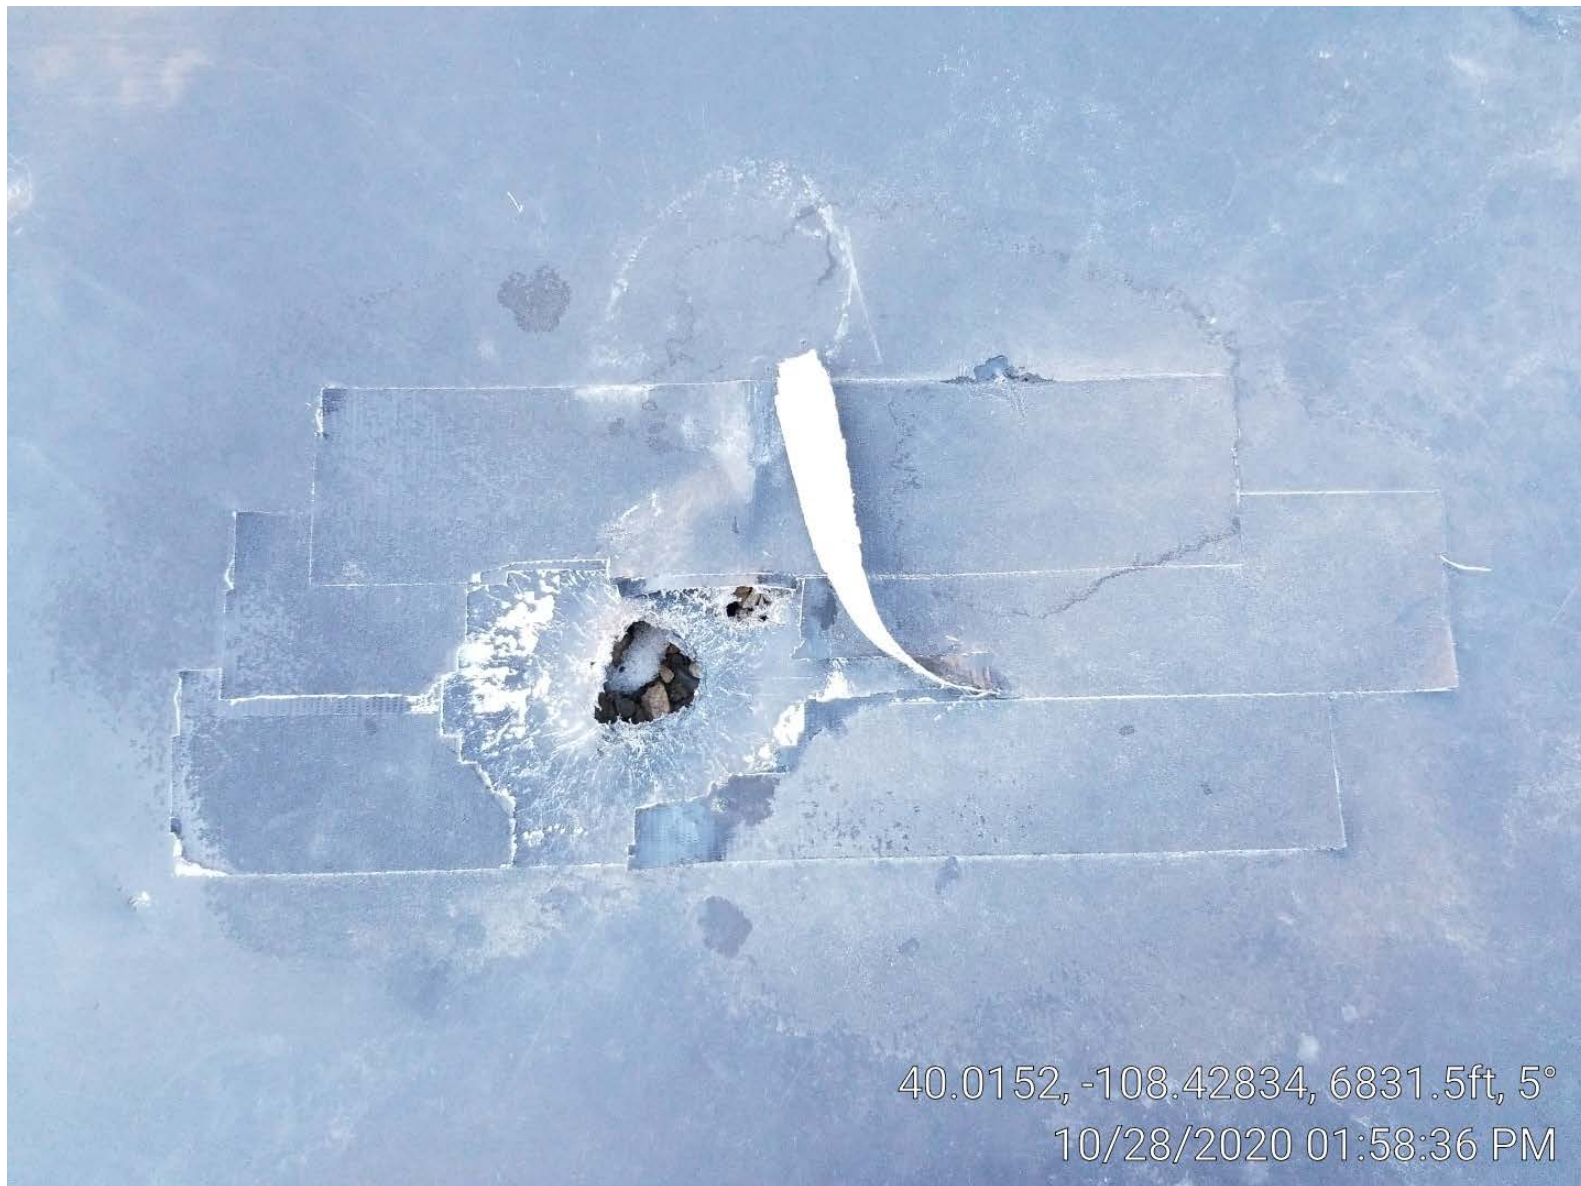
**Photo 7. Hole in tank liner.**
