Inspection Photos

Location Name: MARALEX RESOURCES INC SULFUR GULCH-69S98W /2SWSW

Location ID: 312662

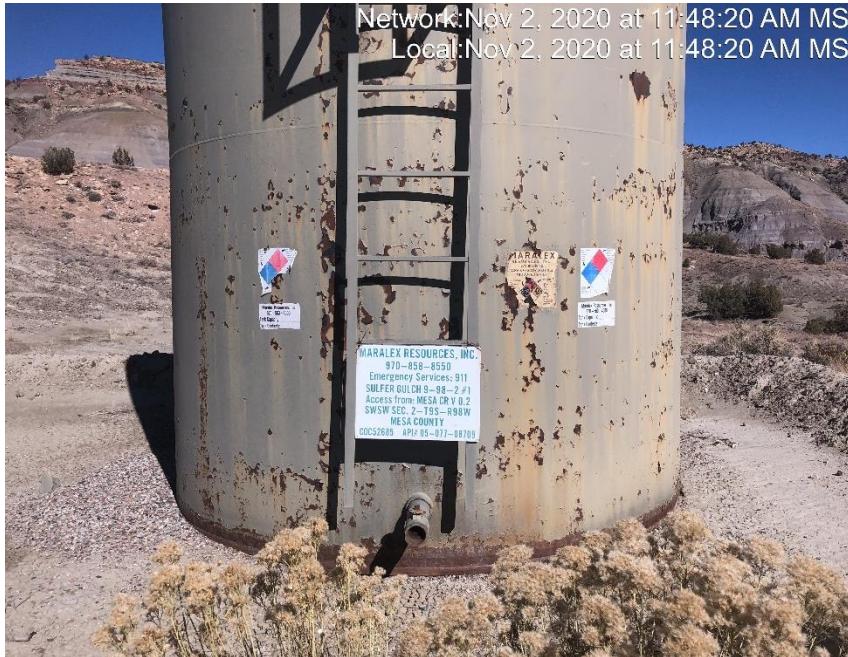
Photo #2157 Tank label and placards are weathered and not legible.

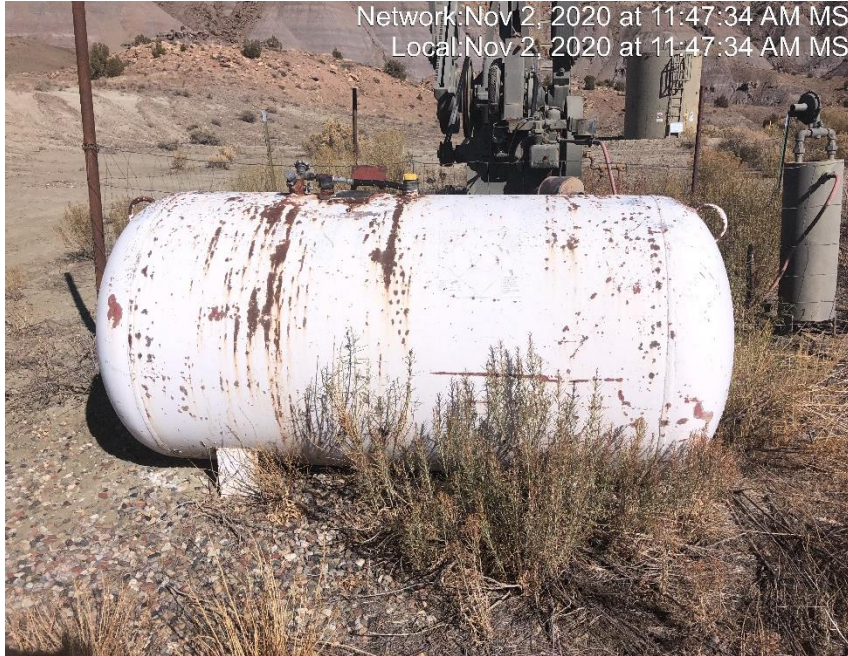
Photo #2156 Tank by wellhead is not properly labeled.

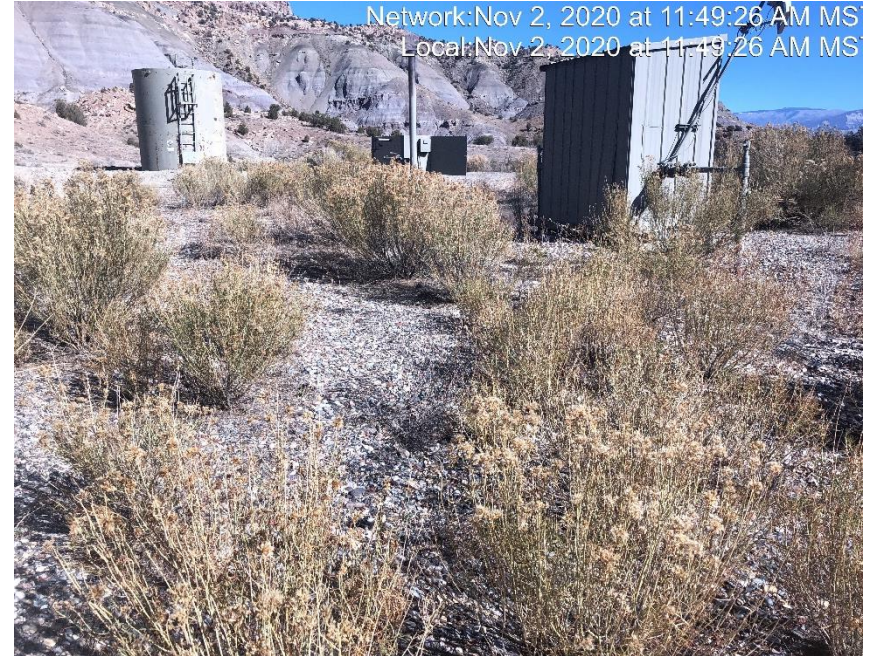
Photo #2158 Multiple places with debris on location.

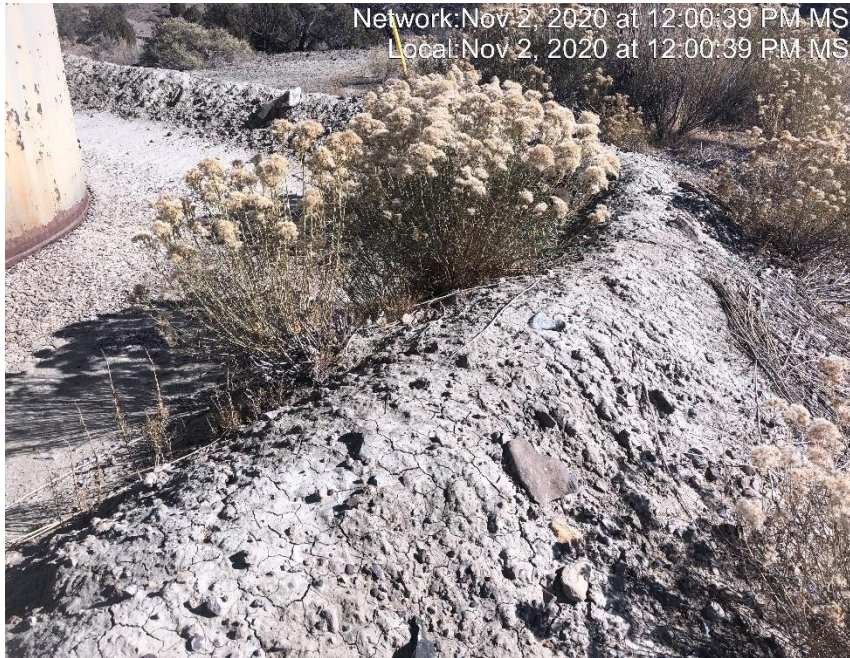
Photo #2159 Vegetation growing on tank containment berm.
