## Inspection Photos

Location Name: MARALEX RESOURCES INC SULFUR GULCH 9-98-10-69S98W /10NWNW

Location ID: 312654

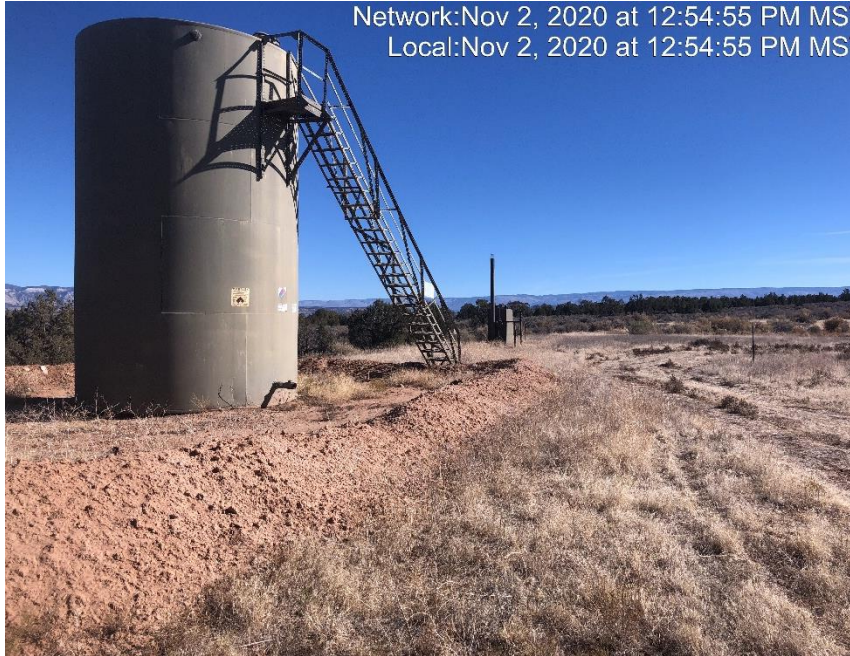
Photo #2162 from entrance to location.

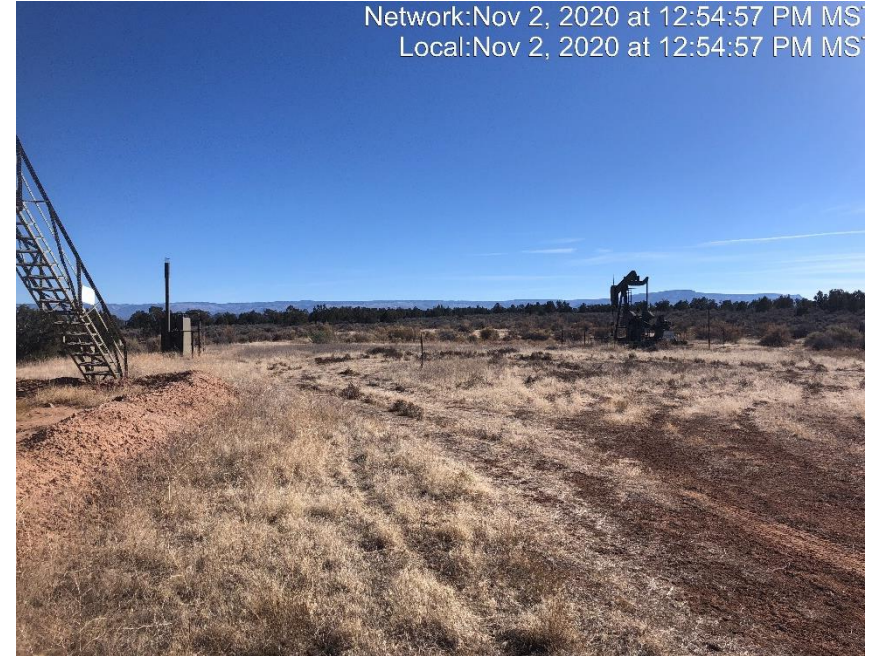
Photo #2163 from entrance to location.

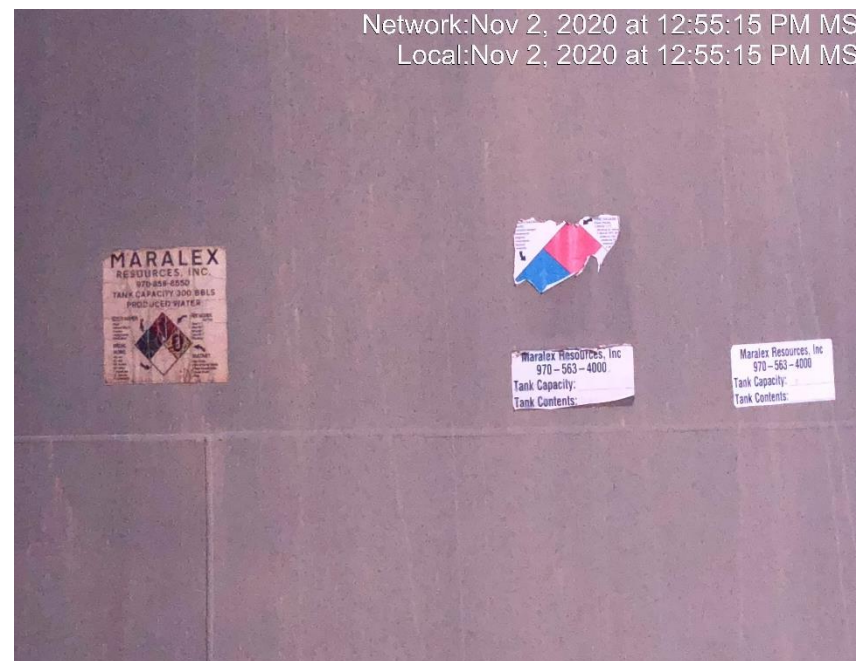
Photo #2164 Tank capacity, contents and NFPA labels weathered and not legible.

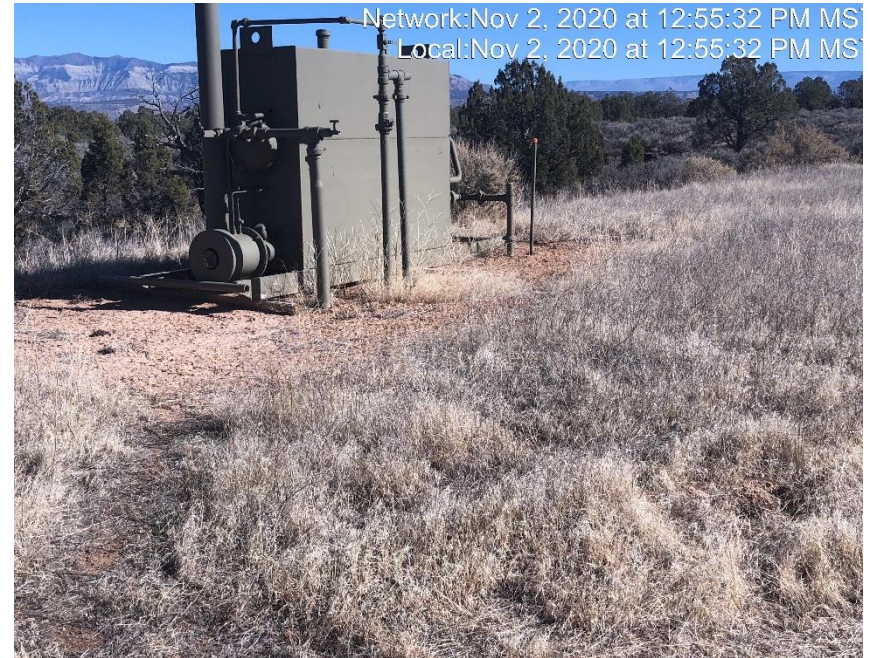
**Photo #2165 Multiple places with debris on location.**

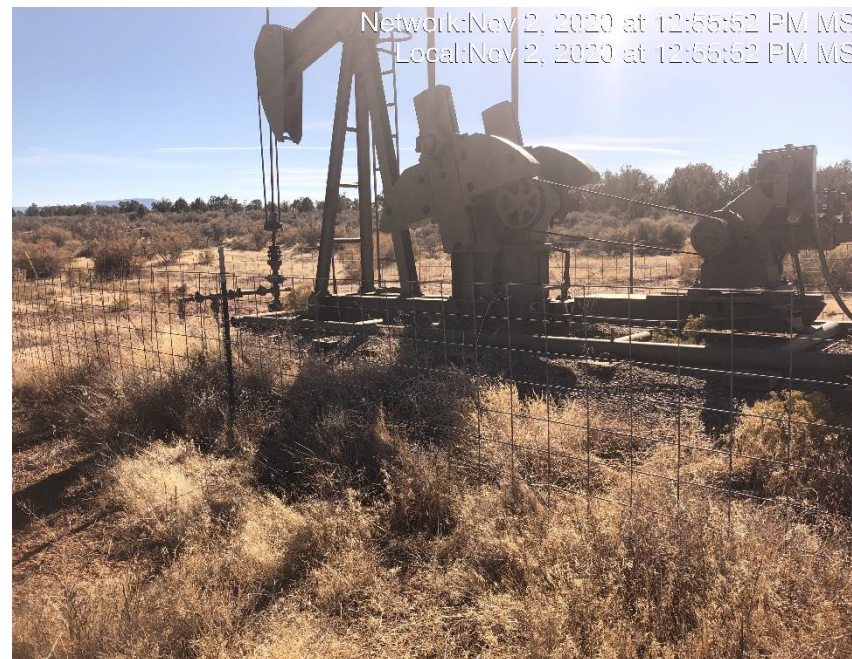
**Photo #2166 Multiple places with debris on location.**
