Inspection Photos

11/02/2020

Operator: LARAMIE ENERGY LLC - 10433

Location ID: 335889

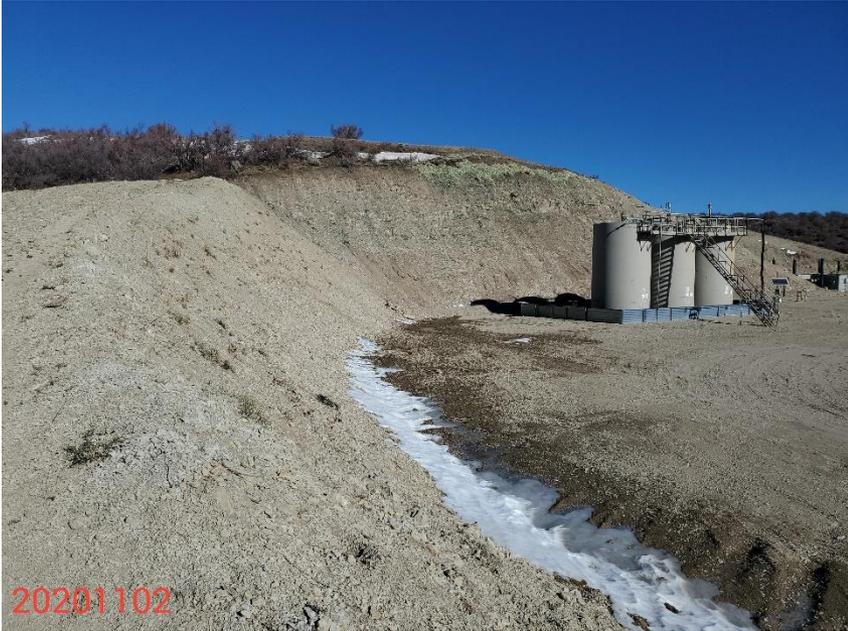
Photo 1: Photo taken from the west end of the Location, facing northeast. Photos show BMPs remain missing or insufficient to stabilize the cut slopes on the northern and western ends of the Location.

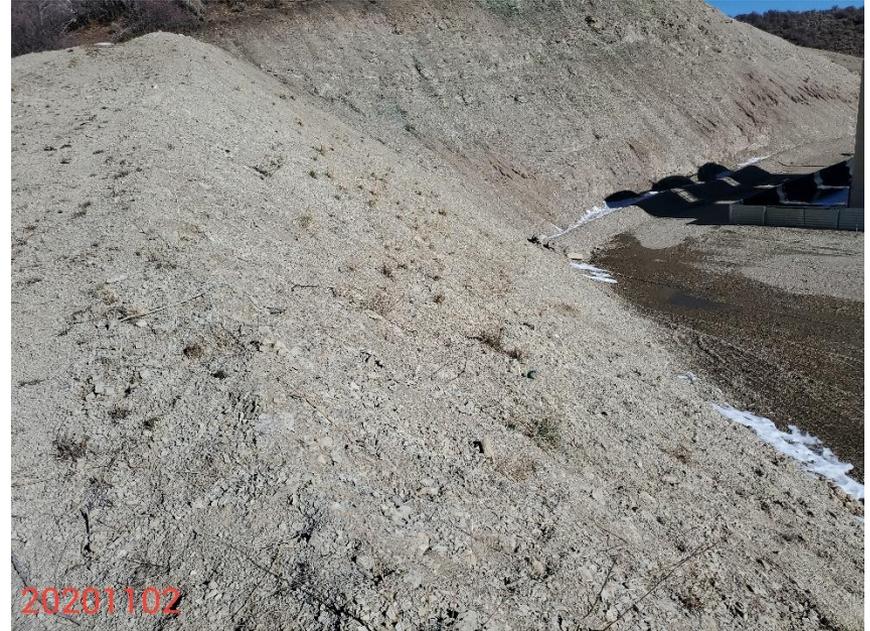
Photo 2: Photo taken from the west end of the Location, facing northeast. Photo shows BMPs remain missing or insufficient to stabilize the cut slopes on the western ends of the Location.

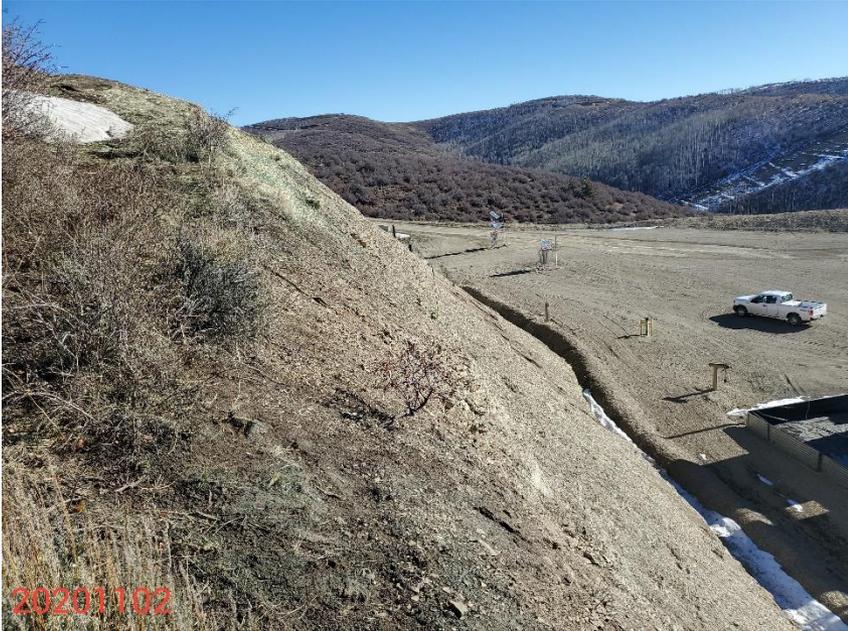
Photo 3: Photo taken from the northwest corner of the Location, facing northeast. Photo shows BMPs remain missing or insufficient to stabilize the slopes on the north end of the Location.

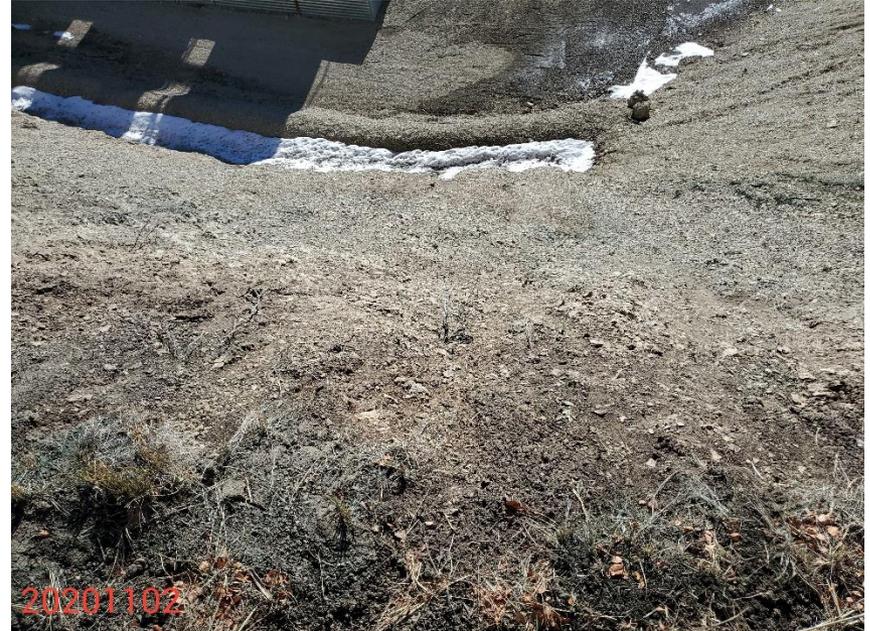
Photo 4: See comments under photo 3

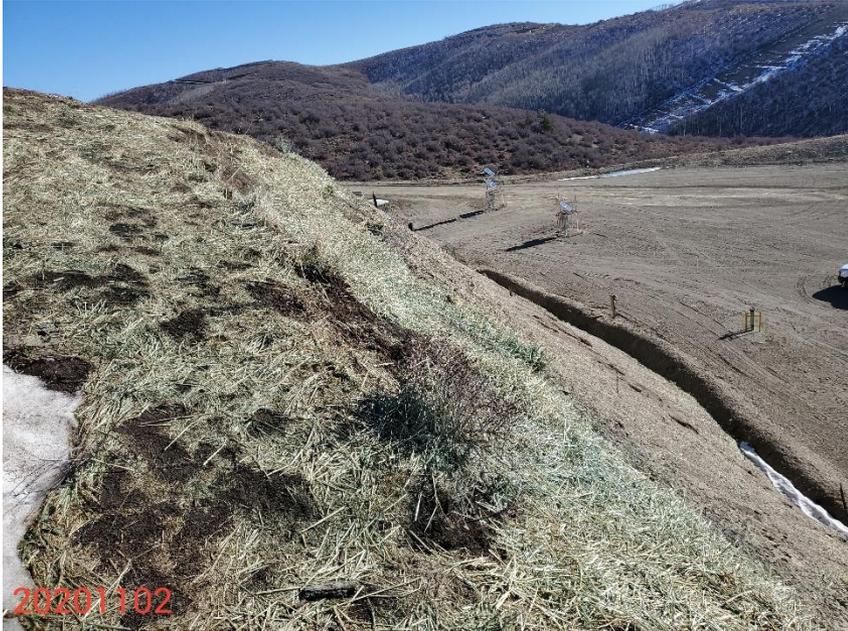
Photo 5: Photo taken from the north end of the Location, facing northeast. Photo shows remnants of mulch that was applied to the northern slopes behind the tank battery. Photo shows BMP is insufficient to stabilize the slopes on the north end of the Location.

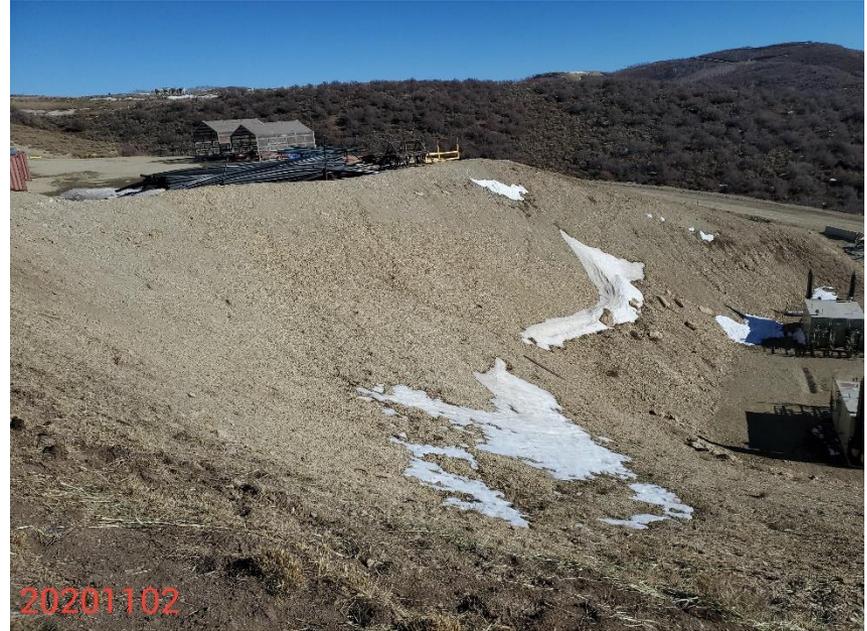
Photo 6: Photo taken from the north end of the Location, facing northeast. Photo shows BMPs remain missing or insufficient to stabilize the cut slopes on the north ends of the Location.

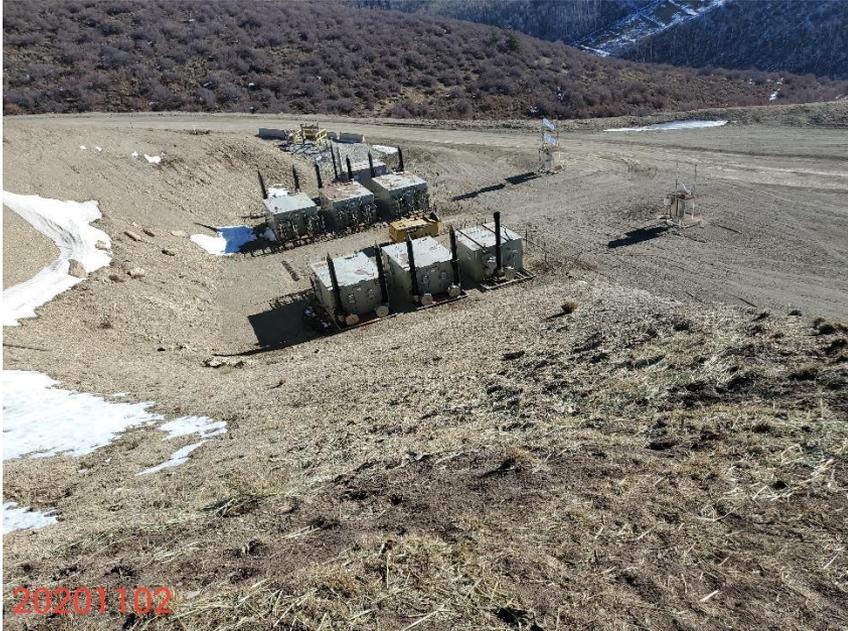
Photo 7: Photo taken from the north end of the Location, facing east. Photo shows BMPs remain missing or insufficient to stabilize the cut slopes on the north ends of the Location.

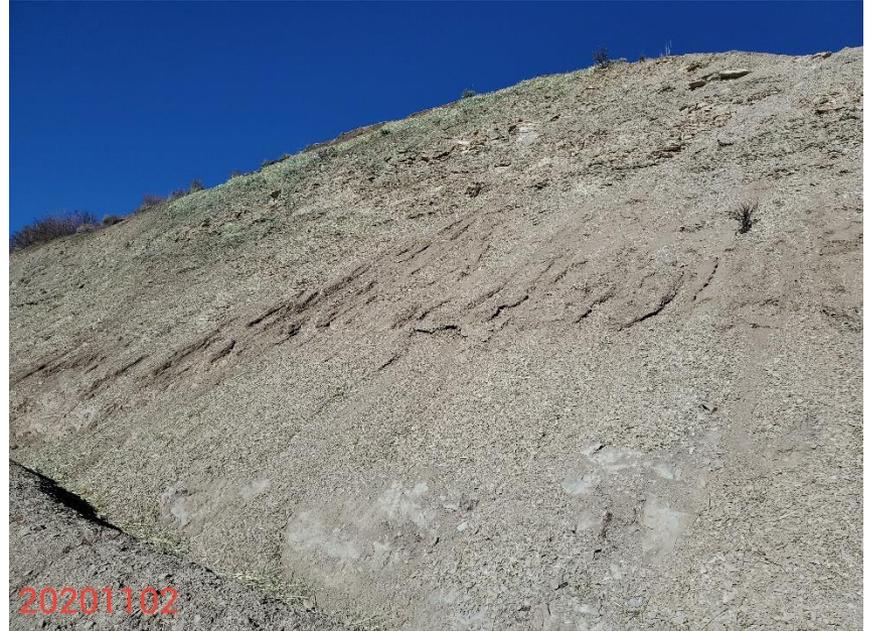
Photo 8: Photo taken from the north end of the Location, facing northwest. Photo shows BMPs remain missing or insufficient to stabilize the cut slopes on the north ends of the Location.

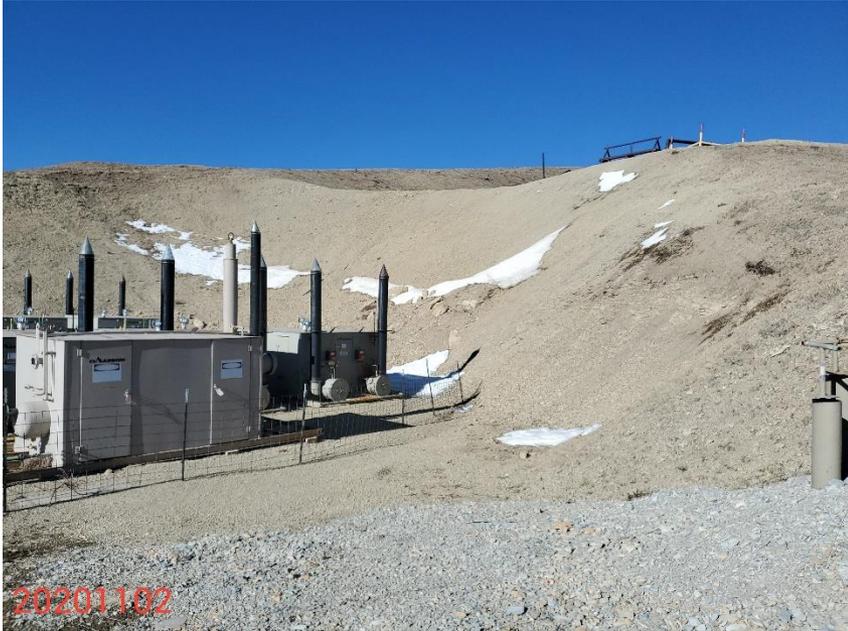
Photo 9: Photo taken from the northeast end of the Location, facing west. Photo shows BMPs remain missing or insufficient to stabilize the cut slopes on the north ends of the Location.

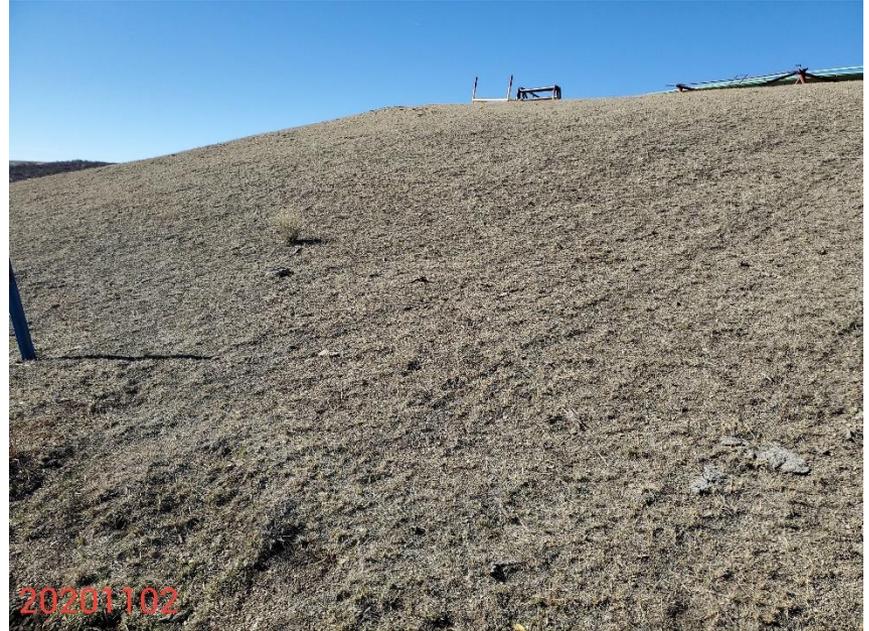
Photo 10: Photo taken from the access road, facing west. Photo shows interim slopes below the “storage area”. Photo shows Operator has installed erosion netting to help stabilize the slopes east and west of the “storage area”. BMP appears to be in proper functioning condition.

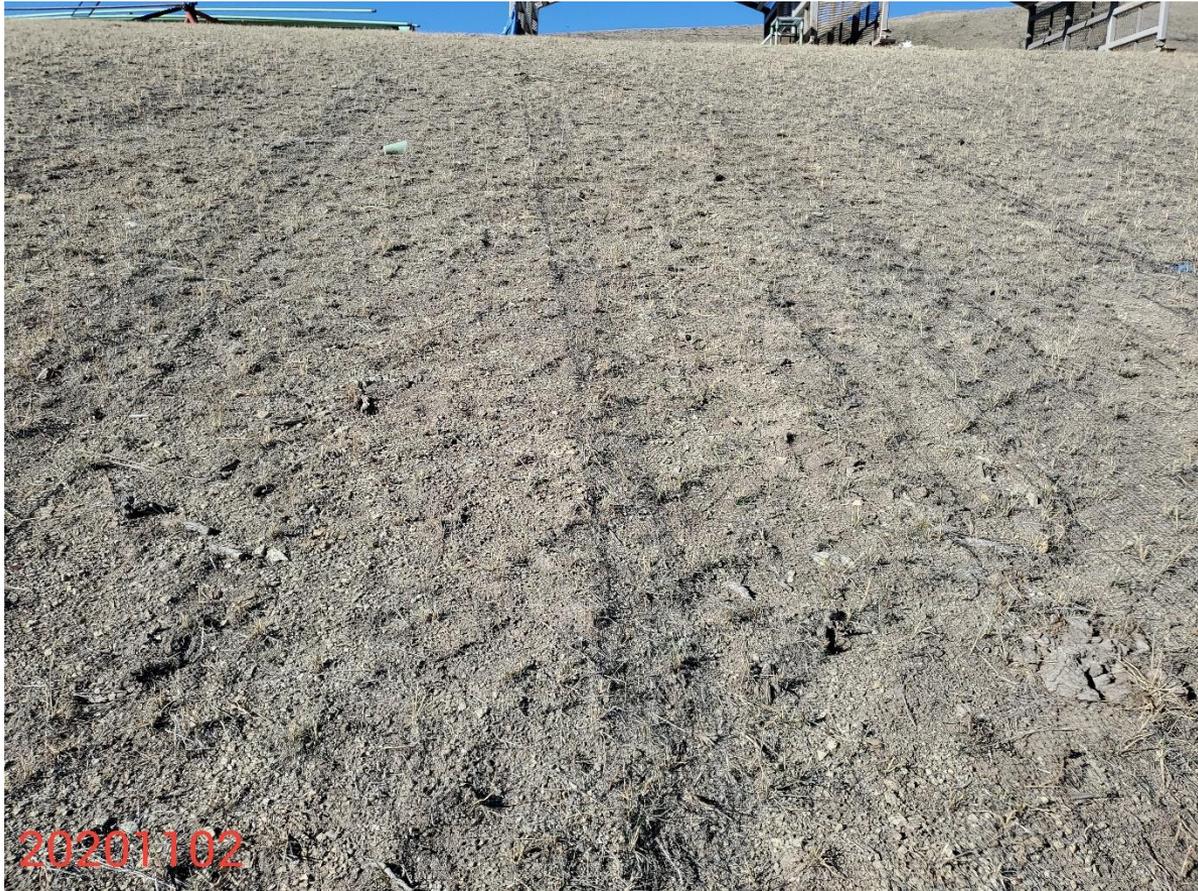
Photo 11: Photo taken from the access road, facing west. Photo shows interim slopes below the “storage area”. Operator has installed erosion netting to help stabilize the slopes east and west of the “storage area”. BMP appears to be in proper functioning condition.
