Inspection Photos

Location Name: LARAMIE ENERGY LLC Homer Deep Unit /9-41

Location ID: 432260

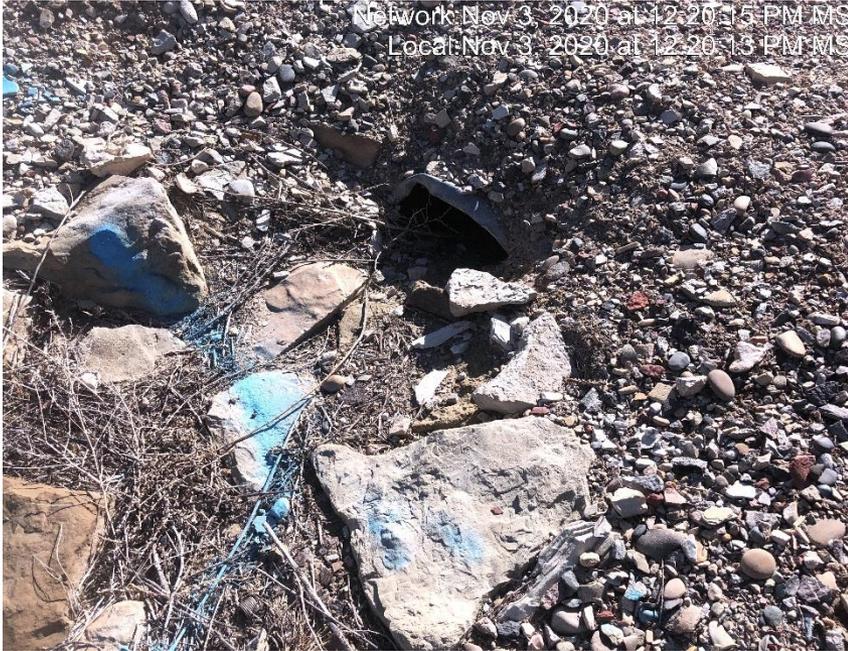
Photo #2175 Culvert inlet and outlet blocked by sediment.

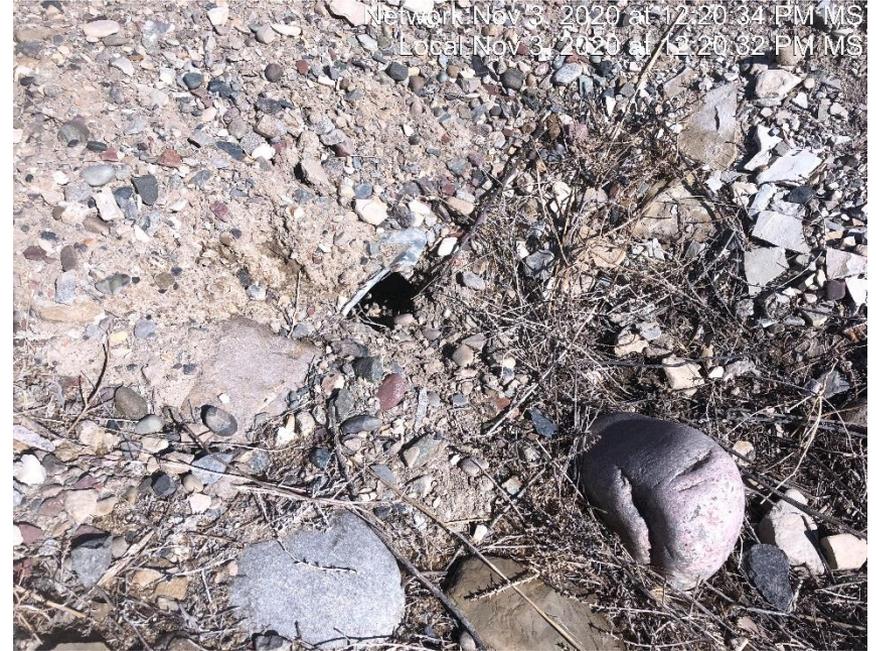
Photo #2176 Culvert inlet and outlet blocked by sediment.

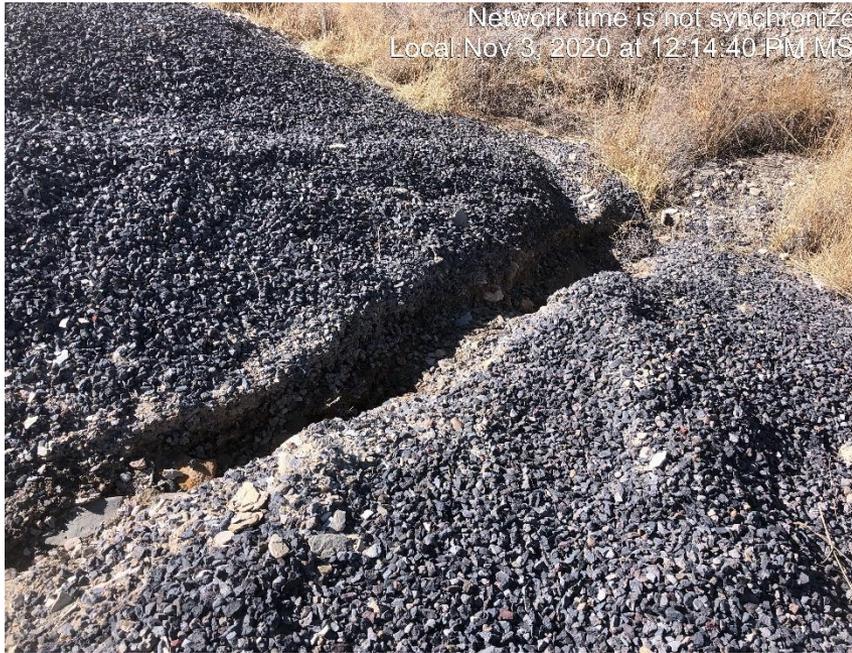
Photo #2174 Rill erosion occurring on west end of location

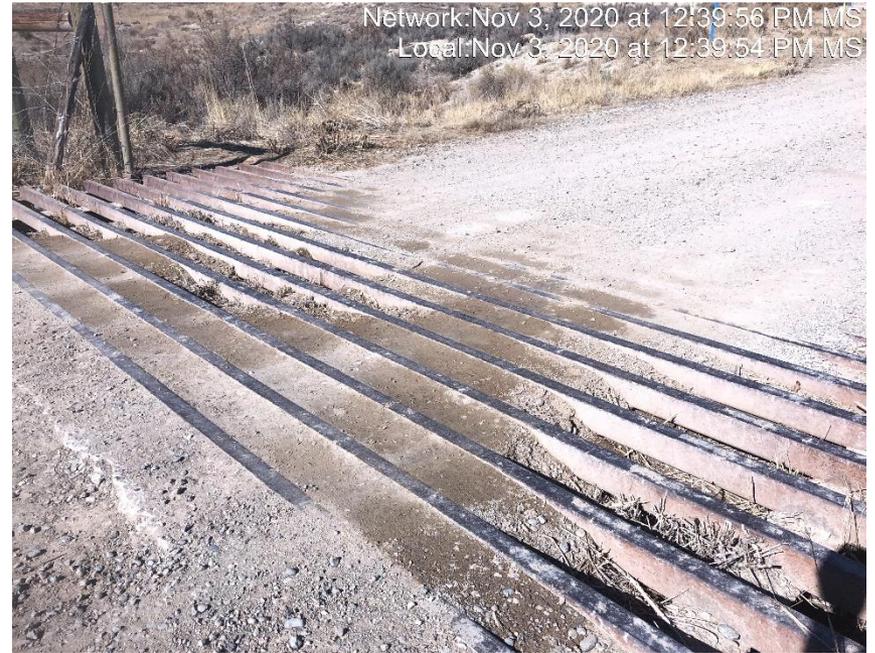
Photo #2177 Cattle guard full of sediment.
