**Inspection Photos**  
**Operator: BP America**  
**API: 067-06641**  
**Date: 11/2/2020**

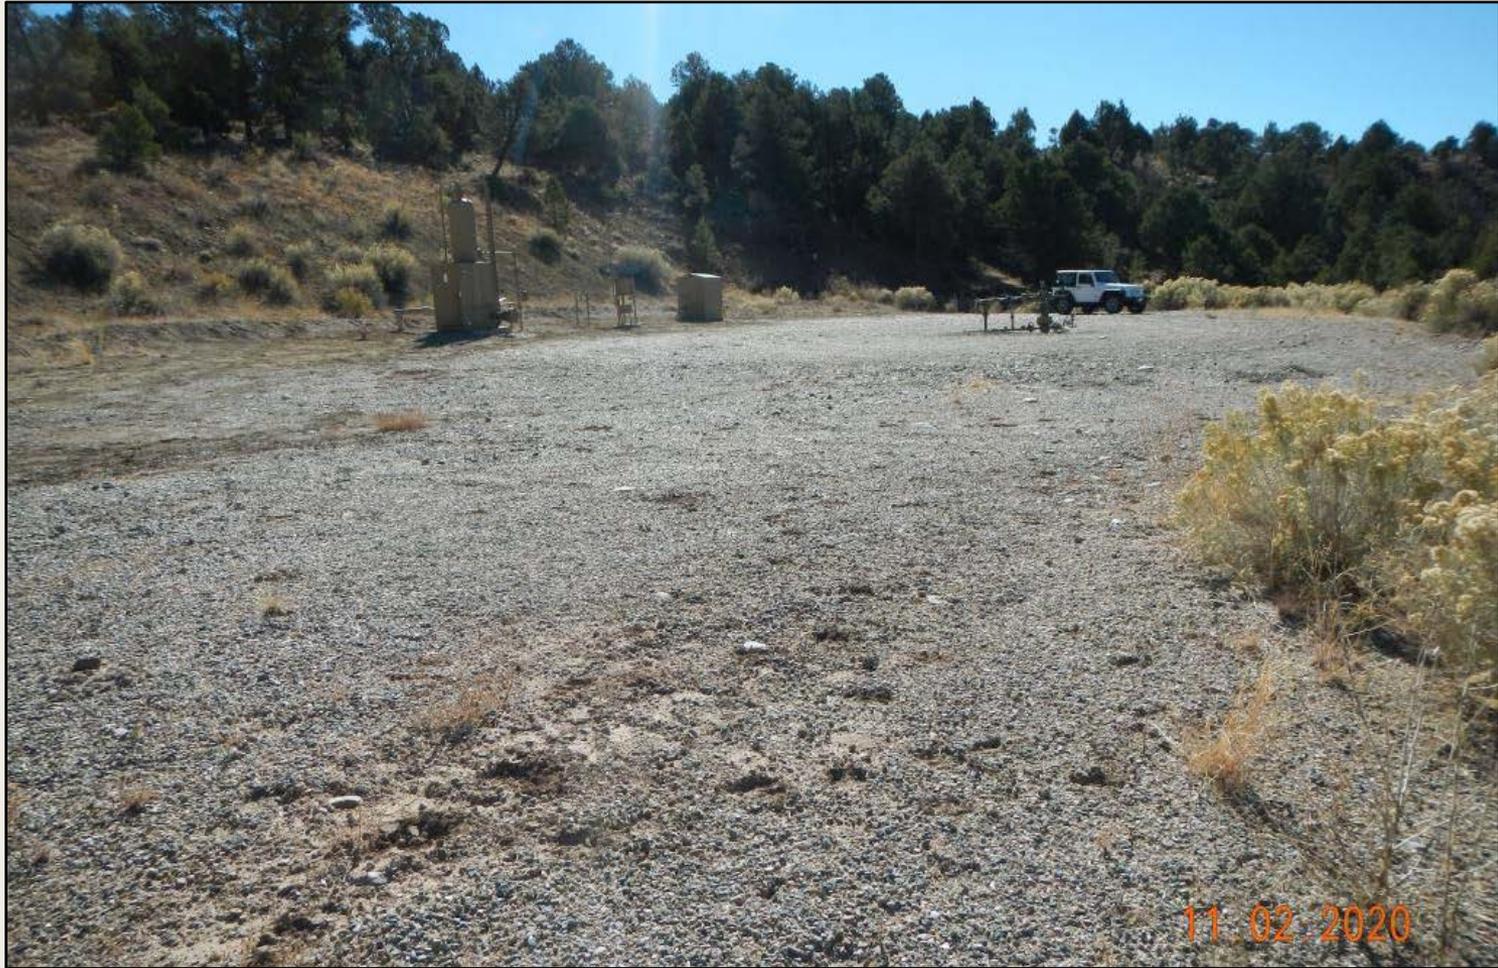
Photo 1. View of the project area from the northeastern corner facing center.

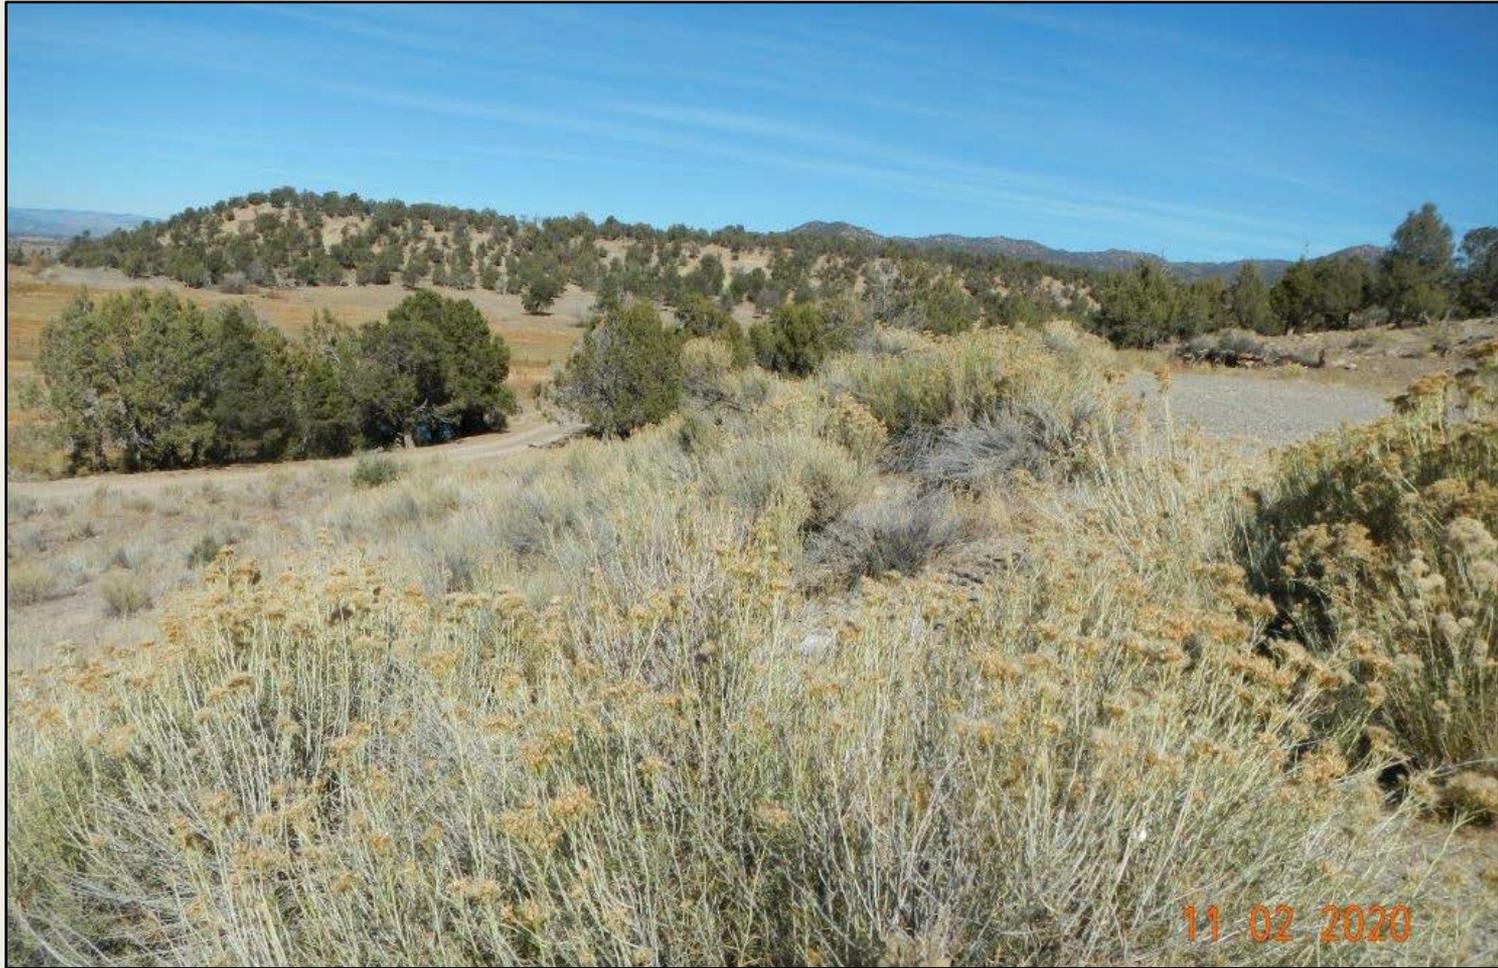
Photo 2. View of the northern fill slope from the northwestern corner facing eastward. Revegetation is progressing with rubber rabbitbrush, western wheatgrass, and crested wheatgrass.

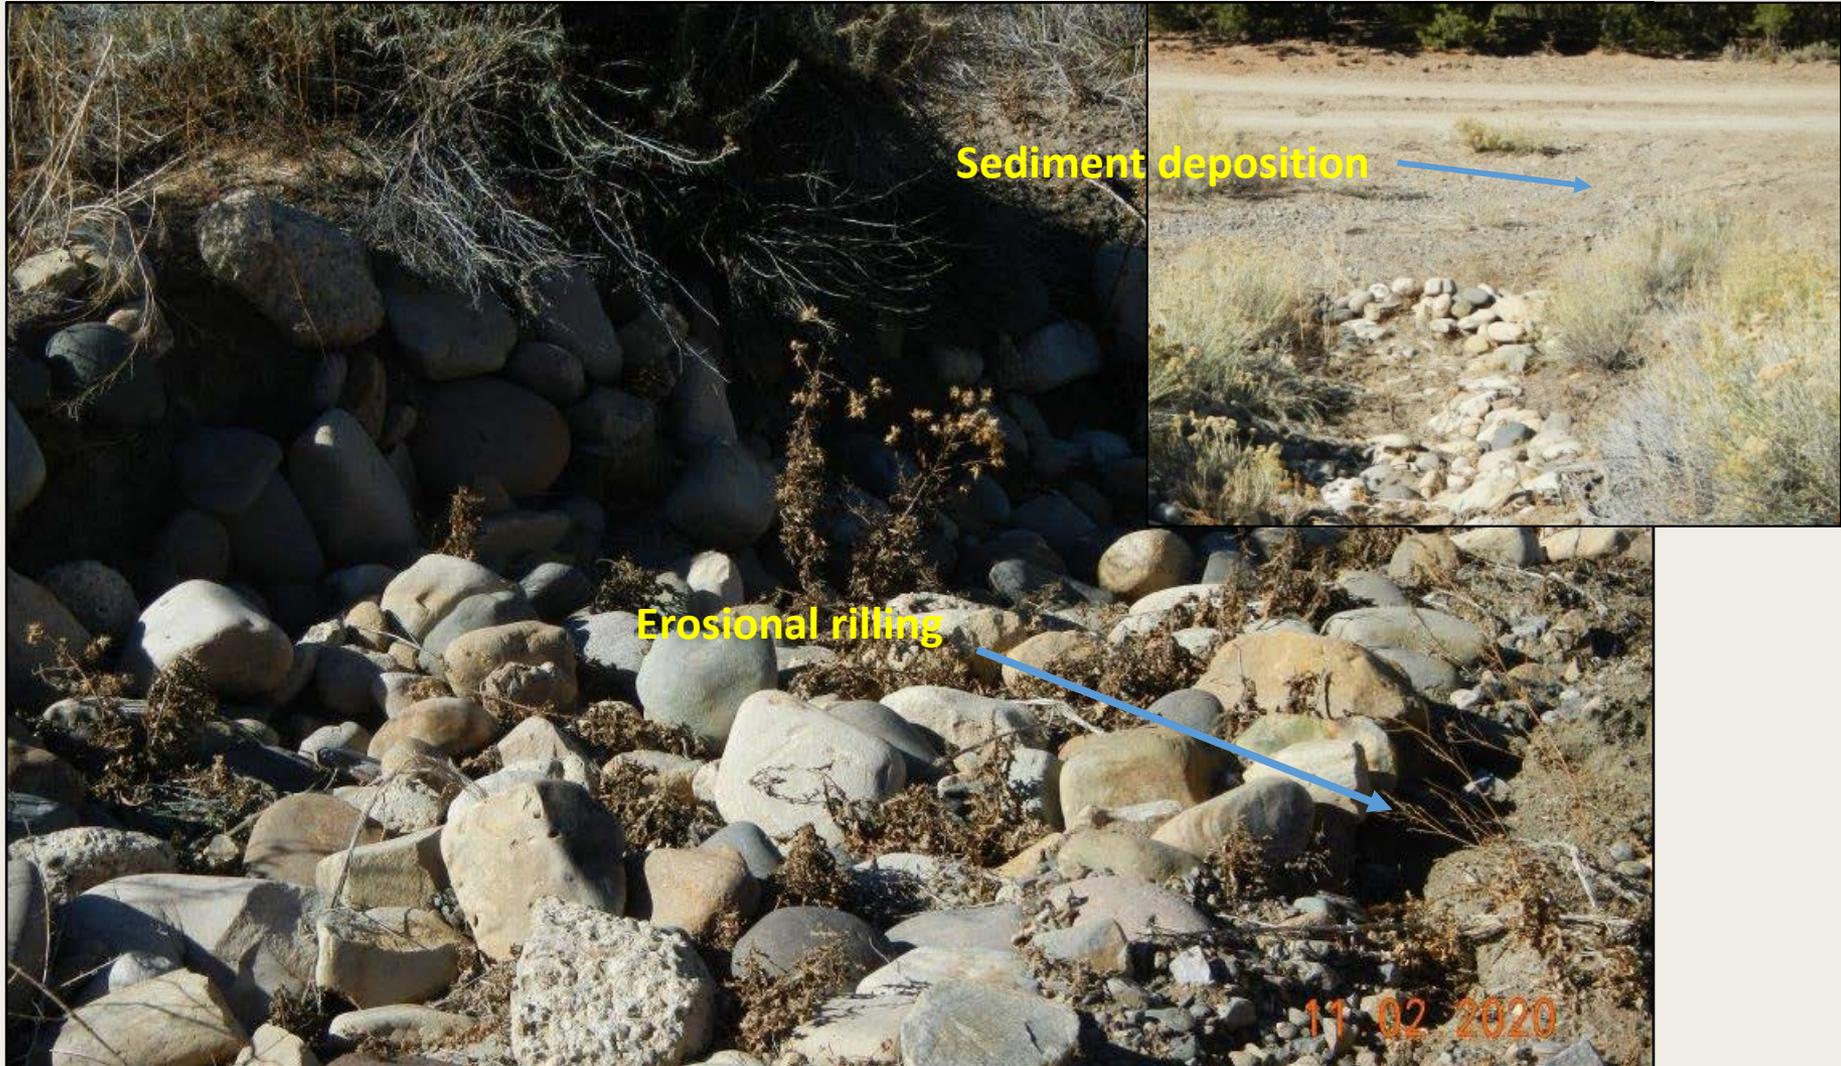
Photo 3. View of cobble run-down in the northern project area. Erosional rilling is occurring around cobbles. Sediment deposition observed at the bottom of the slope (inset). Canada thistles appear to be herbicide treated.

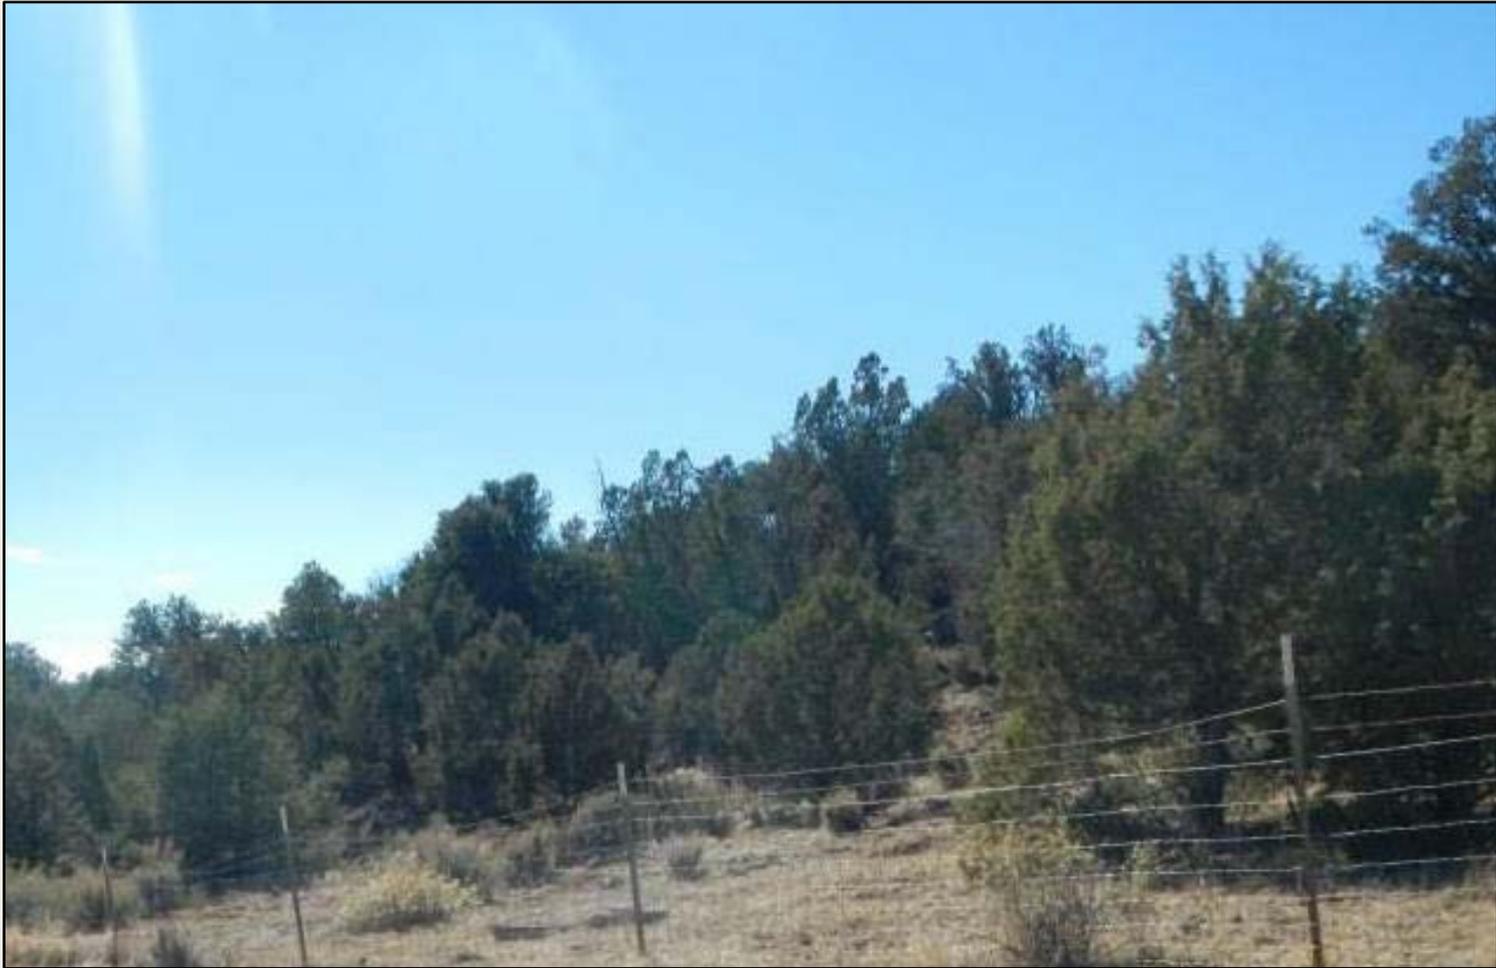
Photo 4. View of reference area comprised of pinyon/juniper woodland with understory of sagebrush, mountain mahogany, squirreltail, and western wheatgrass.

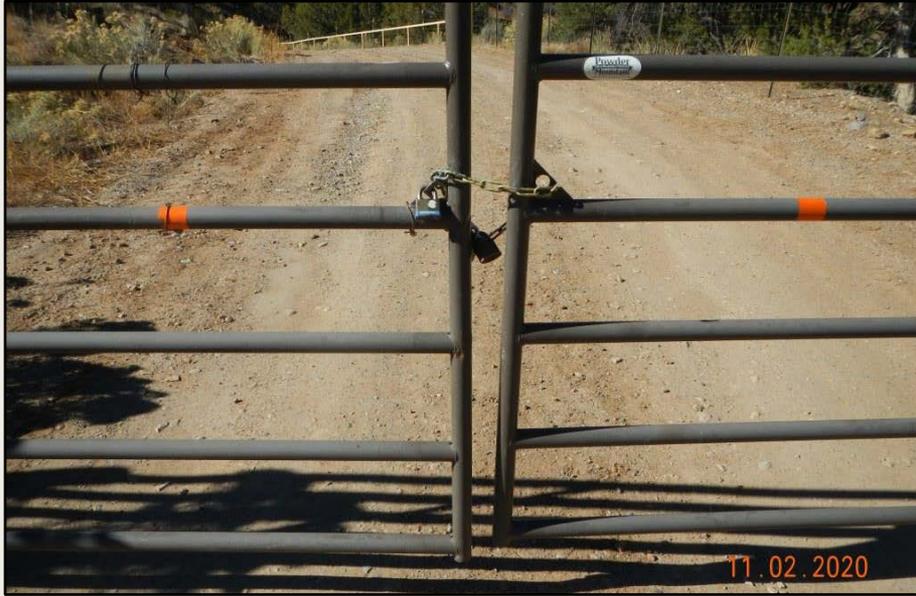
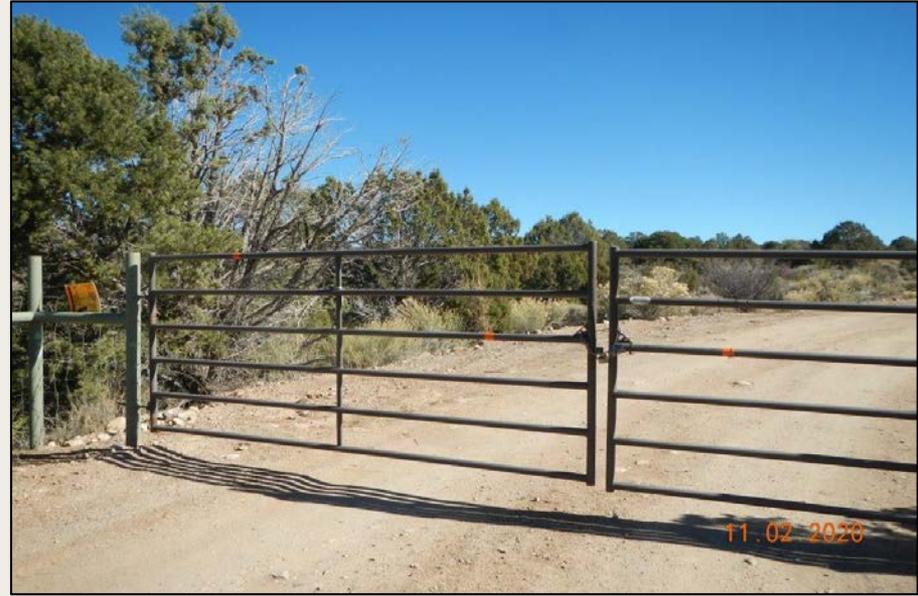
Photos 5/6. View of closed gates after entering (left) and leaving (right) project area.
