Inspection Photos
Operator: BP America
API: 067-06783
Date: 11/2/2020

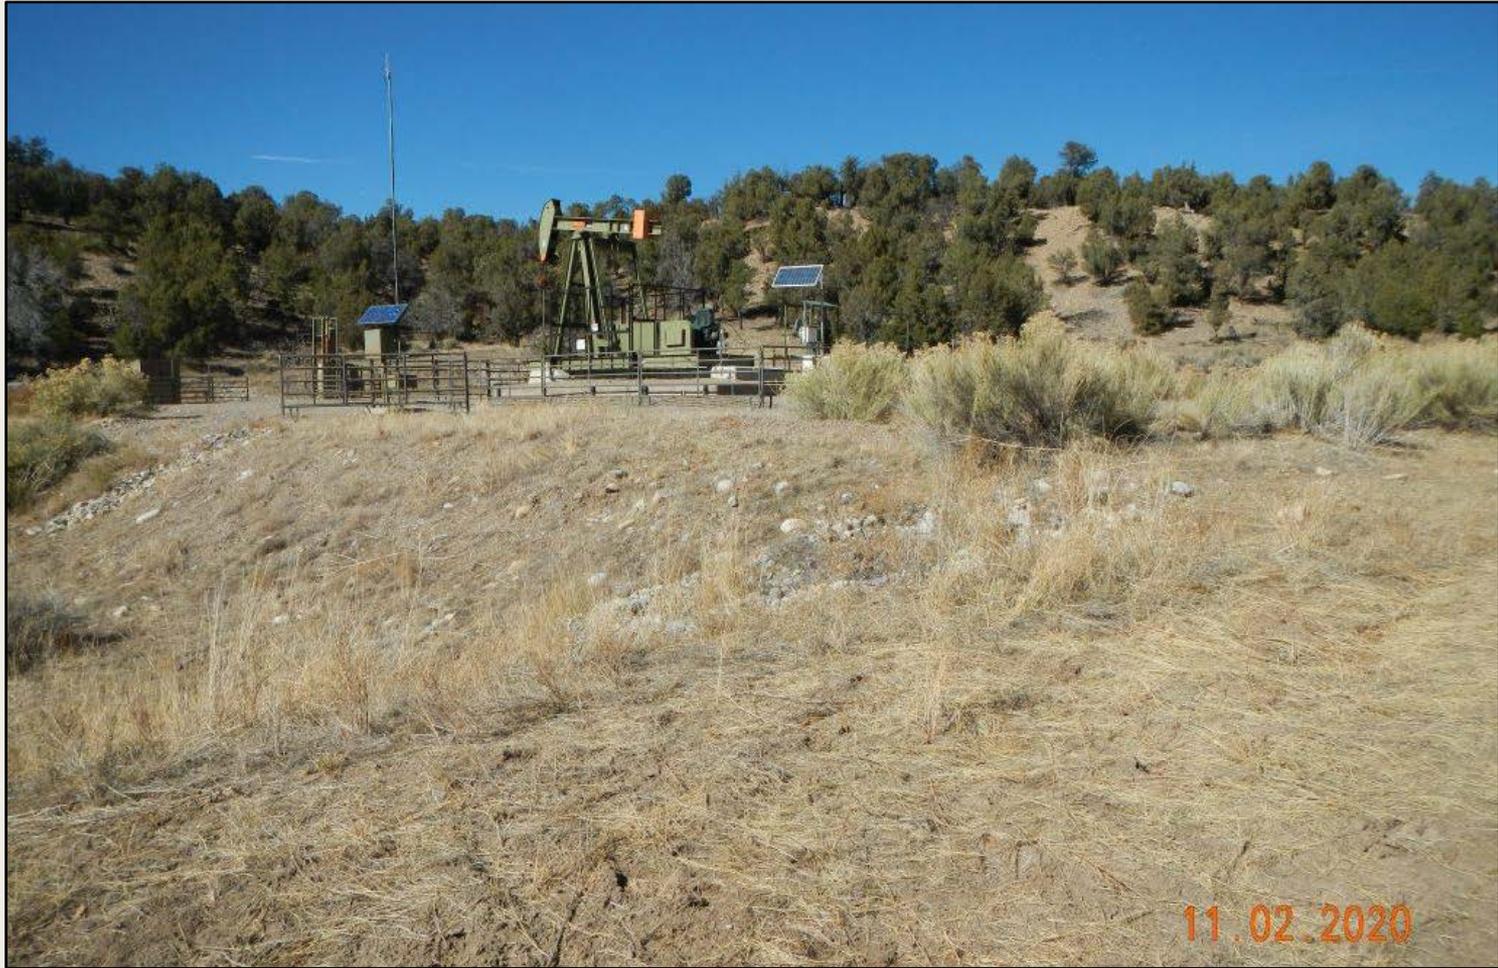
Photo 1. View of the project area from the southeastern corner facing center.

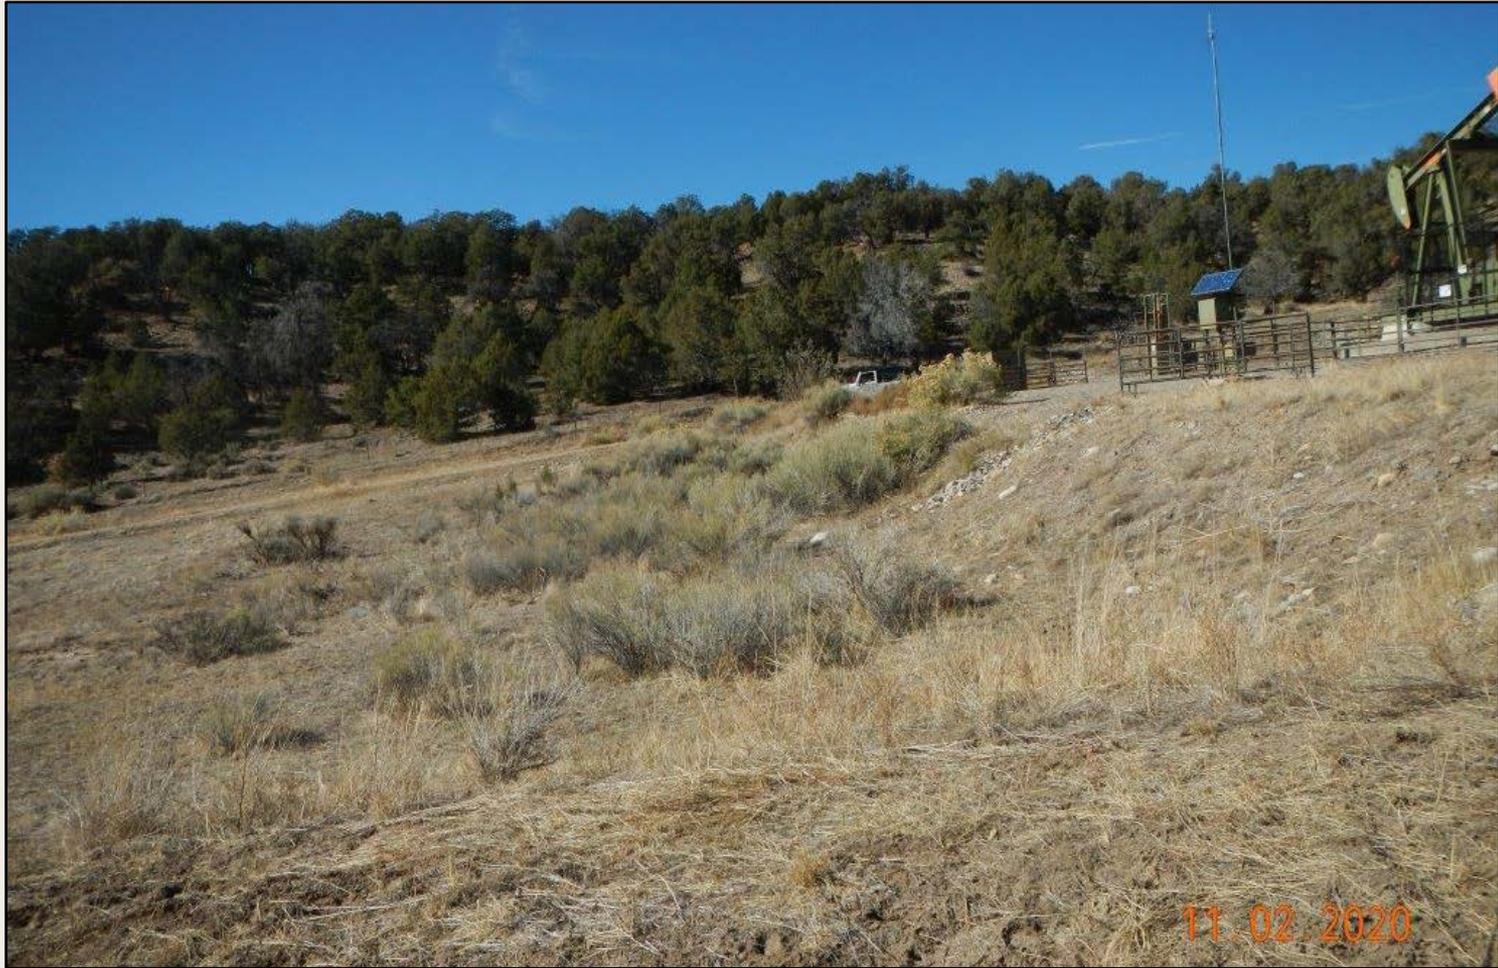
Photo 2. View of the southern fill slope from the southeastern corner facing westward. Revegetation is progressing with rubber rabbitbrush, western wheatgrass, and crested wheatgrass.

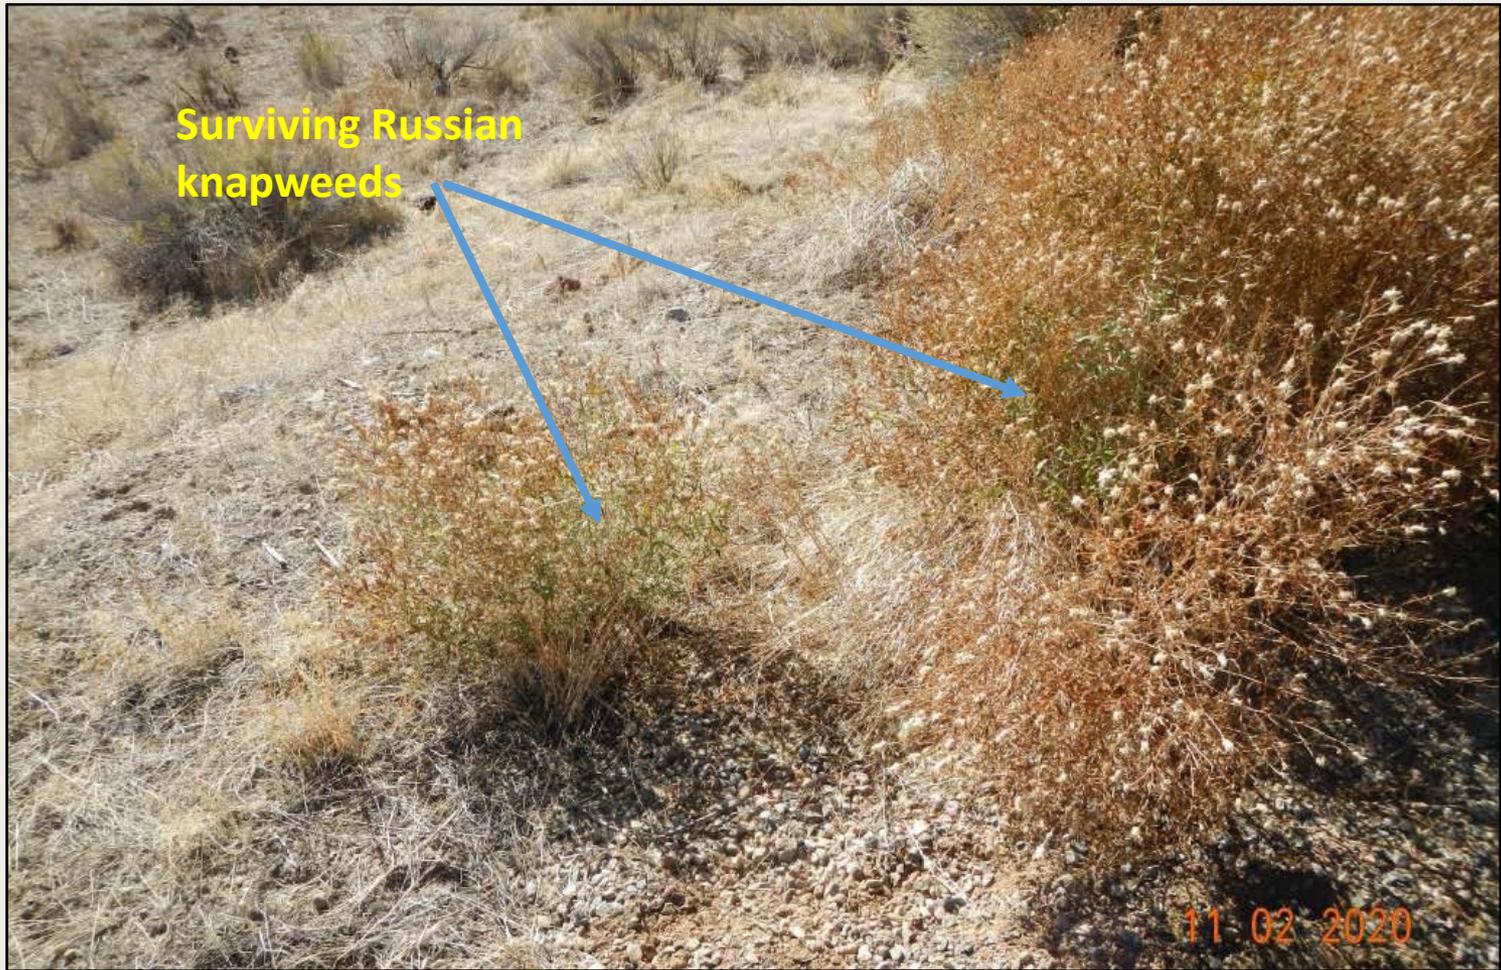
Photo 3. View of Russian knapweeds, largely appear herbicide-treated, although surviving individuals remain.

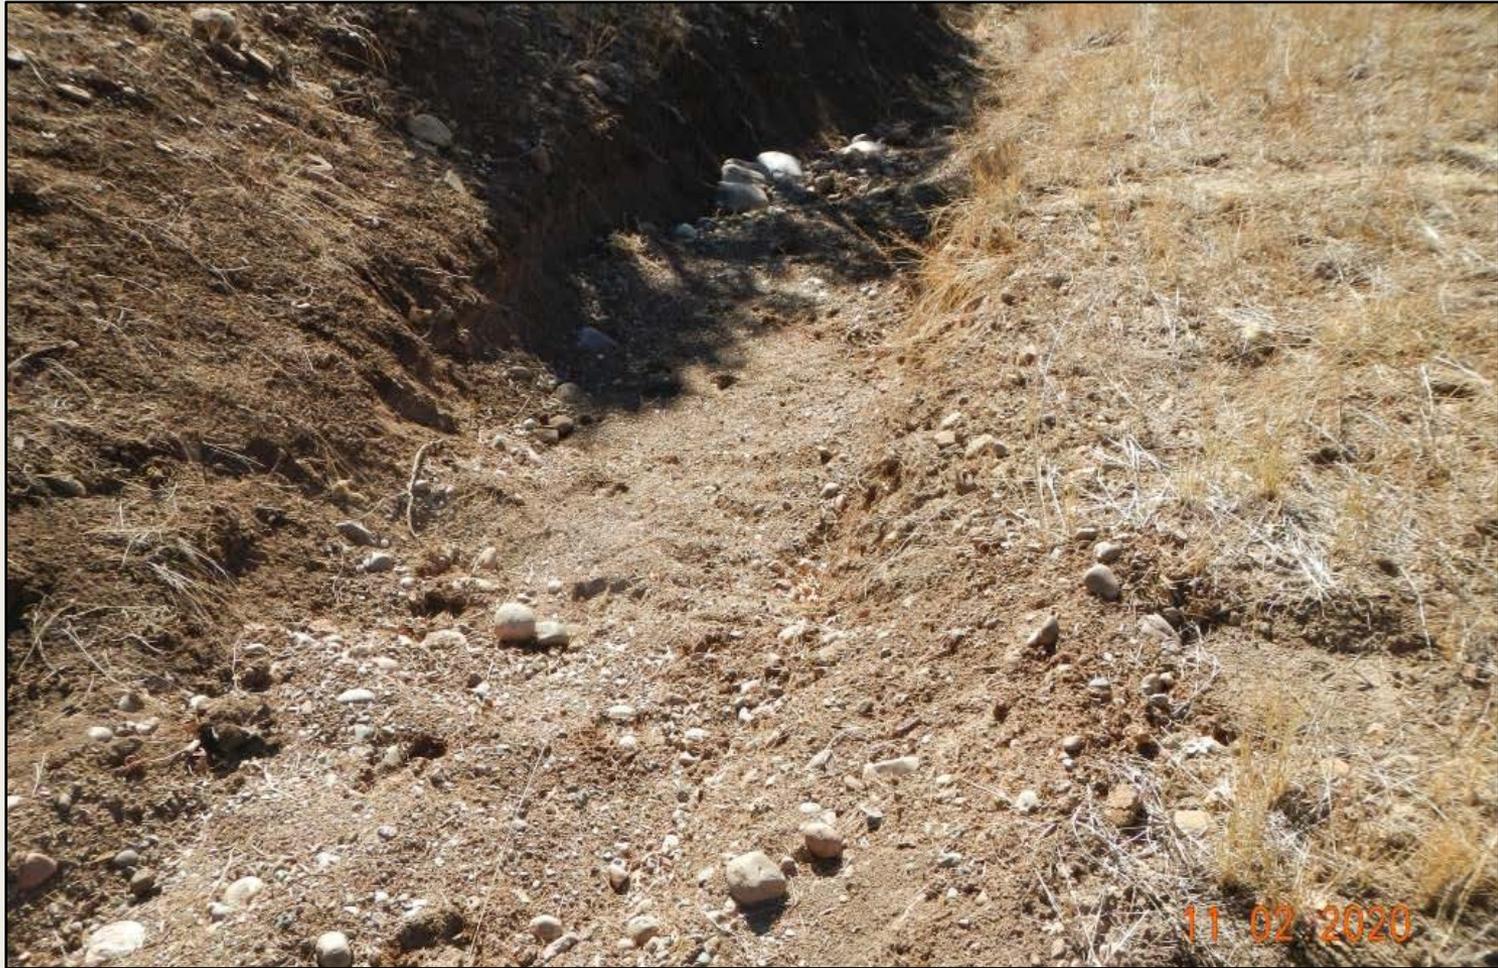
Photo 4. View of repaired headcut within the southeastern corner of the project area. Bare soils need additional stabilization.

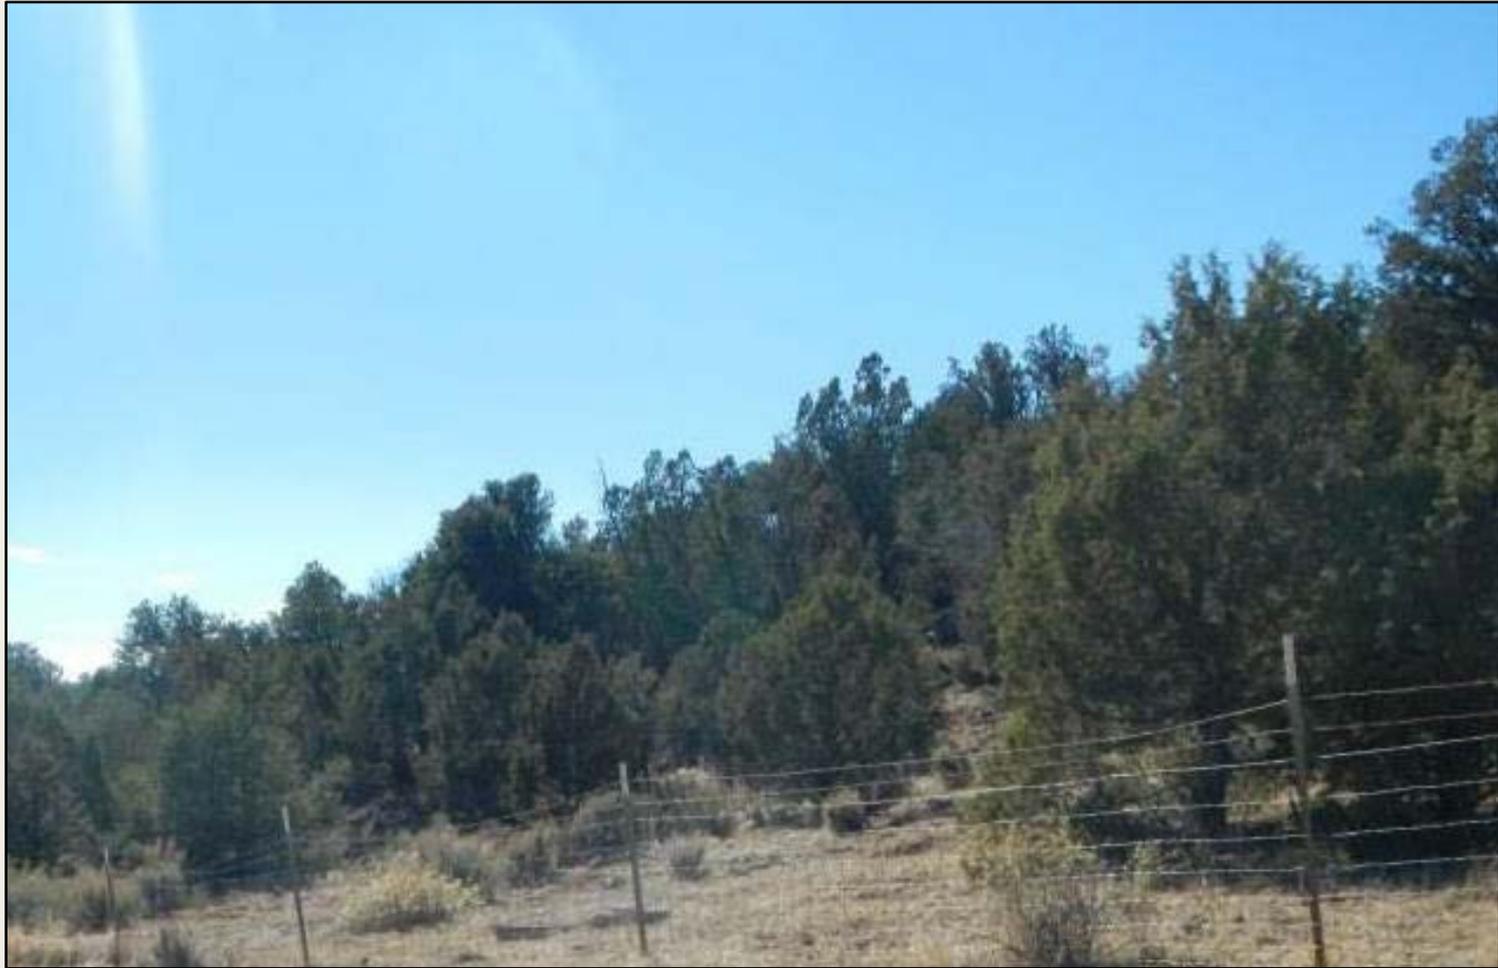
Photo 5. View of reference area comprised of pinyon/juniper woodland with understory of sagebrush, mountain mahogany, squirreltail, and western wheatgrass.

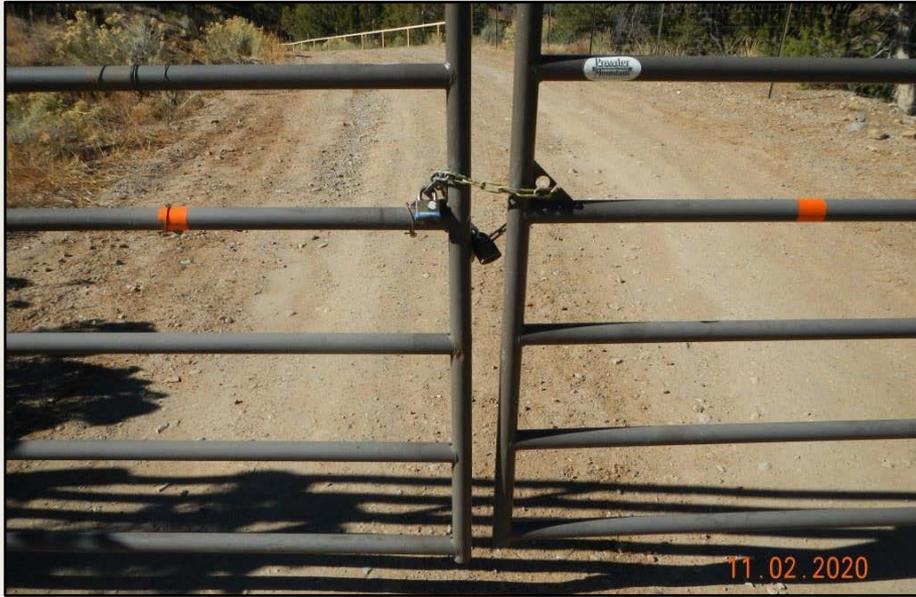
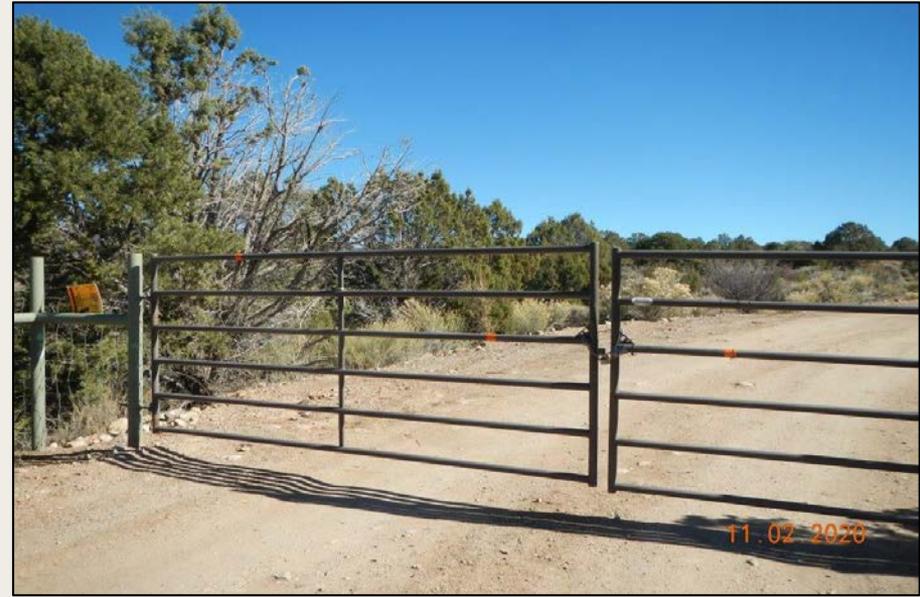
Photos 6/7. View of closed gates after entering (left) and leaving (right) project area.
