## Inspection Photos

Location Name: Marvin E Schutt Unit #1 Treating facility

Facility ID: 467173

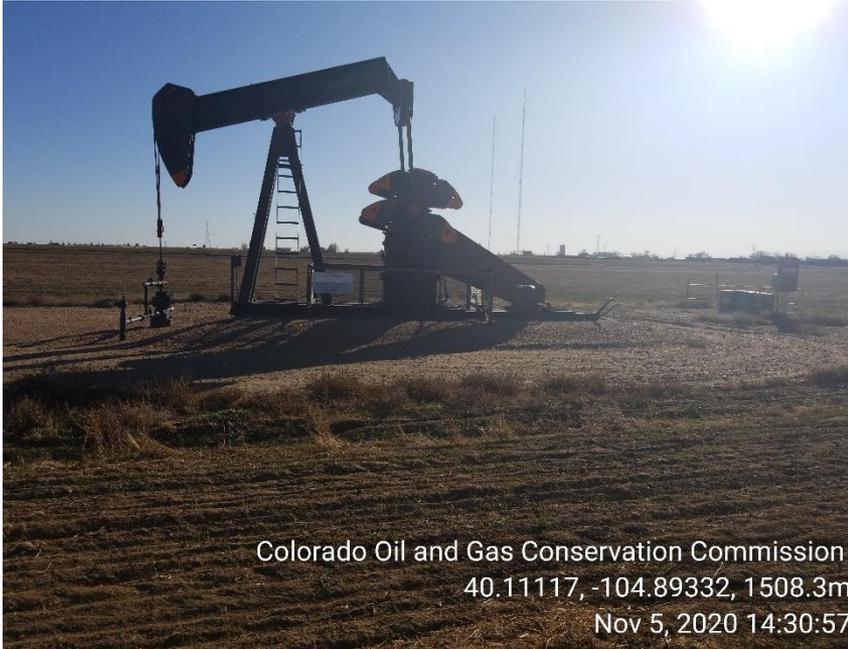
**Photo 2 Energy Minerals Unit B#1 pumping unit Well is SI**

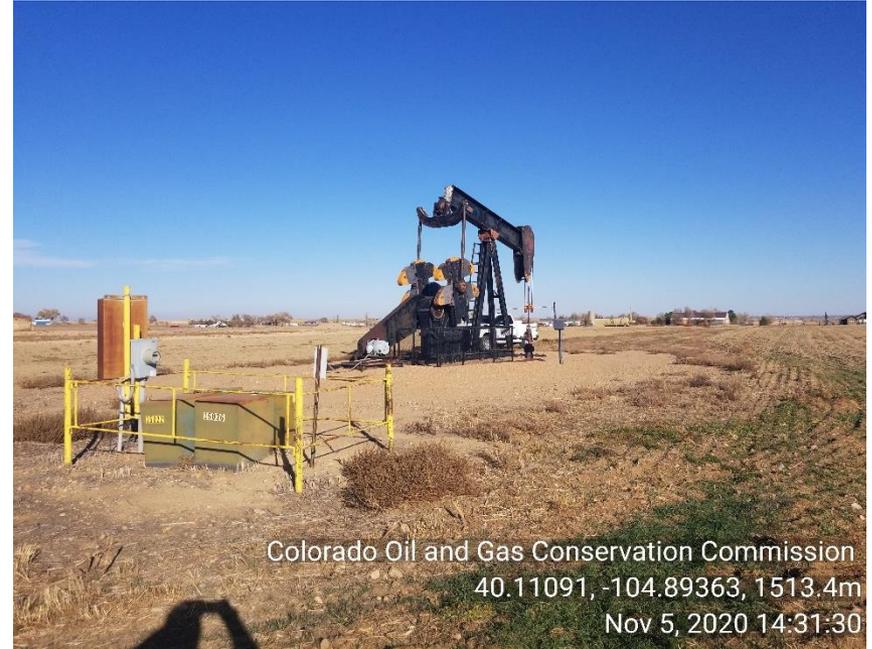
**Photo 2 Energy Minerals Unit B#1 loc pic**

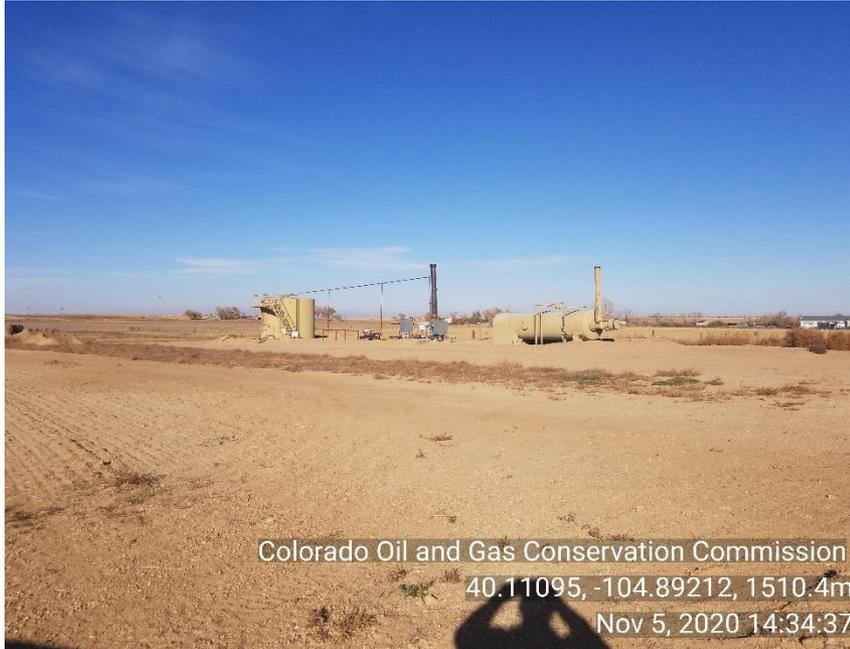
**Photo 3 Marvin E. Schutt Unit 1 Treating Facility loc pic**

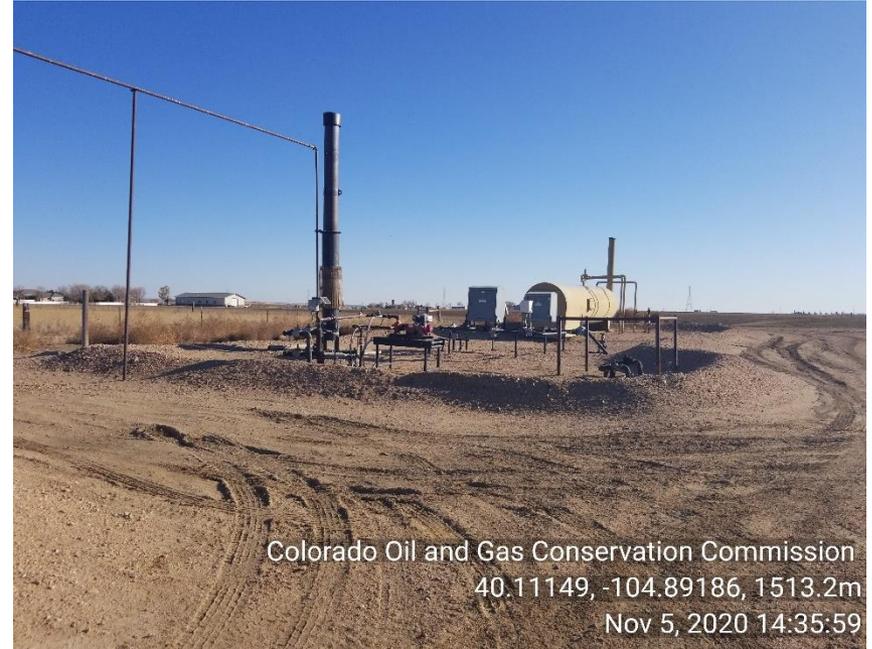
**Photo 4 production equipment. Pilot does not appear to be lit on ECD and is venting gas.**

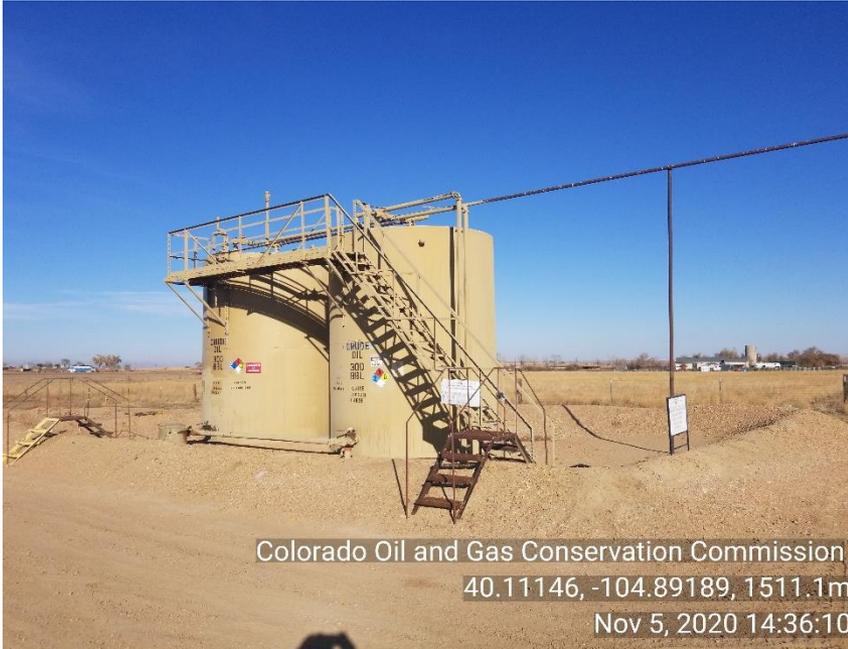
**Photo 5 TNK BTRY**

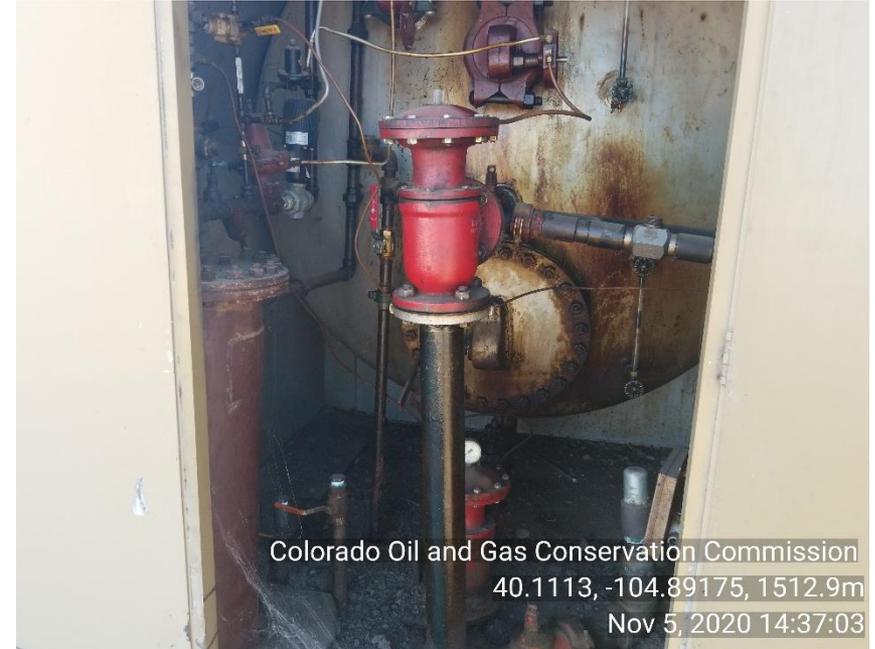
**Photo 6 HOZ sep Mechanical issue: piping appear to be wet and seeping.**

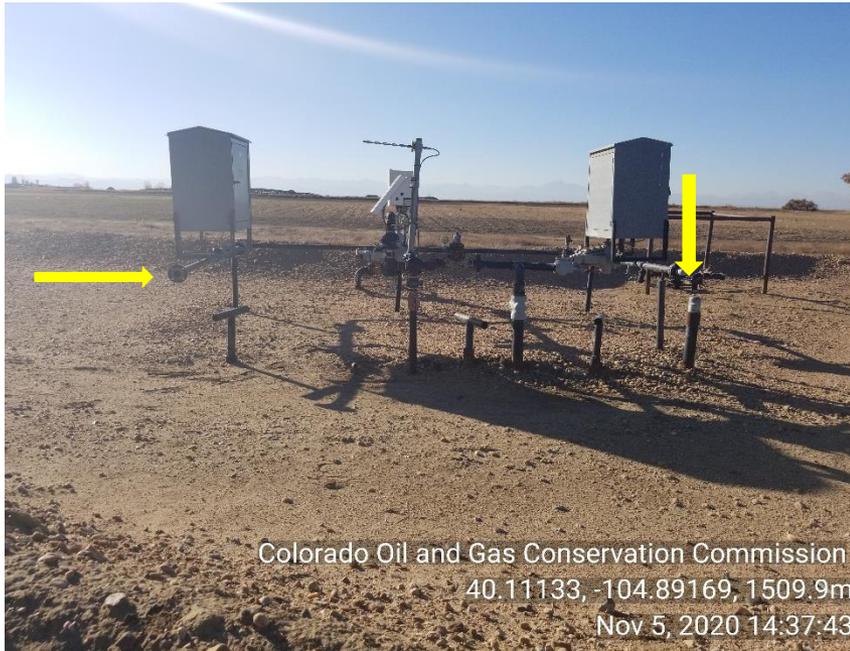
**Photo 7 open ended piping and Unmarked not LOTO risers on two unused meter runs.**

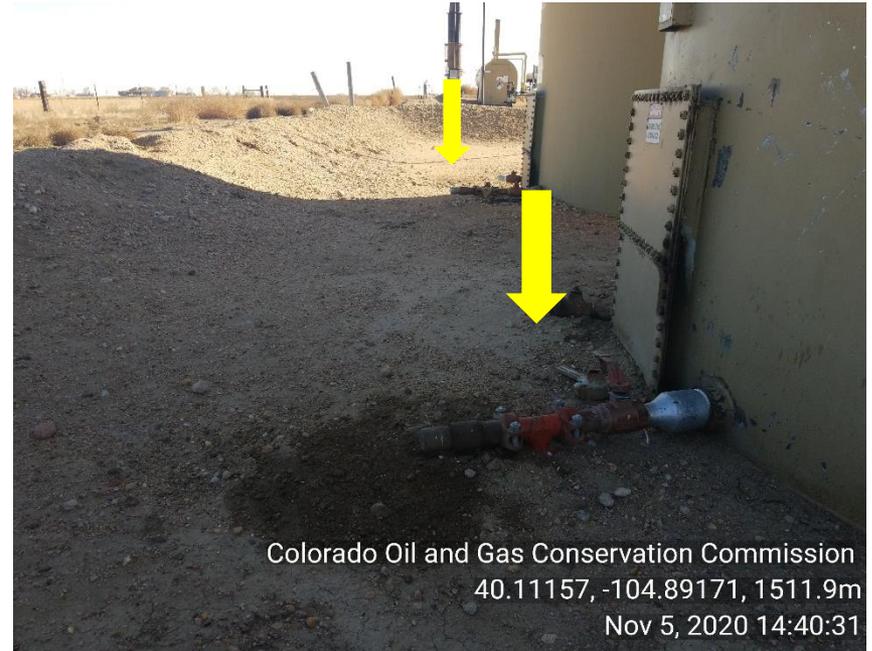
**Photo 8 Mechanical issue: back side load lines leaking south crude oil tank actively leaking . Stained soil under each 2" line on crude oil tanks.**

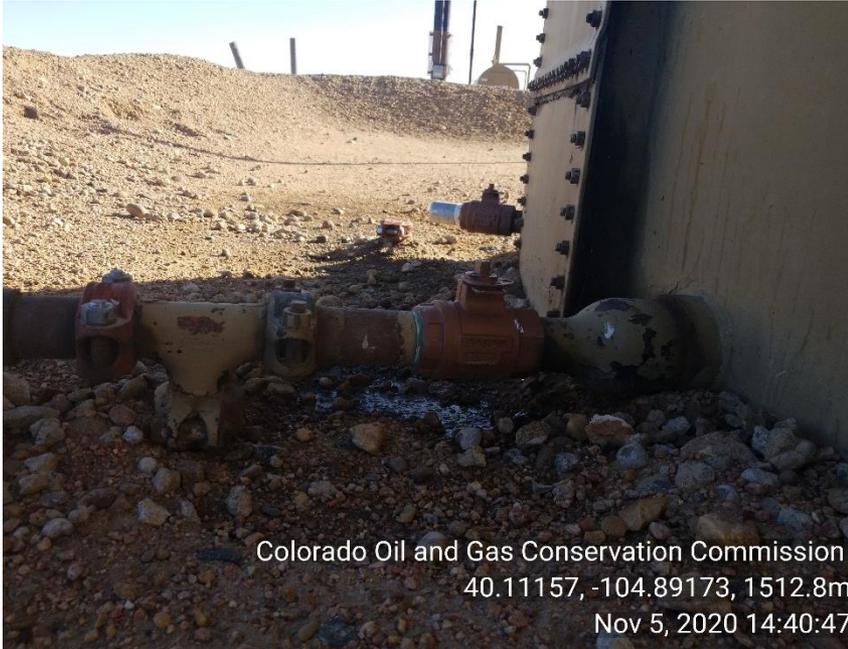
**Photo 10 2" line on crude oil tank actively leaking.**

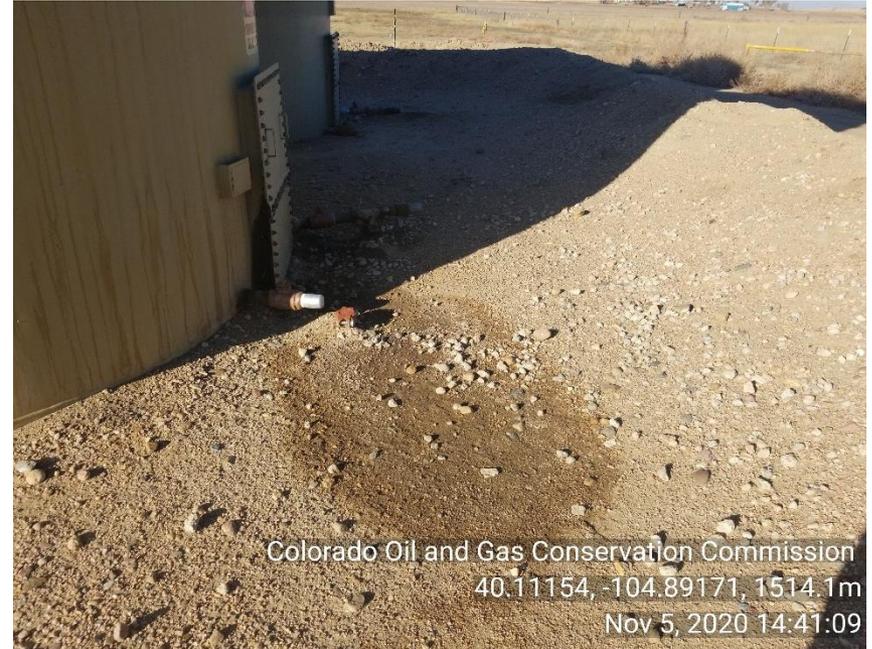
**Photo 11 Stained soil from leaking 2" crude oil line.**

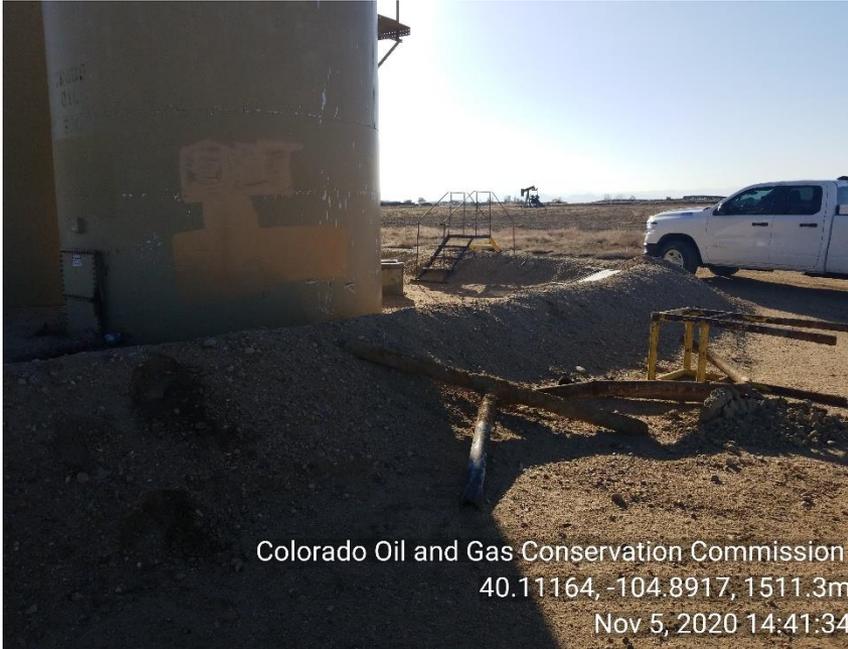
**Photo 12 unused equipment: piping and guards on location.**

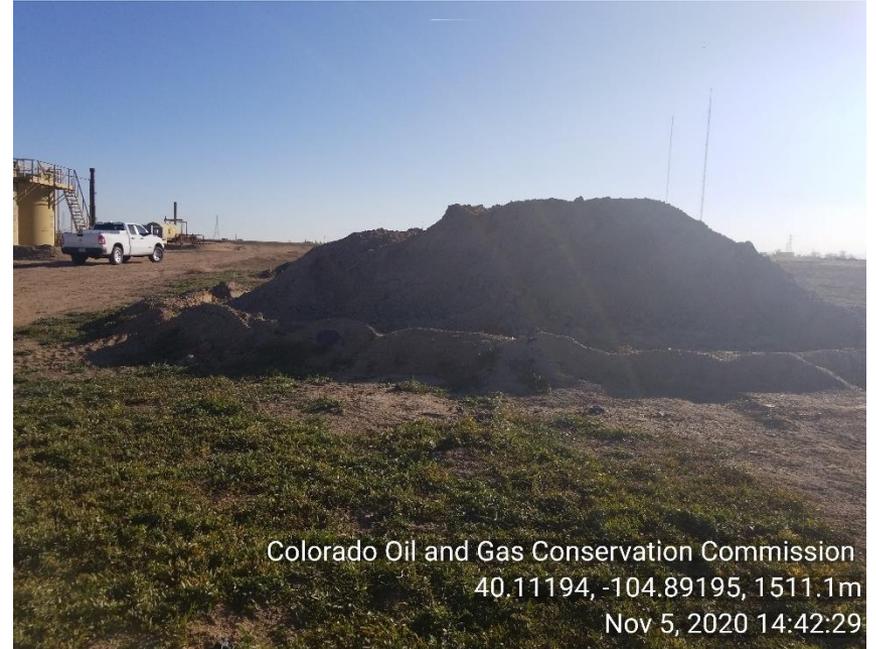
**Photo 13 BMP around material from spill remediation not adequate.**

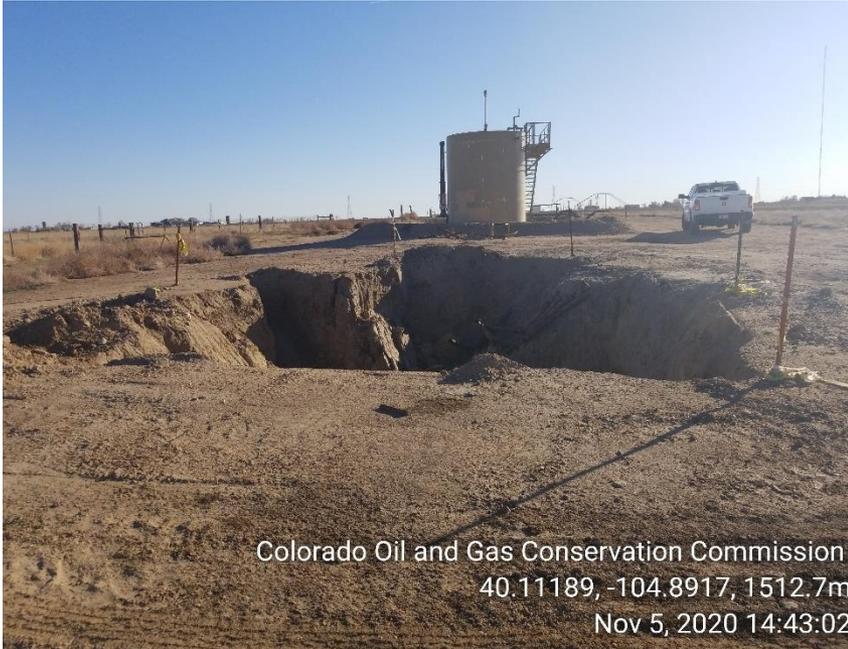
**Photo 14 no BMP's around spill remediation in place. No safety fence.**

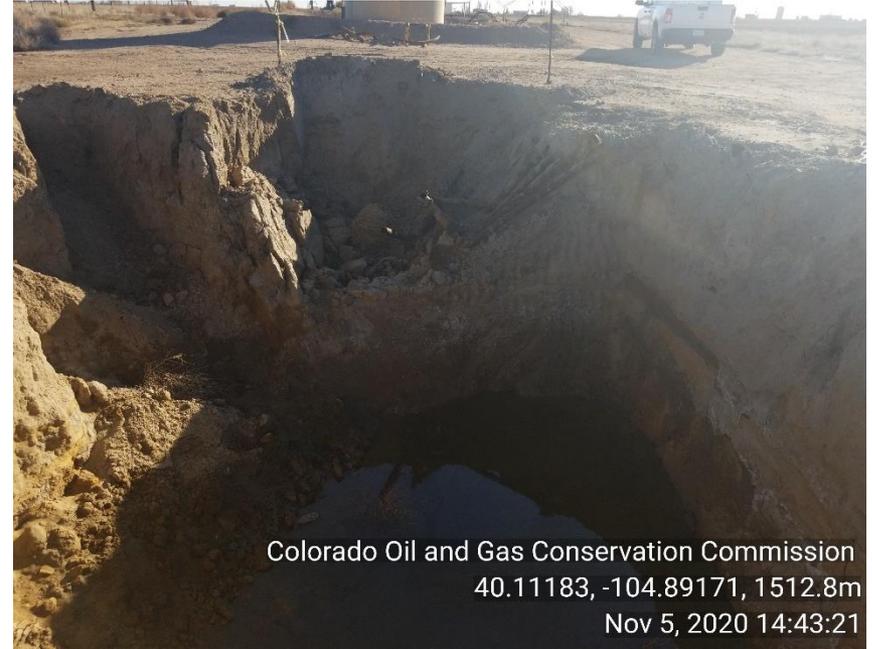
**Photo 15 Flow lines in excavation not capped or bull plugged and damaged. Stained soil from flow lines leaking.**

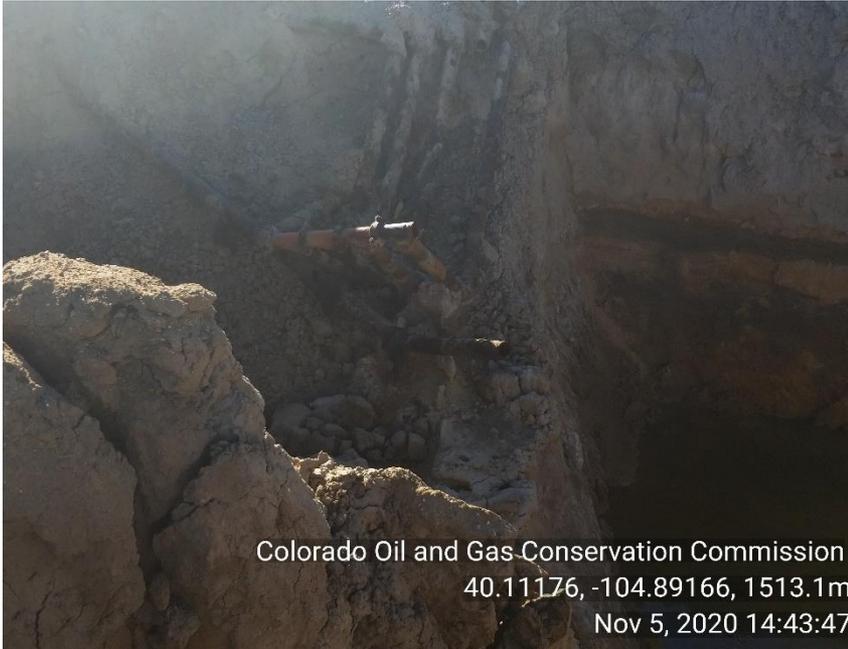
**Photo 16 15 Flow lines in excavation not capped or bull plugged and damaged. Stained soil from flow lines leaking.**

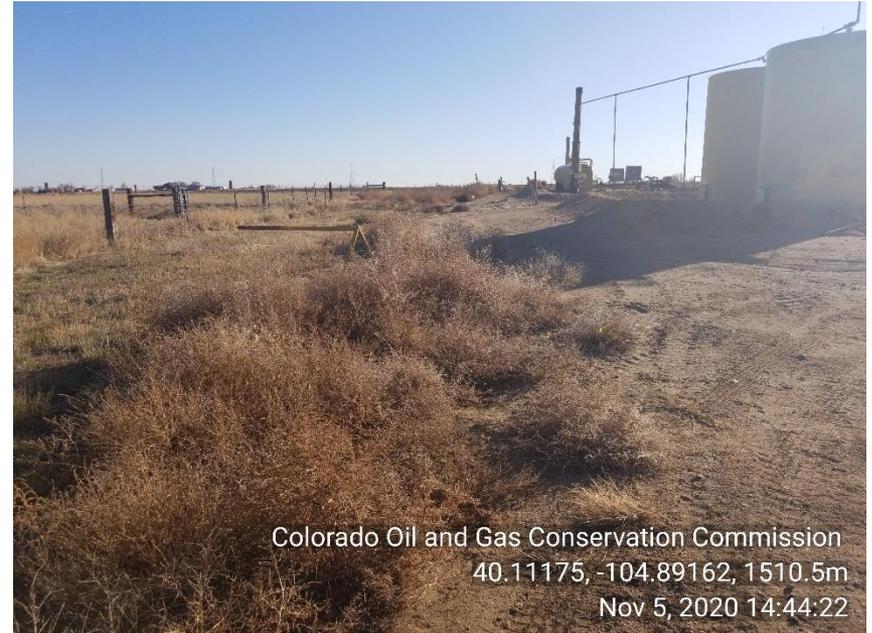
**Photo 17 Debris: Dead weeds on location.**
