## Inspection Photos

Location Name: GUNNISON ENERGY LLC HOTCHKISS FEDERAL 1289 #18-22A /18-22A PAD

Location ID: 324483

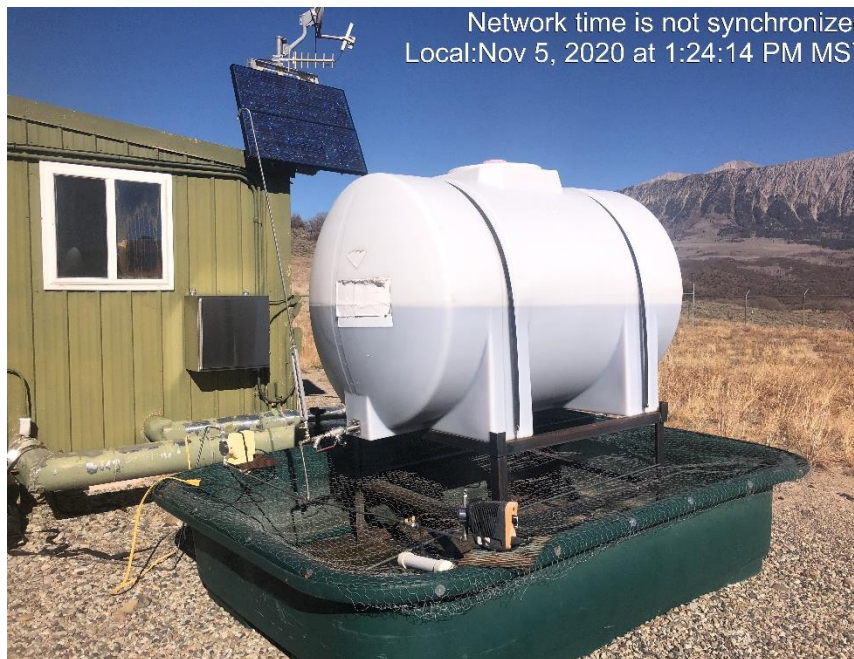
**Photo #2200 Chemical tank NFPA label weathered and not legible.**

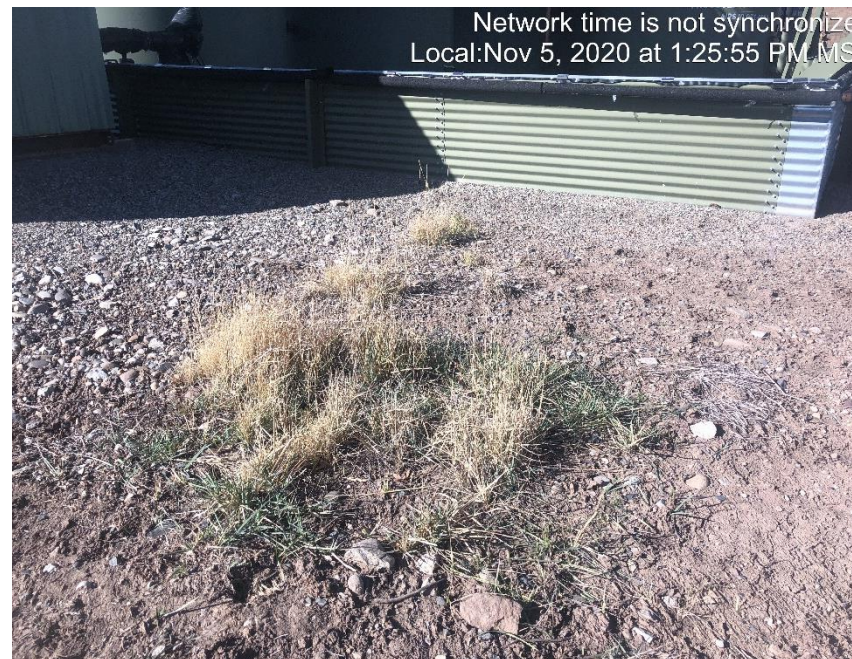
**Photo #2201 Multiple places with debris inside tank containment.**

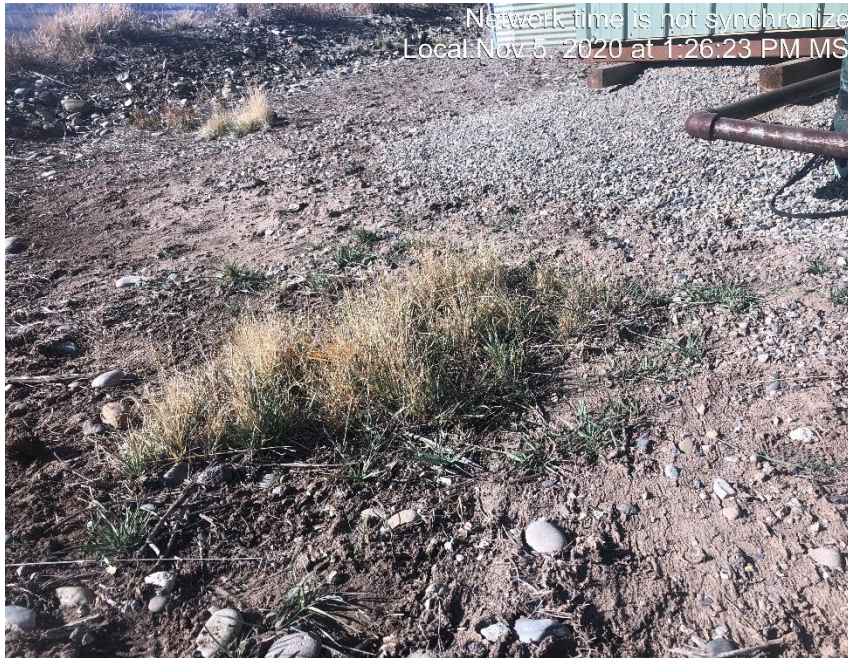
**Photo #2202 Multiple places with debris inside tank containment.**

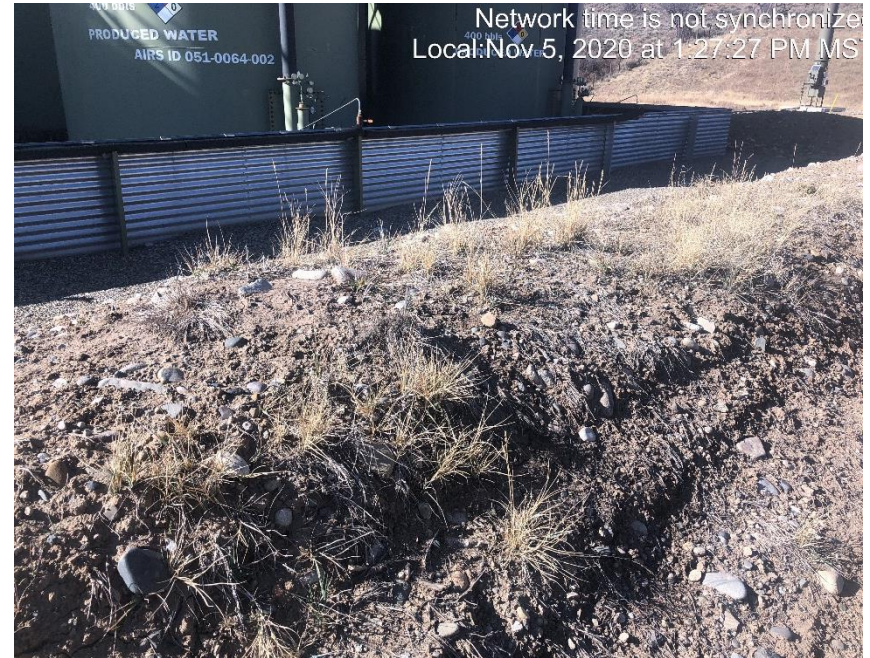
**Photo #2203 Debris on East side of tank containment berm.**

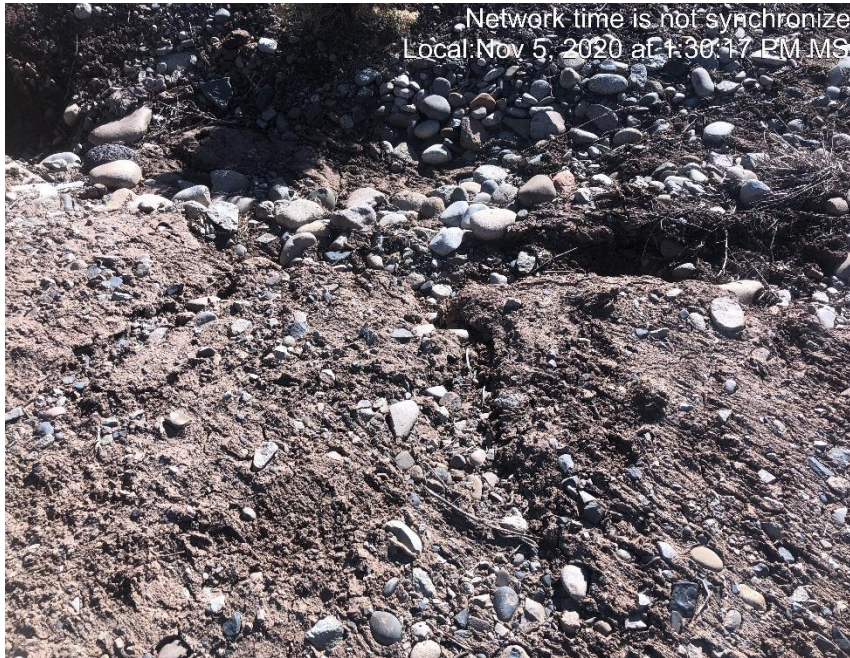
**Photo #2207 Rill erosion occurring in ditch at inlet to culvert.**

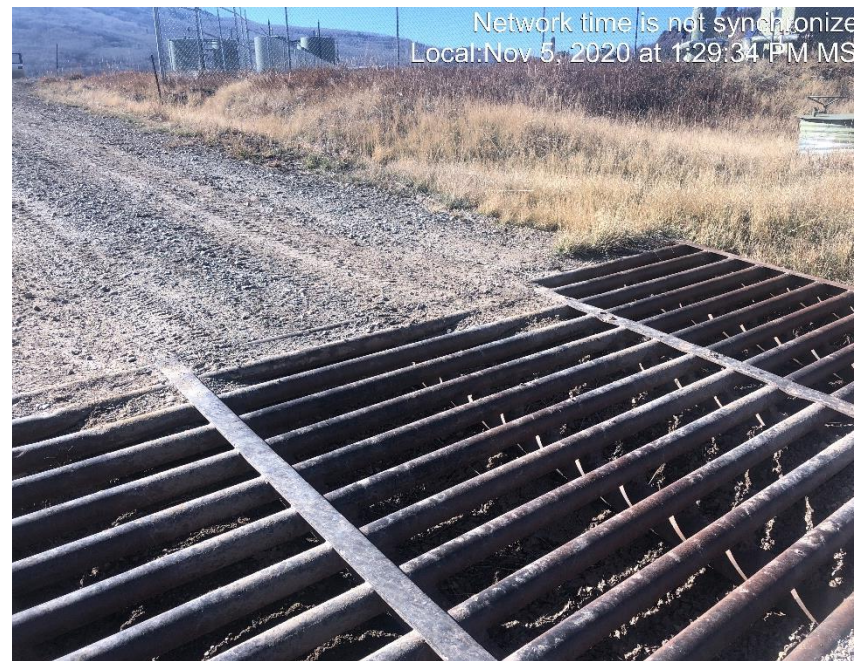
Photo #2206 Sediment present in cattle guard.
