# Inspection Photos

Operator: Hilcorp Energy  
API: 067-08199  
Date: 11/5/2020

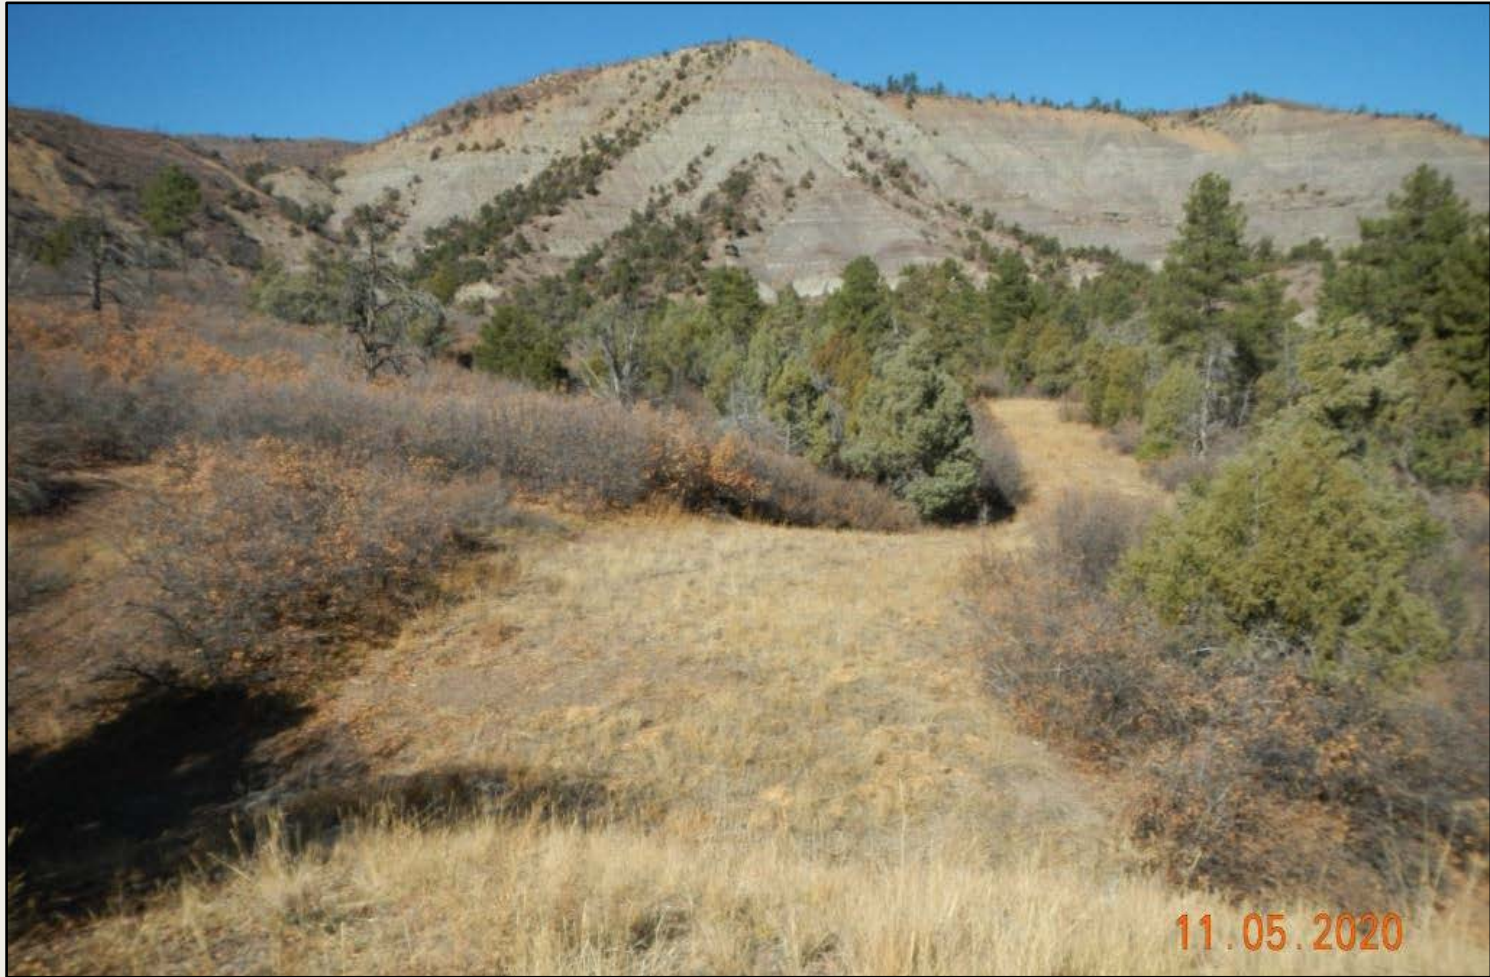
Photo 1. View of the reclaimed access from the beginning, facing along the road alignment. Reference area vegetation is comprised of a mosaic of gambel oak shrubland, with ponderosa pine, pinyon and juniper trees, shrubs such as mountain mahogany, and grasses/forbs such as rocky mountain penstemon, squirreltail, and field sedge.

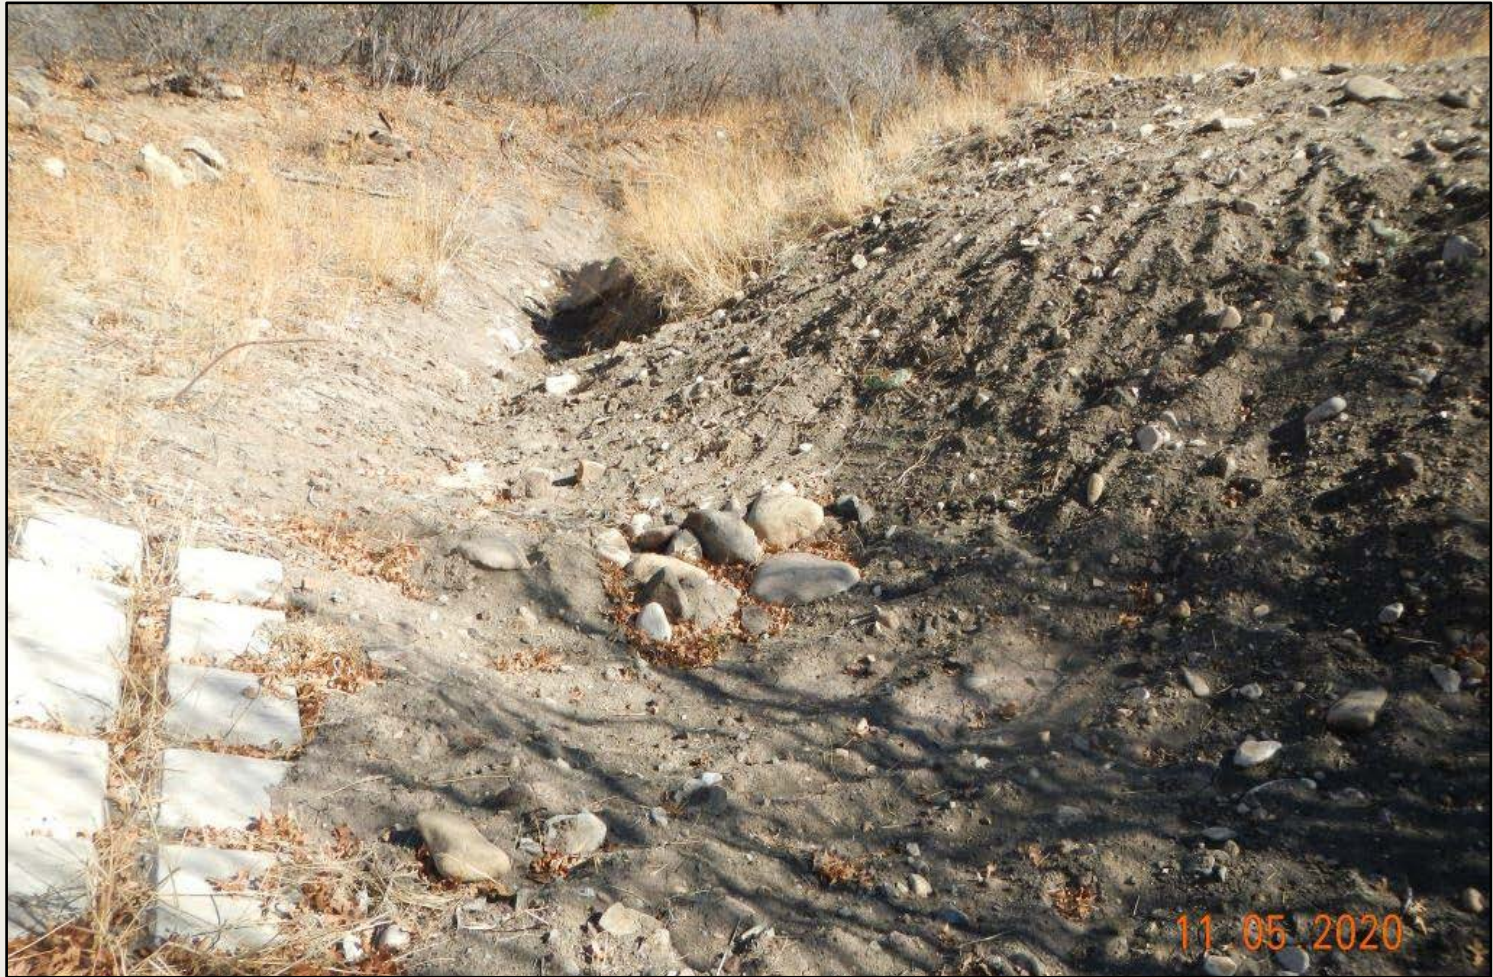
Photo 2. View of work conducted where erosional head-cut was observed during an earlier reclamation inspection. Bare soils are not protected, and will likely rapidly erode.

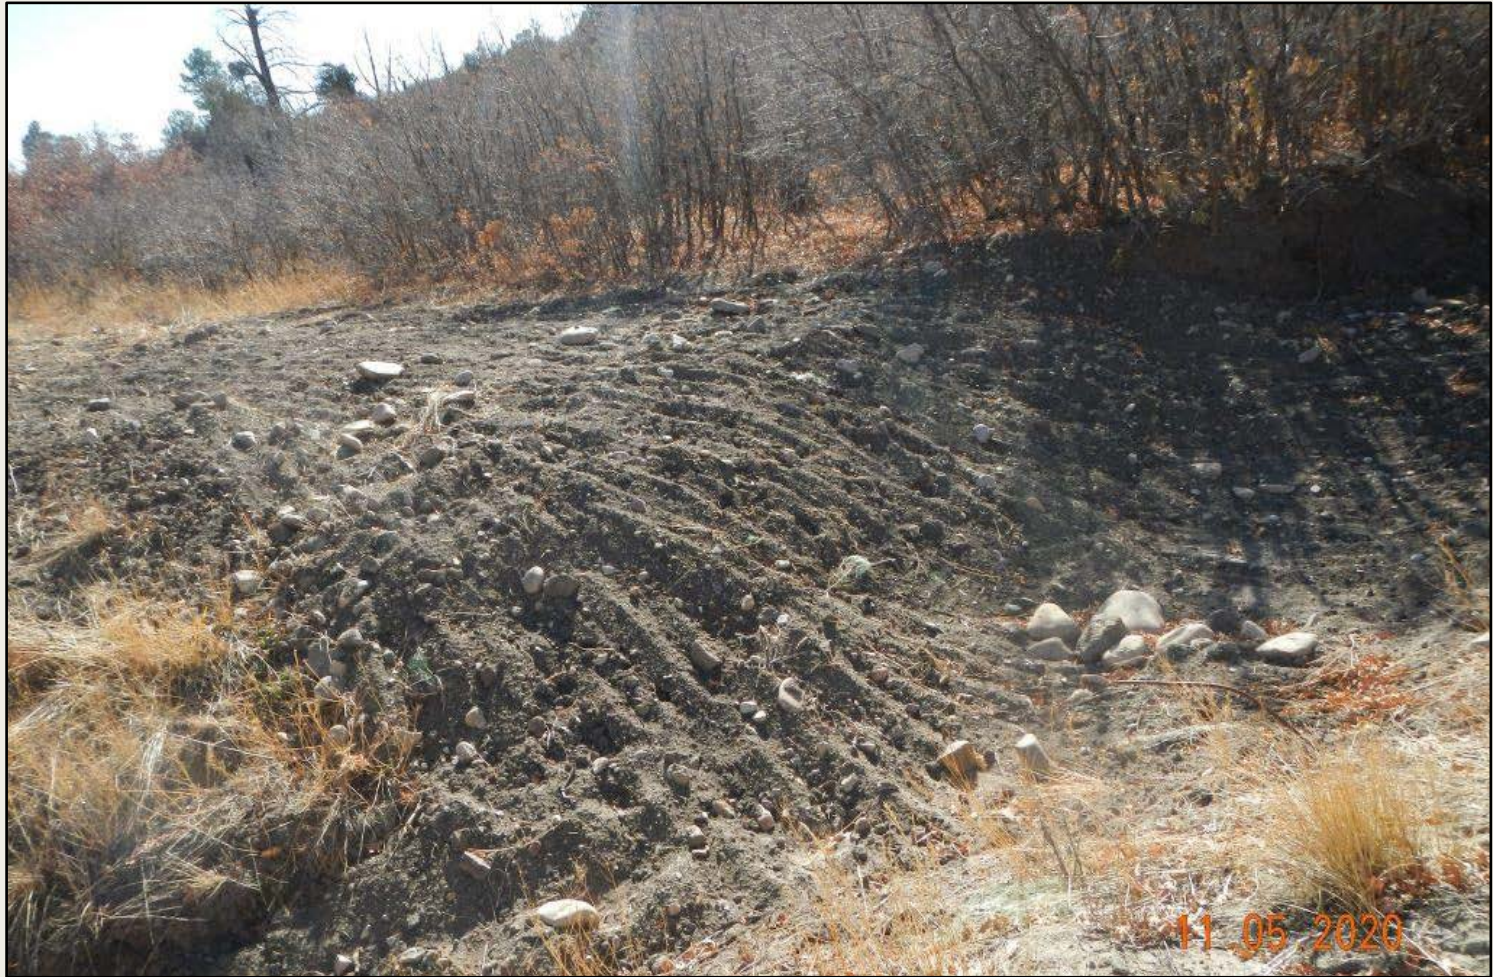
Photo 3. View of disturbed soils at the bank of erosional repair. Seeding is not apparent.

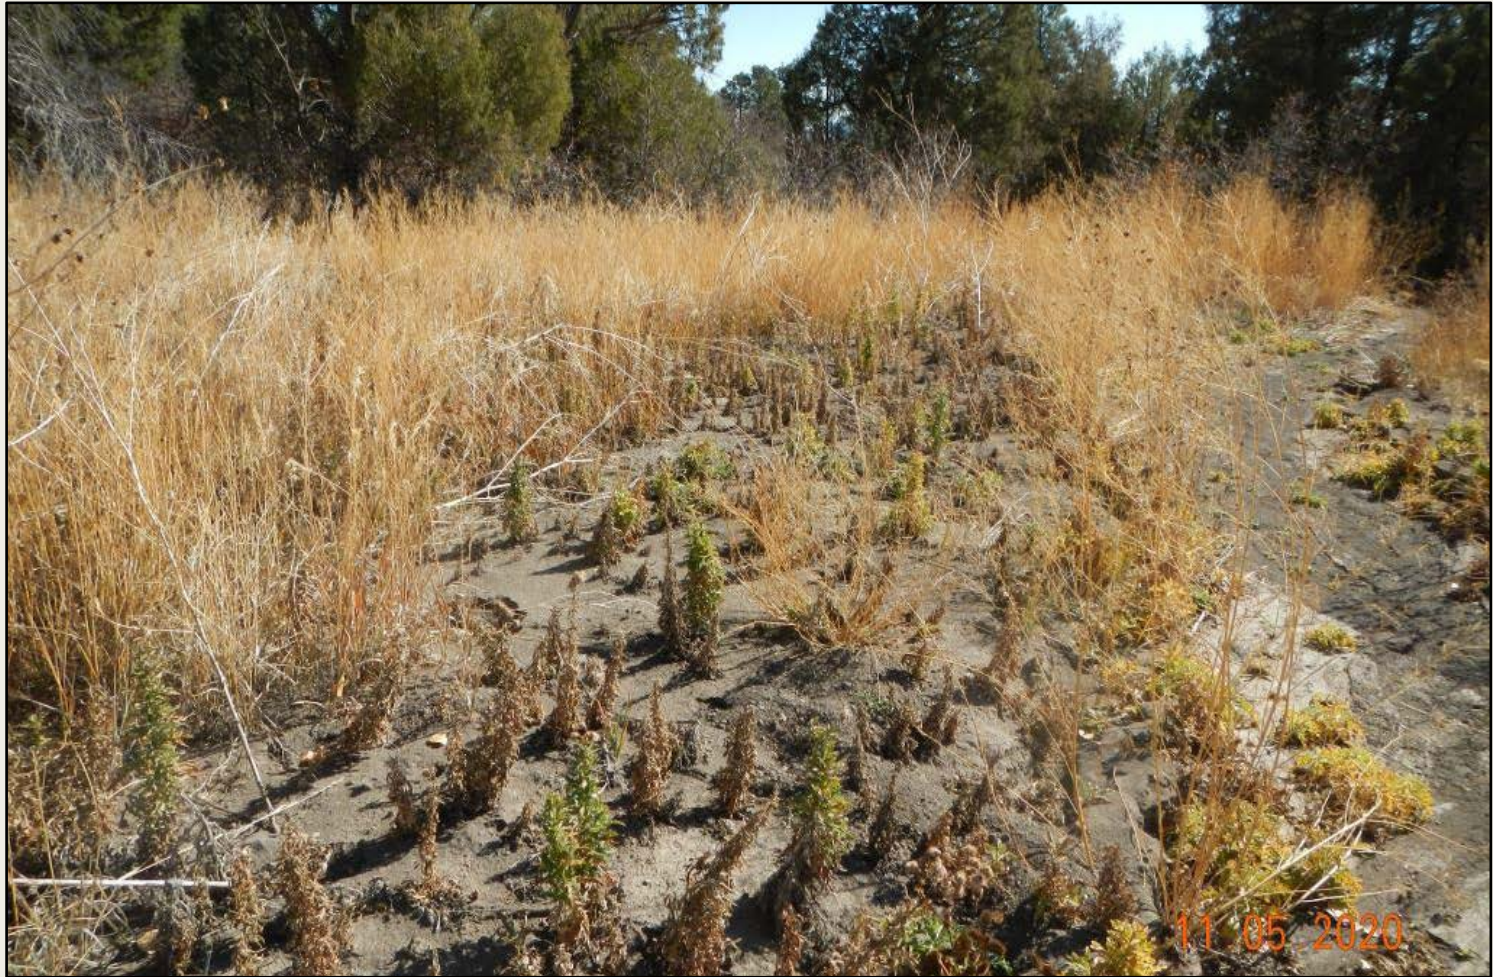
Photo 4. View of Canada thistles within the northern project area. Some appear to be herbicide-treated, others are surviving. 1000s of individuals observed.

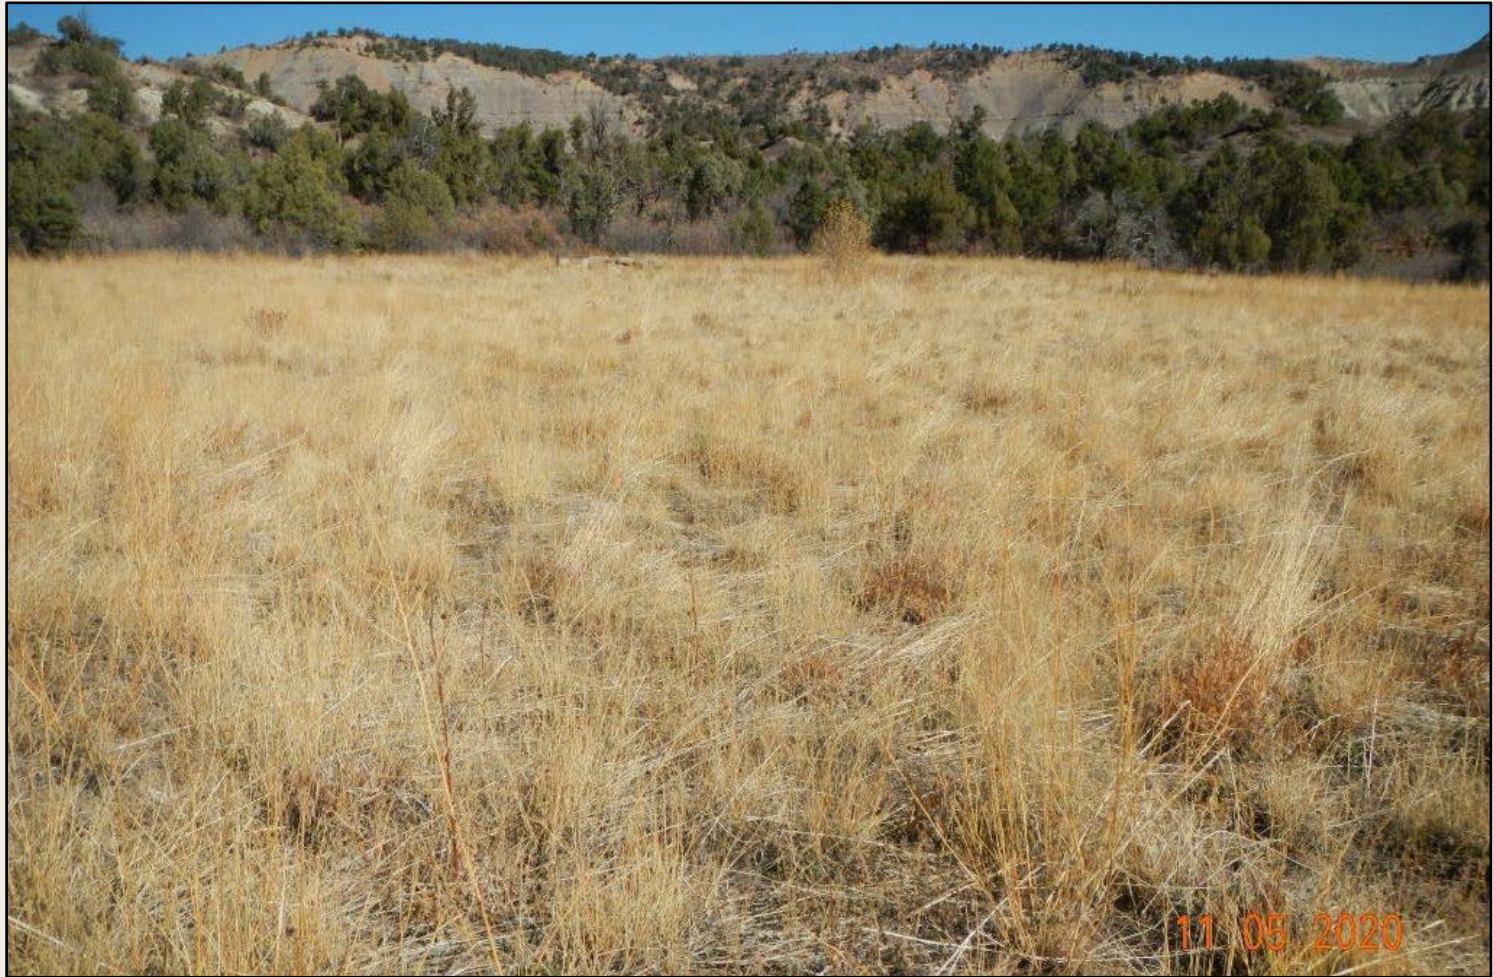
Photo 5. View of the project area from the southwestern corner facing center.

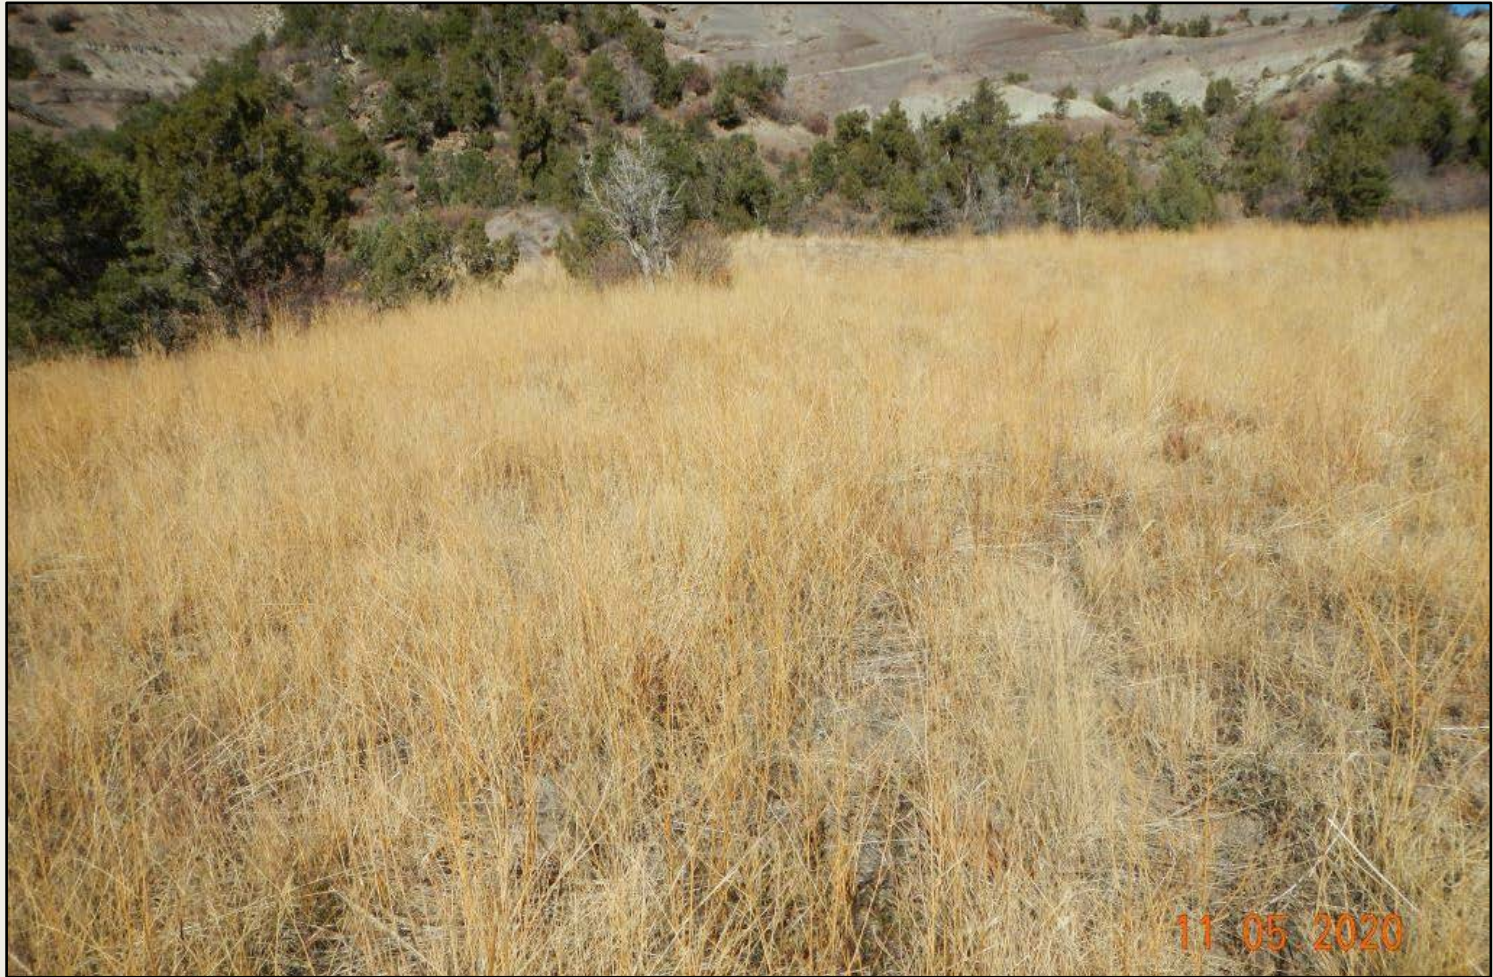
Photo 6. View of the western project area from the southwestern corner facing northward.
