## Stormwater Inspection Report

<b>Operator:</b>	Laramie Energy, LLC
<b>Project:</b>	Homer Deep
<b>Location:</b>	HDU 9-41AH / HDU 9-11AH
<b>Date:</b>	Thursday, November 5, 2020
<b>Weather:</b>	Partly Cloudy, Breezy, High 67° Lo 27°

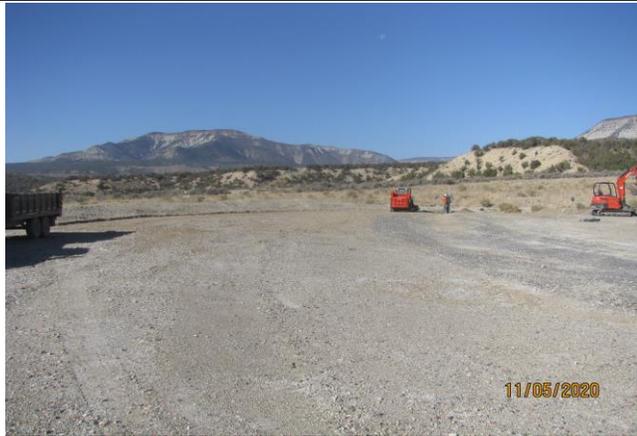
**Photo 1**

*Corrective Actions on the HDU 9-41AH Pad*

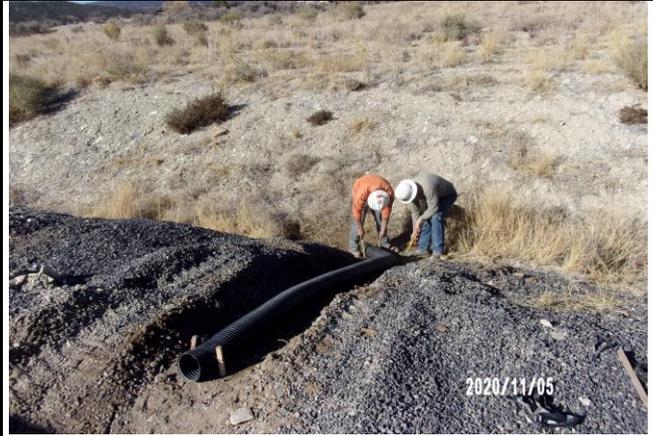
**Photo 2**

*Corrective Actions on the HDU 9-41AH Pad*

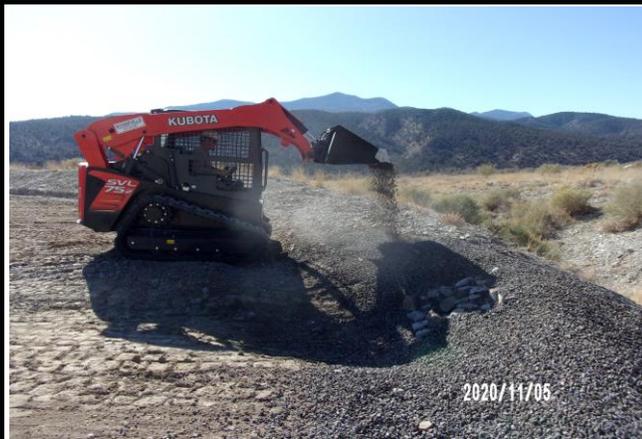
**Photo 3**

*Corrective Actions on the HDU 9-41AH Pad*

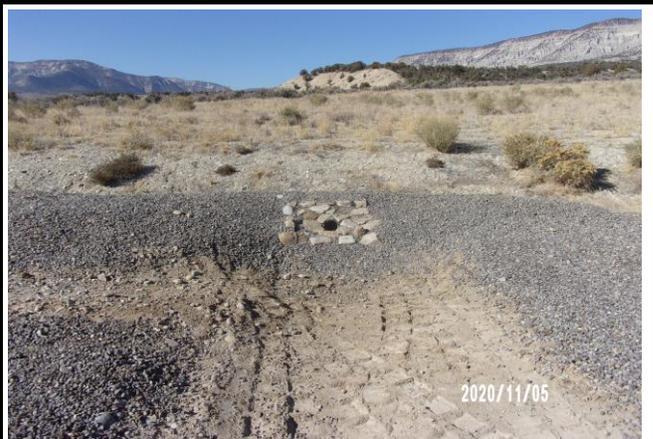
**Photo 4**

*Corrective Actions on the HDU 9-41AH Pad*
