Inspection Photos
Operator: BP America
API: 067-05312
Date: 11/13/2020

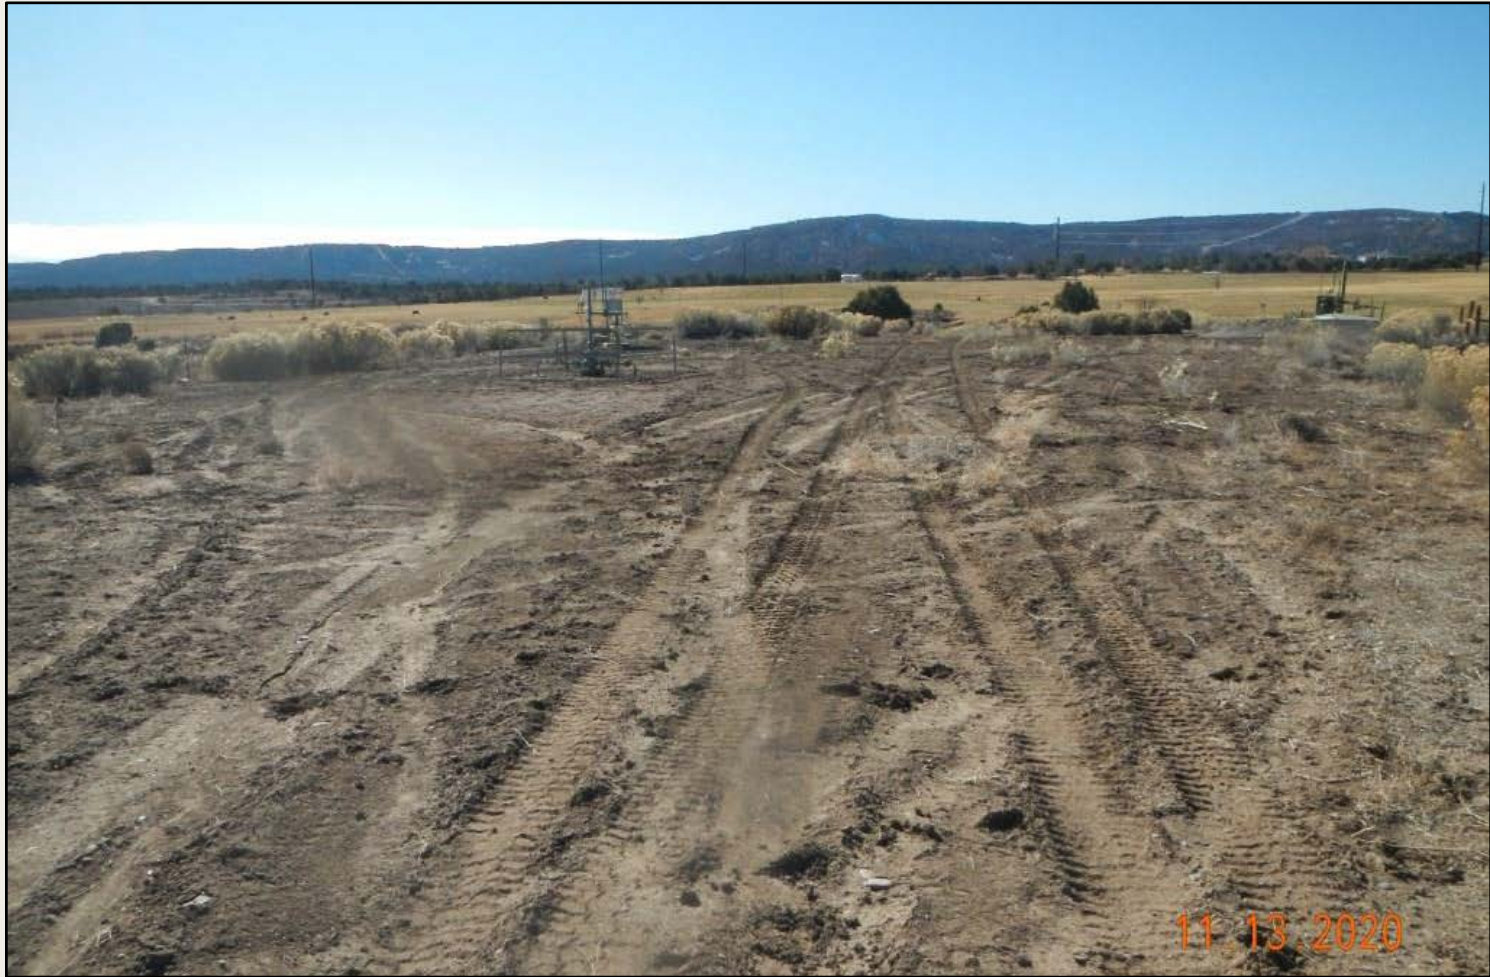
Photo 1. View of the project area from the well pad entrance facing center.

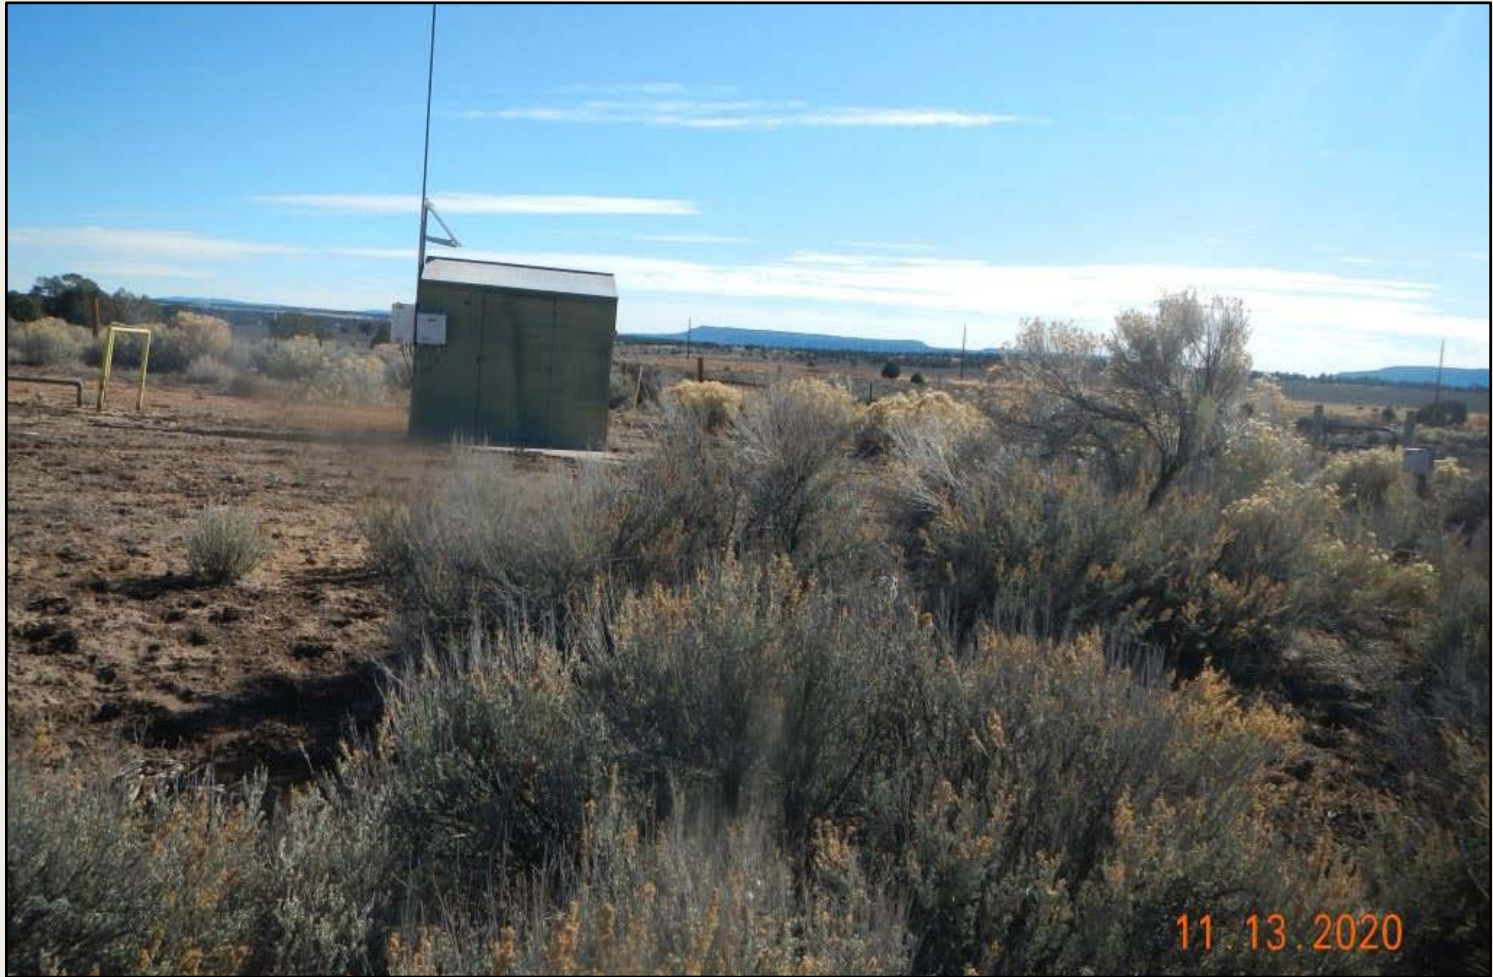
Photo 2. View of the southern project area from the southwestern corner facing eastward. Revegetation is progressing with sagebrush and rubber rabbitbrush.

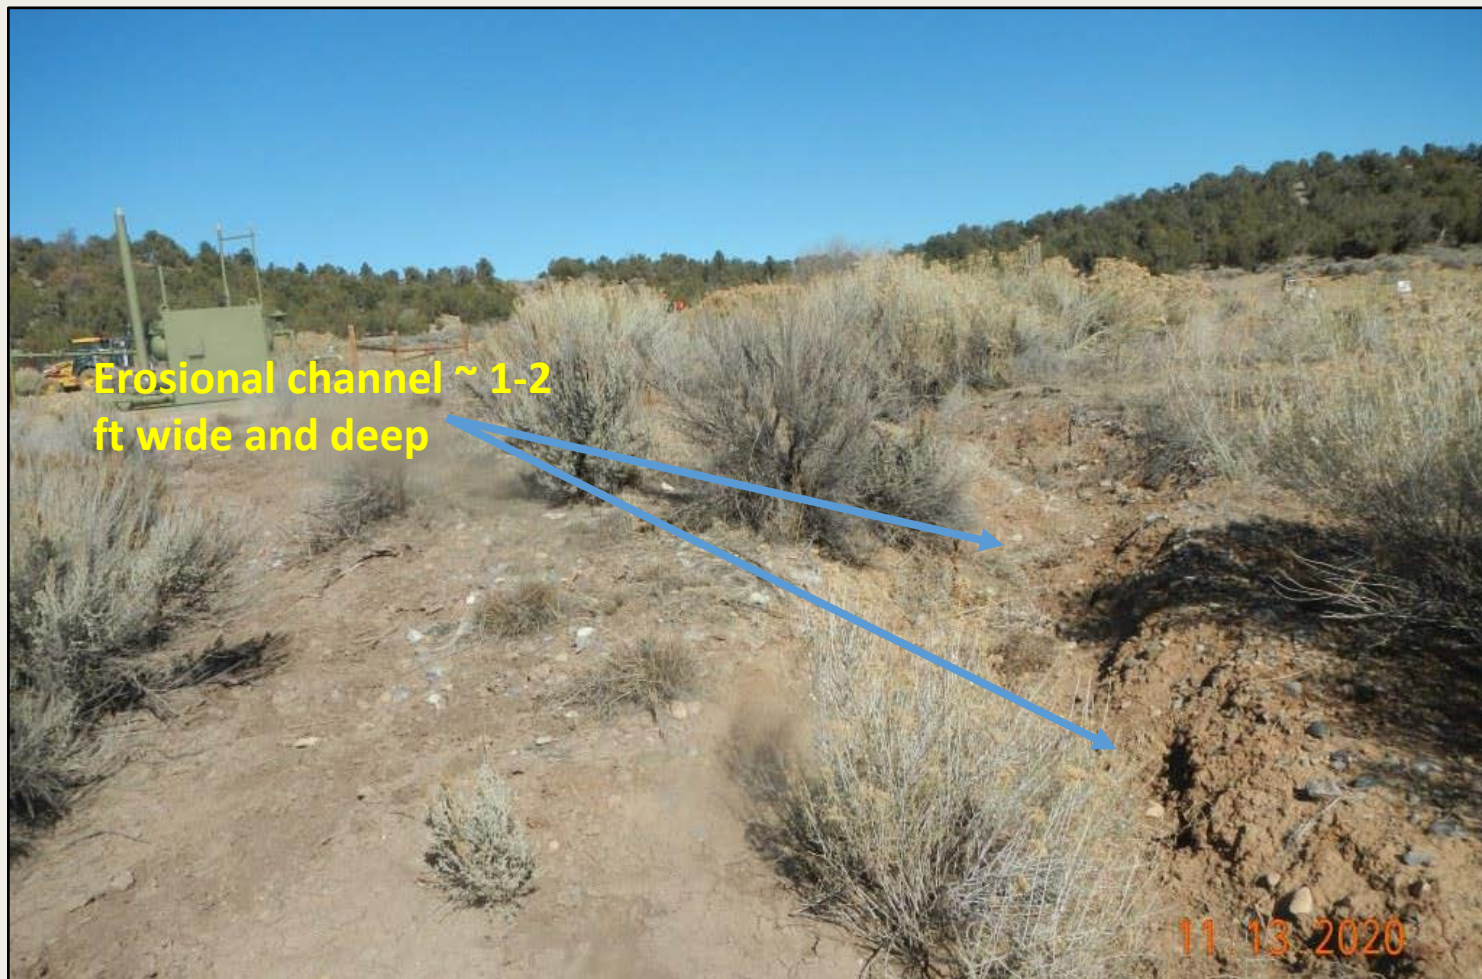
Photo 3. View of erosional channel in the central project area from upper well pad to lower well pad, needs stabilization.

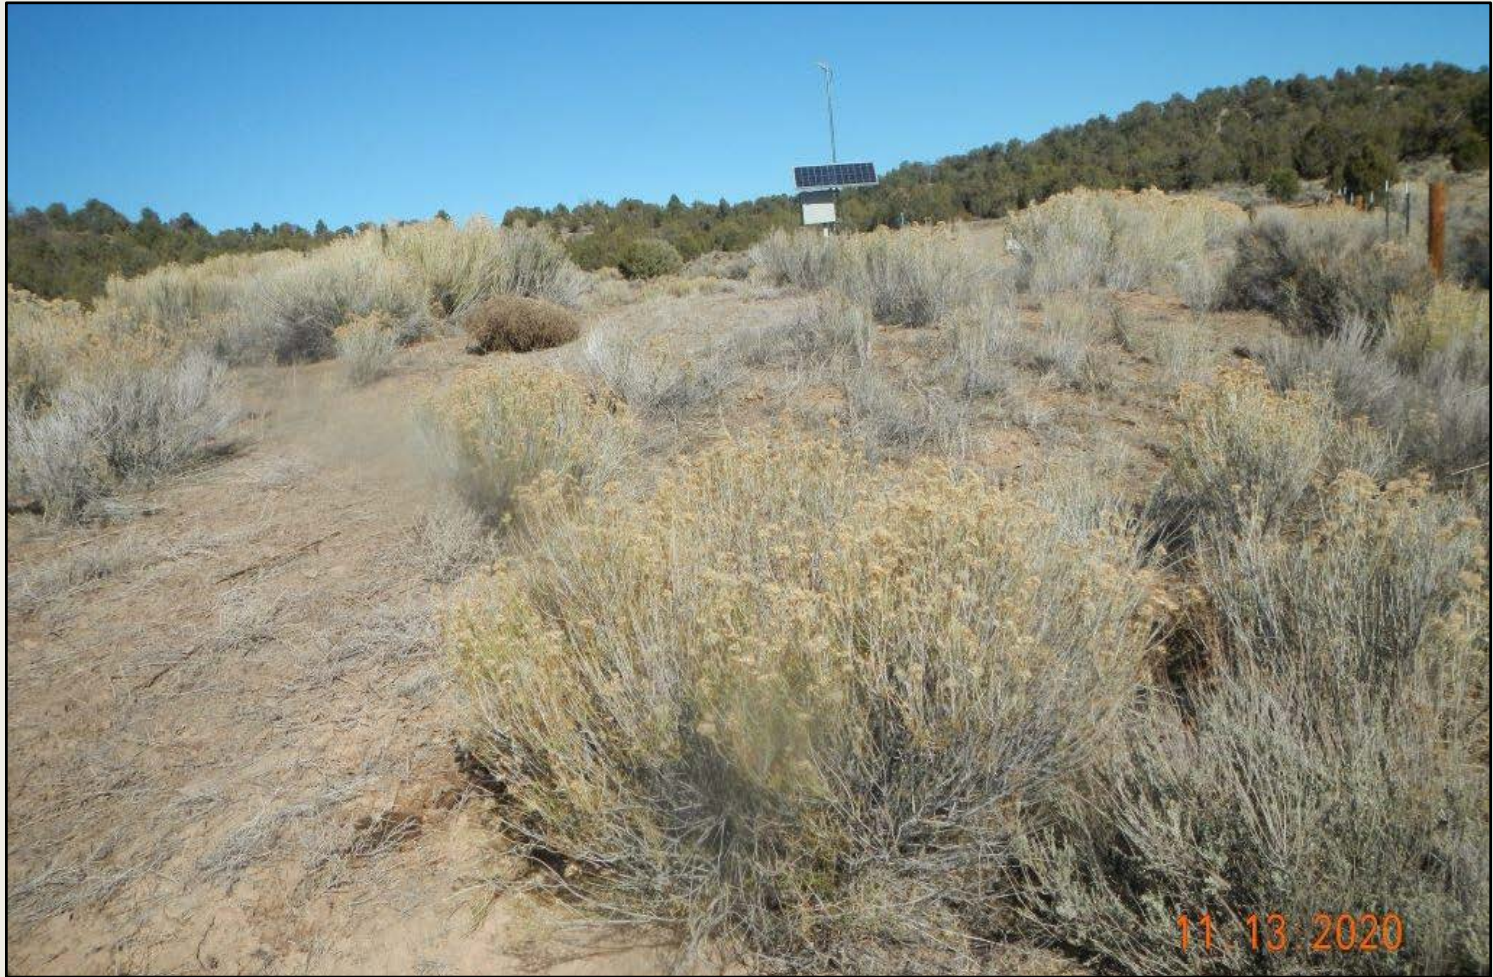
Photo 4. View of the eastern project area from the southeastern corner facing northward.

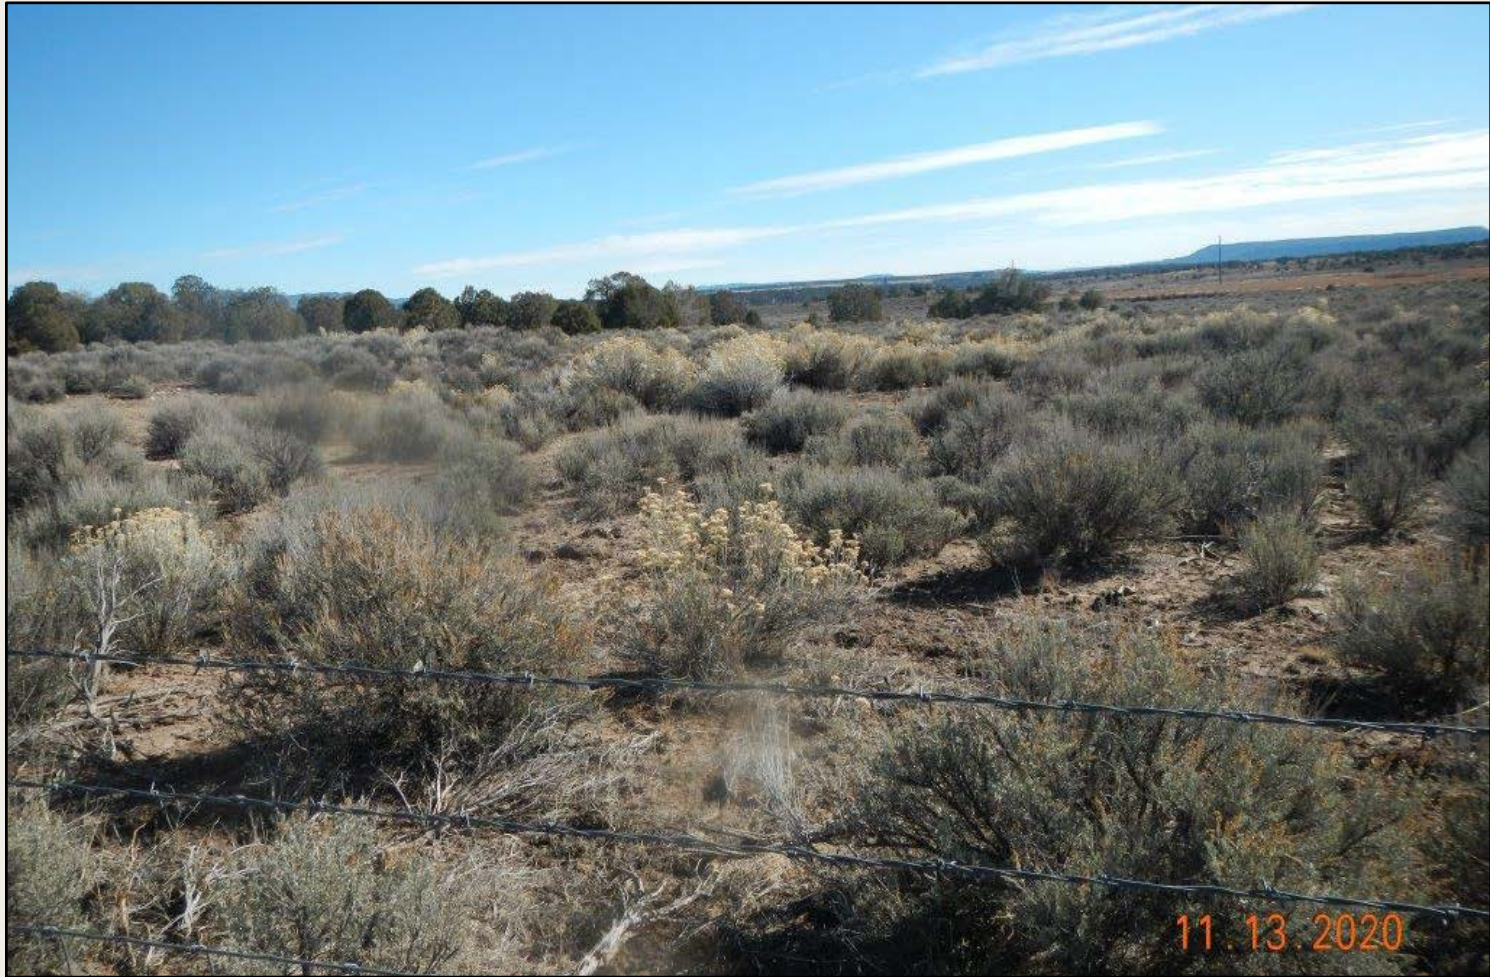
Photo 5. View of reference area comprised of sagebrush shrubland with purple threeawn, James galleta, thickspike wheatgrass, and prickly pear.
