Inspection Photos
Operator: Rim Operating
API: 067-08071
Date: 11/13/2020

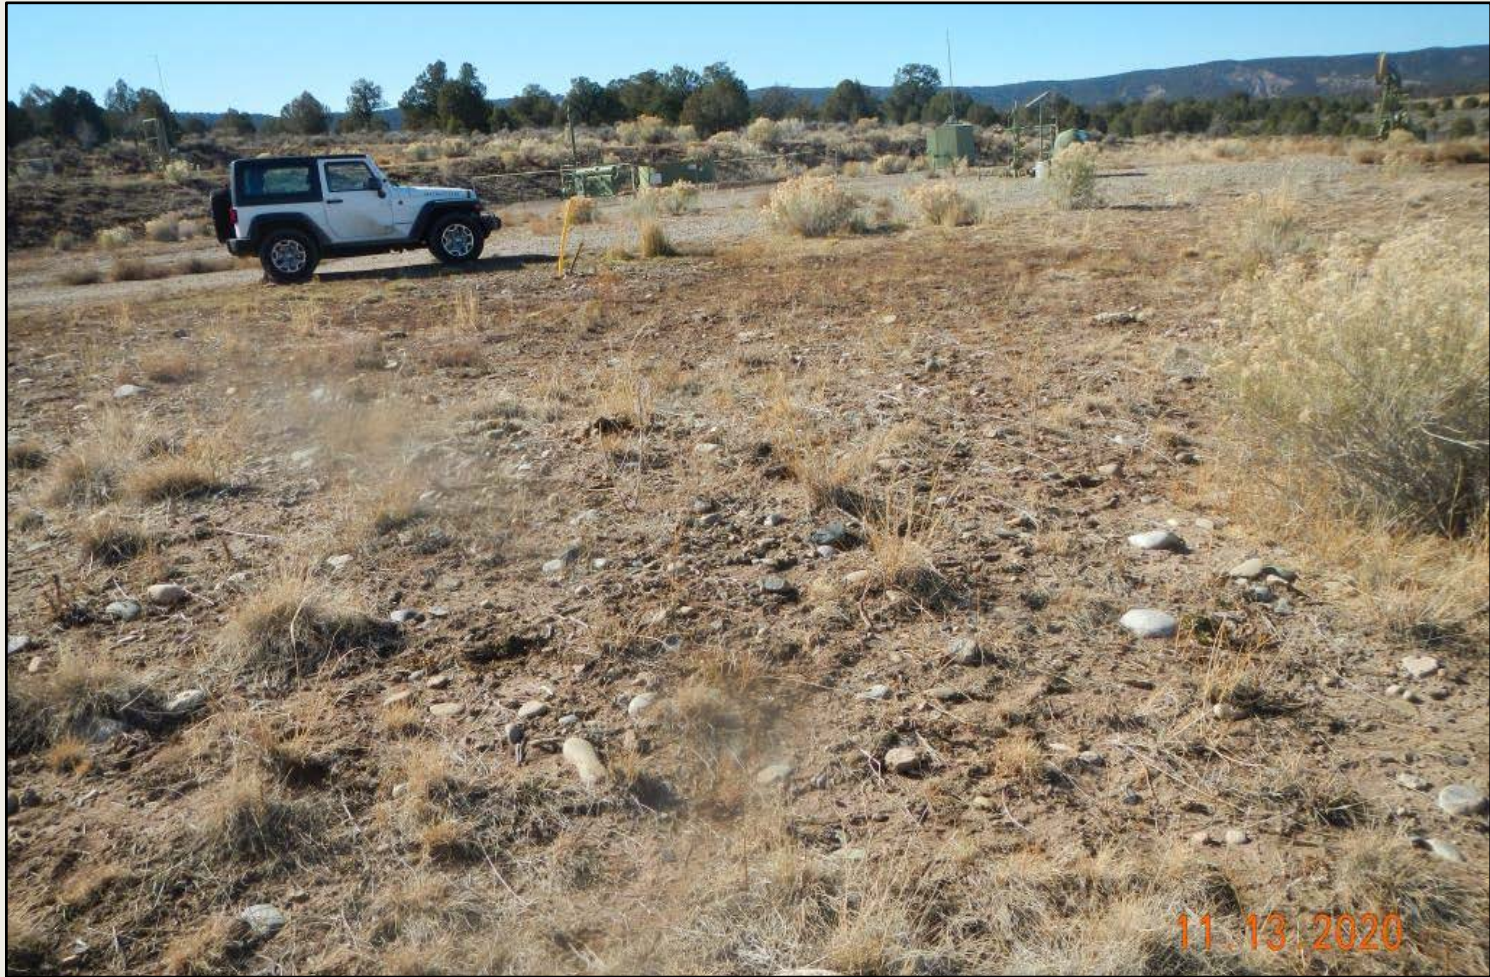
Photo 1. View of the project area from the northeastern corner facing center. Revegetation is progressing with grasses and shrubs such as thickspike wheatgrass, rubber rabbitbrush, and purple threeawn.

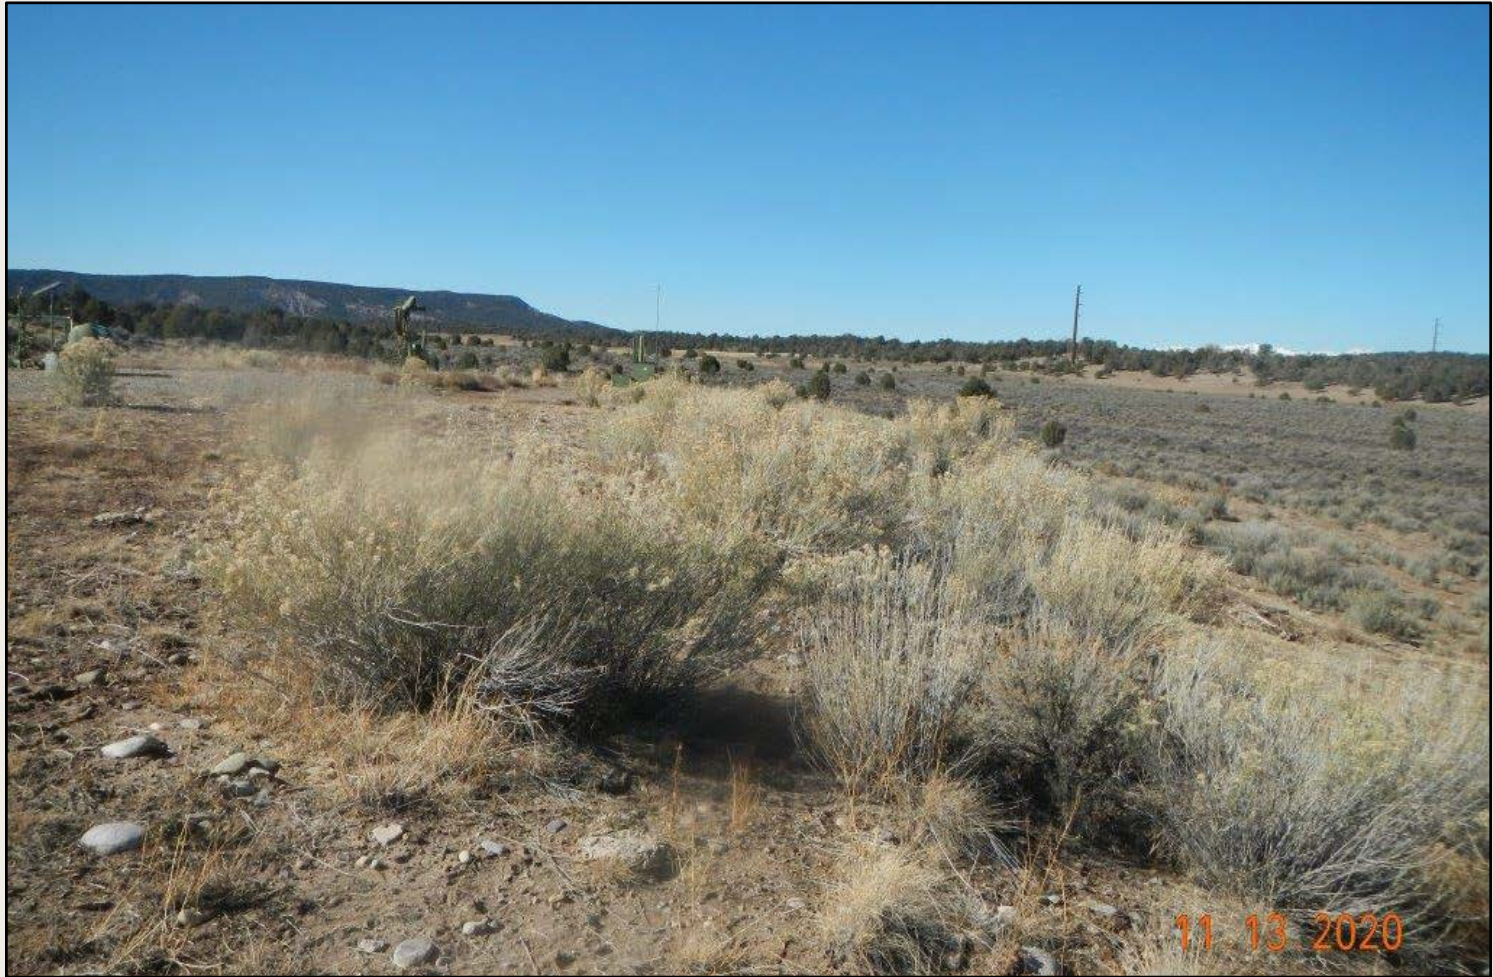
Photo 2. View of the northern project area from the northeastern corner facing westward.

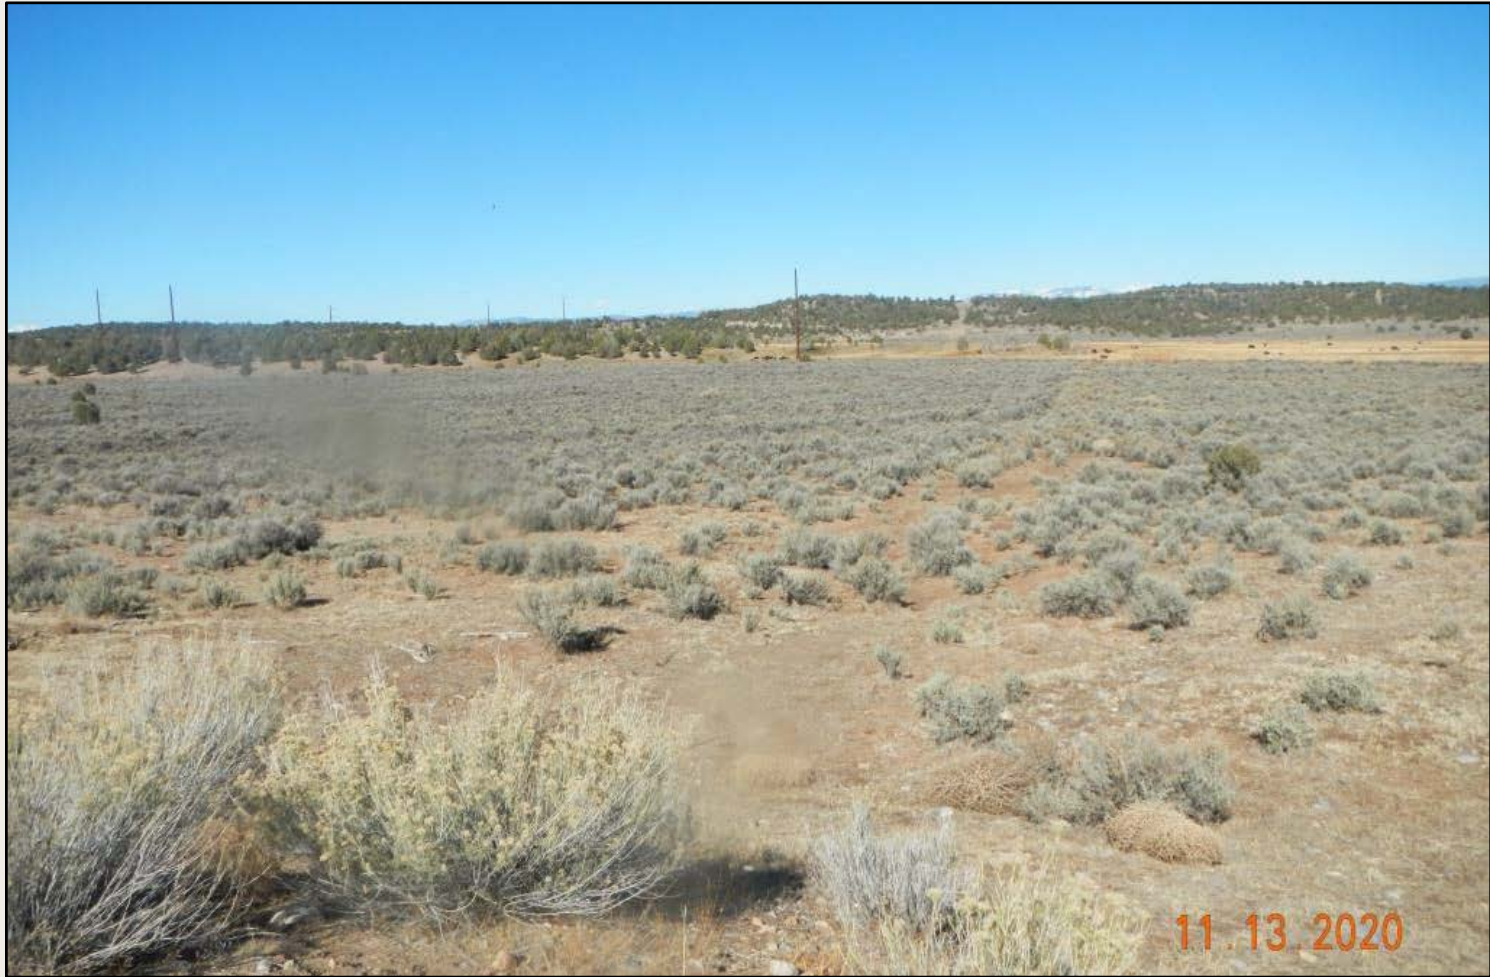
Photo 3. View of reference area comprised of sagebrush shrubland with understory of James galleta, purple threeawn, Arizona gumweed, snakeweed, and prickly pear.
