Inspection Photos

Location Name: LARAMIE ENERGY LLC Currier /26-15 Pad

Location ID: 334528

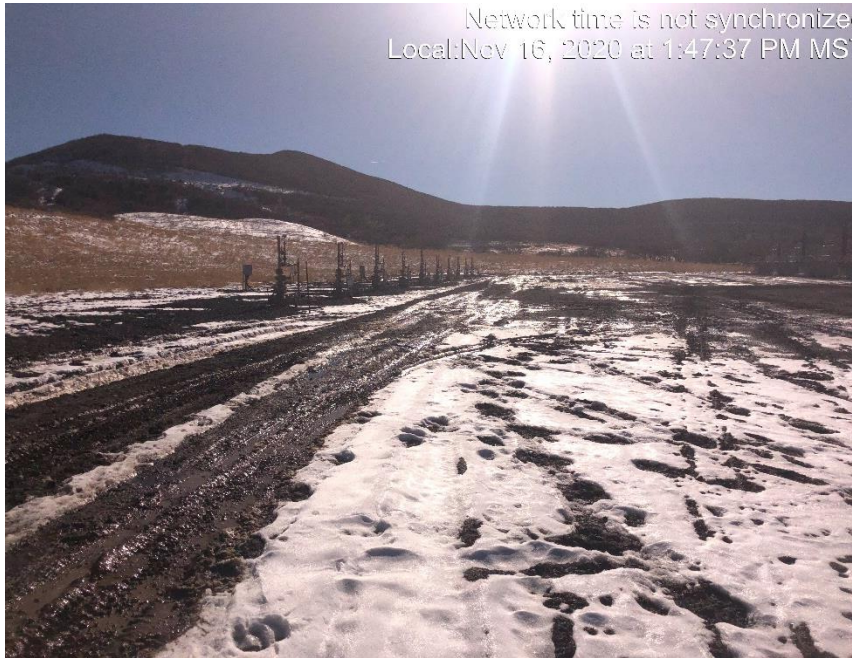
Photo #2246 from entrance to location.

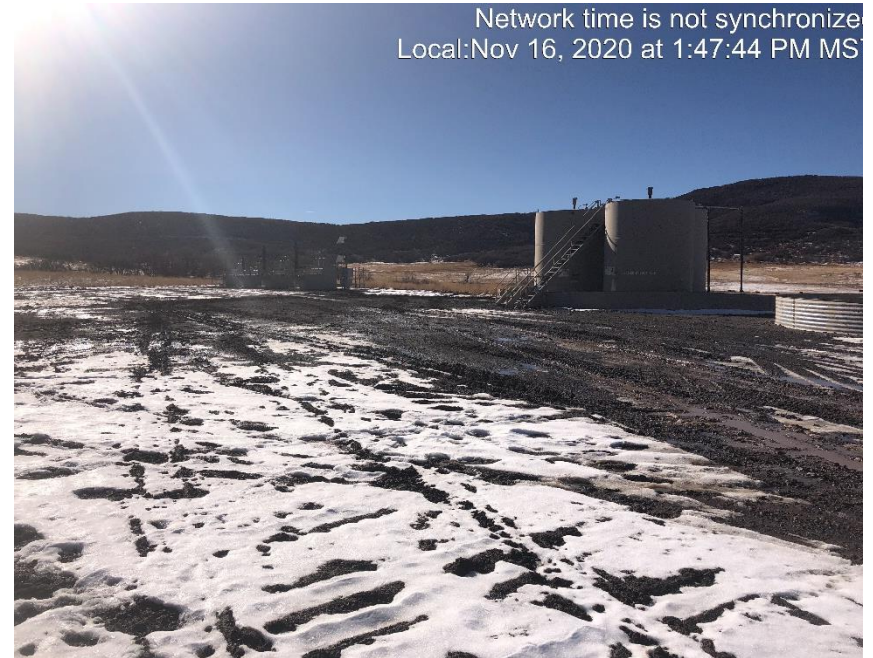
Photo #2247 from entrance to location.

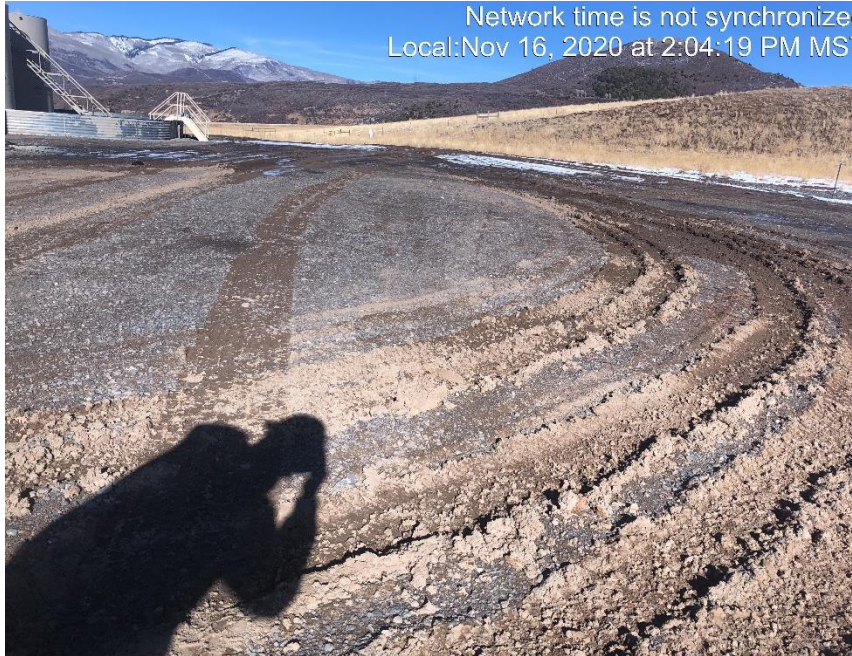
Photo #2250 Sediment migrating off of location and on to access road due to tracking.

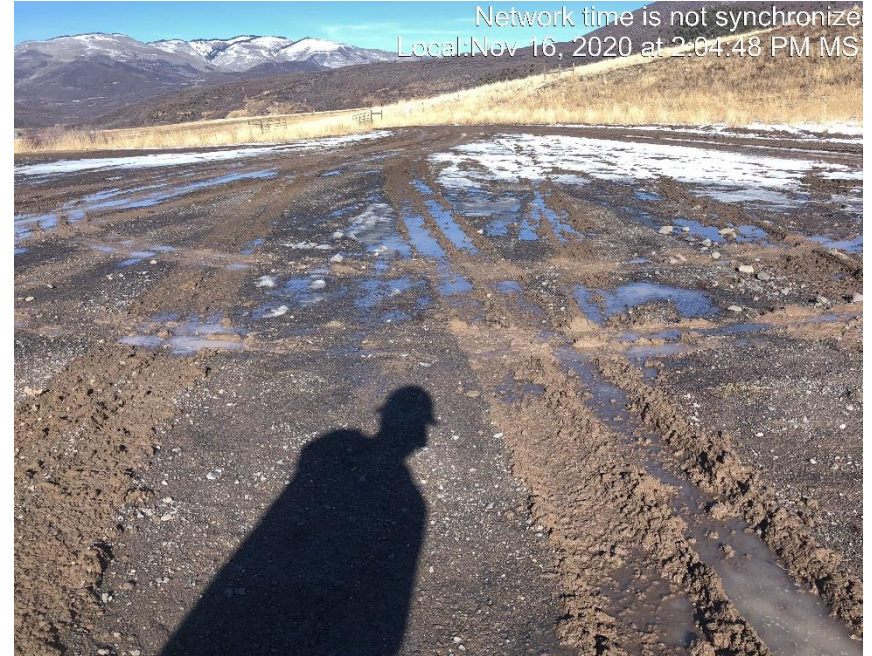
Photo #2251 Sediment migrating off of location and on to access road due to tracking.

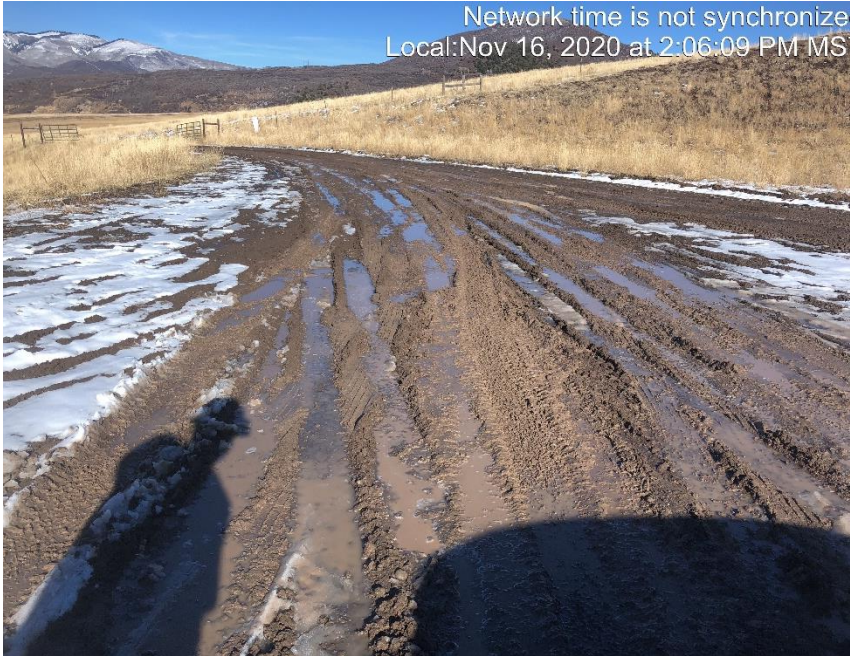
Photo #2252 Tracking at entrance to location

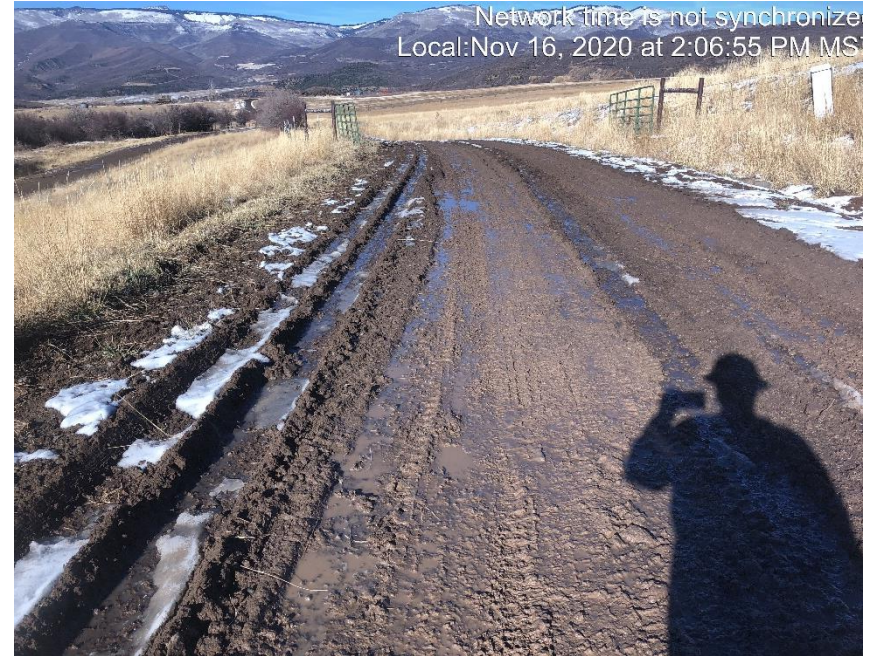
Photo #2253 Tracking at entrance to location

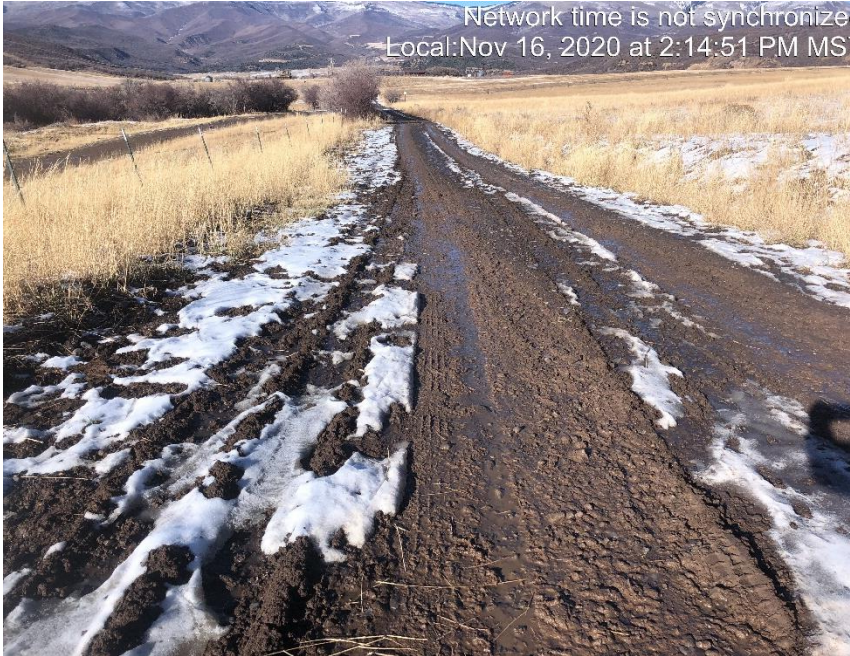
Photo #2254 Access road.
