KP Kauffman – Follow-up COGCC Inspection Photos
Location: UPPR 43 PAN AM G Consolidation #2 OLF Release
Spill ID # 478086 Date 11/06/2020

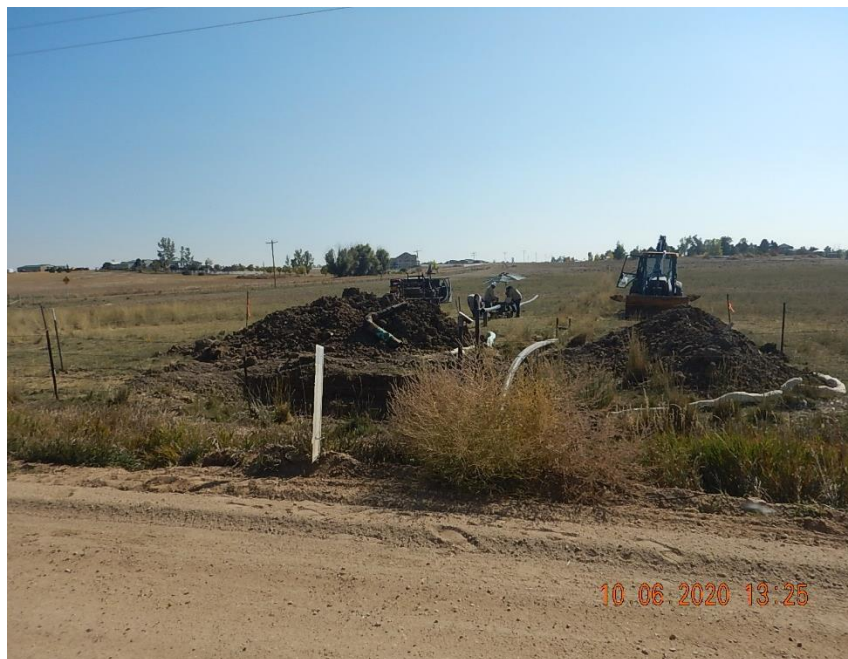
**KPK roustabout crew in process of completing HDPE poly fusion welding to construct new consolidation flowline;
View S from WCR 4**

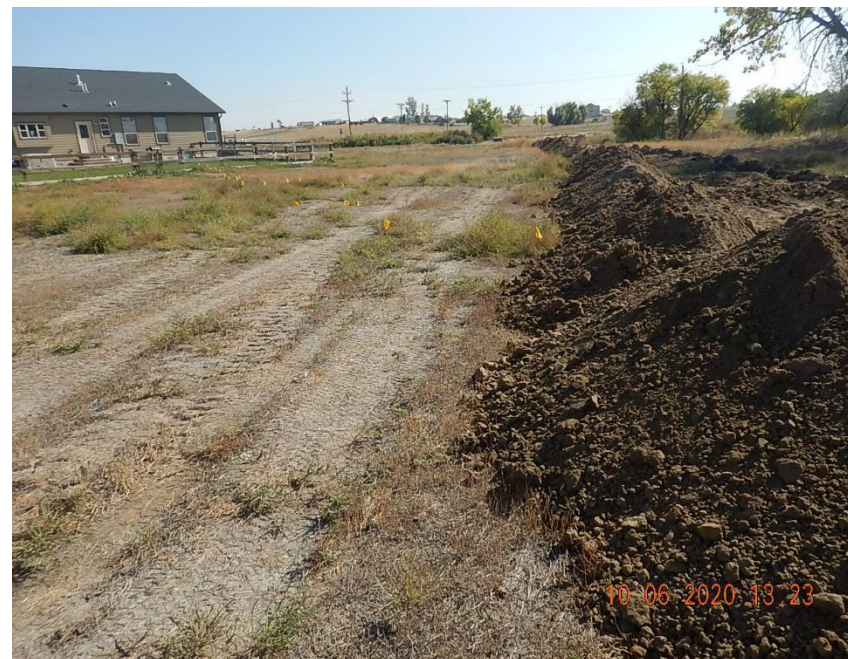
View of existing (abandoned/ OOS) flowline marked with pin flags; view of new flowline trench/ spoil pile (realignment) to the west; View looking S-SE

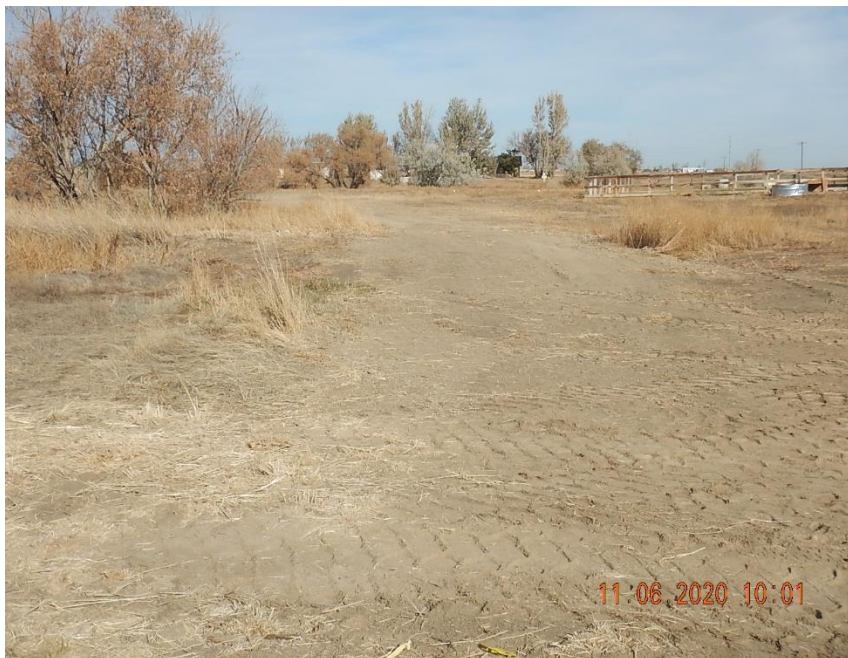
View of UPPR 43 PAN AM G Consolidation flowline trench after being backfilled and re-contoured; Looking N-NW

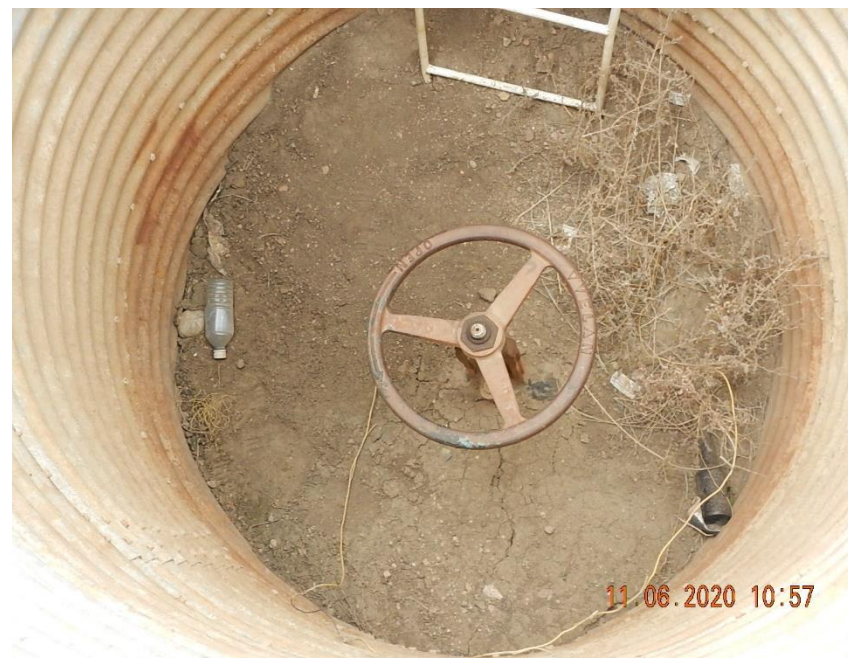
View into SE flowline isolation valve can; Valve handle

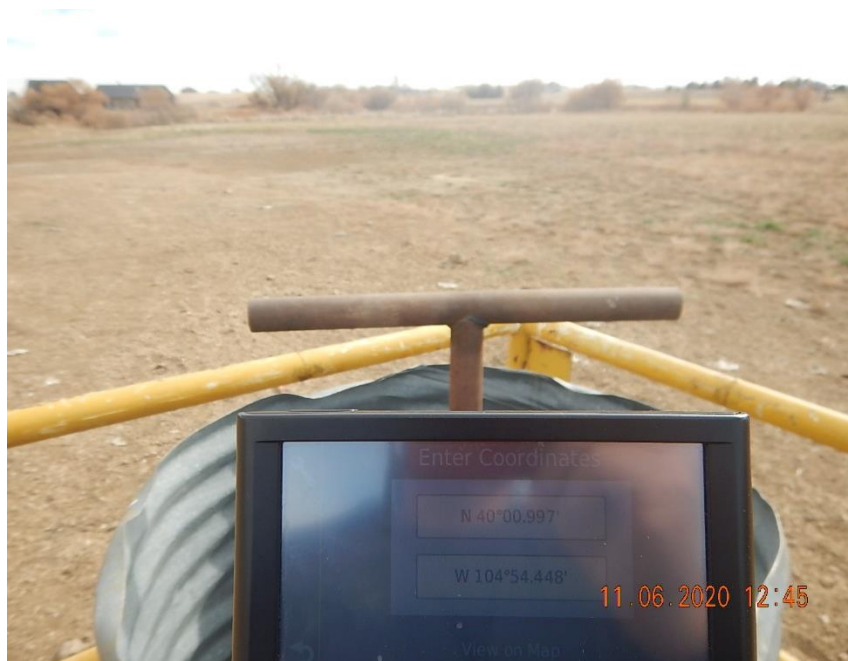
View and location of NW isolation valve; looking SE

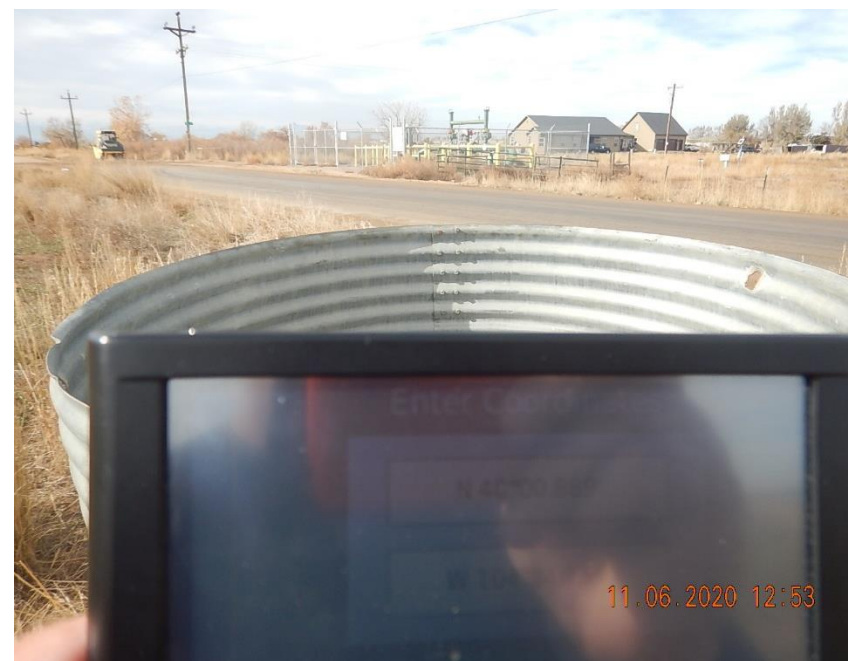
View and location of SE isolation valve; looking NW

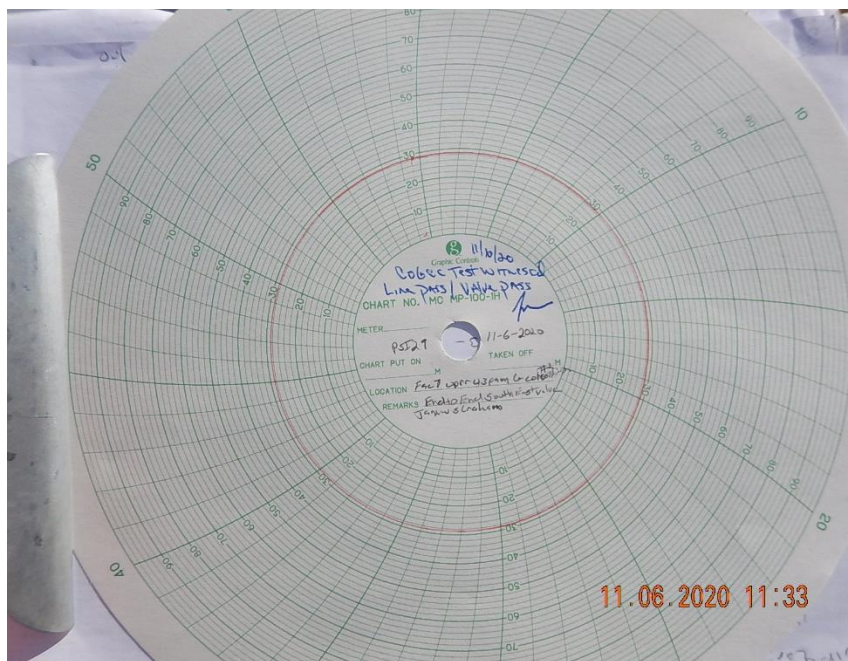
**Flowline pressure testing chart; Satisfactory test for new/
 repaired flowline segment and SE isolation valve**

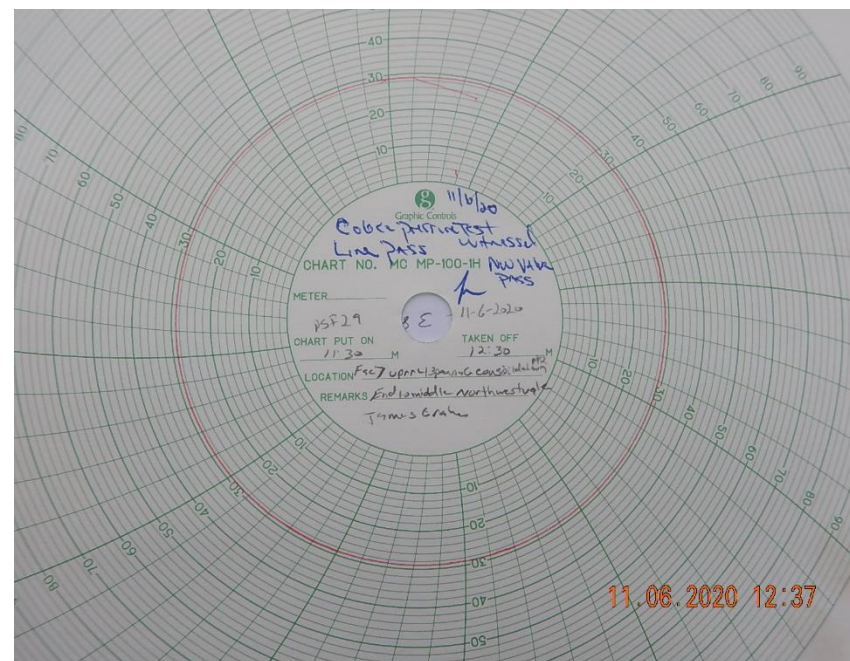
**Flowline pressure testing chart; Satisfactory test for new/
 repaired flowline segment and NW isolation valve**
