Inspection Photos

Location Name: LARAMIE ENERGY LLC BCU /150 Pad

Location ID: 334554

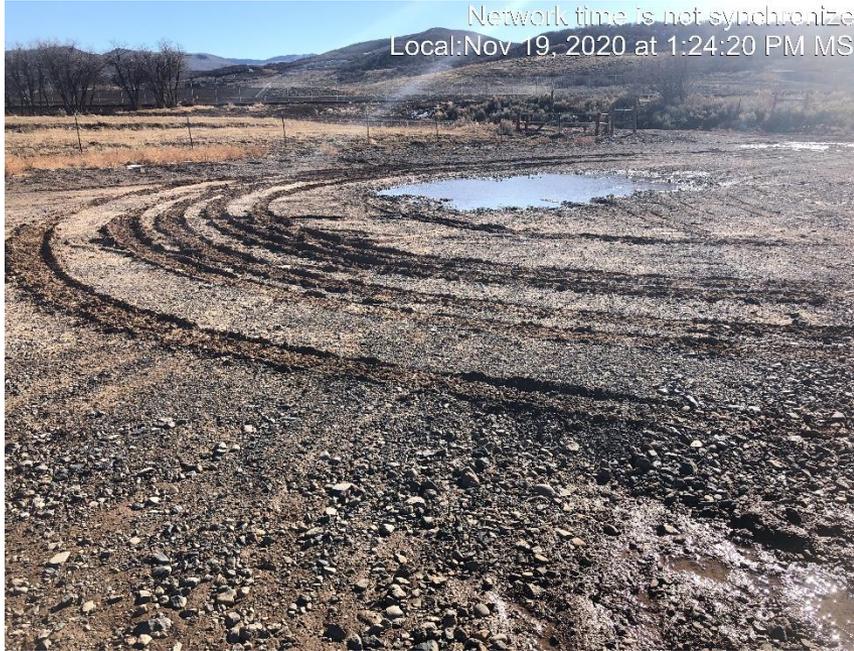
Photo #2293 Rutting occurring due to lack of stabilization.

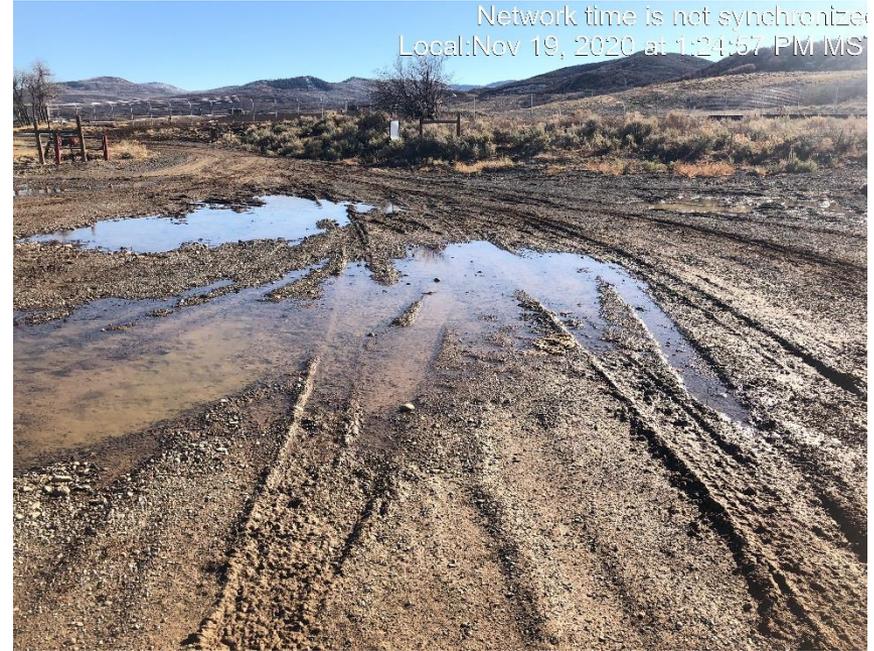
Photo #2294 Tracking occurring from location to access road.
