Inspection Photos

API: 071-07412

Operator: TIMBER CREEK OPERATING
OGRIS OPERATING LLC

Inspection Date: 11/19/2020

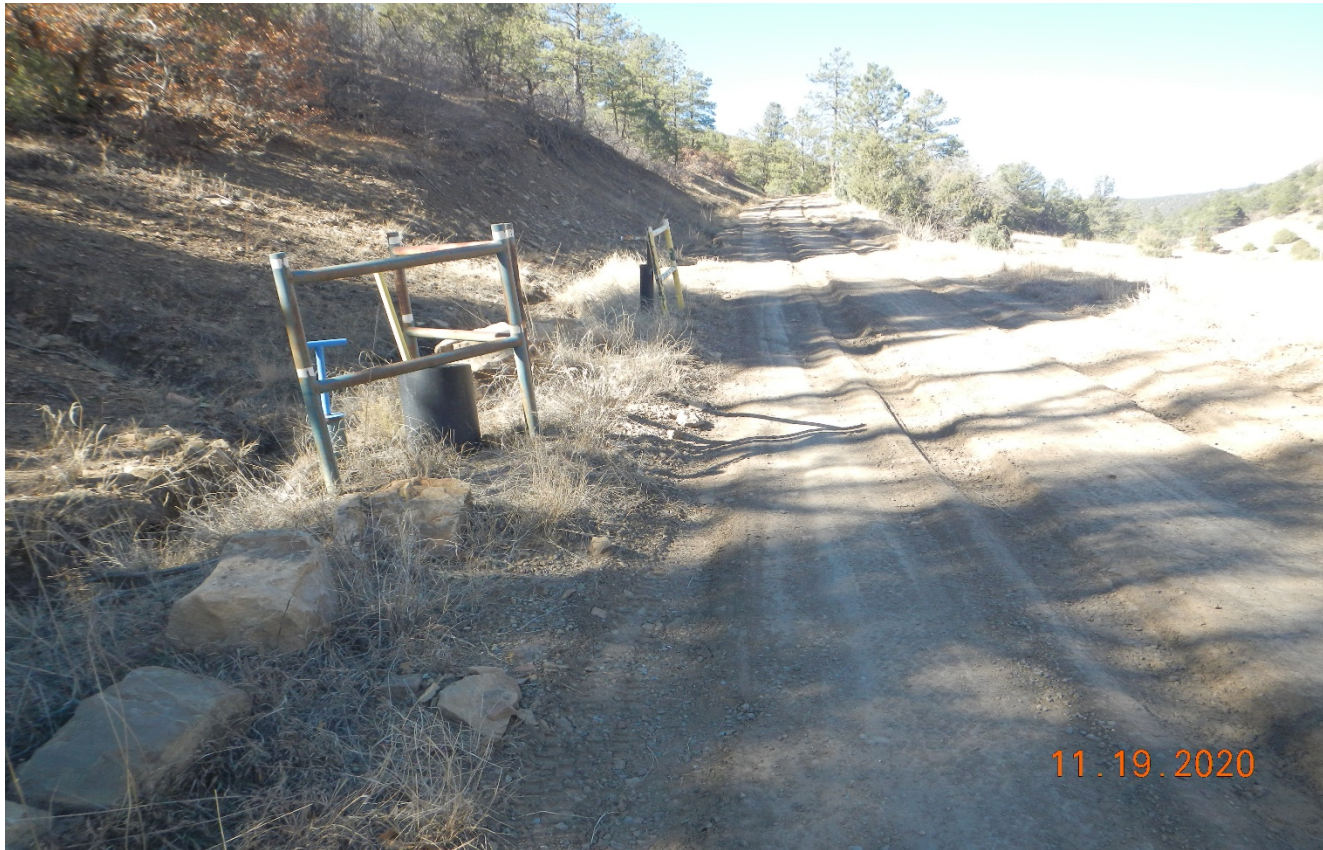
Photo 1. There is vehicle rutting at the beginning of the access road from the main road in Bingham Canyon. This section of road is directing stormwater down the road to the main road. BMP's such as gravel and water bars are needed to prevent rutting and road degradation.

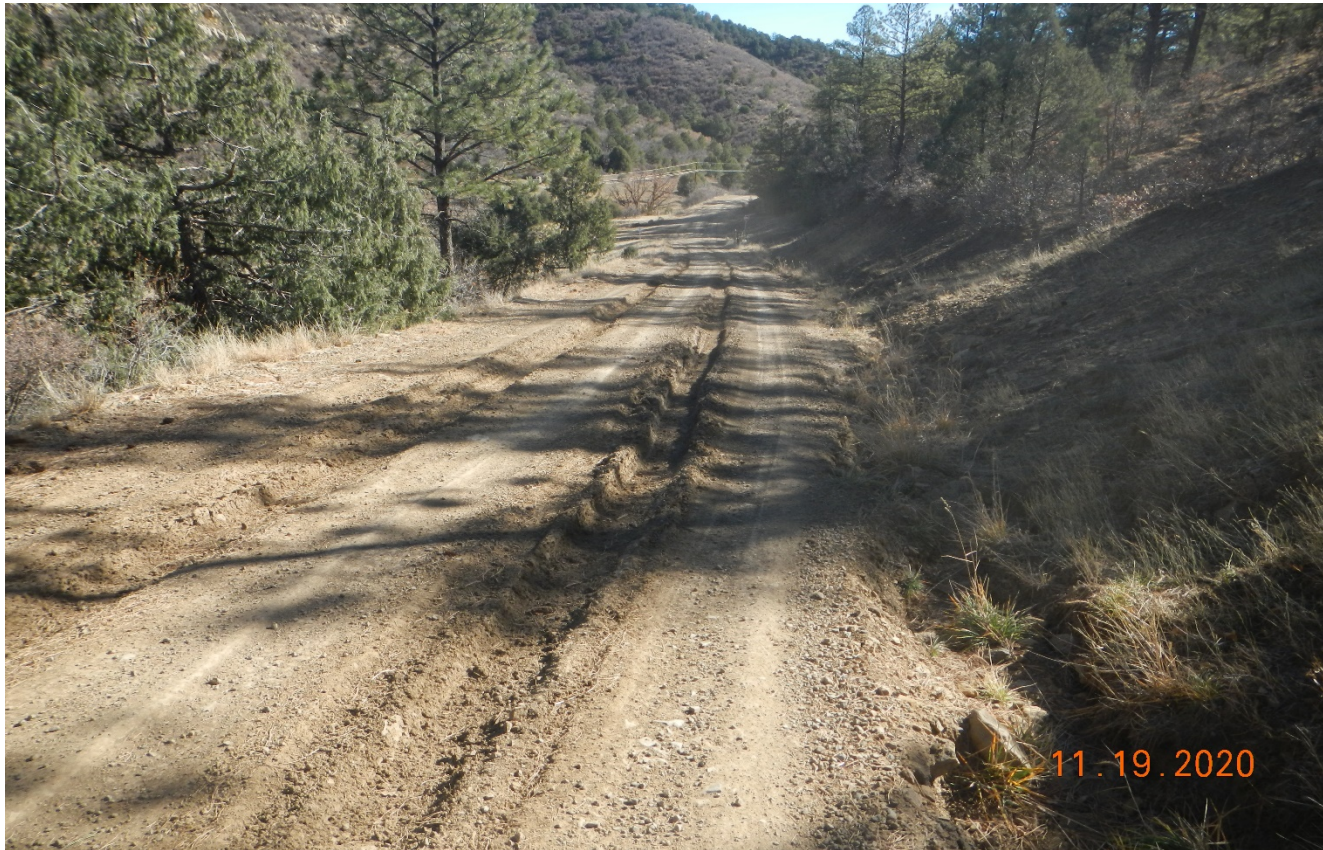
Photo 2. Facing back down the access road shows vehicle rutting. This issue has previously been documented and needs to be repaired and prevented.

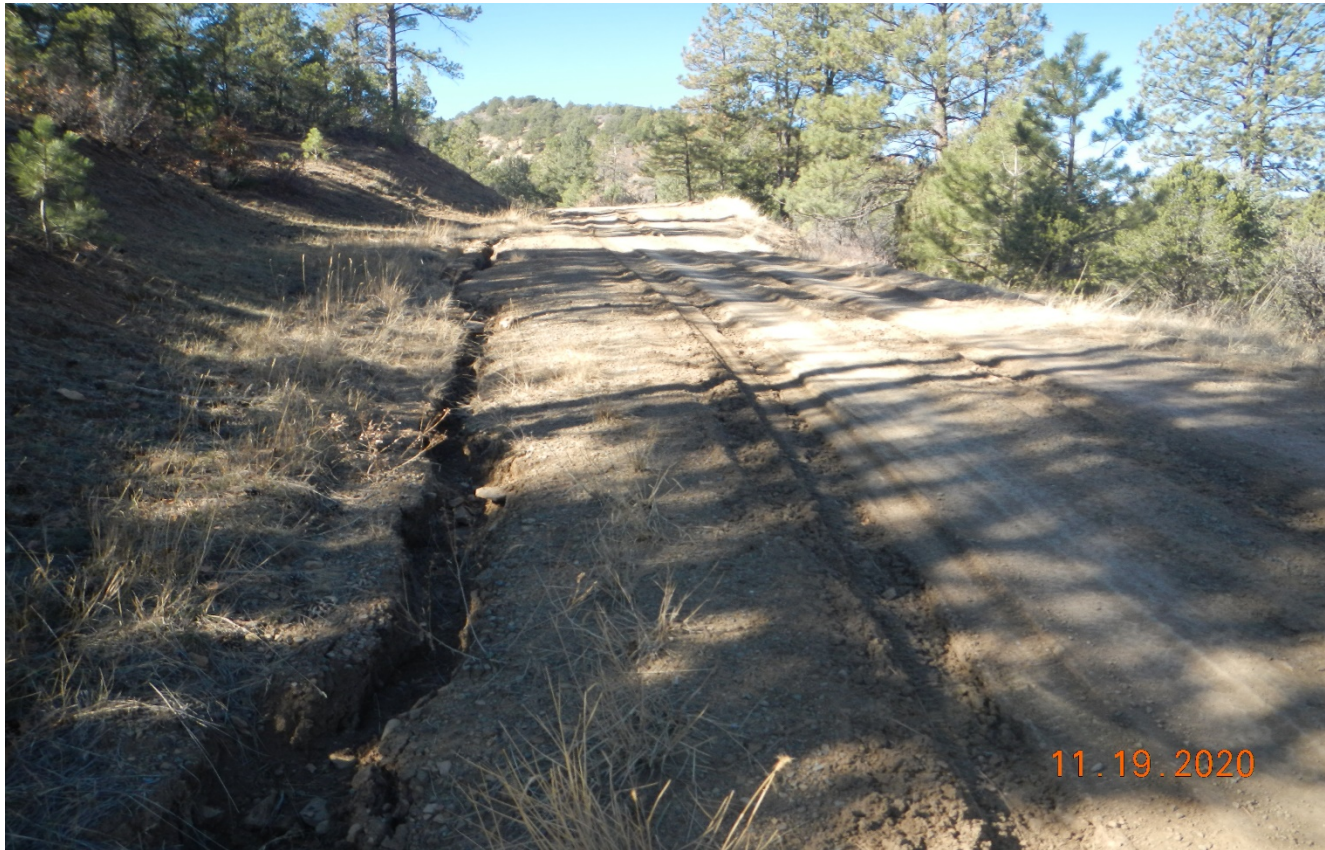
Photo 3. Storm water erosion is occurring down the side of the road. BMP's need to be installed to prevent erosion.

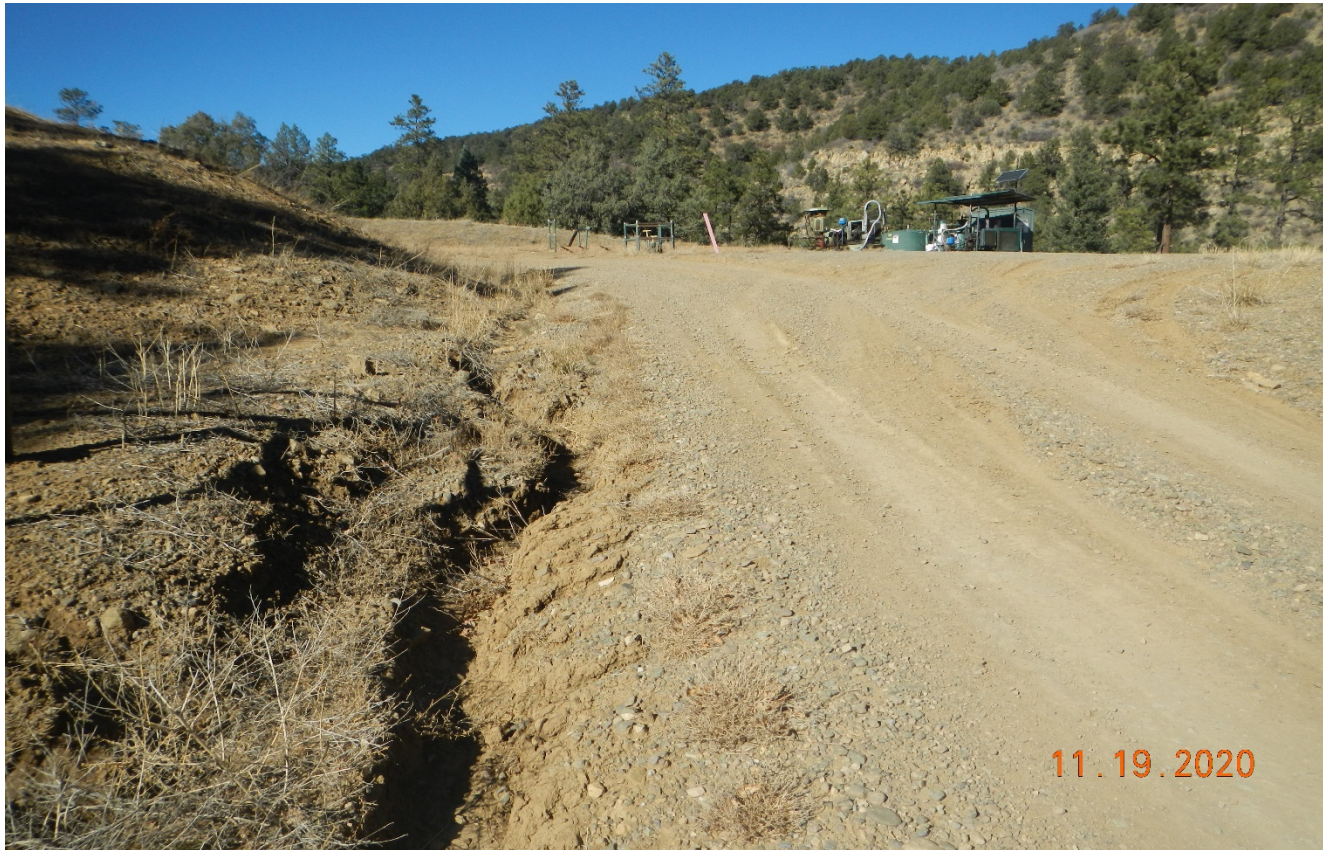
Photo 4. Facing toward the location. Storm water erosion is occurring down the side of the road. BMP's need to be installed to prevent erosion.
