Inspection Photos

Operator: Hilcorp Energy
API: 067-08698
Date: 11/20/2020

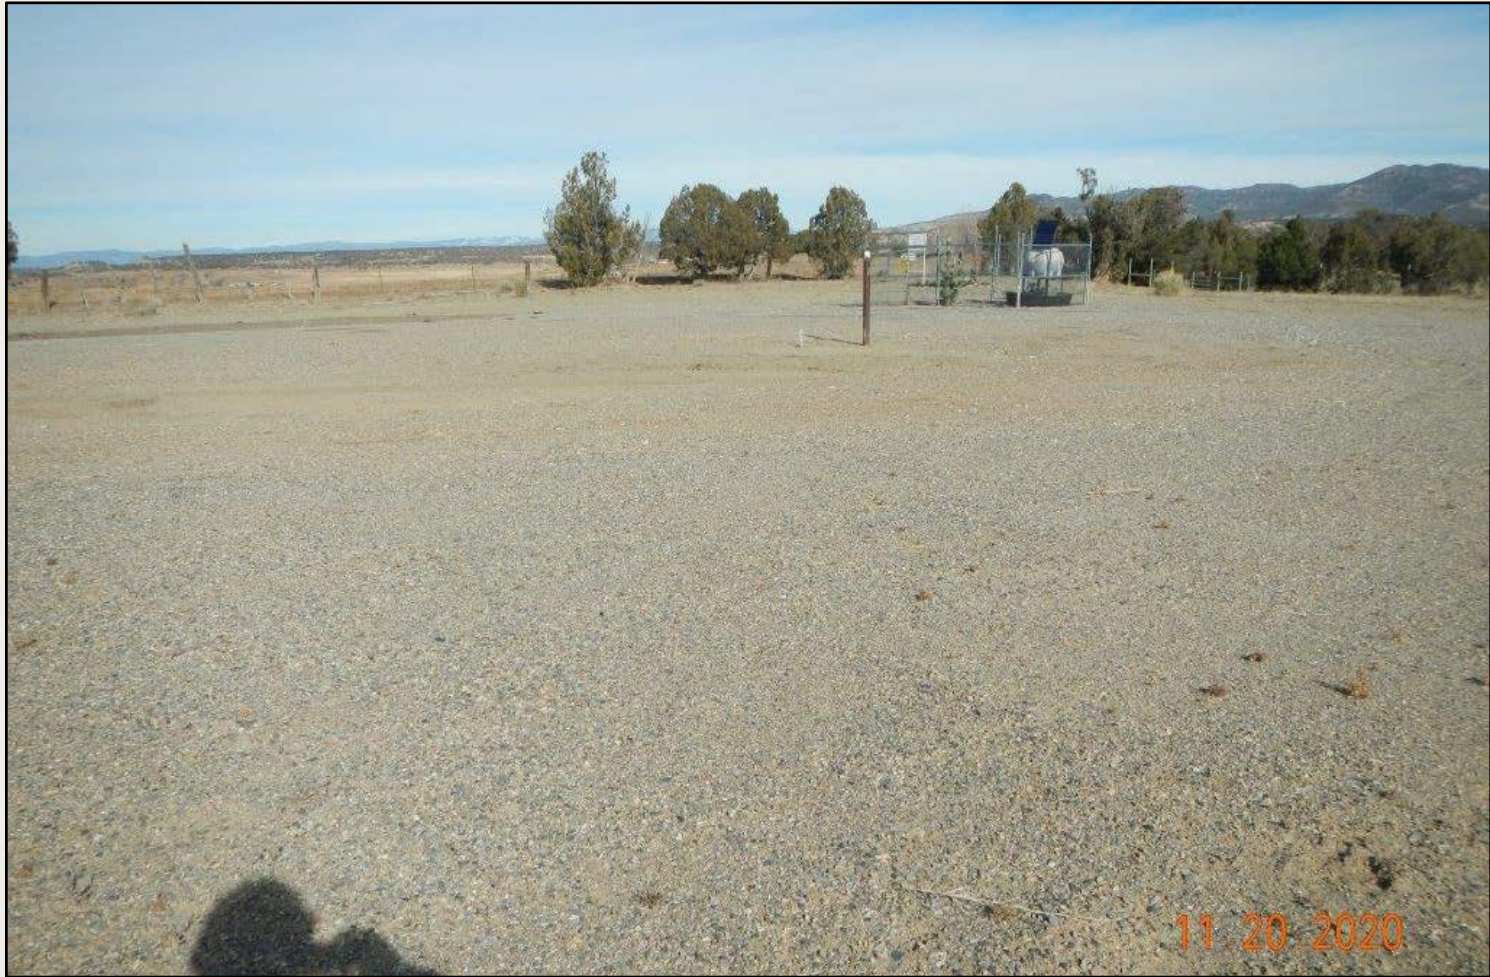
Photo 1. View of the project area from the southeastern corner facing center.

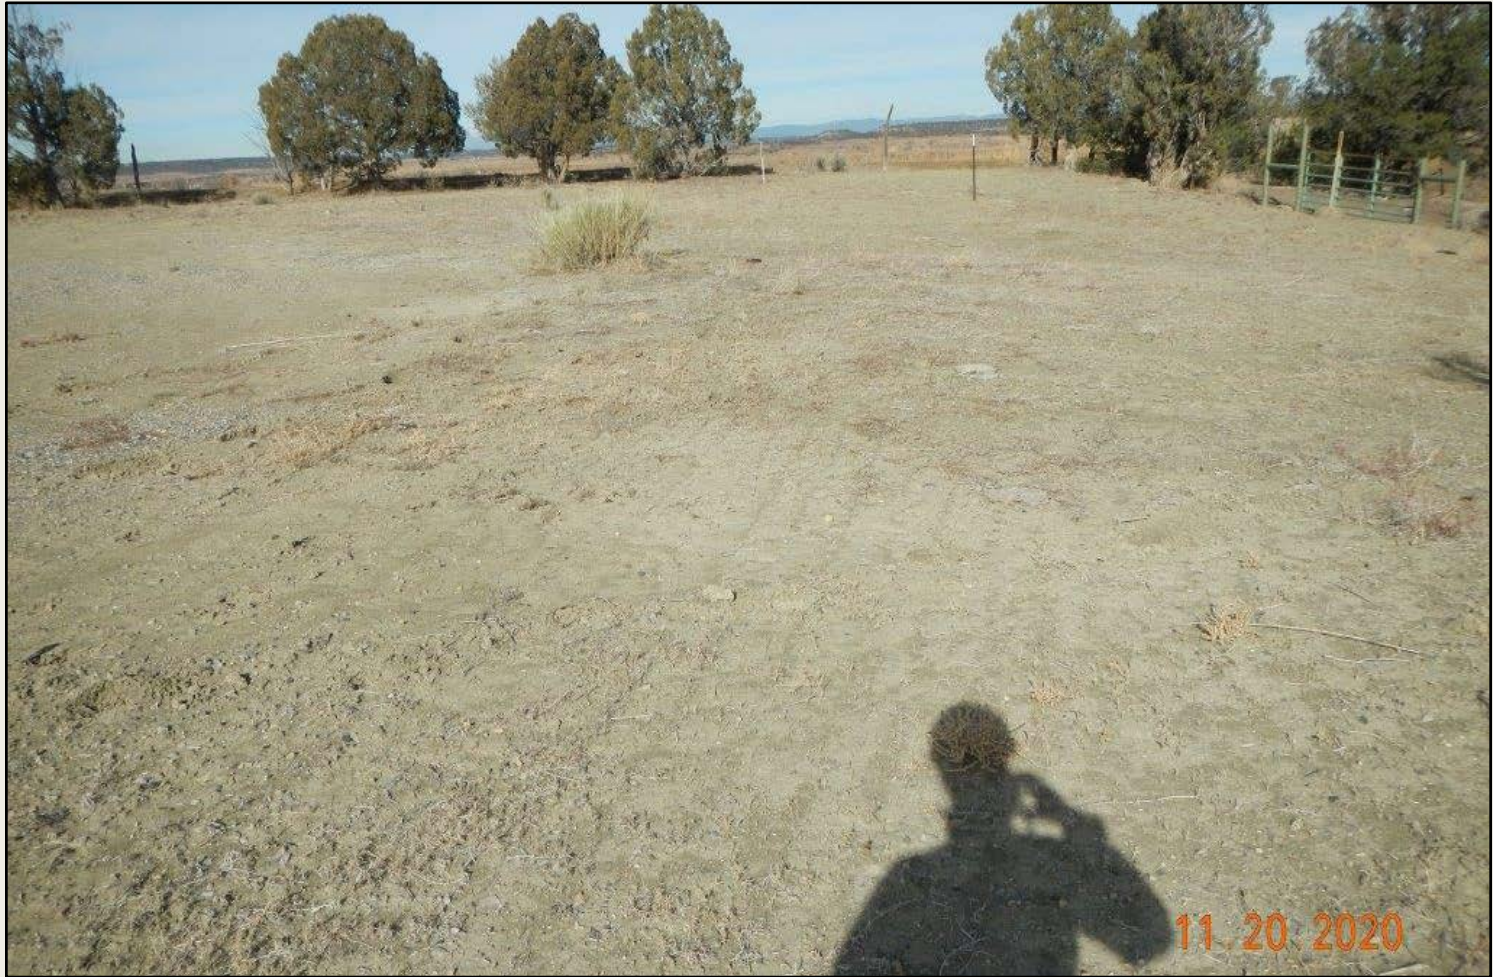
Photo 2. View of the northern project area from the northeastern corner facing westward. Area appears to be recently seeded.

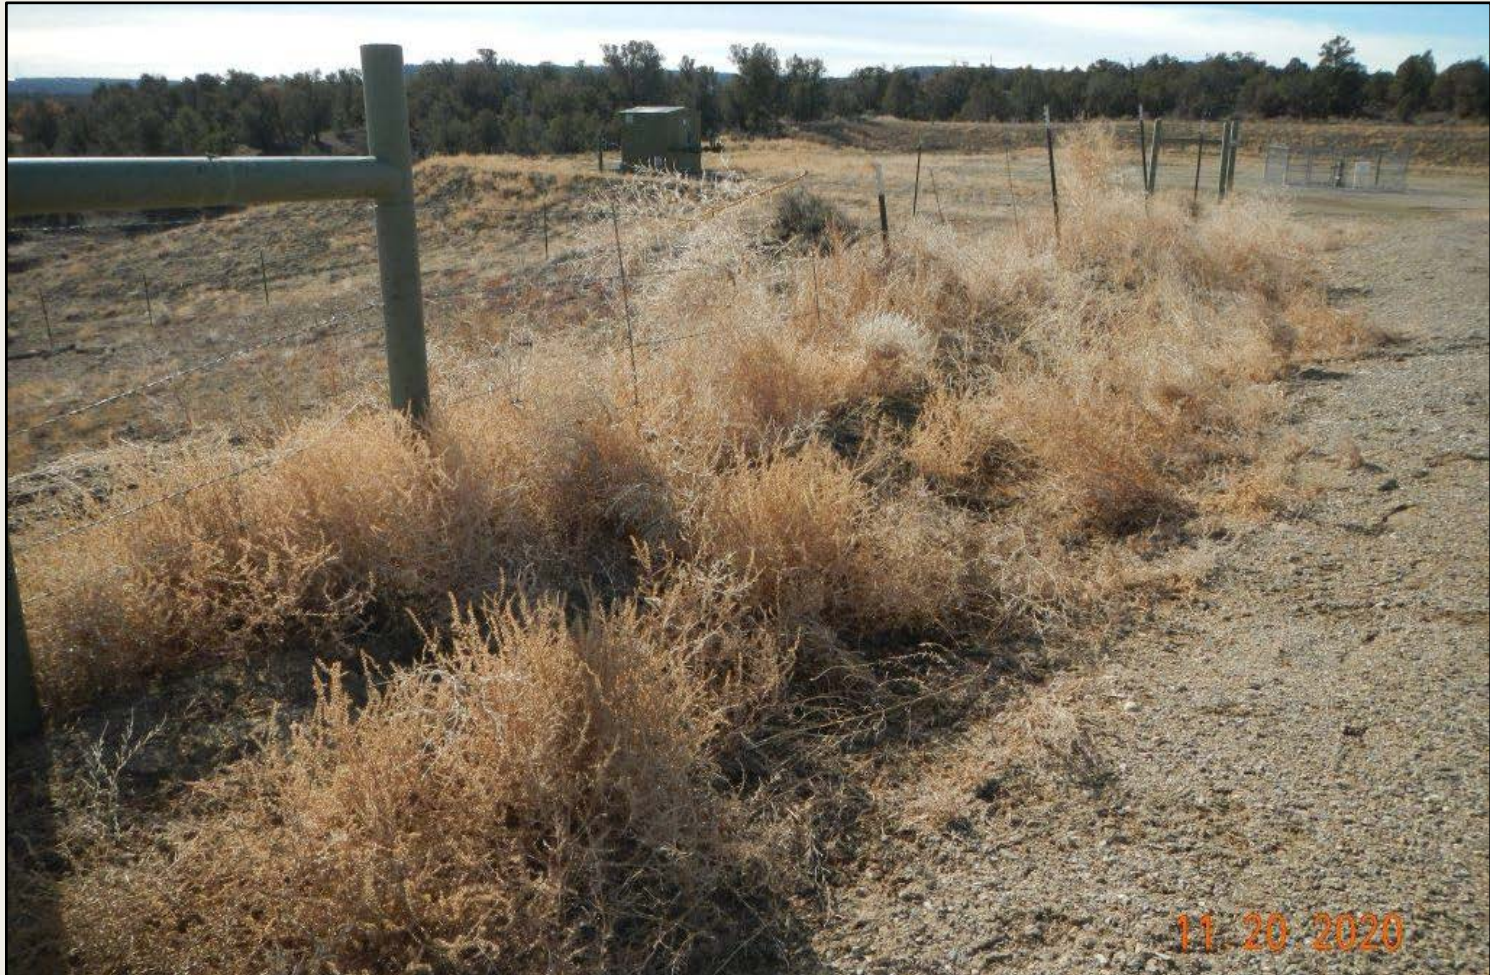
Photo 3. View of Russian thistle debris along the eastern well pad fence.

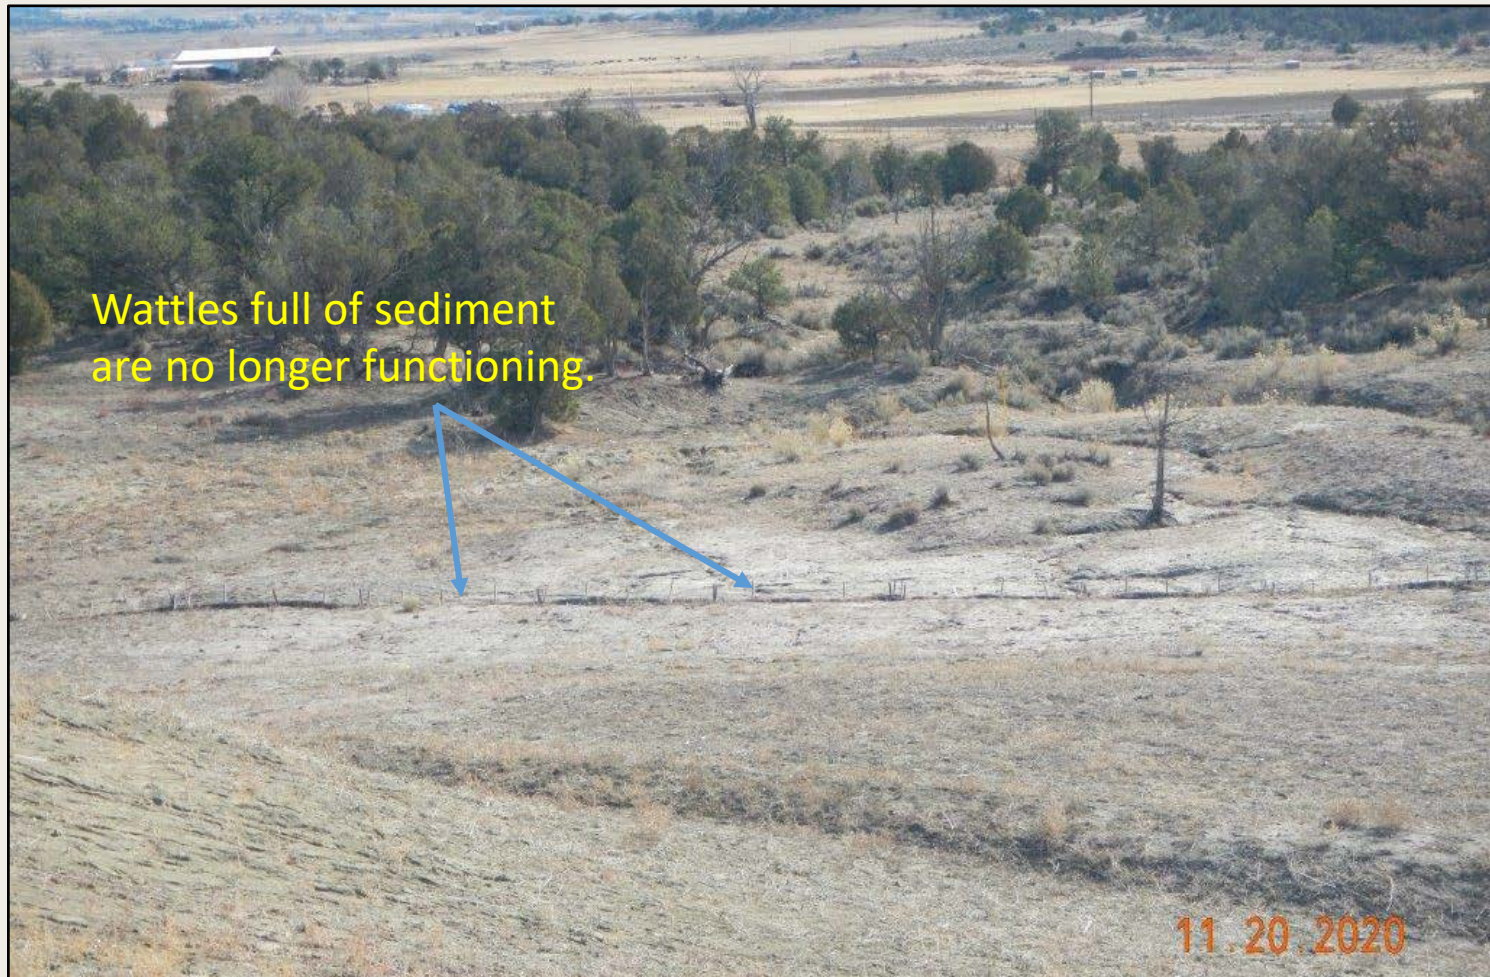
Wattles full of sediment
are no longer functioning.

Photo 4. View of area along the eastern pipeline alignment, that is eroding.

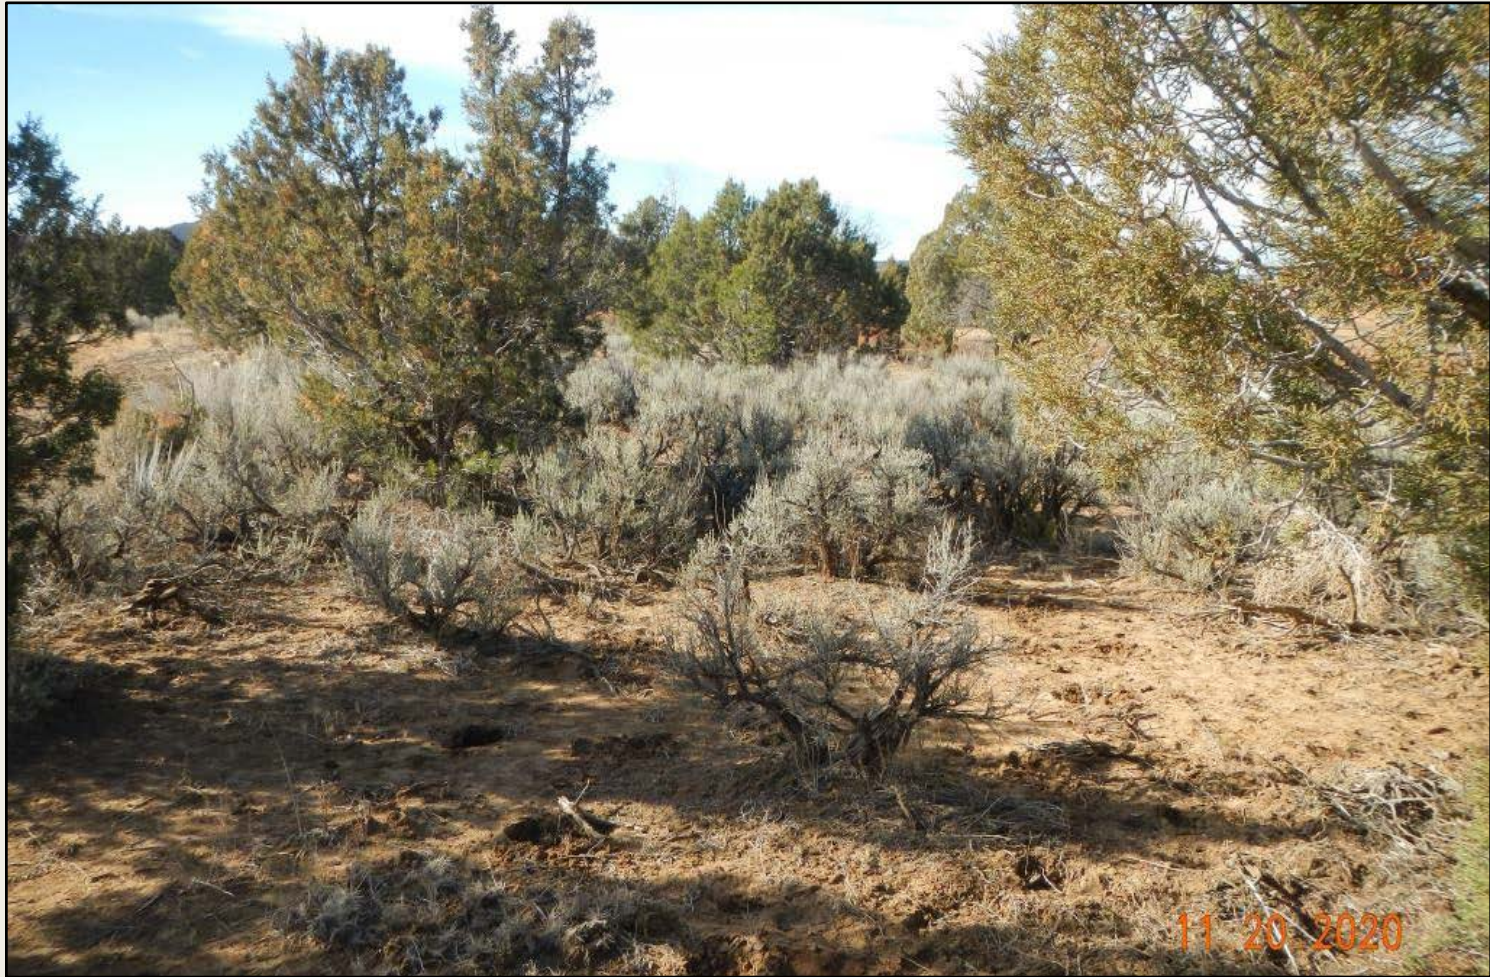
Photo 5. View of the reference area comprised of sagebrush shrubland with scattered pinyon and juniper trees and understory of grasses and forbs such as squirreltail, prickly pear, and crested wheatgrass.

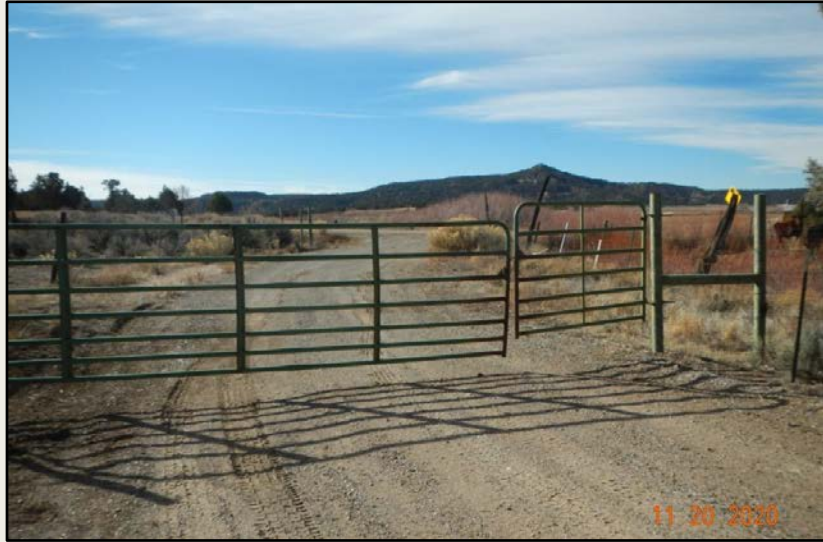
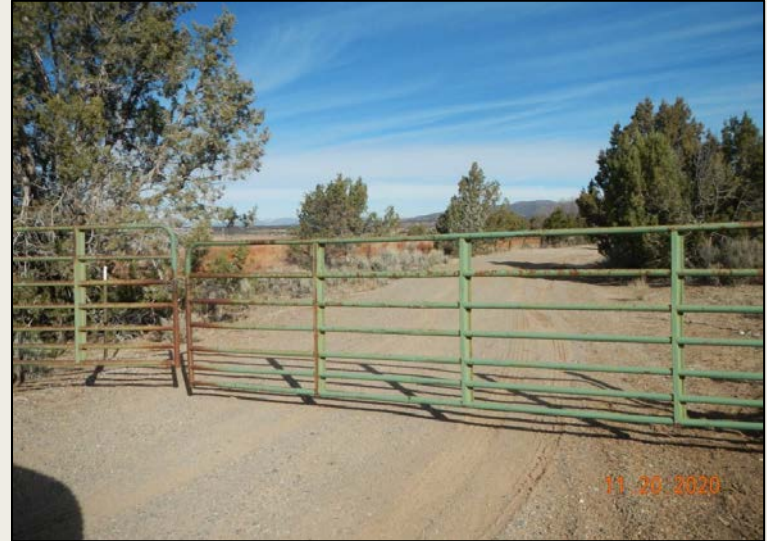
Photos 6/7. View of closed gates after entering and leaving location.
