**TEP ROCKY MOUNTAIN LLC
UNOCAL-66S96W 32NWNE
Location ID: 335274**

COLORADO
Oil & Gas Conservation
Commission
Department of Natural Resources

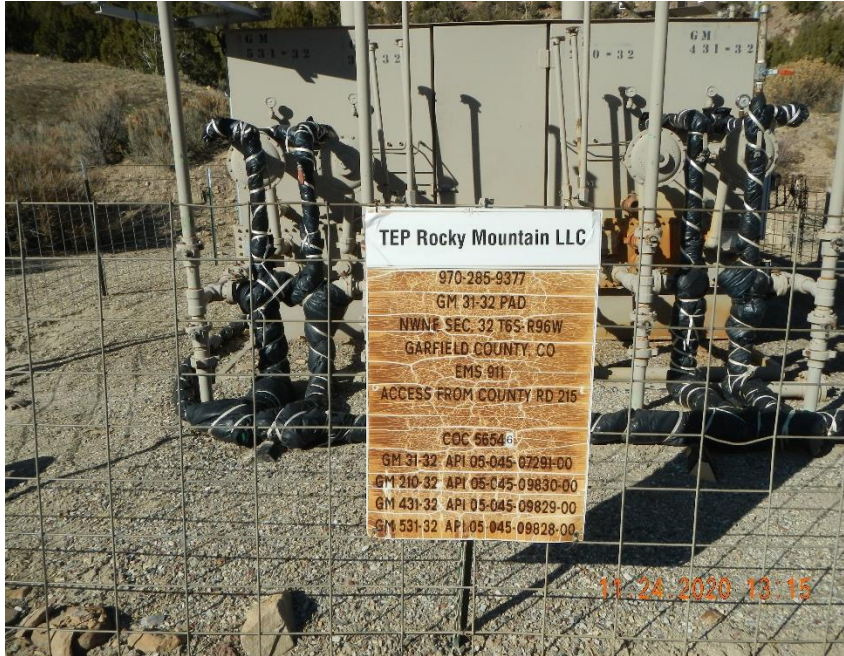
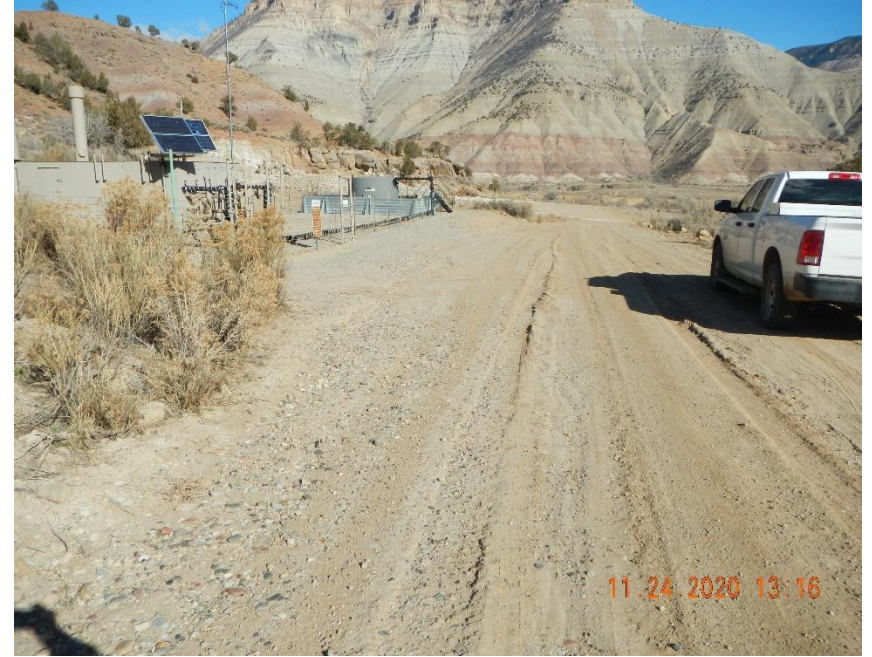
**Ruts on road in front of separators and
tank battery.**

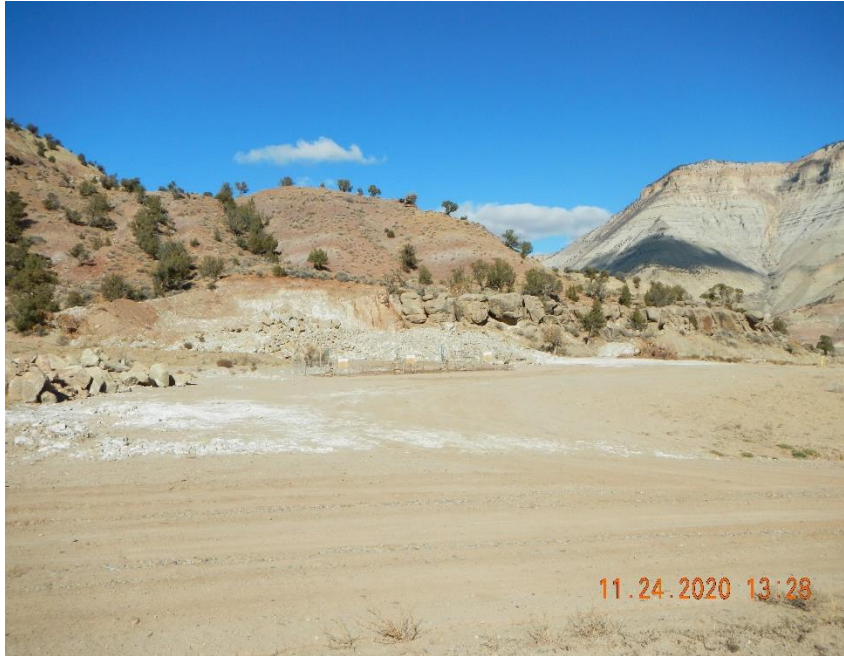
Mining of rocks from behind wells.

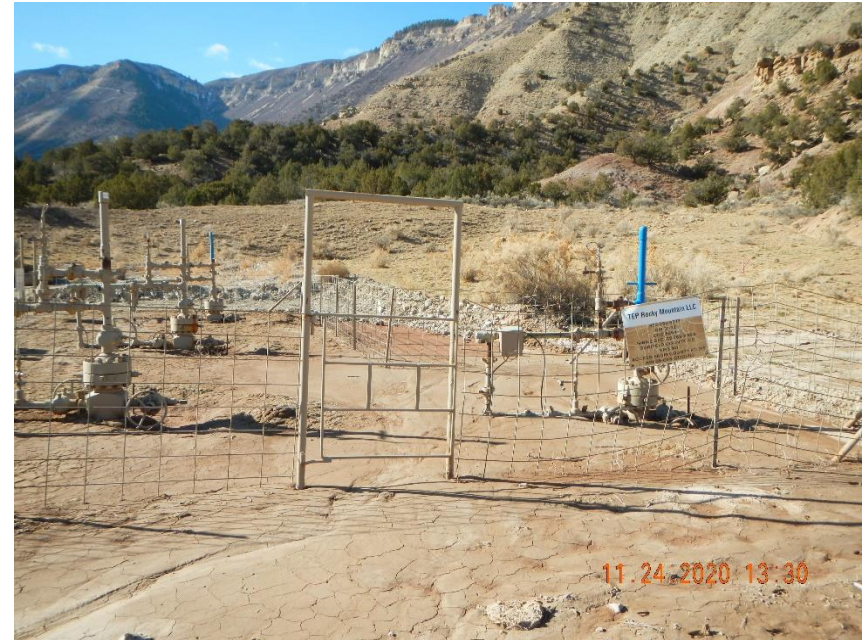
Sediment built up around wells.

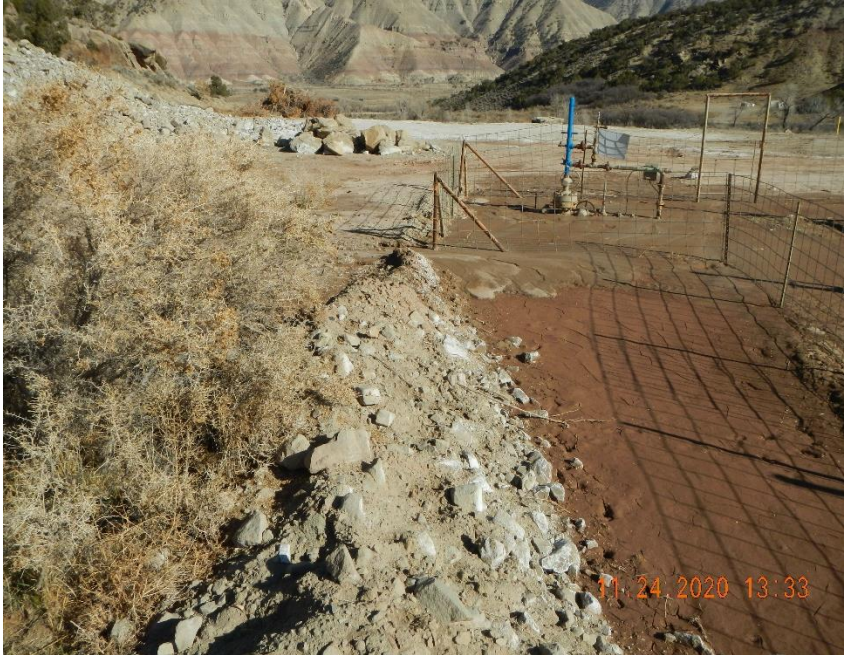
Storm water and sediment flowing to well heads.

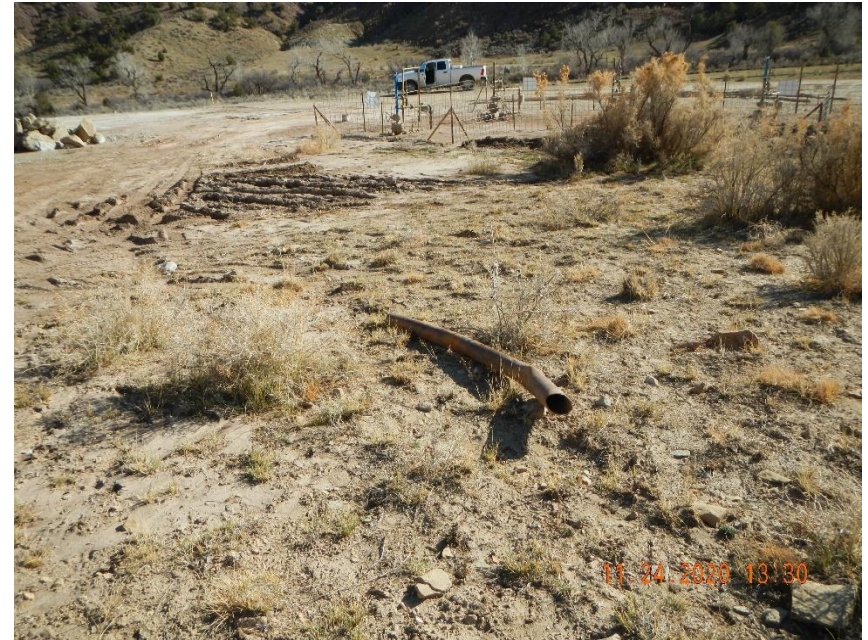
Unused pipe.

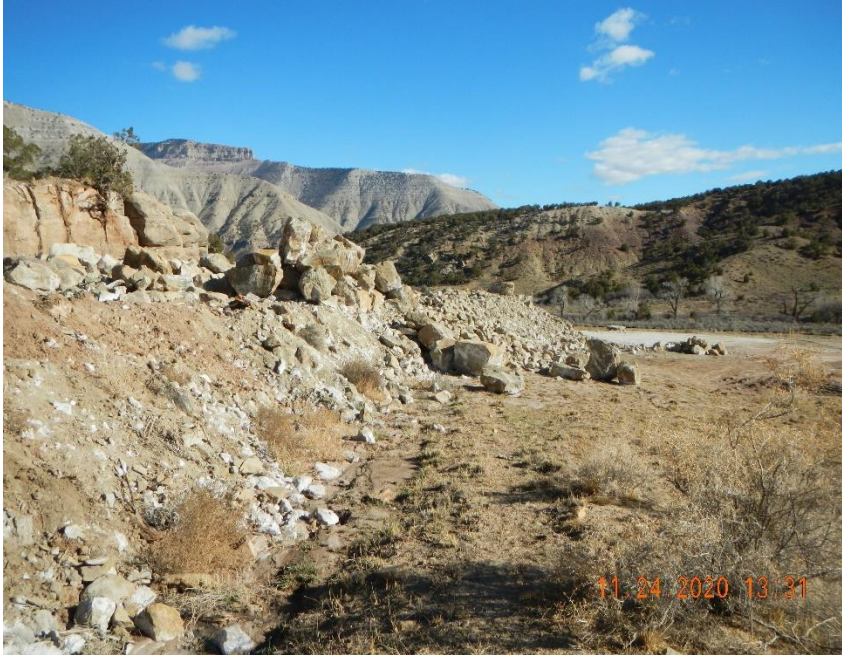
Diversion ditch is blocked off by rock mining.

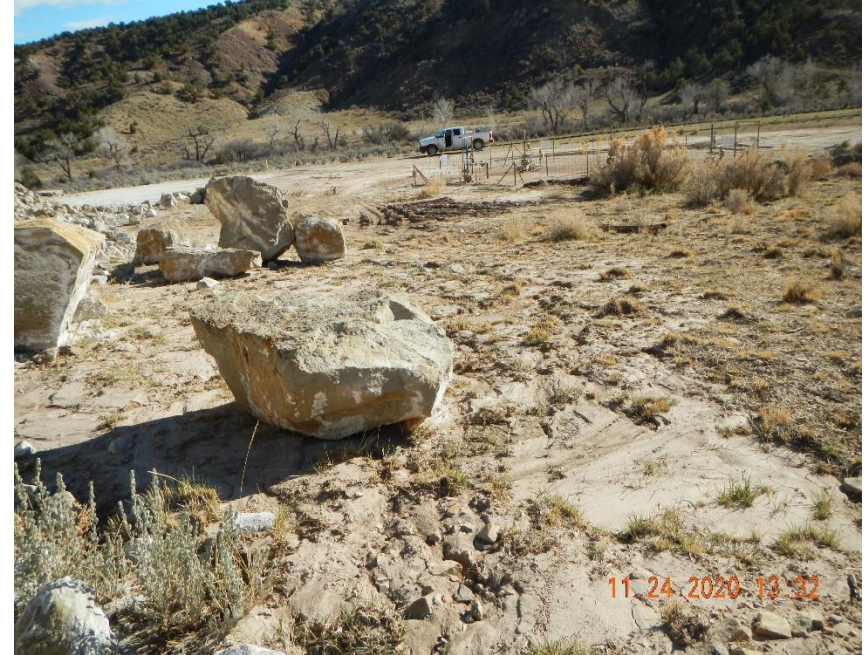
Storm water and sediment flowing to well heads.

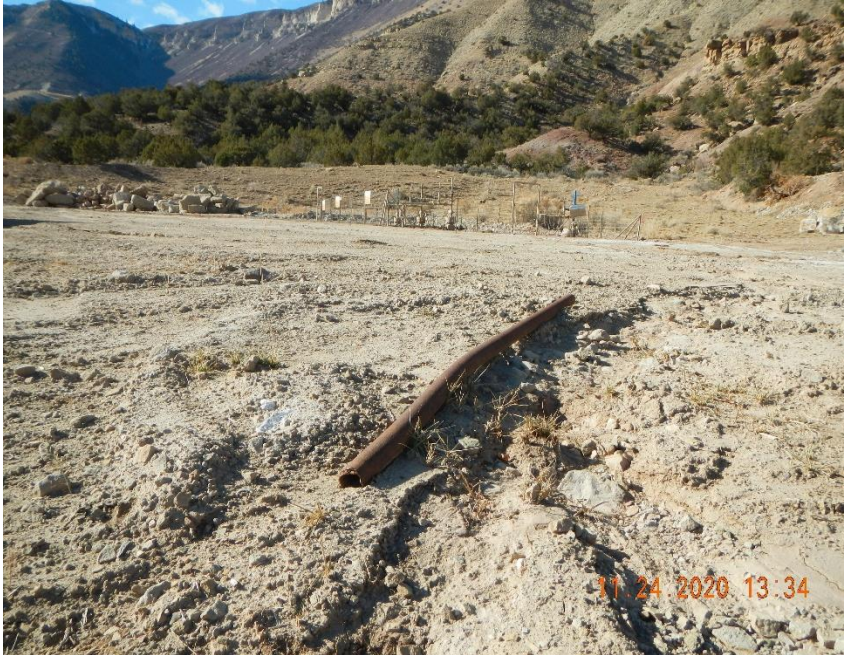
Unused pipe.

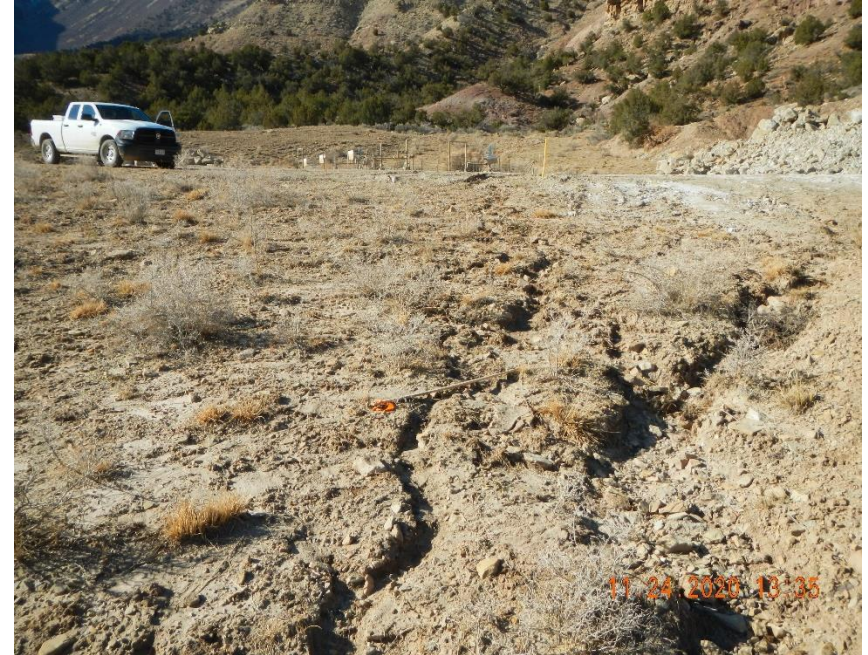
**Storm water washing over location and
riling reclaim area.**

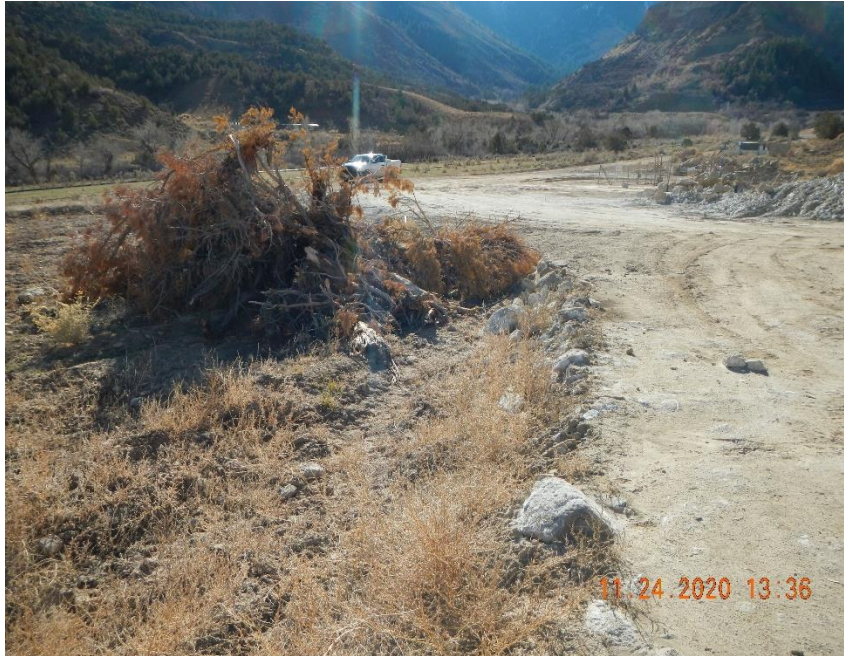
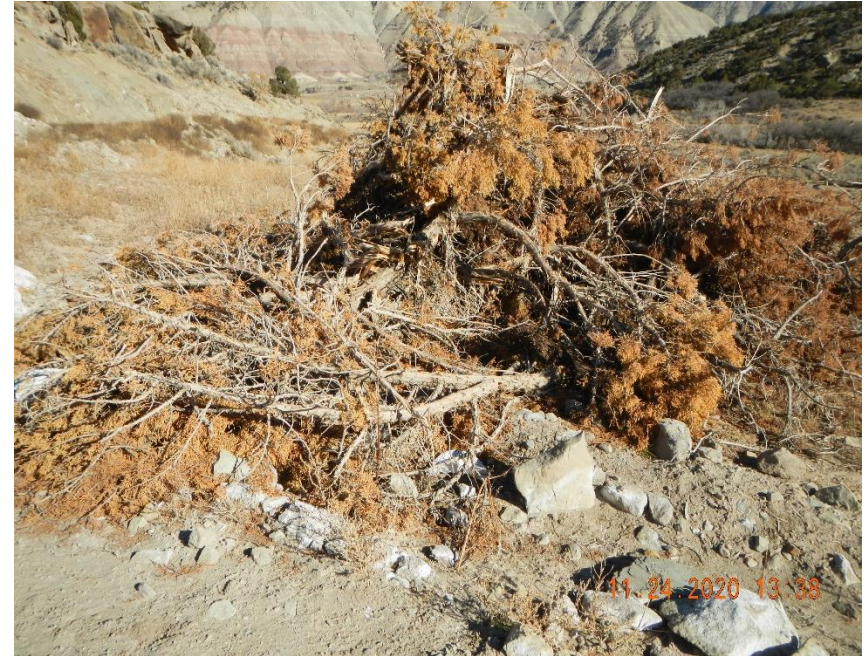
Dead debris on edge of location.

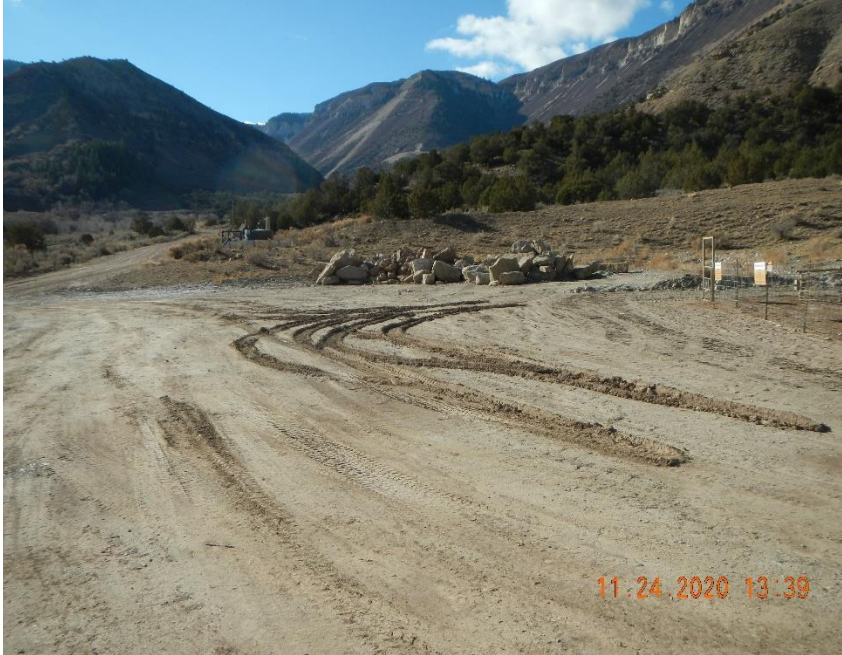
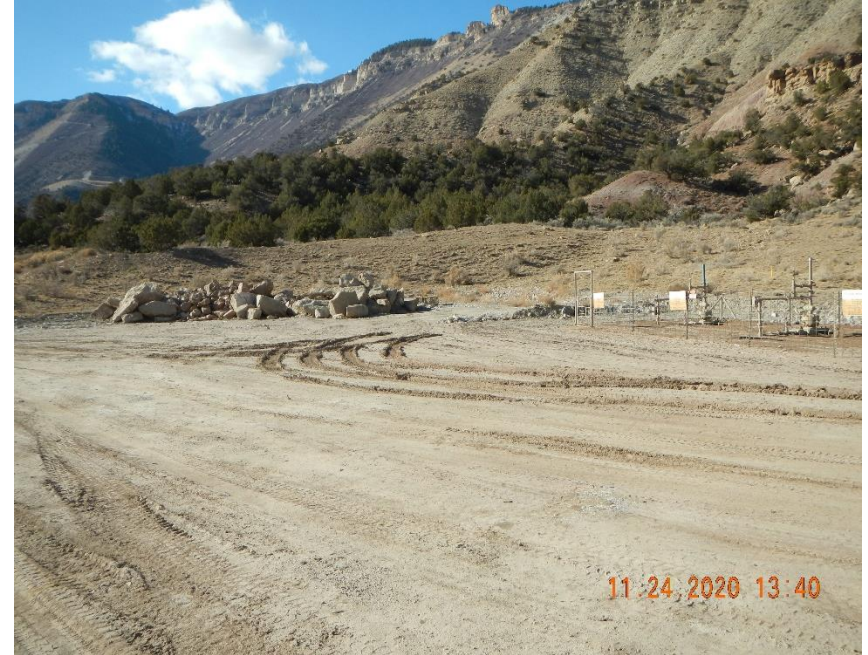
Rutting on location.

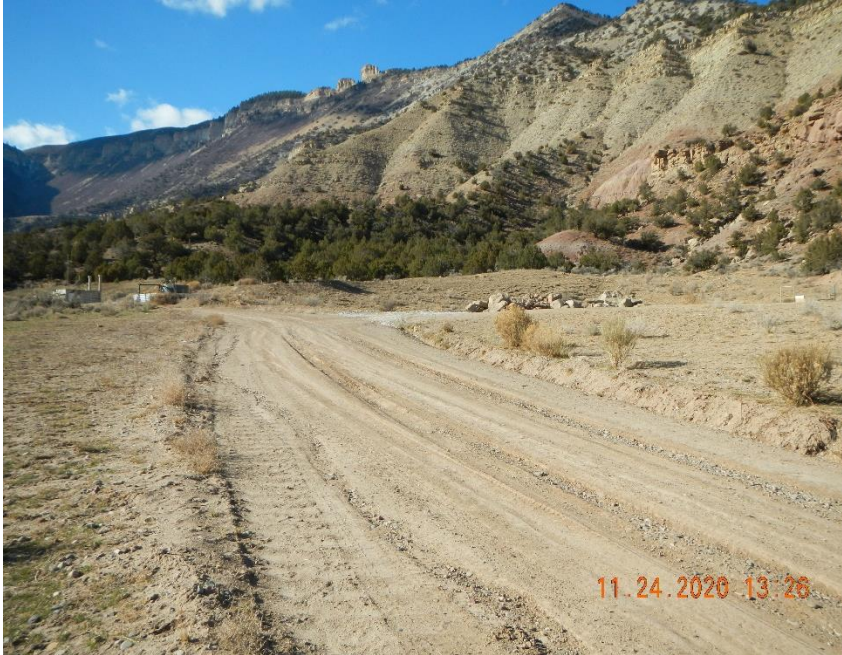
Rutting on access road.

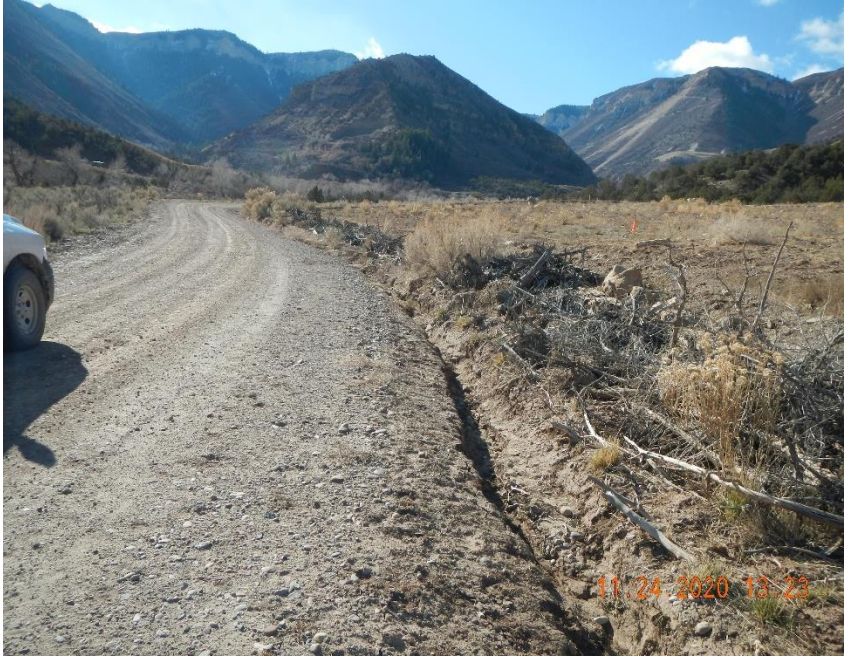
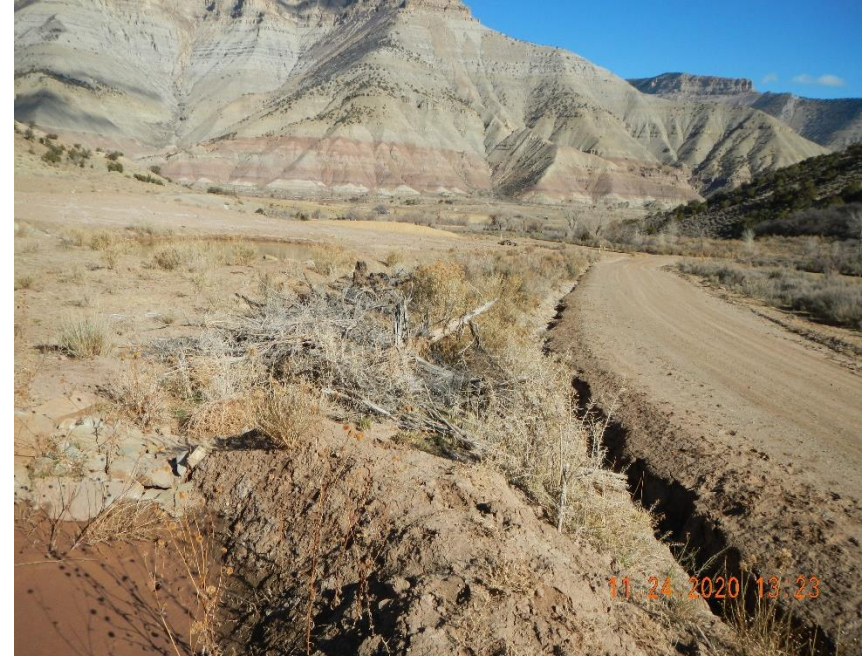
Dead debris along side of access road.
