Inspection Photos

Location Name: CAERUS PICEANCE LLC KNOX-68S96W /14SENW,

Location ID: 334083

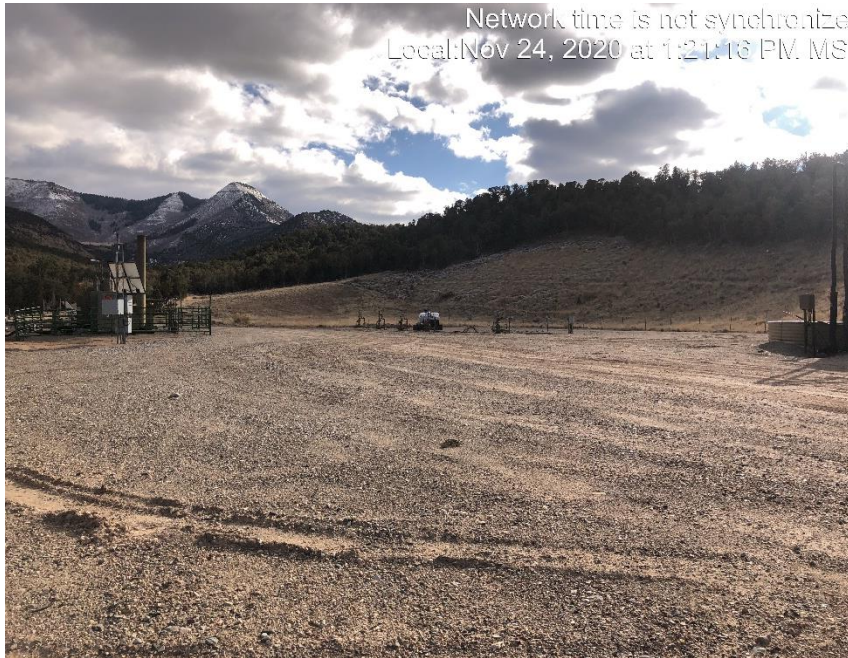
Photo #2321 from entrance to location.

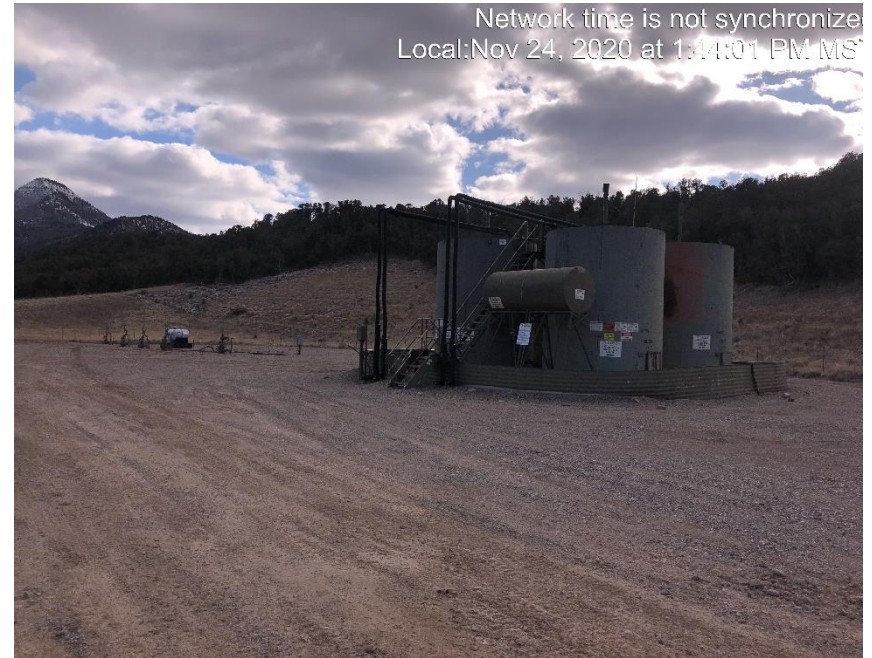
Photo #2322 from entrance to location.

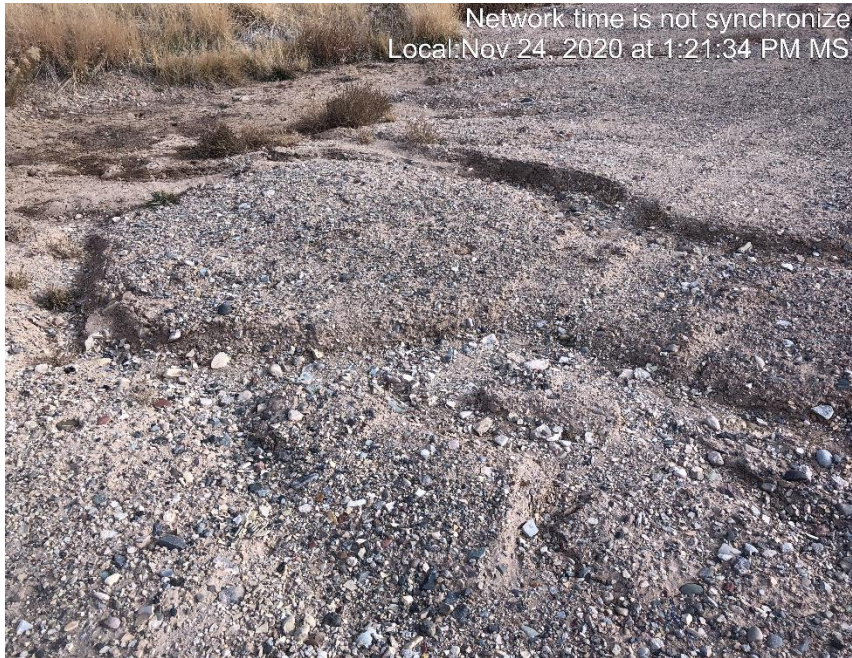
Photo #2323 Rill erosions occurring in the NE corner of location.

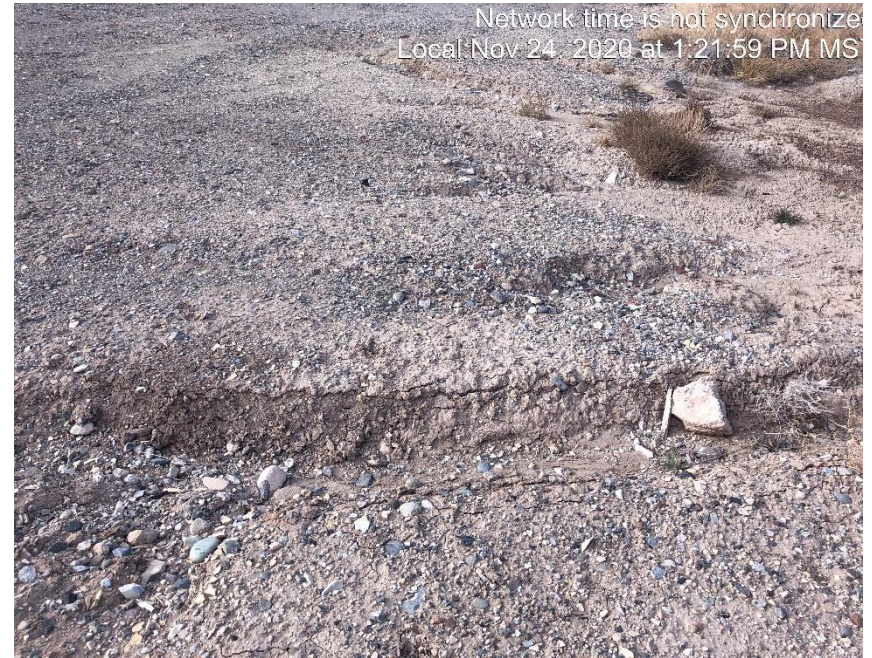
Photo #2324 Rill erosions occurring in the NE corner of location.

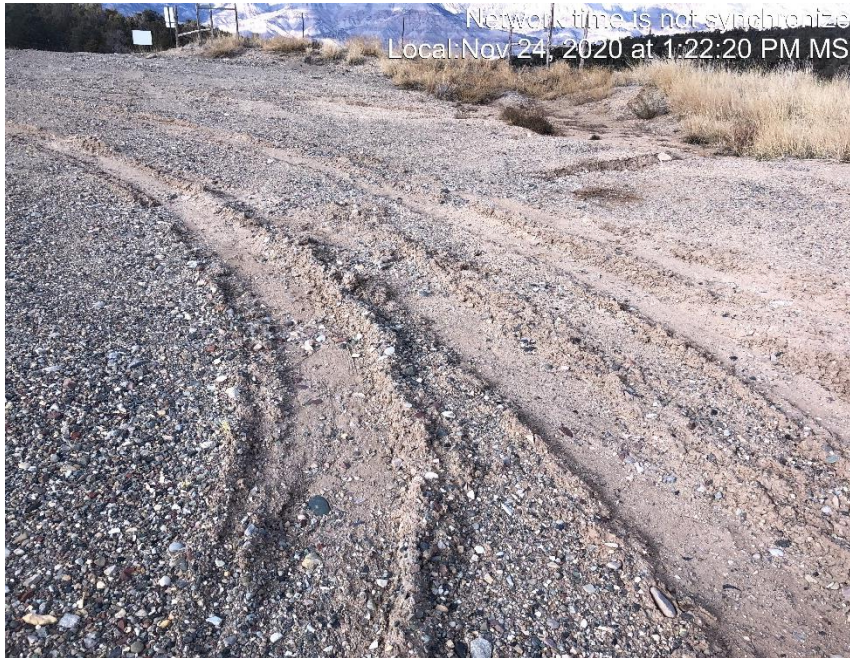
Photo #2325 Tracking occurring due to lack of stabilization.

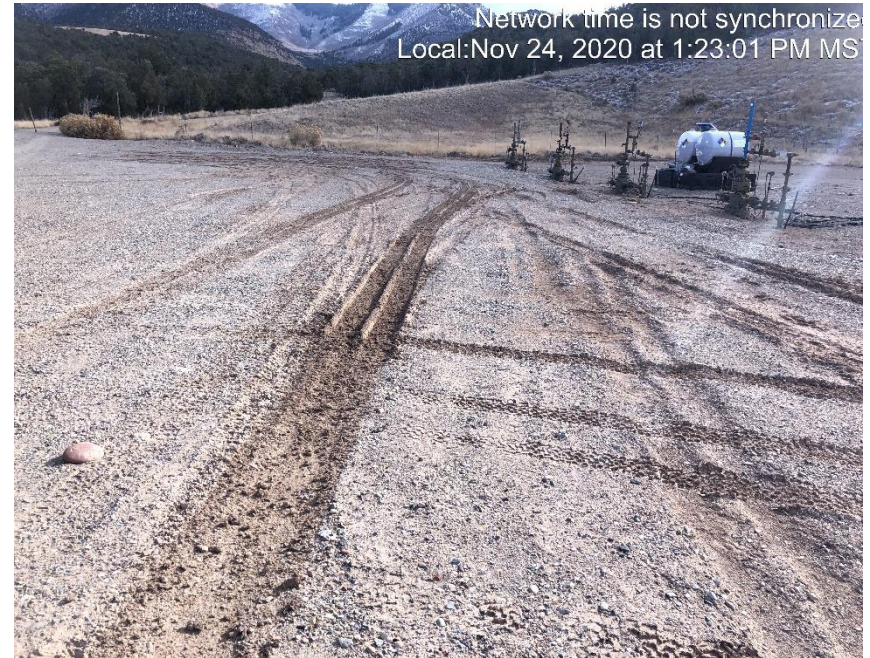
Photo #2326 Tracking occurring due to lack of stabilization.

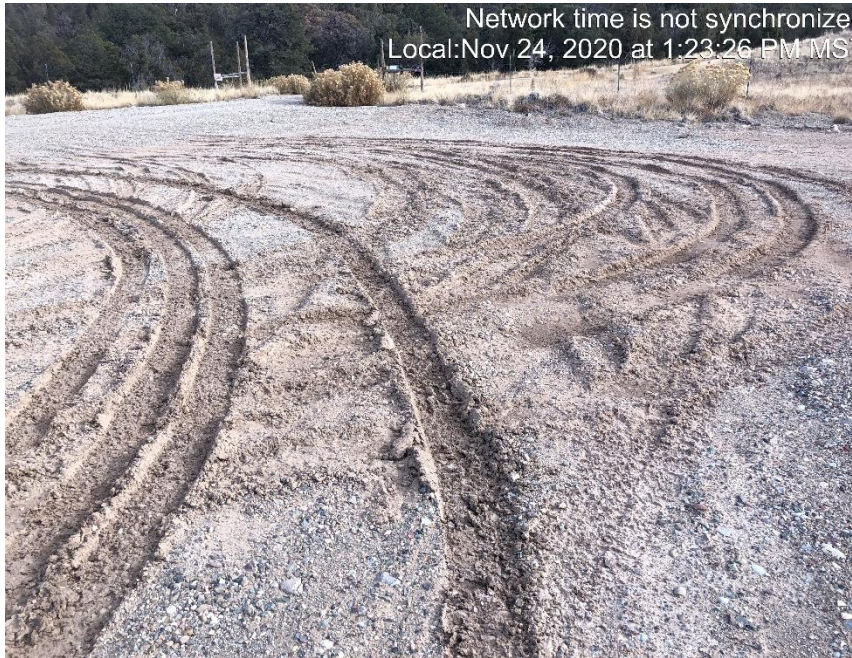
Photo #2327 Tracking occurring due to lack of stabilization.
