Inspection Photos
Location Name: Ignacio 33-7 #19A
API: 05-067-08071

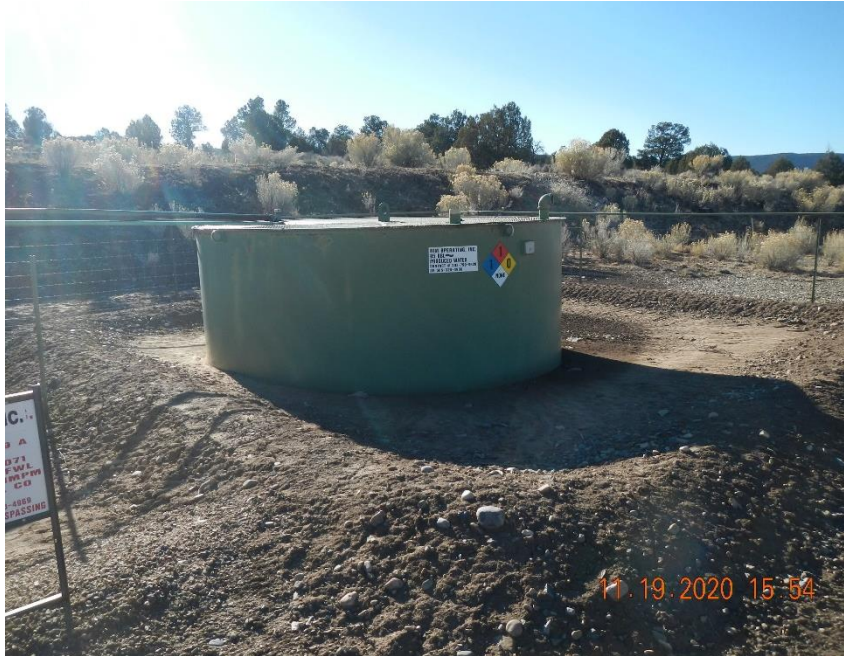
Open topped steel produced water vessel. Ensure that secondary containment berm has adequate capacity.

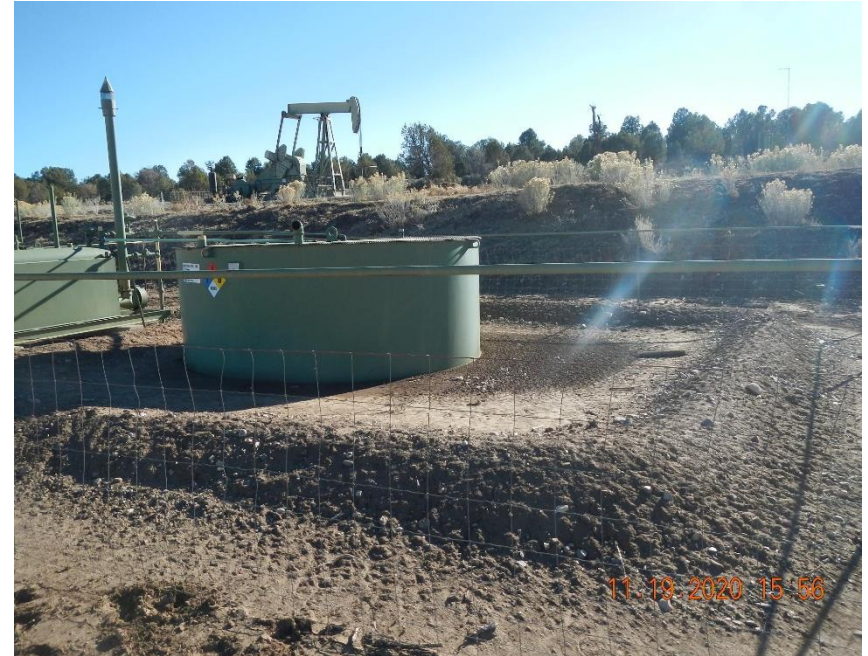
Secondary containment berm does not appear to have adequate capacity per Rule 605.a.4.

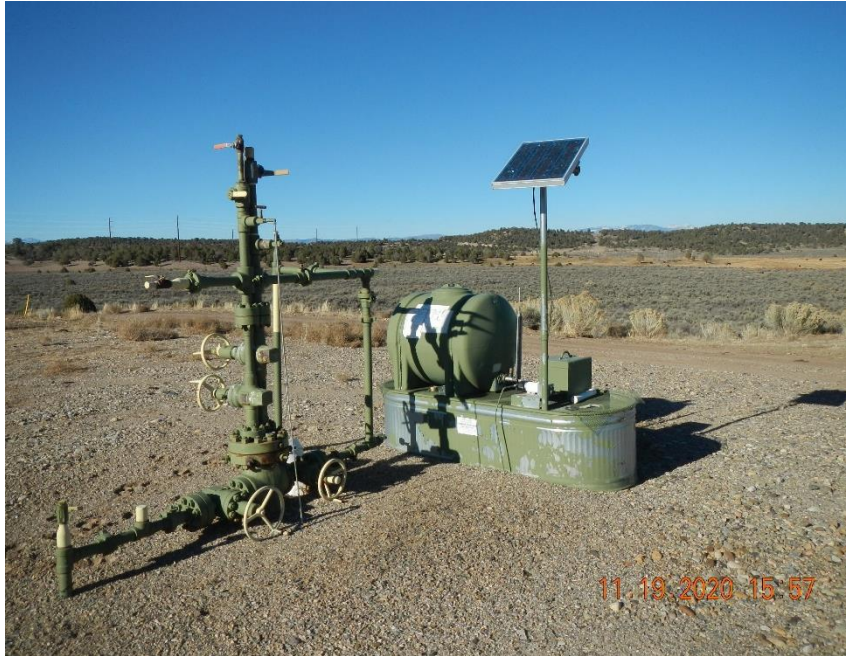
Ignacio 33-7 #19A well head and chemical injection system.

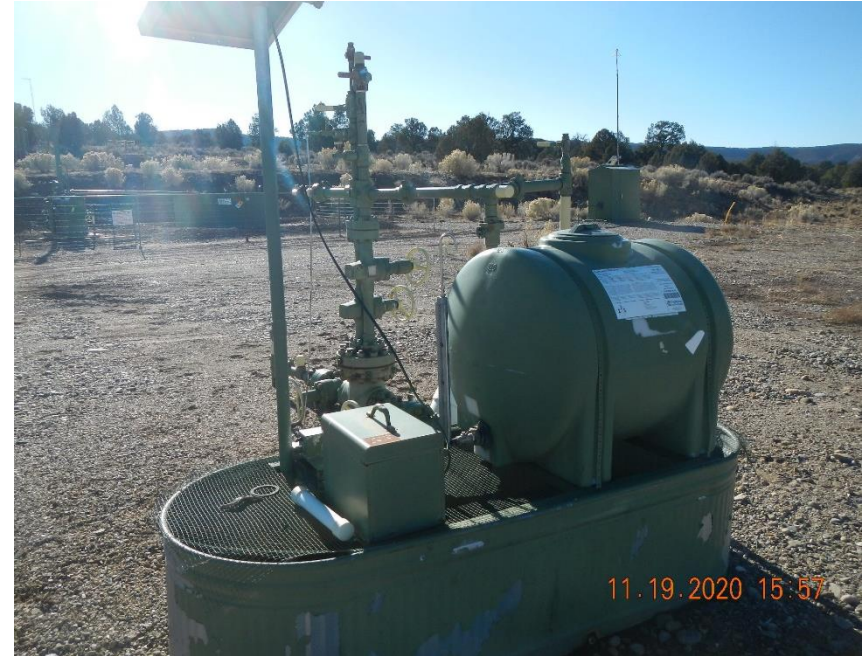
Chemical injection system on secondary containment.
