Inspection Photos
Location Name: Ignacio 33-7 #19
API: 05-067-05743

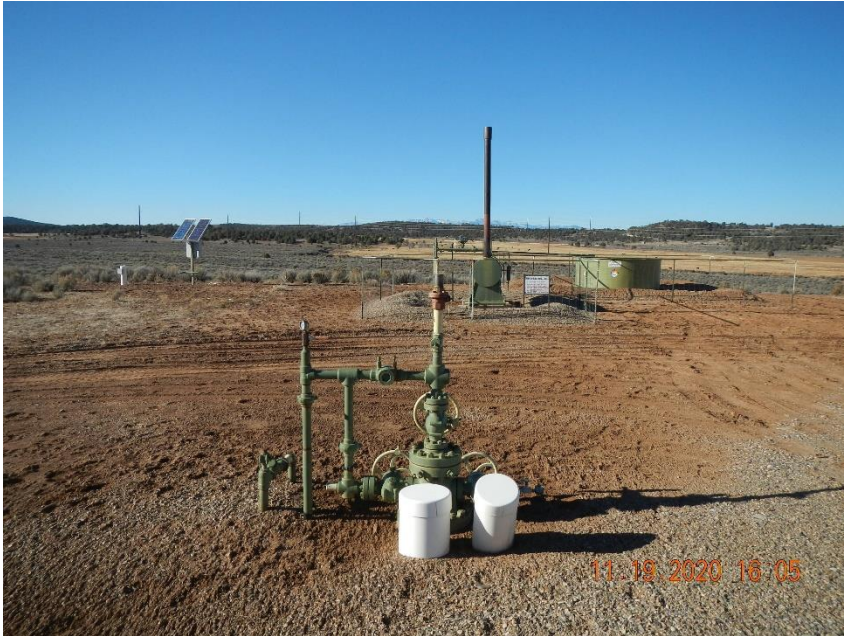
Ignacio 33-7 #19 location photo.

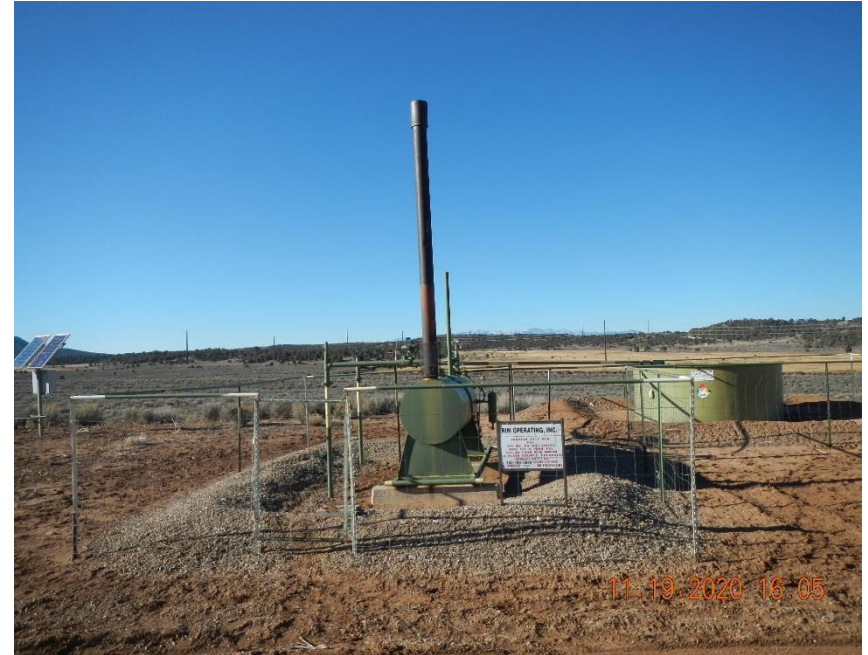
Ignacio 33-7 #19 separator and fiberglass open topped tank.

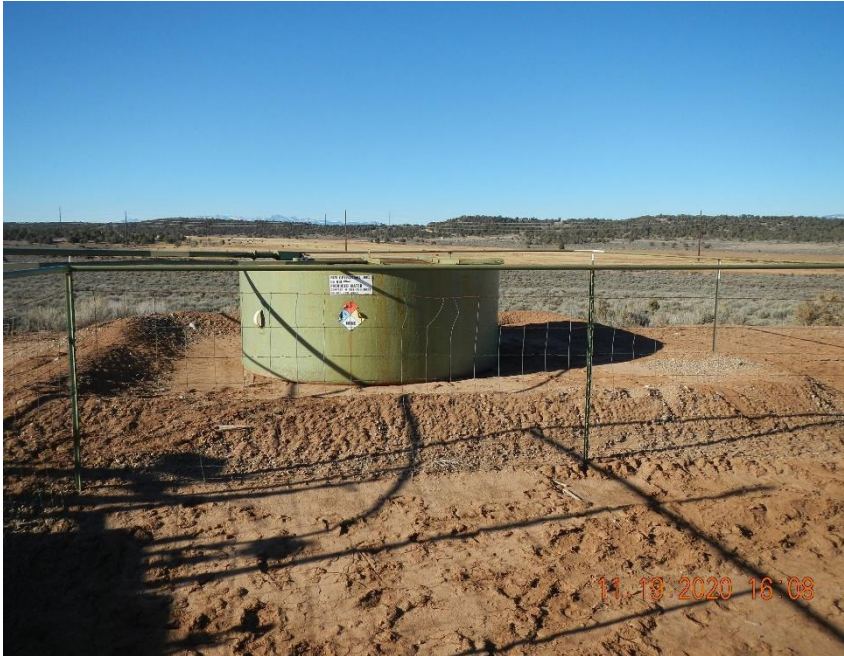
NFPA placard is peeling off of tank.

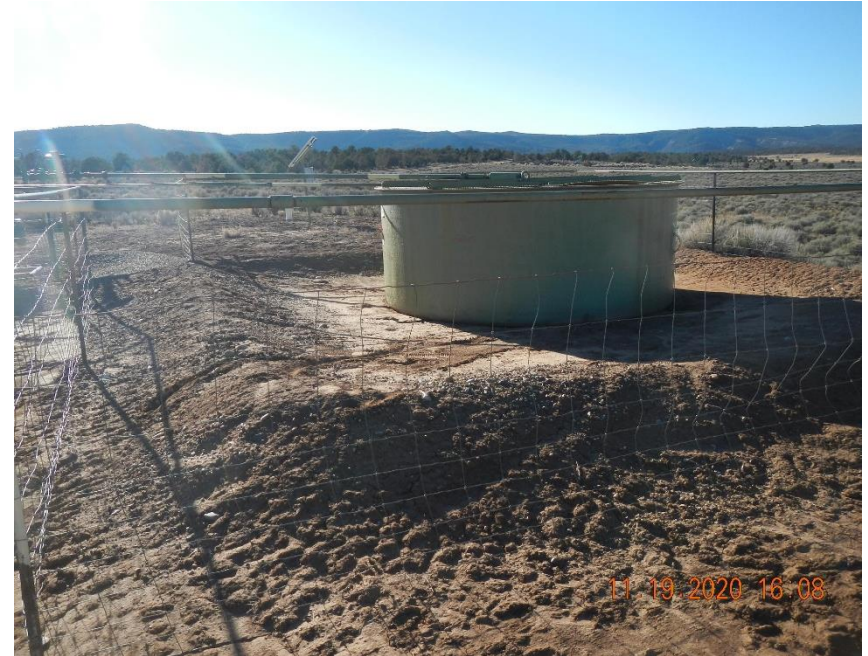
Secondary containment berm does not appear to have adequate capacity per Rule 605.a.4.
