# *Inspection Photos*

*API#057-06625*

*Operator: Gulf Exploration*

Inspection Photos: Gulf Ex PA Eagle Hill API#057-06625

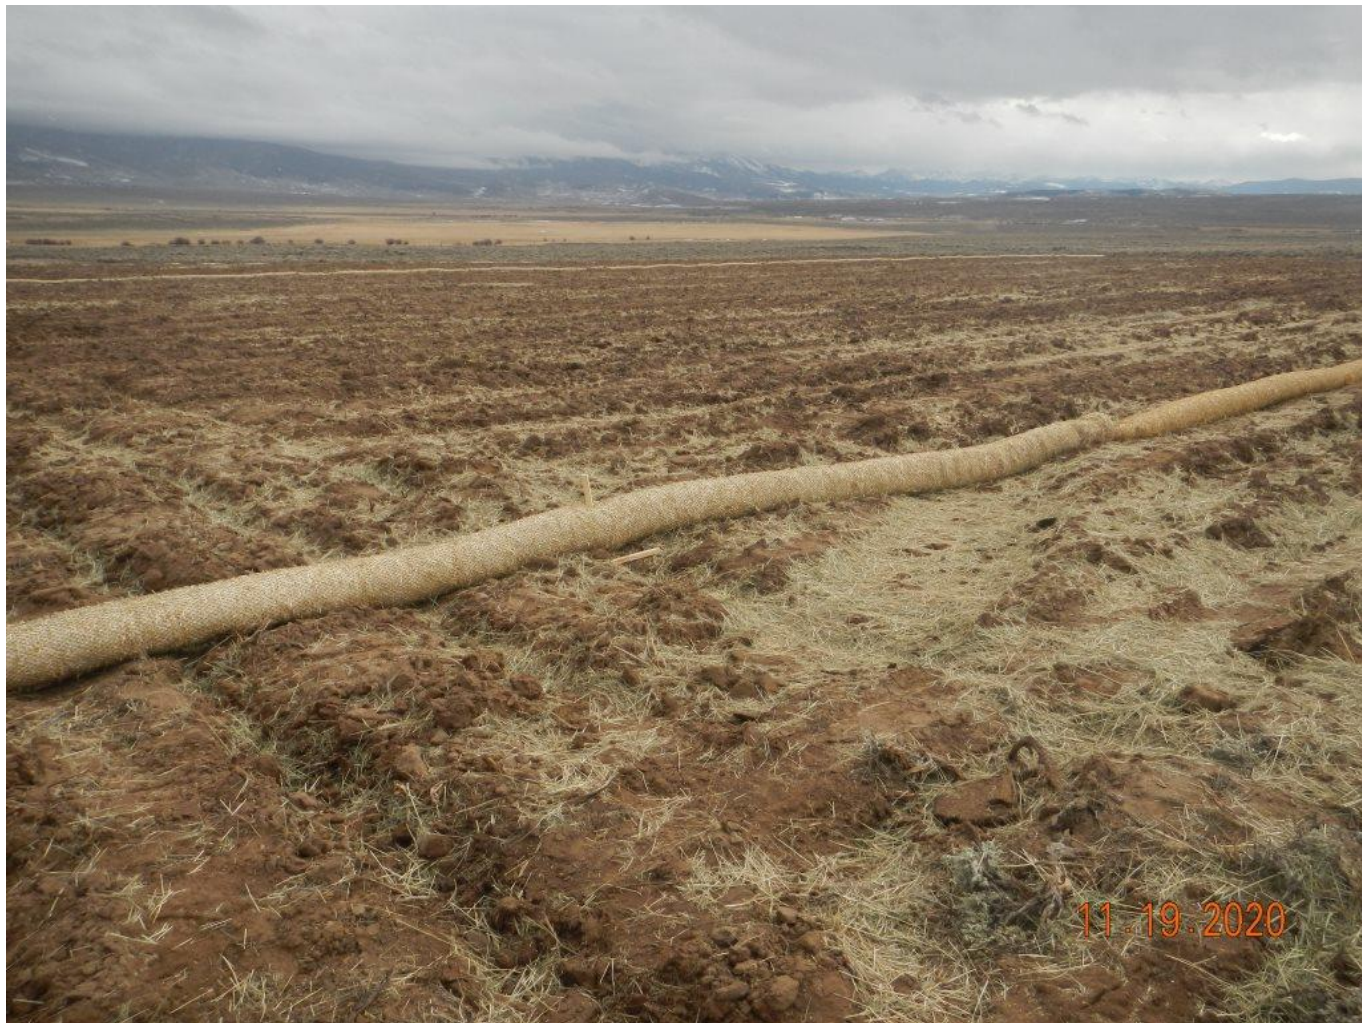
**Photo#1:**

Overview of Location from Northwest corner to Southeast. Wattles are not properly positioned or installed with good engineering practices. Lack of uniform mulch application.

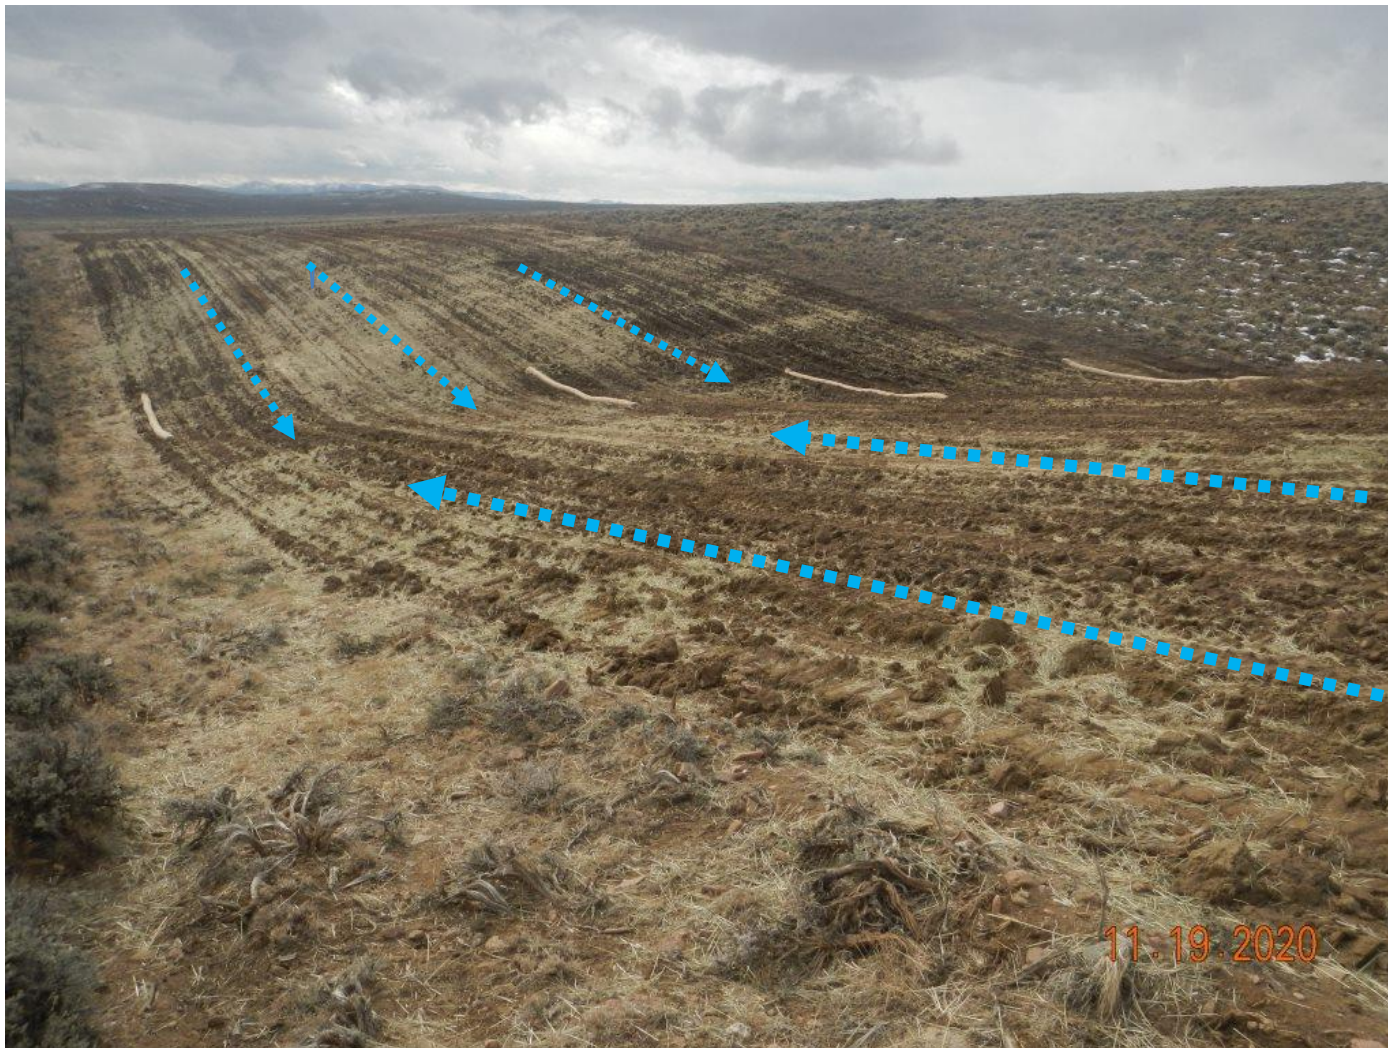
Photo#2:

Swale portion of access road; view to Southwest. No BMPs installed across swale slopes to control SW flowing down channels created by ripping. Blue arrows indicate stormwater flow direction.

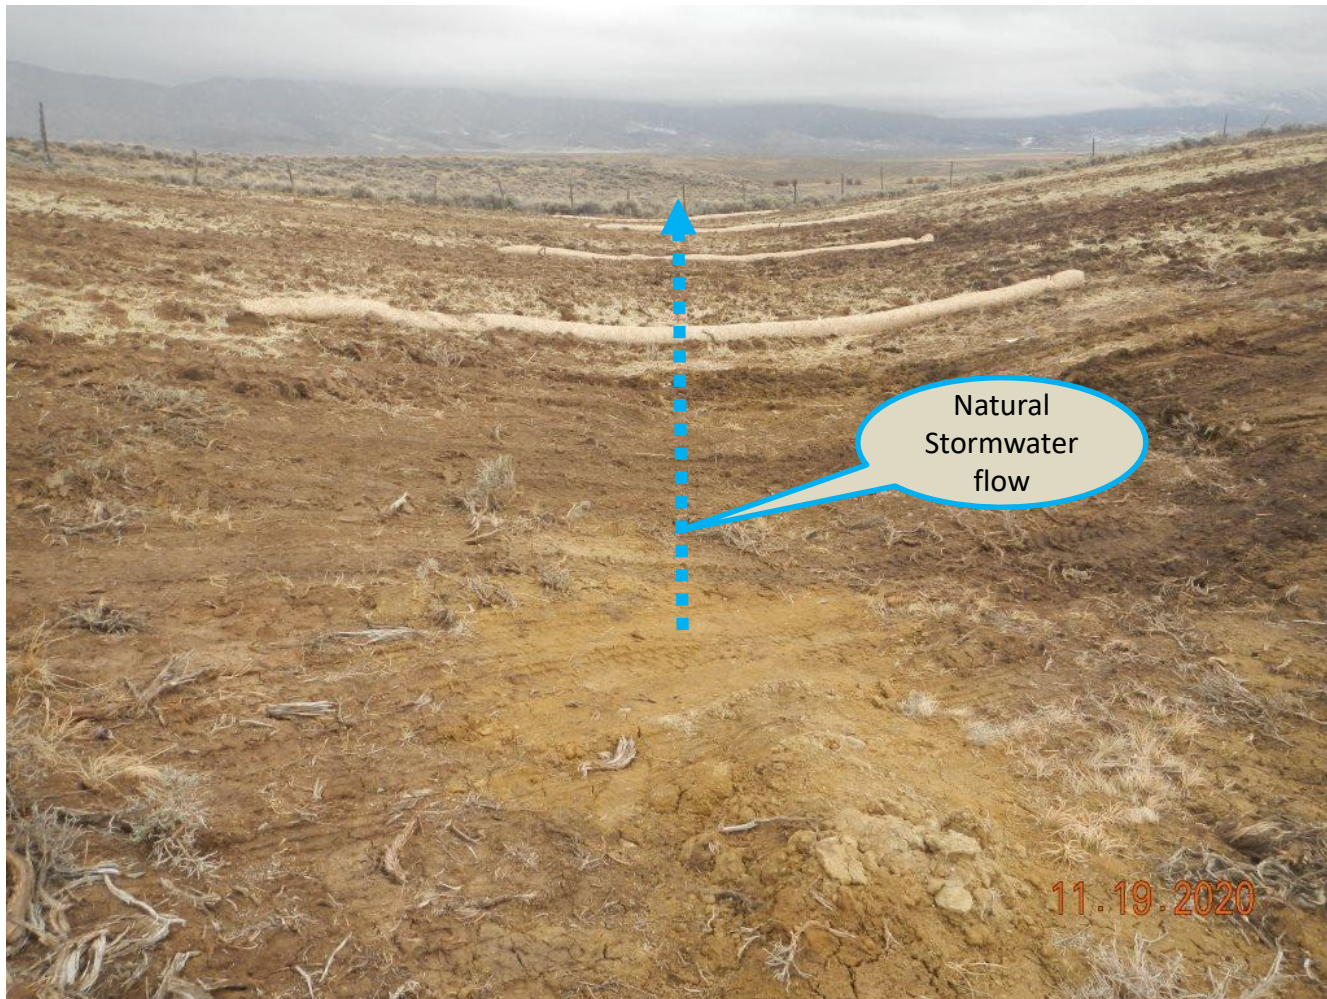
Photo#3:

At bottom of swale (see overview in Photo#2) stormwater pathway is interrupted. Properly engineered BMPs with inlet, and outlet pathway are needed to return natural drainage that existed prior to Oil & Gas disturbance.

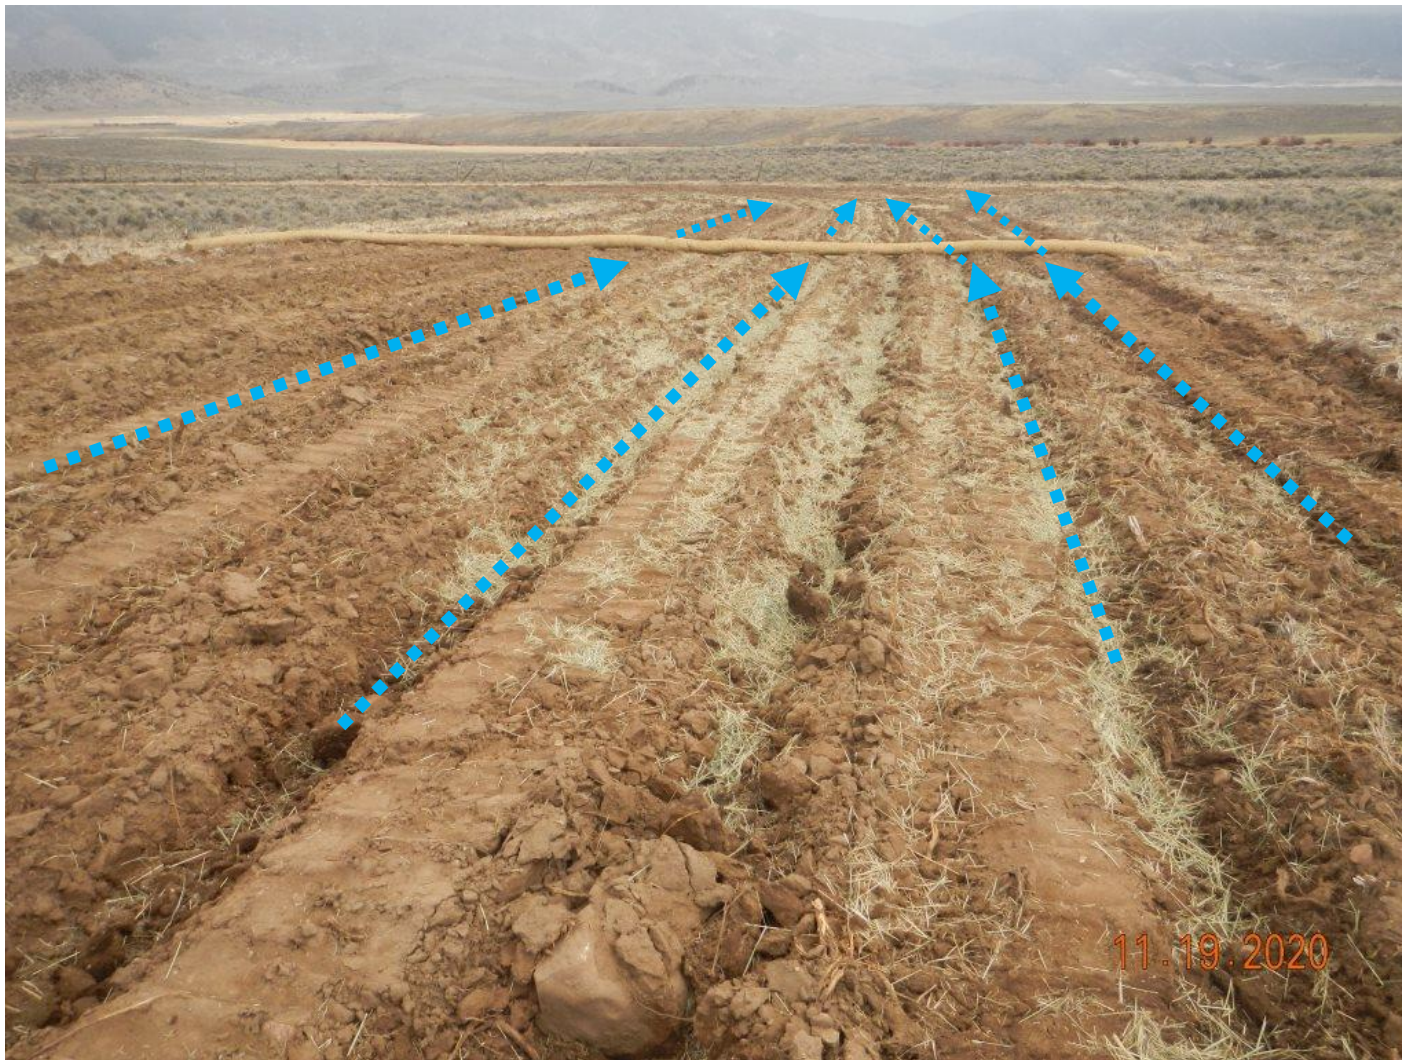
Photo#4:

View along access road to NE. Wattle has been improperly installed. SW will flow under the wattles along the ripping channels. Blue arrows indicate stormwater flow.

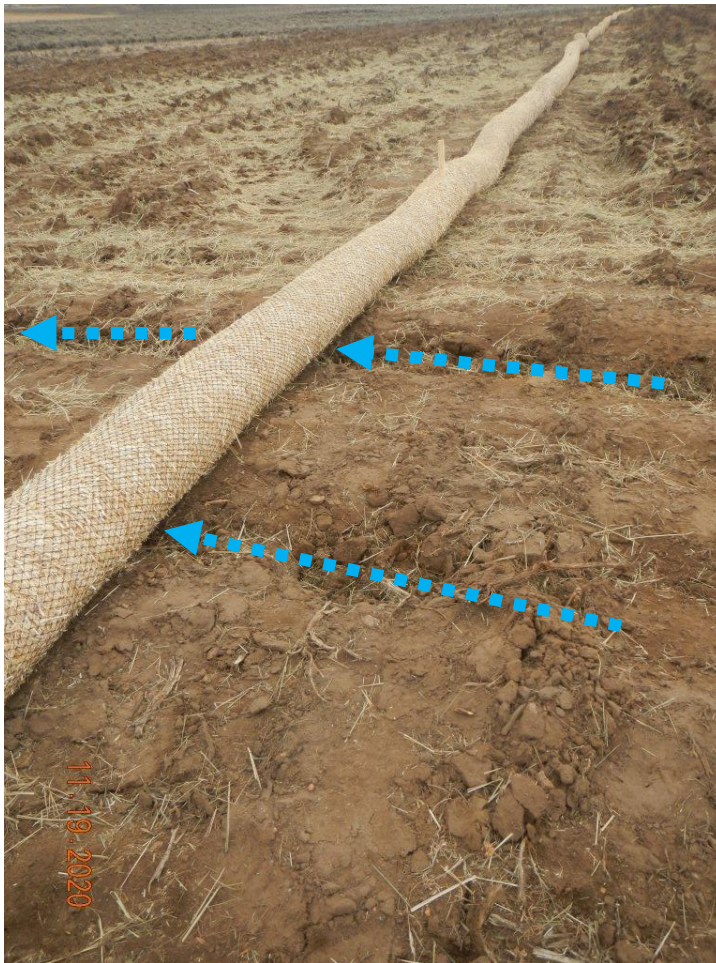
Photo#5:  
View along West perimeter of Location; improperly positioned and installed wattle. Blue arrows indicate stormwater flow under the wattle.

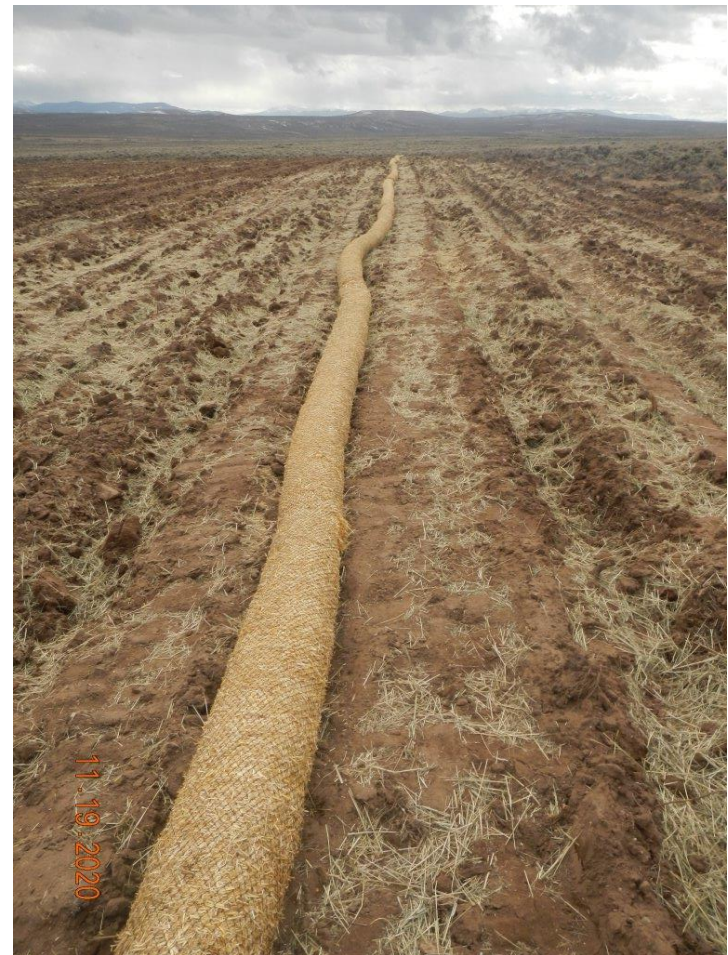
Photo#6:  
View along West perimeter of Location; improperly positioned and installed wattle.

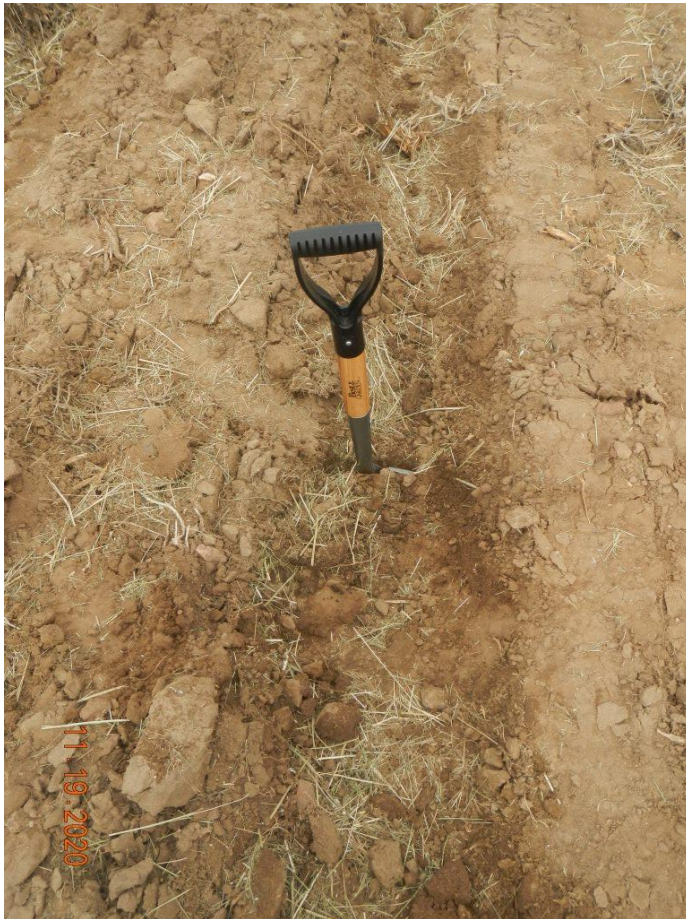
**Photo#7:**  
Showing de-compaction depth; Shovel penetrated to 12”.

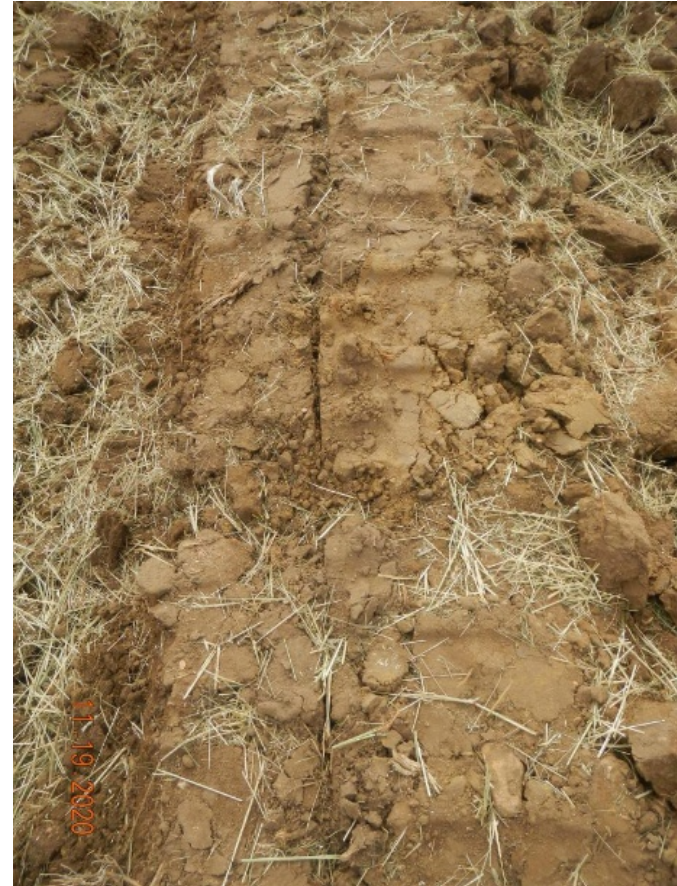
**Photo#8:**  
Showing Improper seedbed preparation and stabilization.
