Inspection Photos

Operator: Hilcorp Energy
API: 067-06464
Date: 12/1/2020

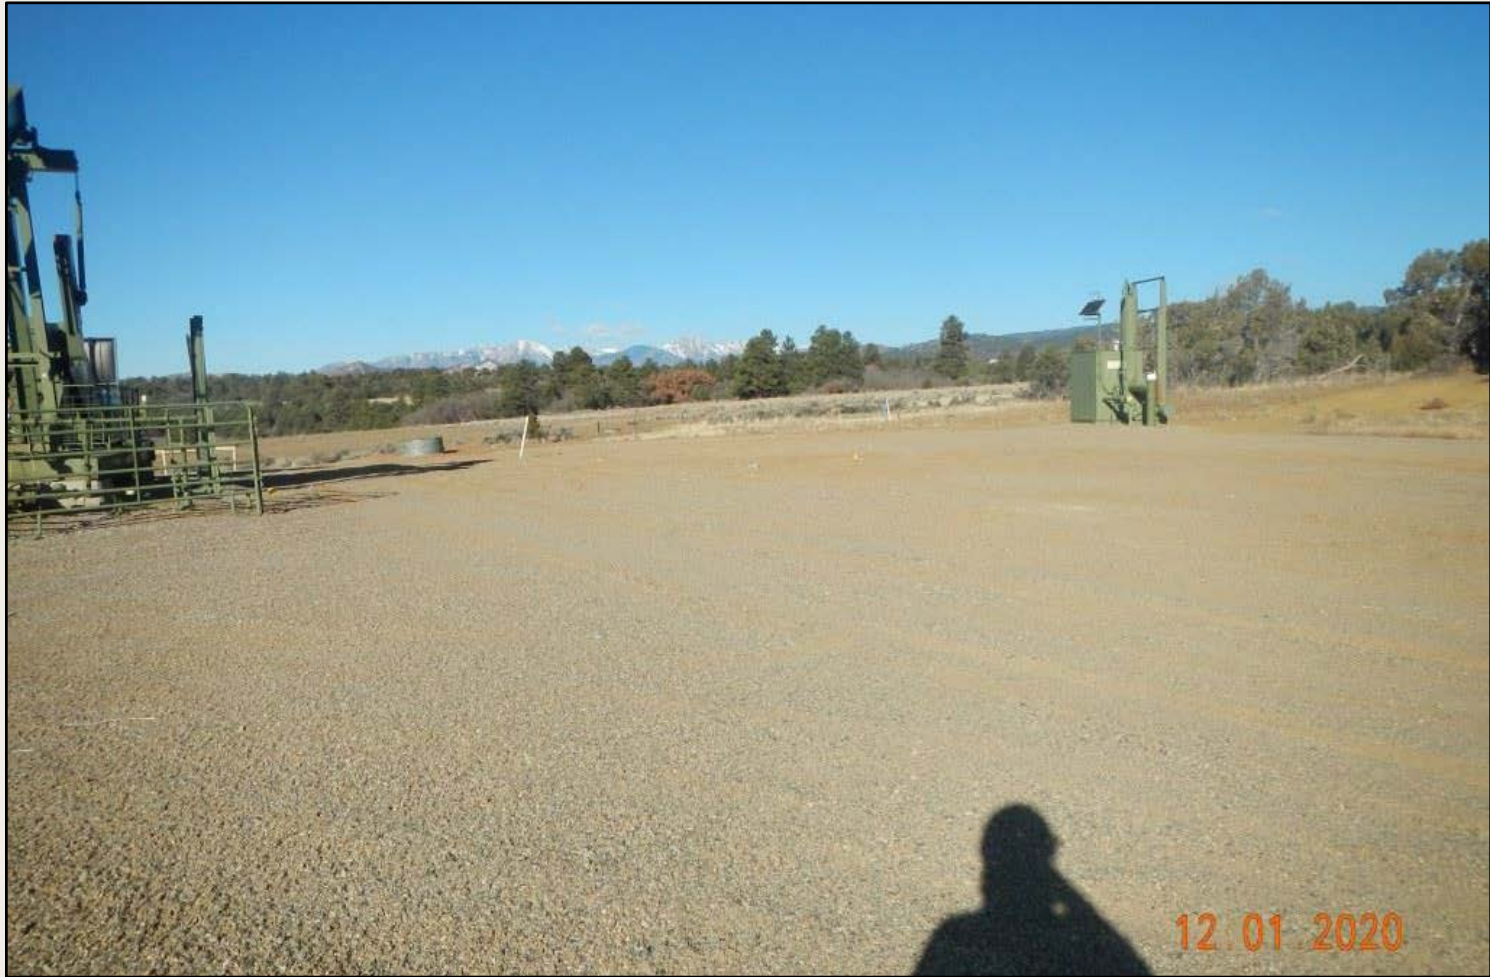
Photo 1. View of the project area from the well pad entrance facing center.

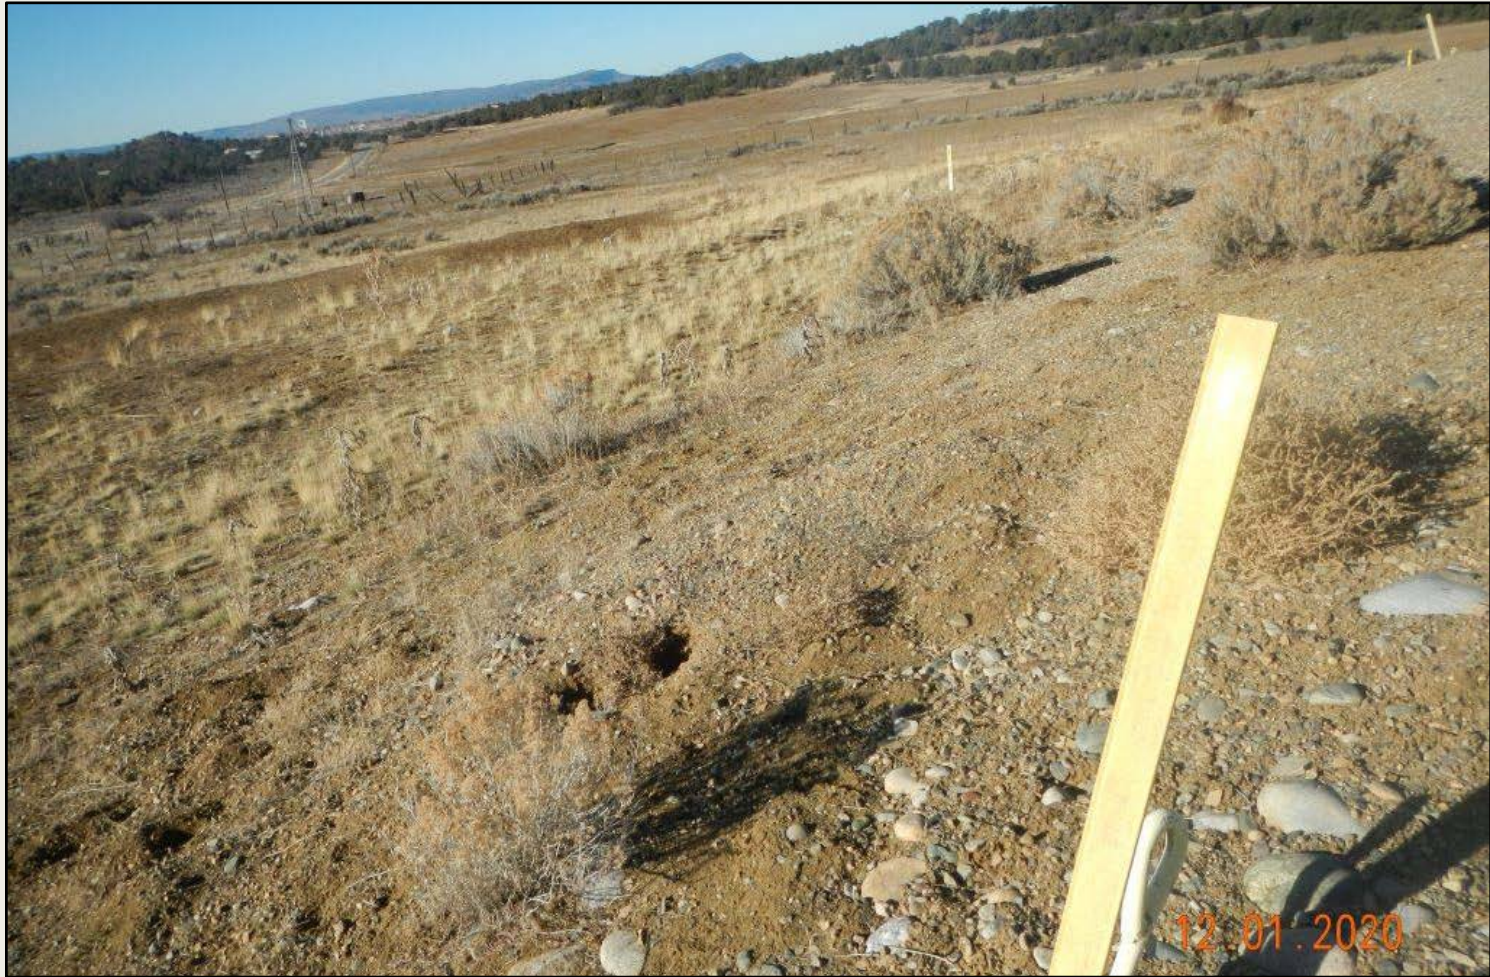
Photo 2. View of the southern project area from the southern edge of the working area, facing westward.

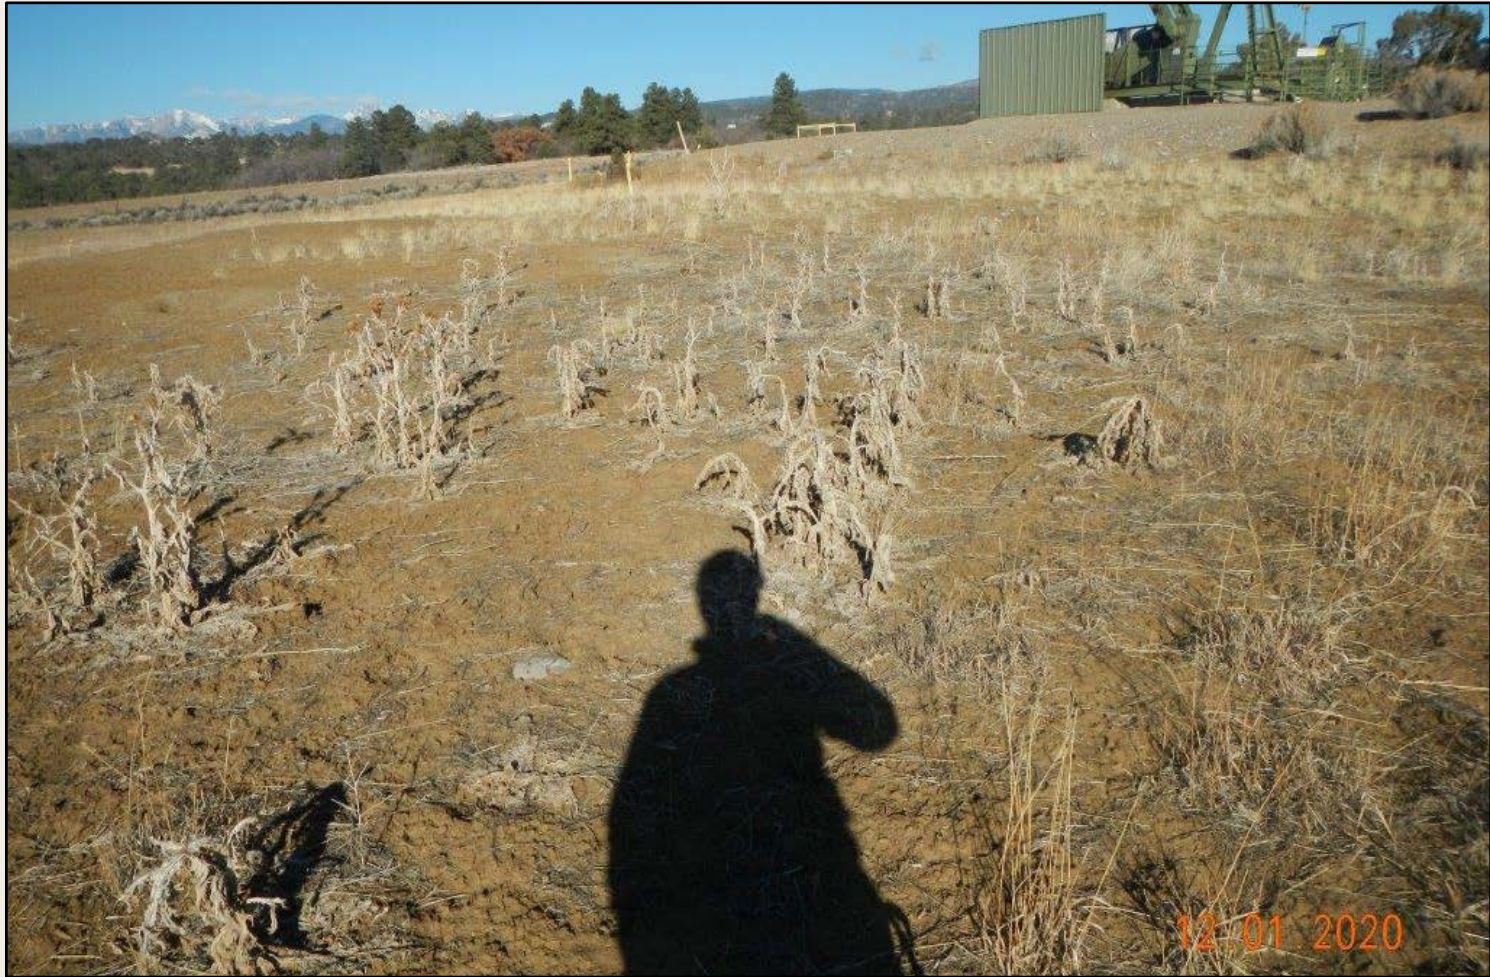
Photo 3. View of Scotch thistles in a post-flowering condition, in the southern project area. Approximately 200 individuals observed.

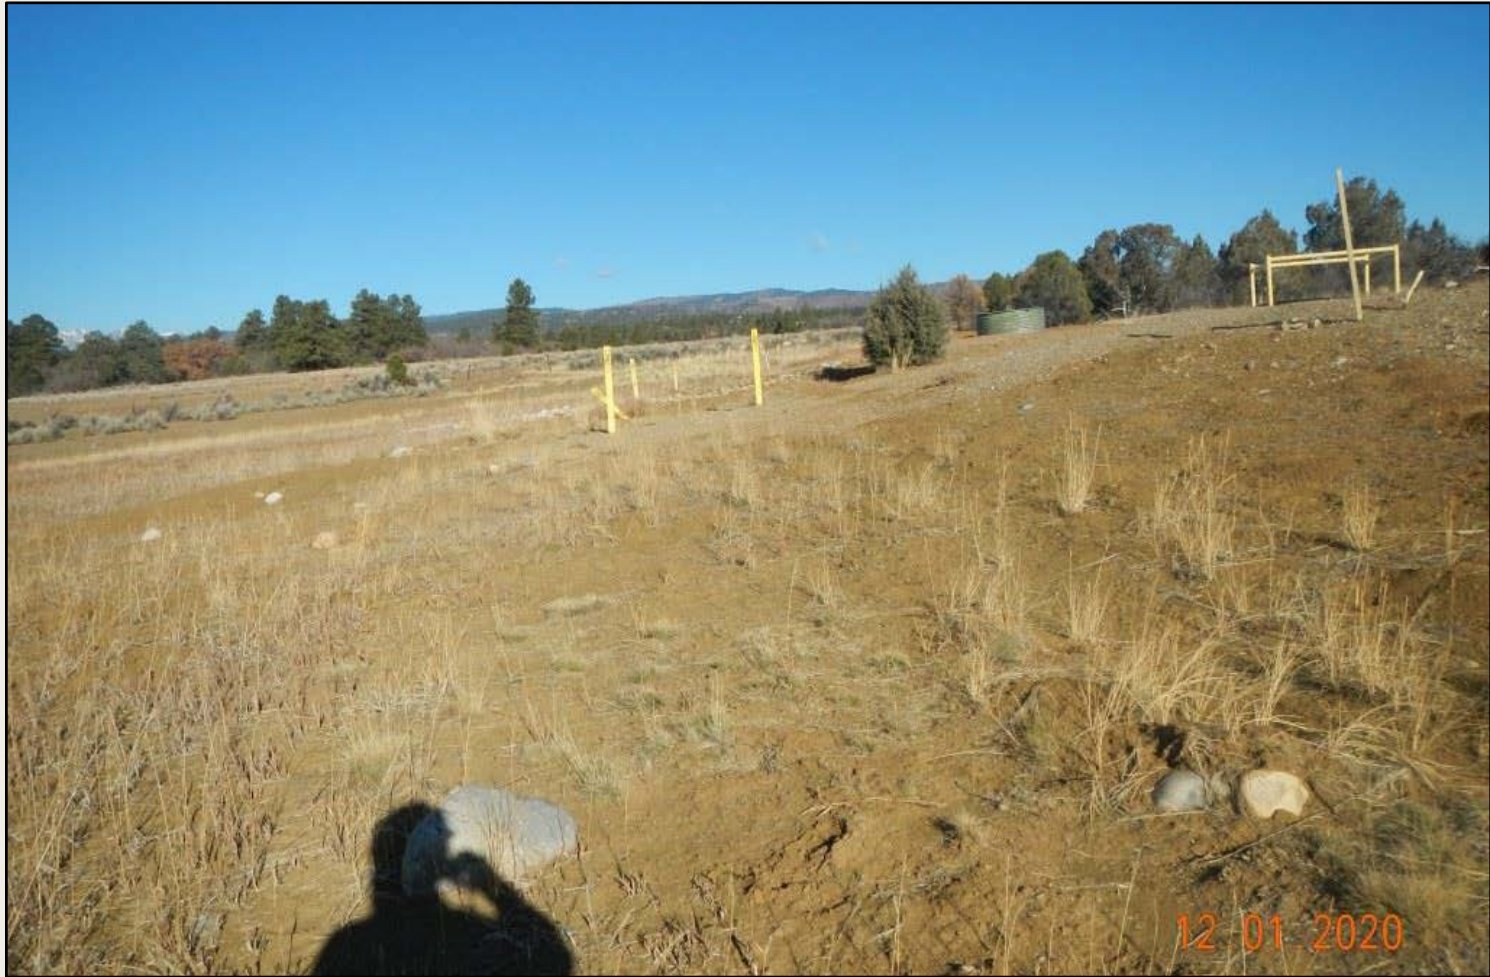
Photo 4. View of the western project area from the southwestern corner facing northward. Gravel and cobble placed where water flows off of the well pad. This will need to be monitored and maintained when erosion occurs here.

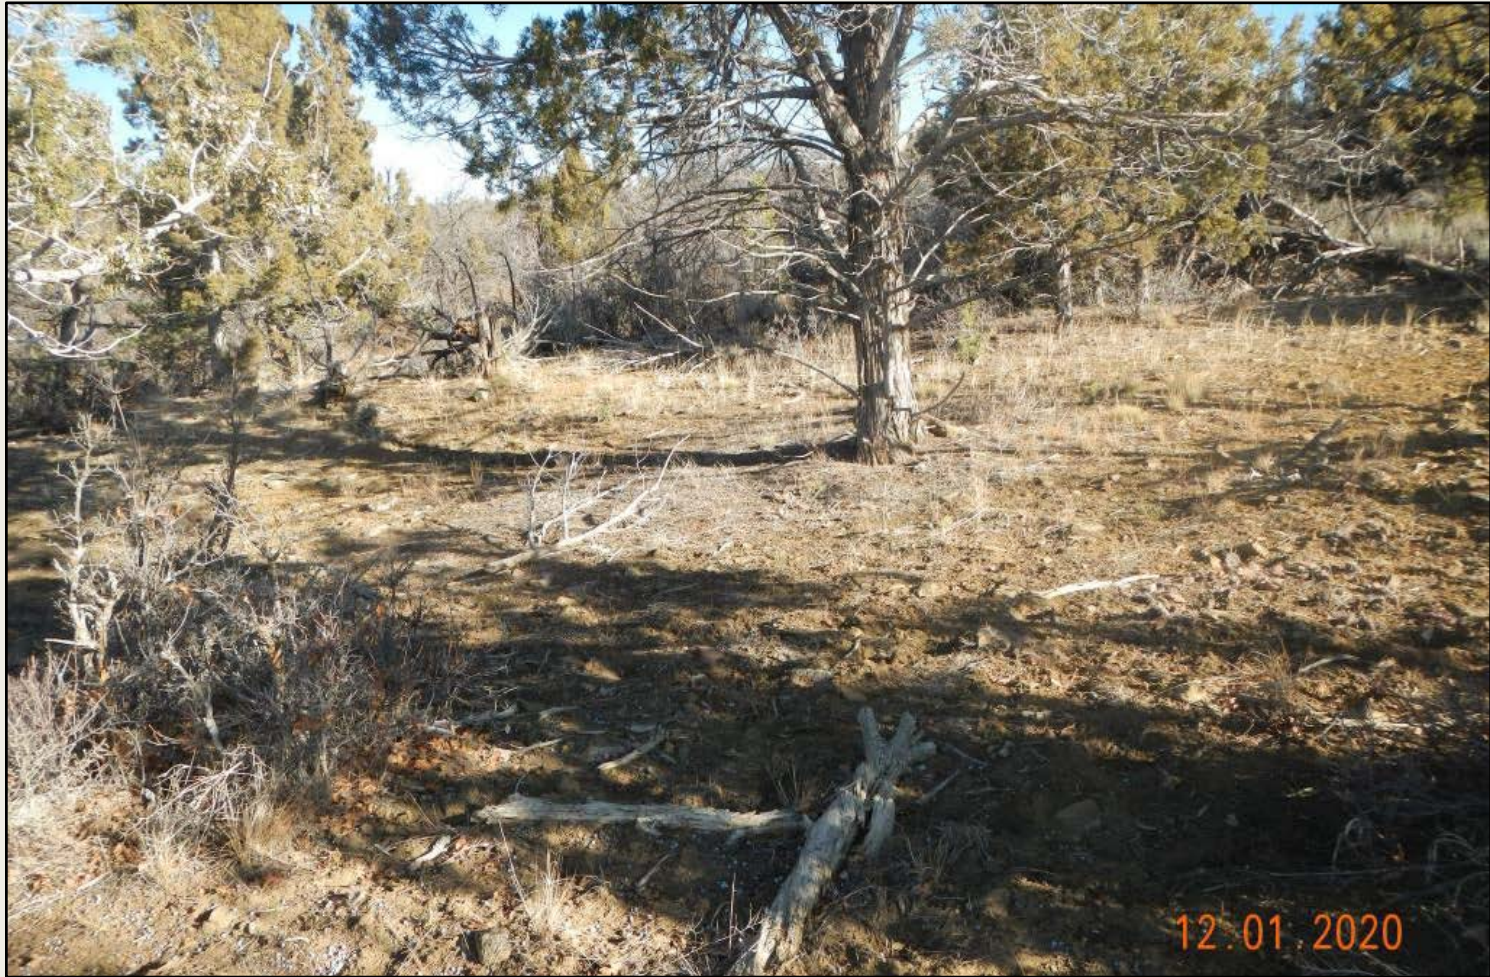
Photo 4. View of unreclaimed well pad from the southern edge facing southeastward.
