Inspection Photos

Operator: Hilcorp Energy
API: 067-09948
Date: 11/20/2020

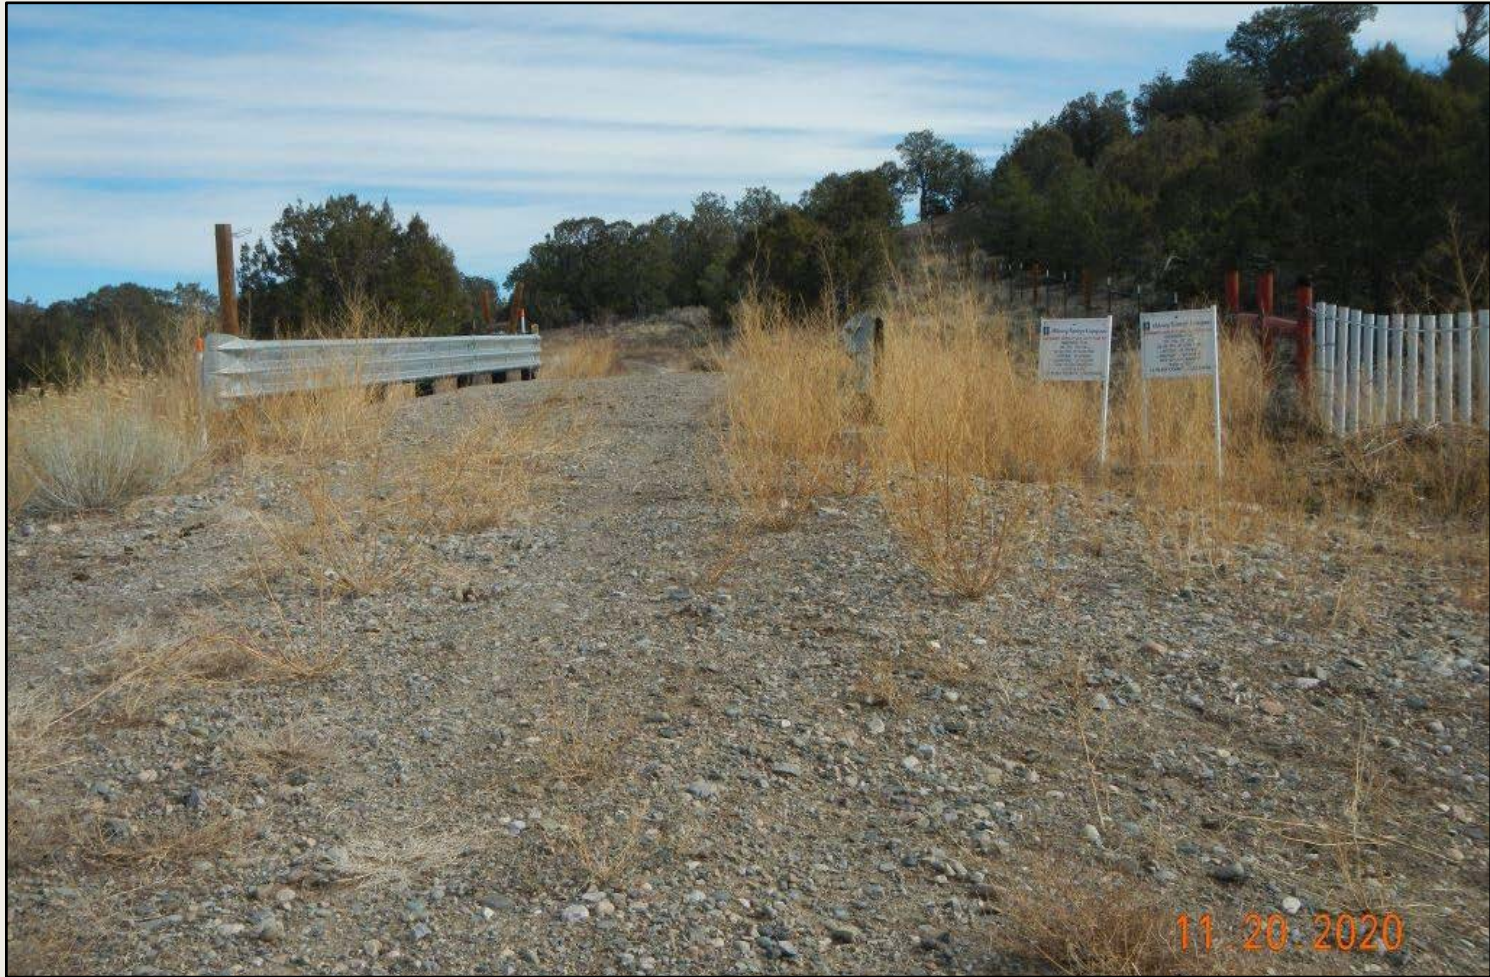
Photo 1. View of the project area from the well pad entrance facing center.

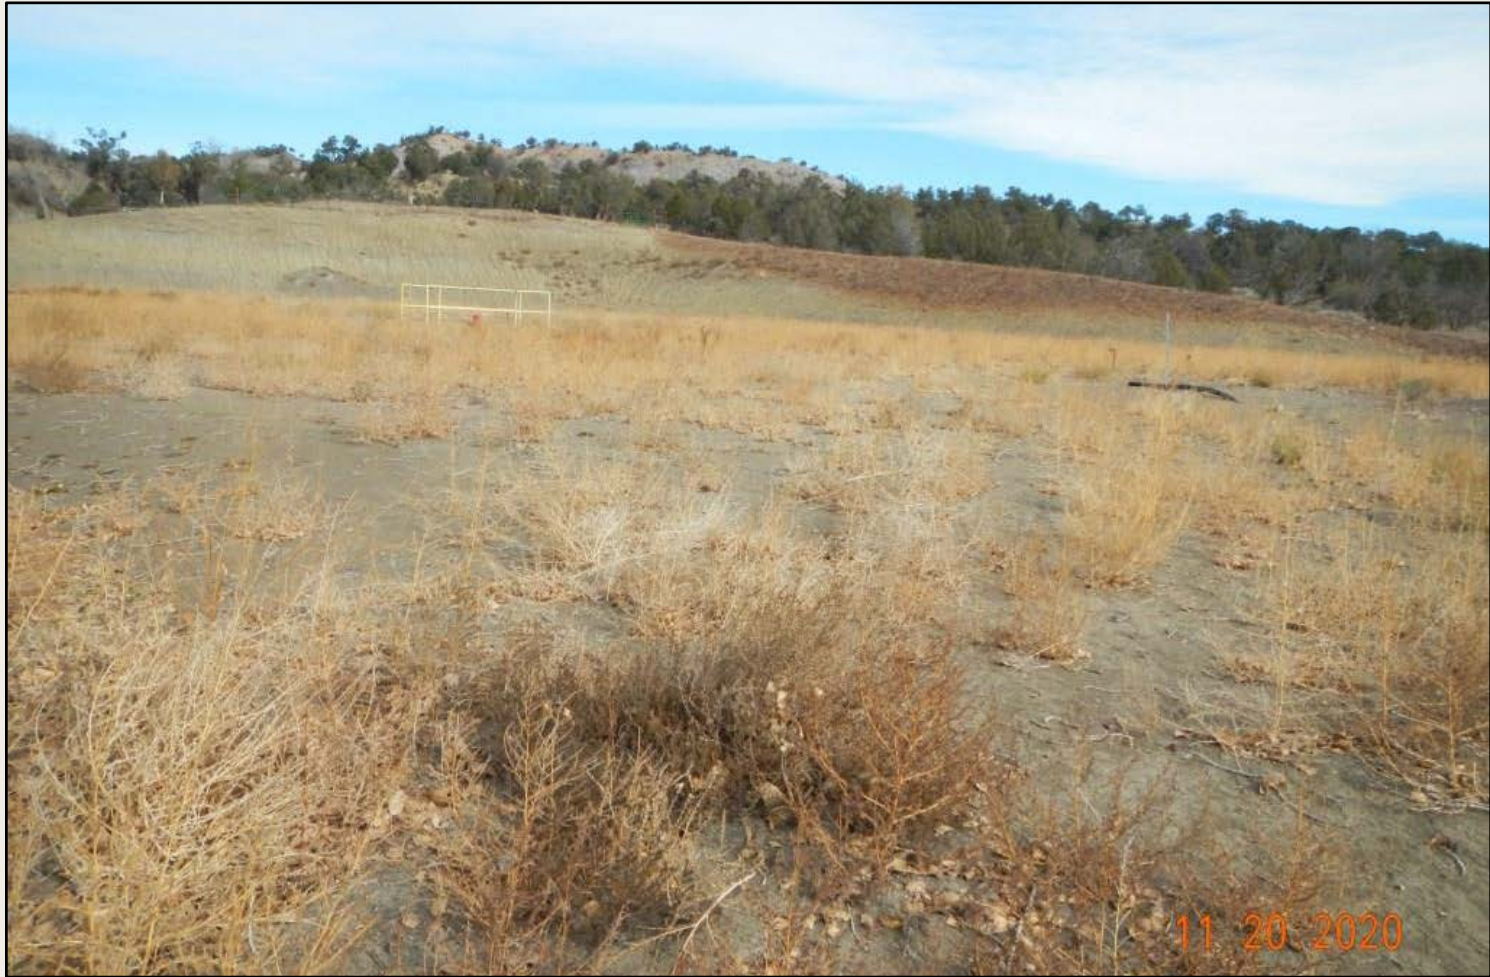
Photo 2. View of the project area from the well pad entrance facing center. Vegetation on the well pad is largely weeds such as kochia, Russian thistle, and yellow sweetclover.

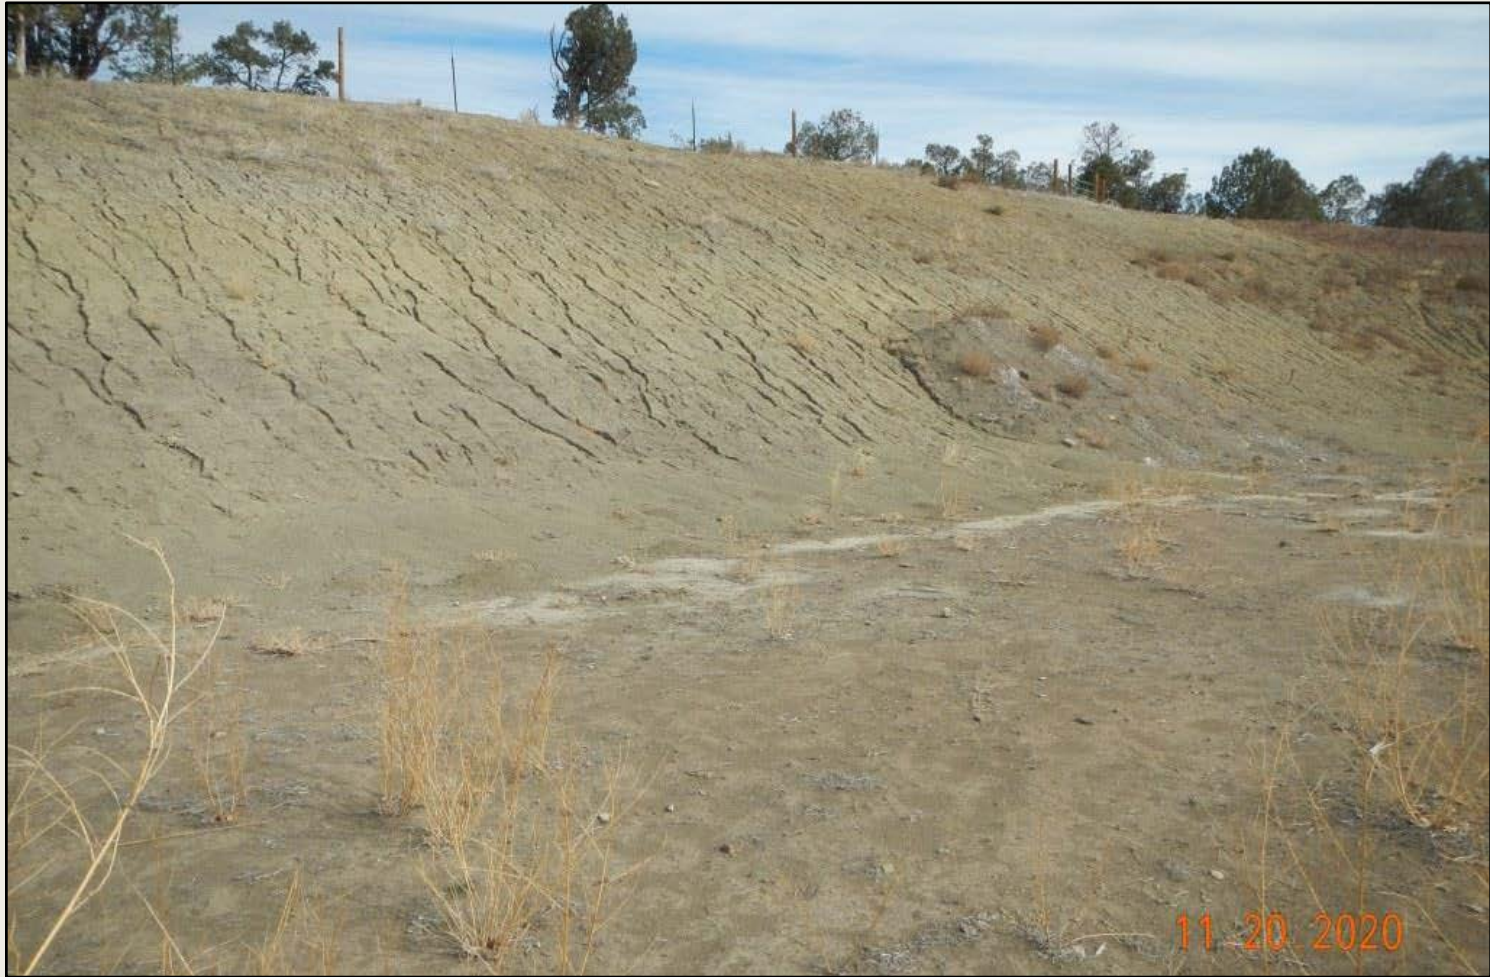
Photo 3. View of the northern project area from the northeastern corner facing westward. Cut slope is largely bare and rapidly eroding.

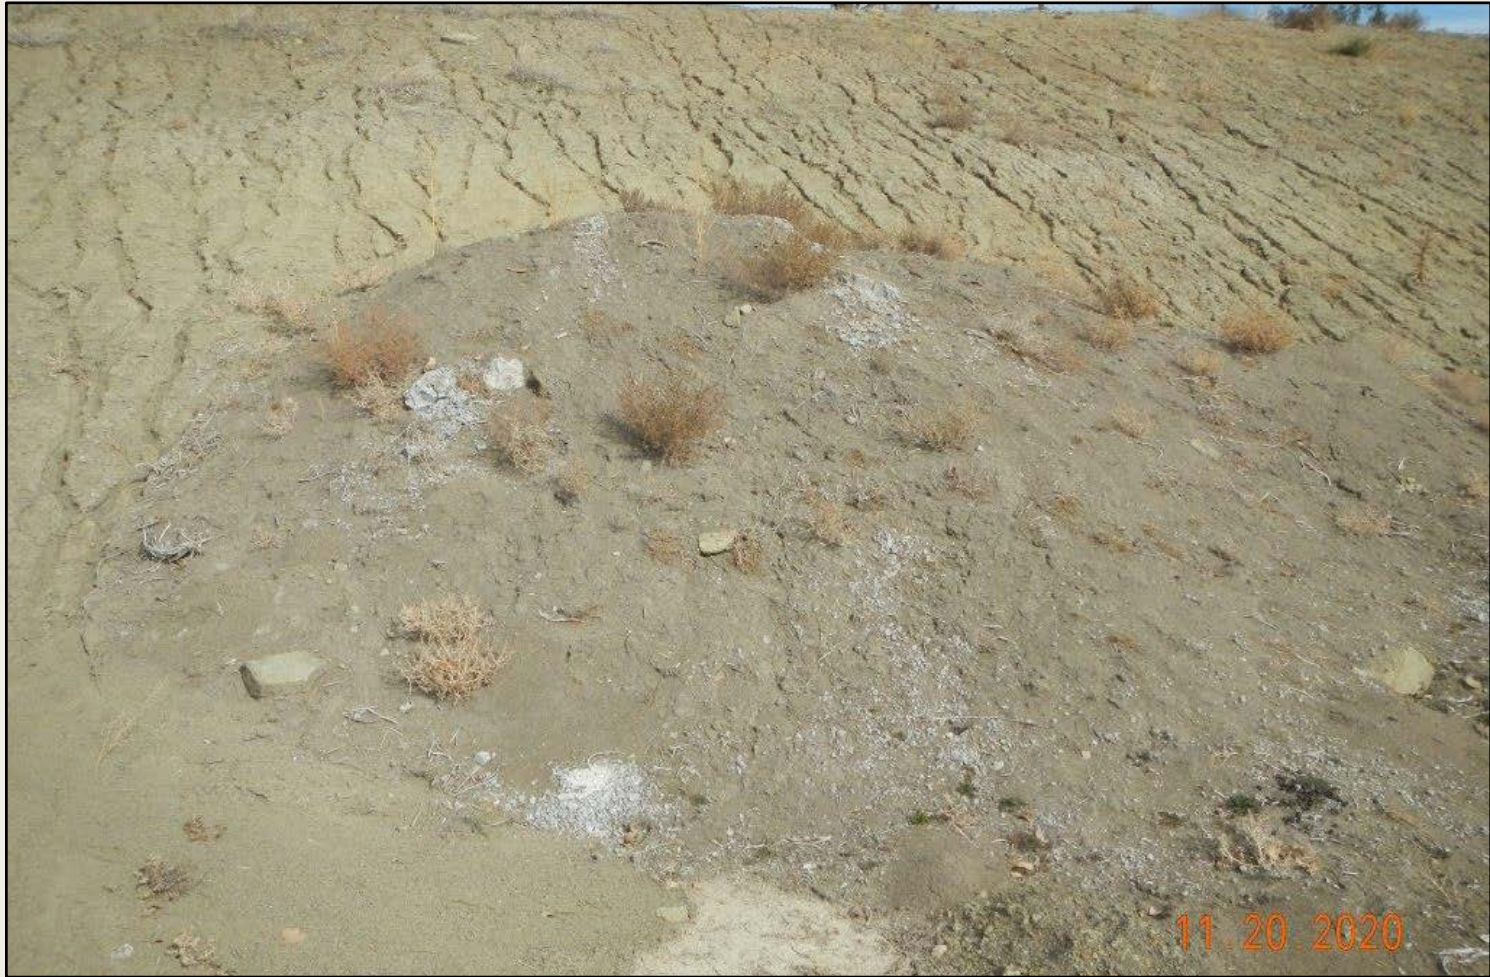
Photo 4. View of unknown soil material that appears to be cuttings, placed at the base of the cut-slope.

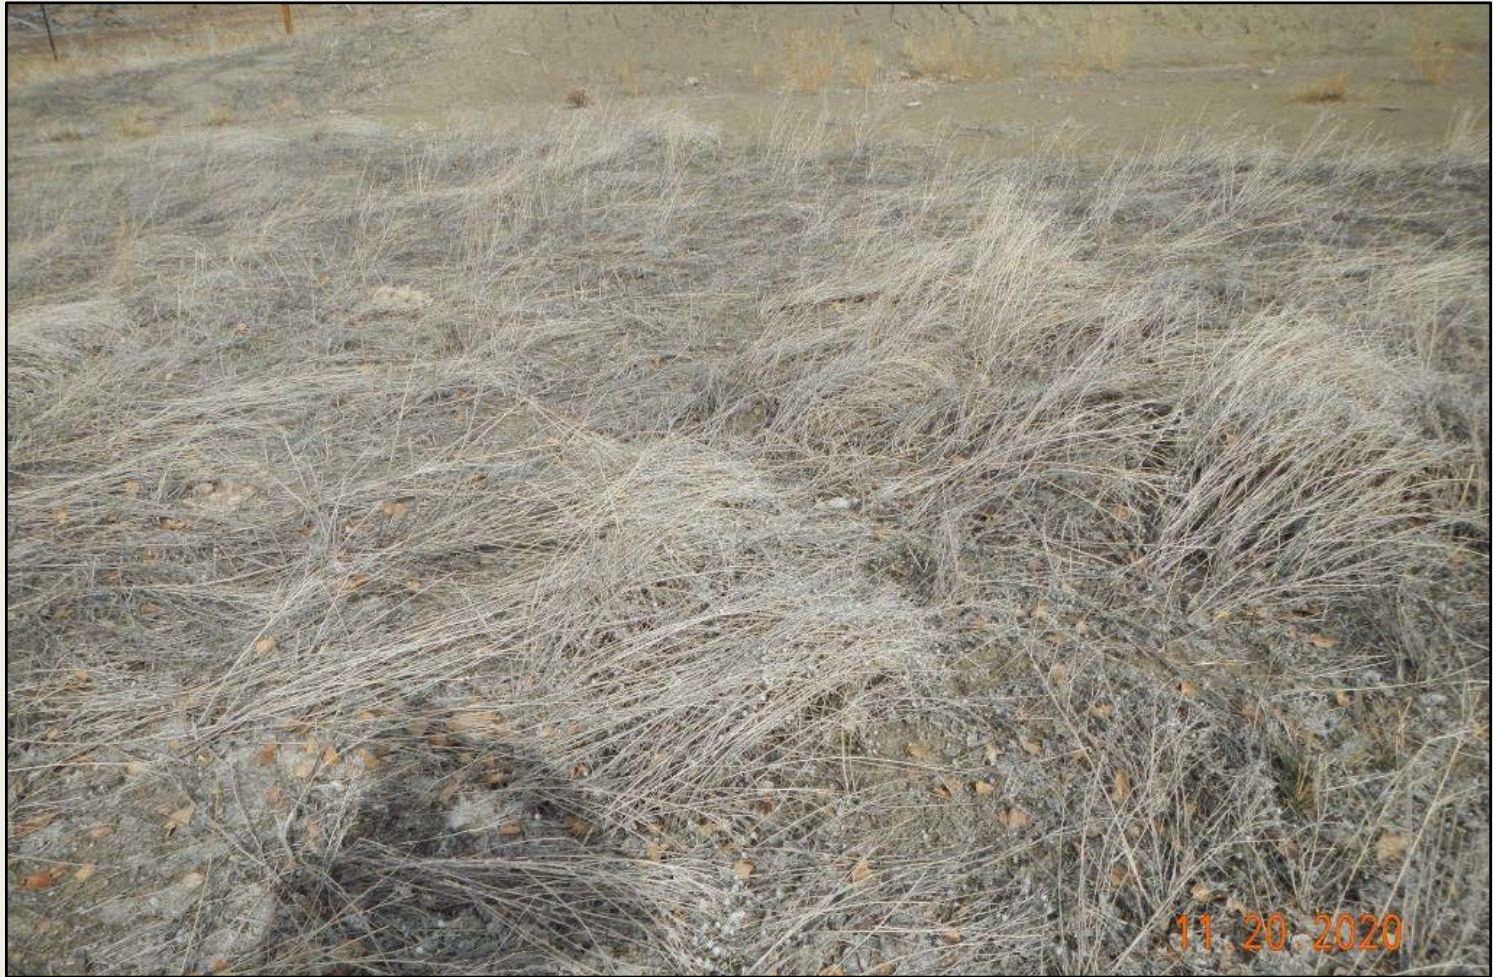
Photo 5. View of dense Russian knapweeds in a dormant vegetative condition, within the northwestern portion of the well pad. 1000s of individuals observed.

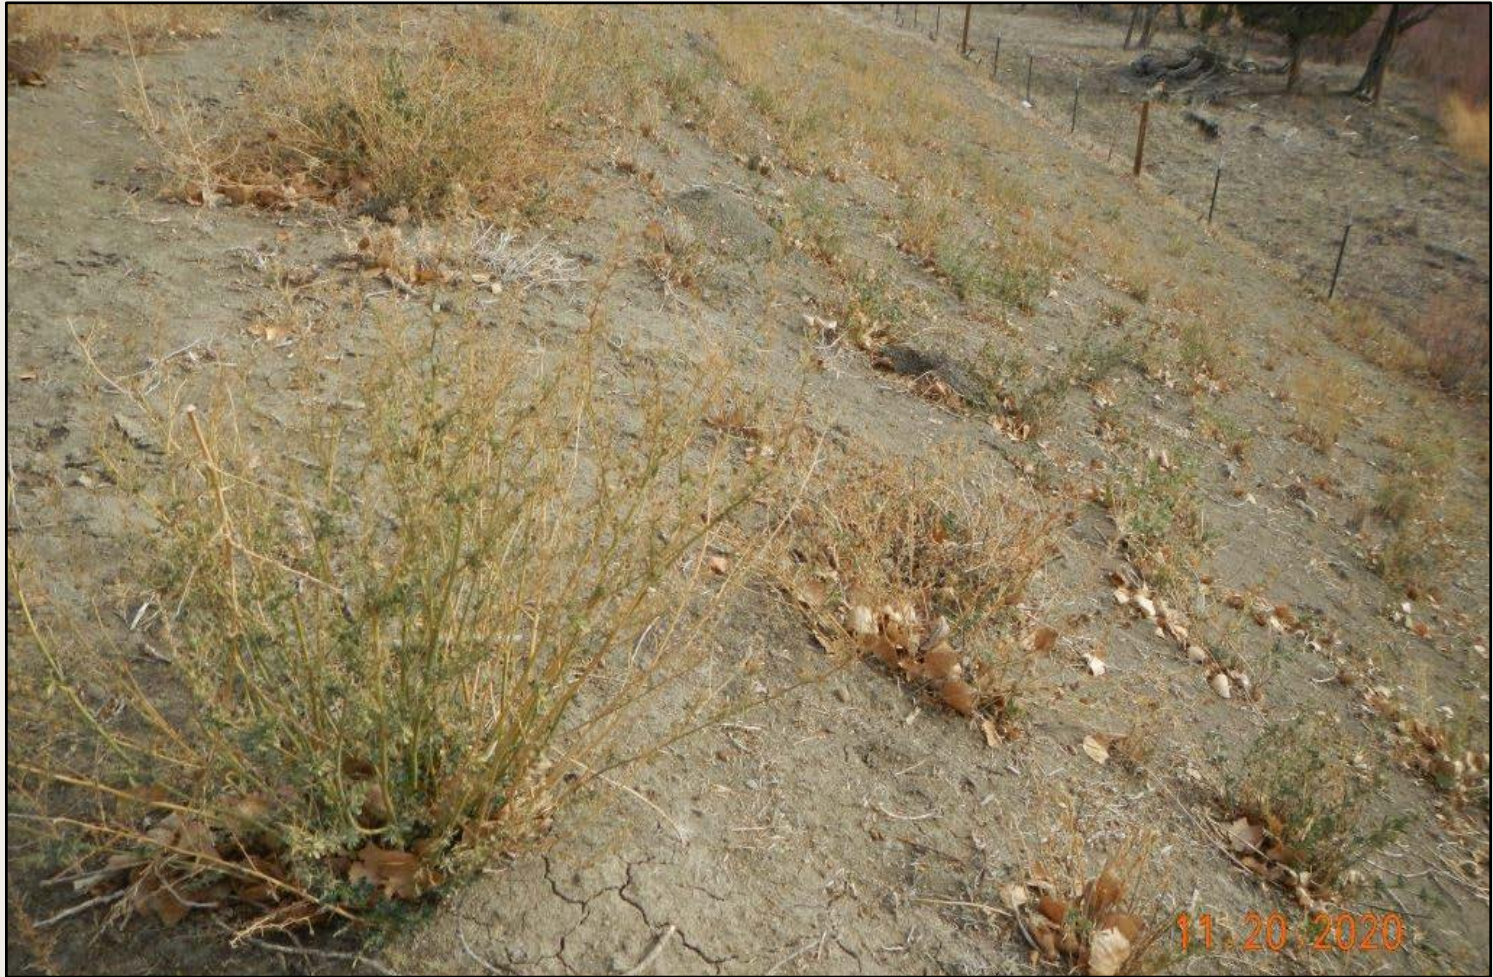
Photo 6. View of southern project area sparsely vegetated with alfalfa.

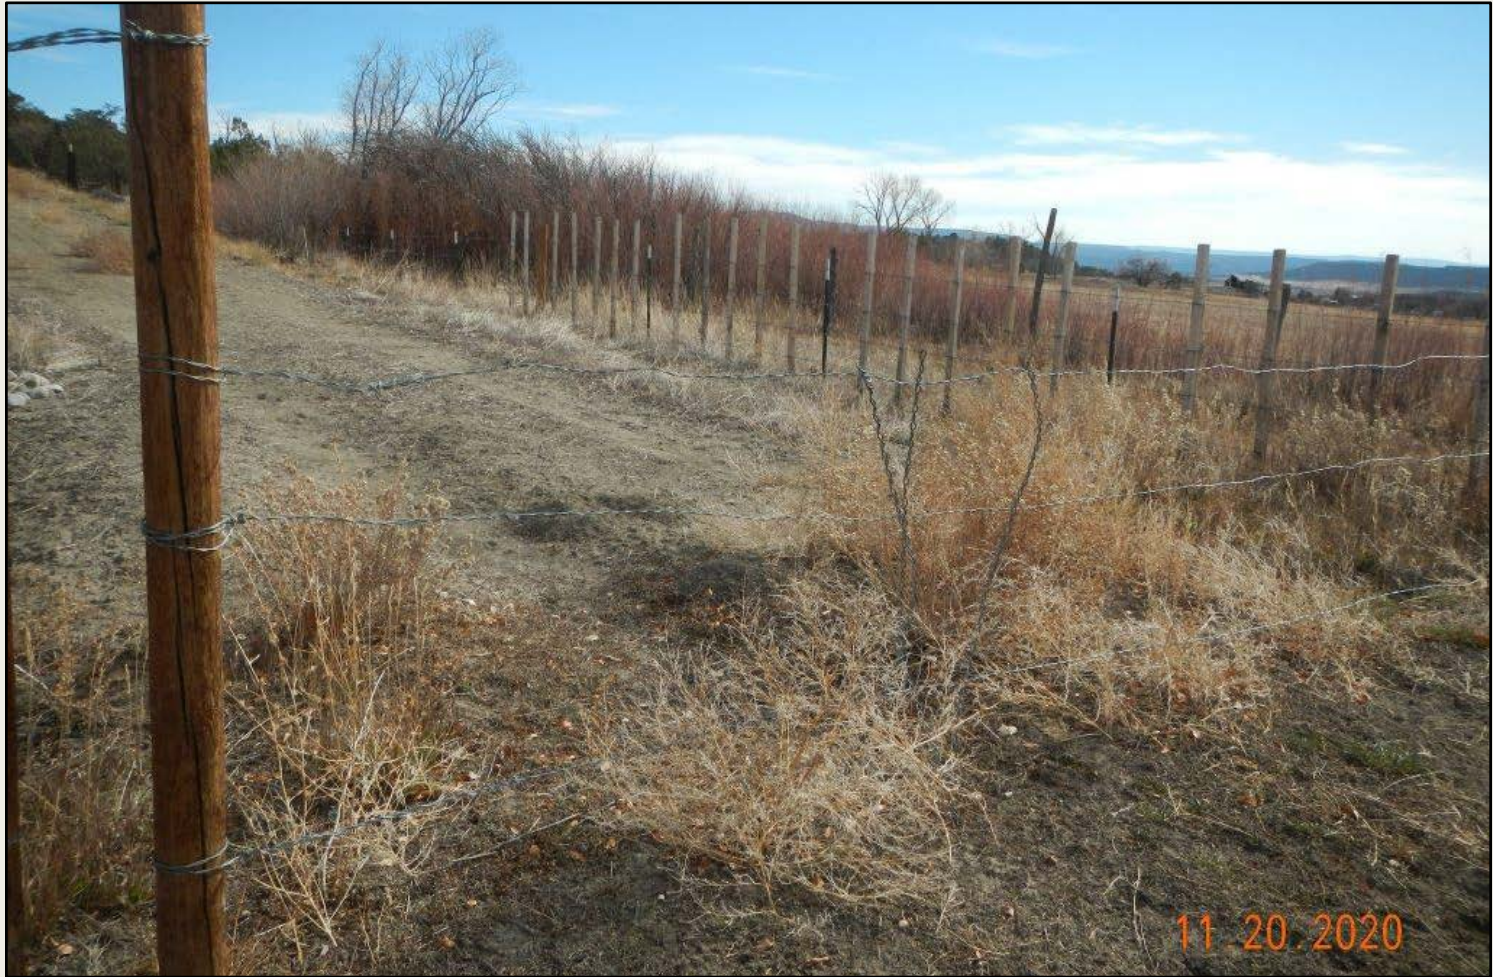
Photo 7. View of wired gate near entrance to project area.

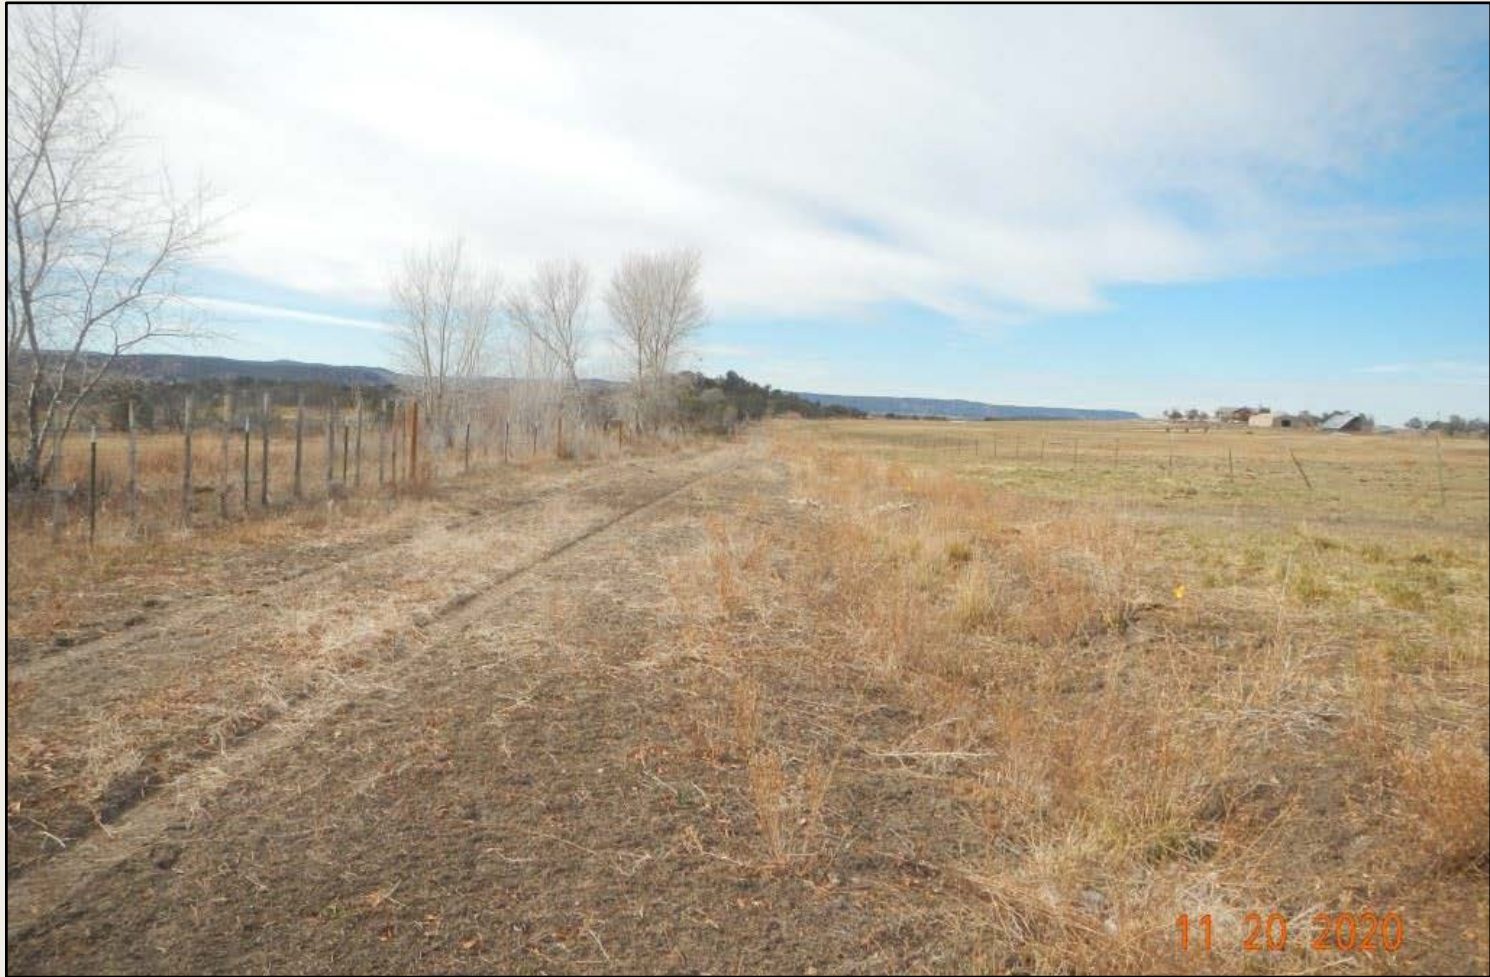
Photo 8. View of access road facing westward. Little use of road observed.

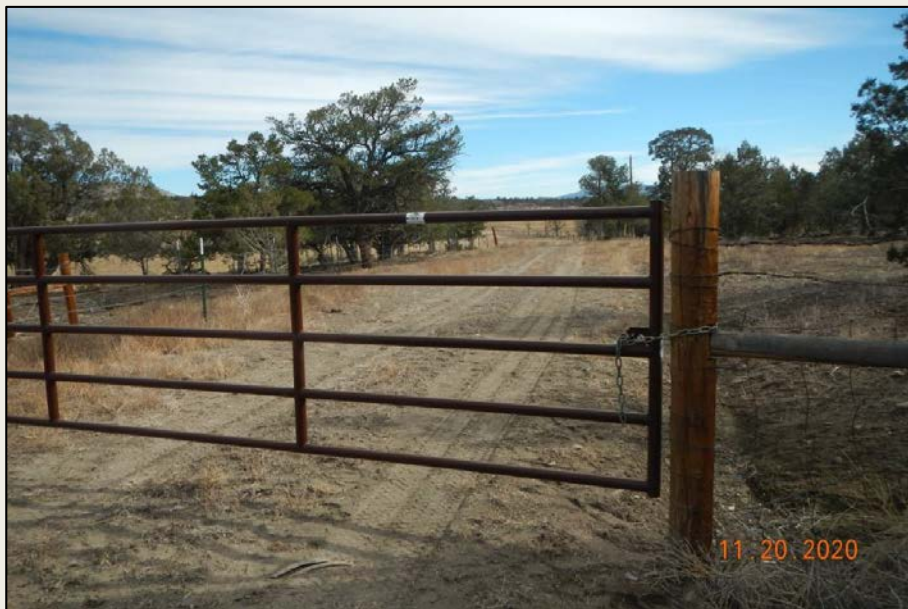
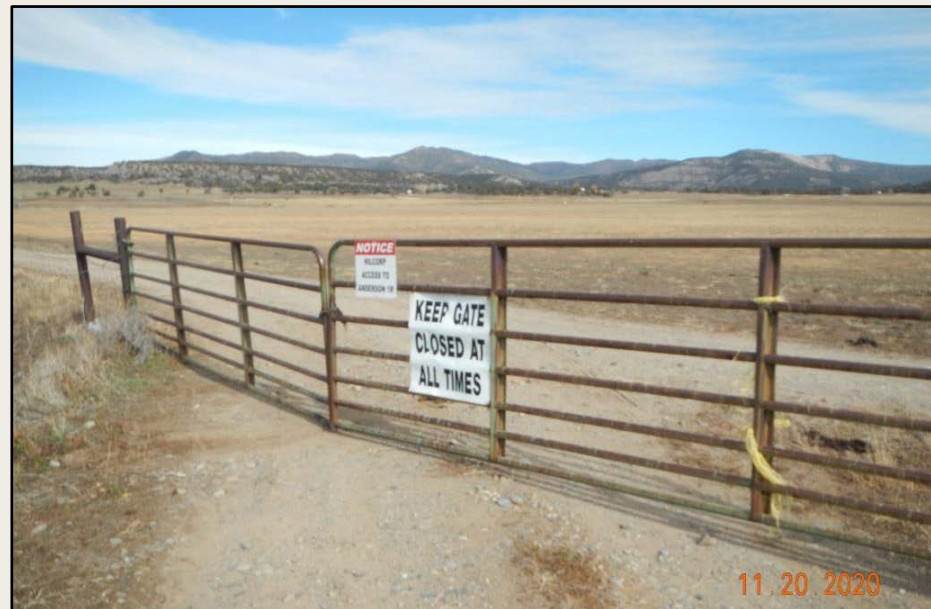
Photo 9/10. View of closed gates after leaving location.
