**Inspection Photos**  
**Operator: Hilcorp Energy**  
**API: 067-09084**  
**Date: 11/20/2020**

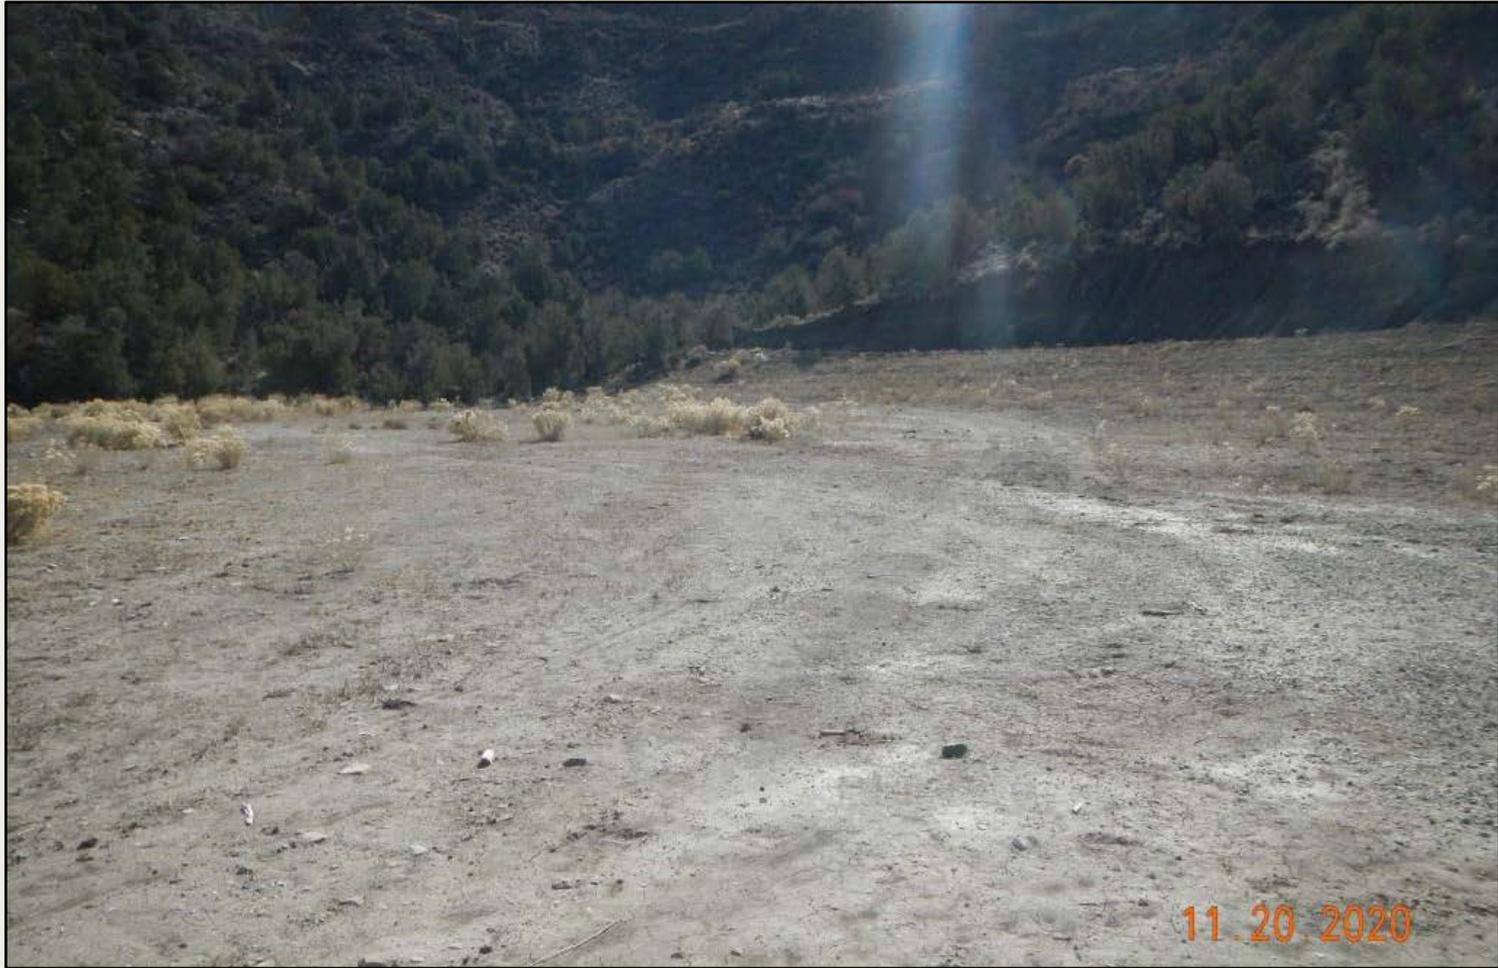
Photo 1. View of the project area from the well pad entrance facing center. Reclamation is not conducted.

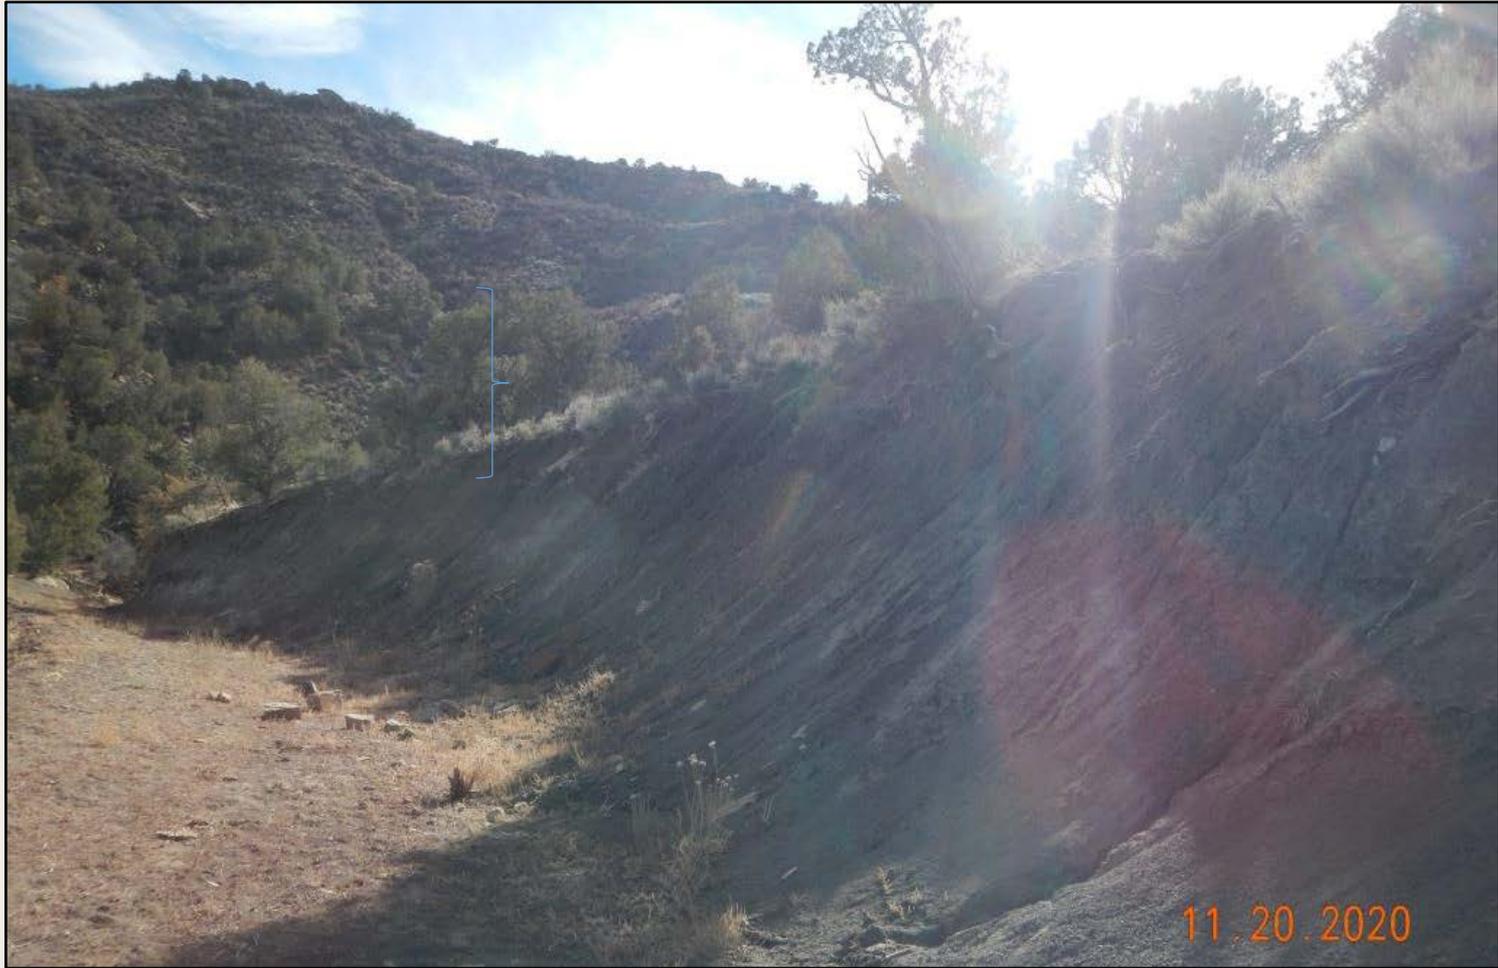
Photo 2. View of eroding cut-slope within the southern project area. Erosional channels, exposed roots, and sediment plumes observed.

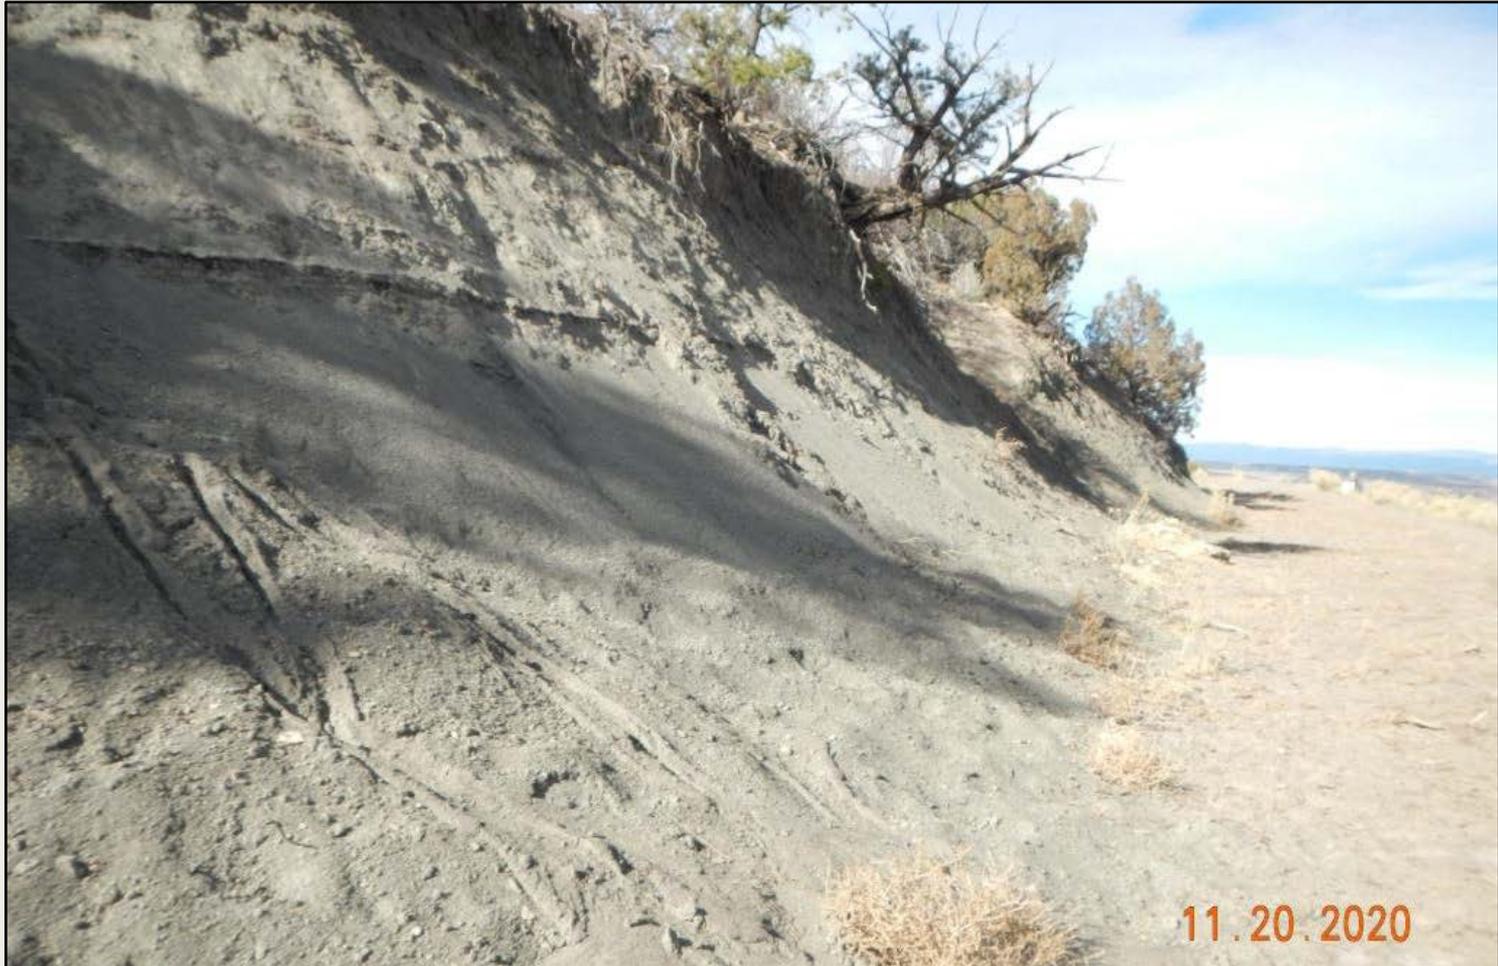
Photo 3. Another view of eroding cut-slope within the southern project area.

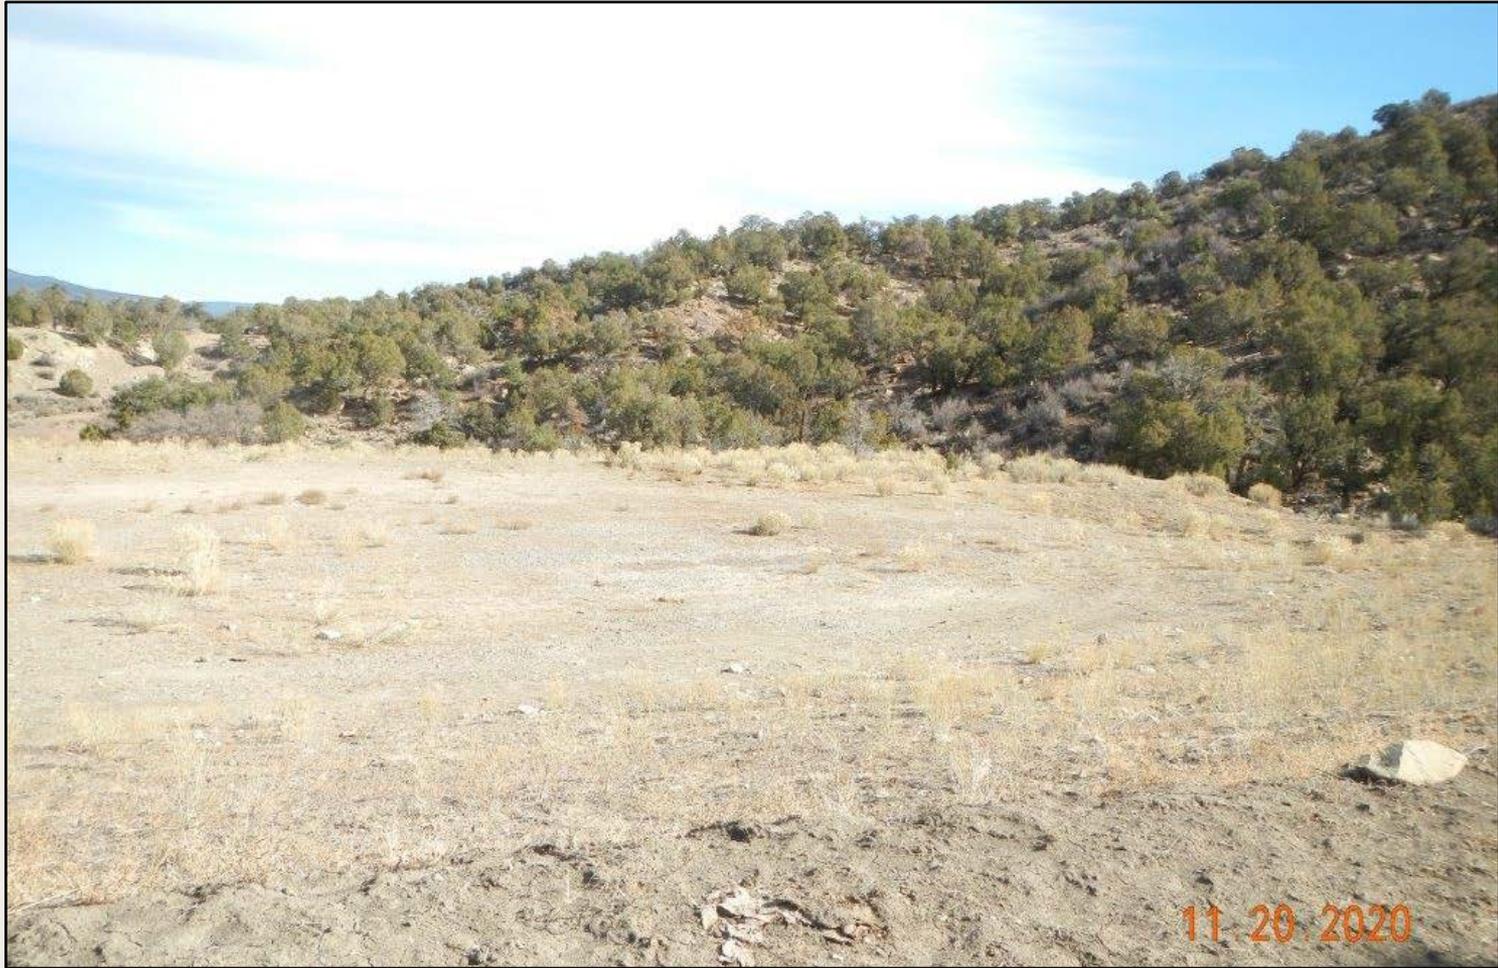
Photo 4. View of unreclaimed well pad from the southern edge facing southeastward.
