Inspection Photos

12/1/2020

Operator: RIO MESA RESOURCES INC - 74740

Location ID: 398846

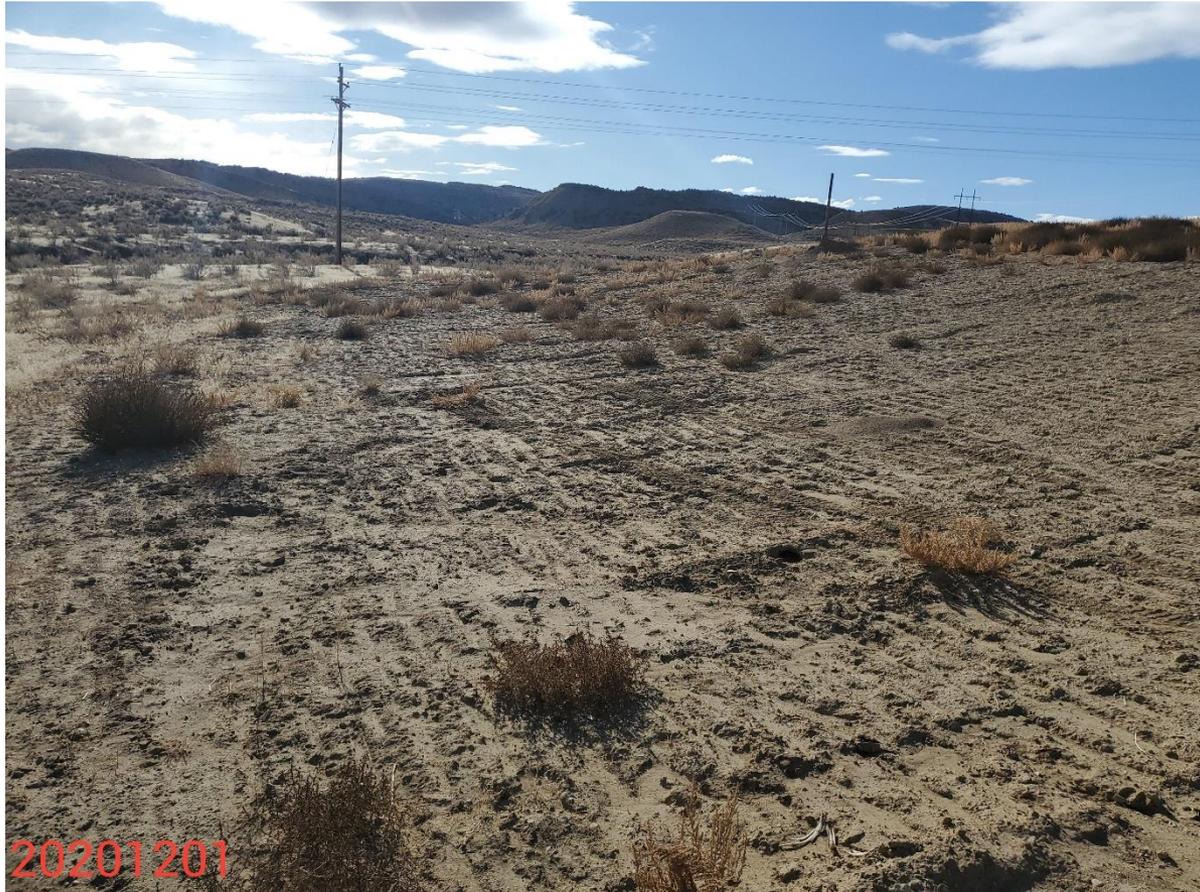
Photo 1: Photo taken from the east end of the Location. Photo provides an overview of the Location. Photo also shows vehicle tracks evident over the reclamation area.

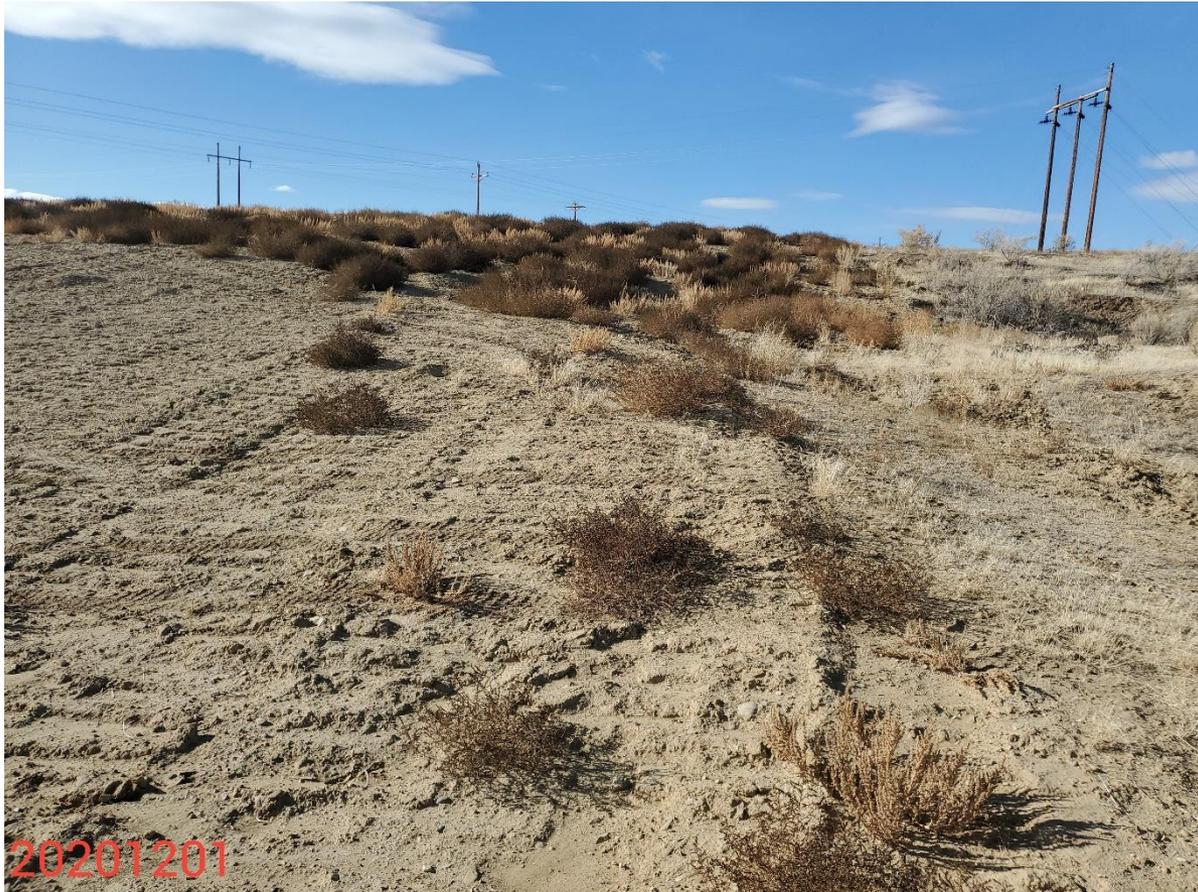
Photo 2: Photo taken from the east end of the Location. Photo provides an overview of the Location. Photo also shows dense weed establishment on the Location.

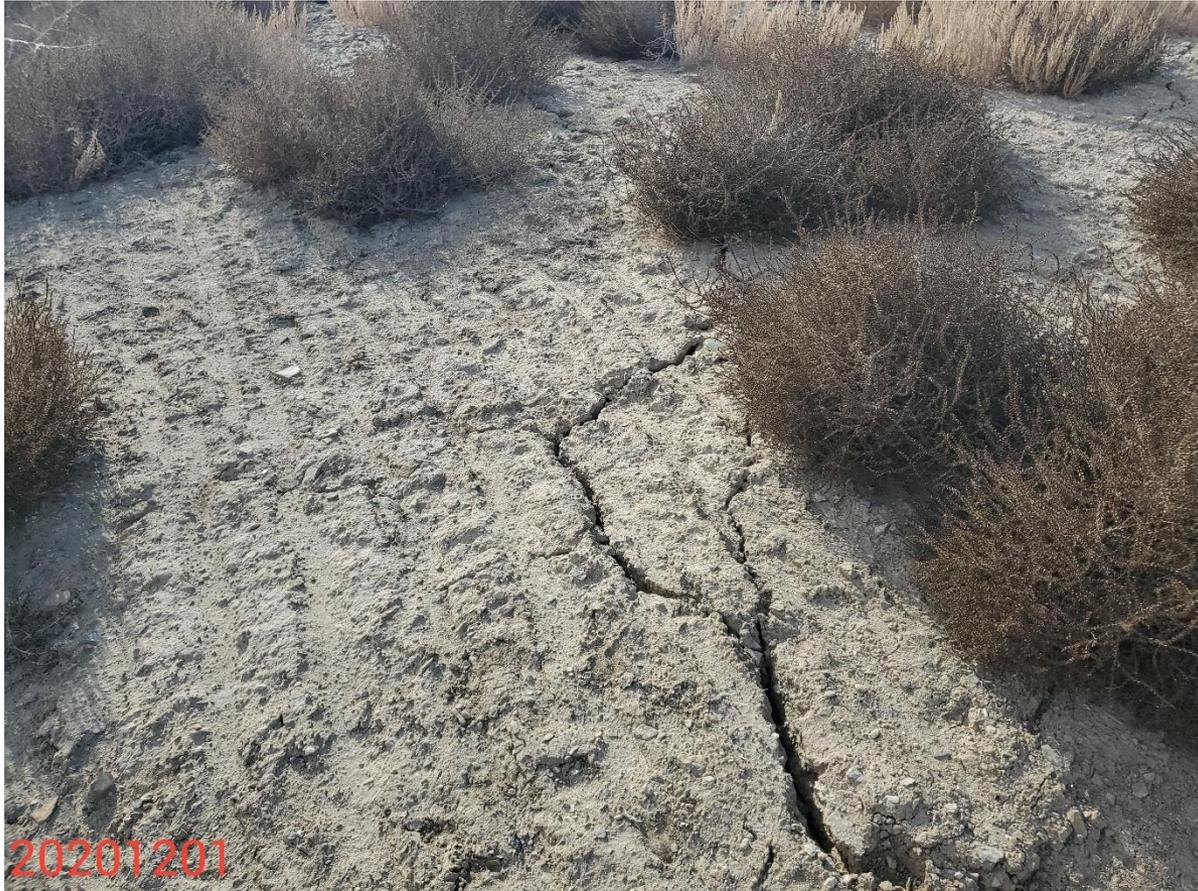
Photo 3: Photo taken from the Location. Previous inspections observed that Operator has installed tracking on the slopes of the pad; Vertical tracking is a temporary erosion control with an approximate lifespan of 2 weeks to a month, and should be used in conjunction with other BMPs. Photo shows that no additional BMPs have been used in conjunction with the vertical tracking, and cracking/rilling now evident.

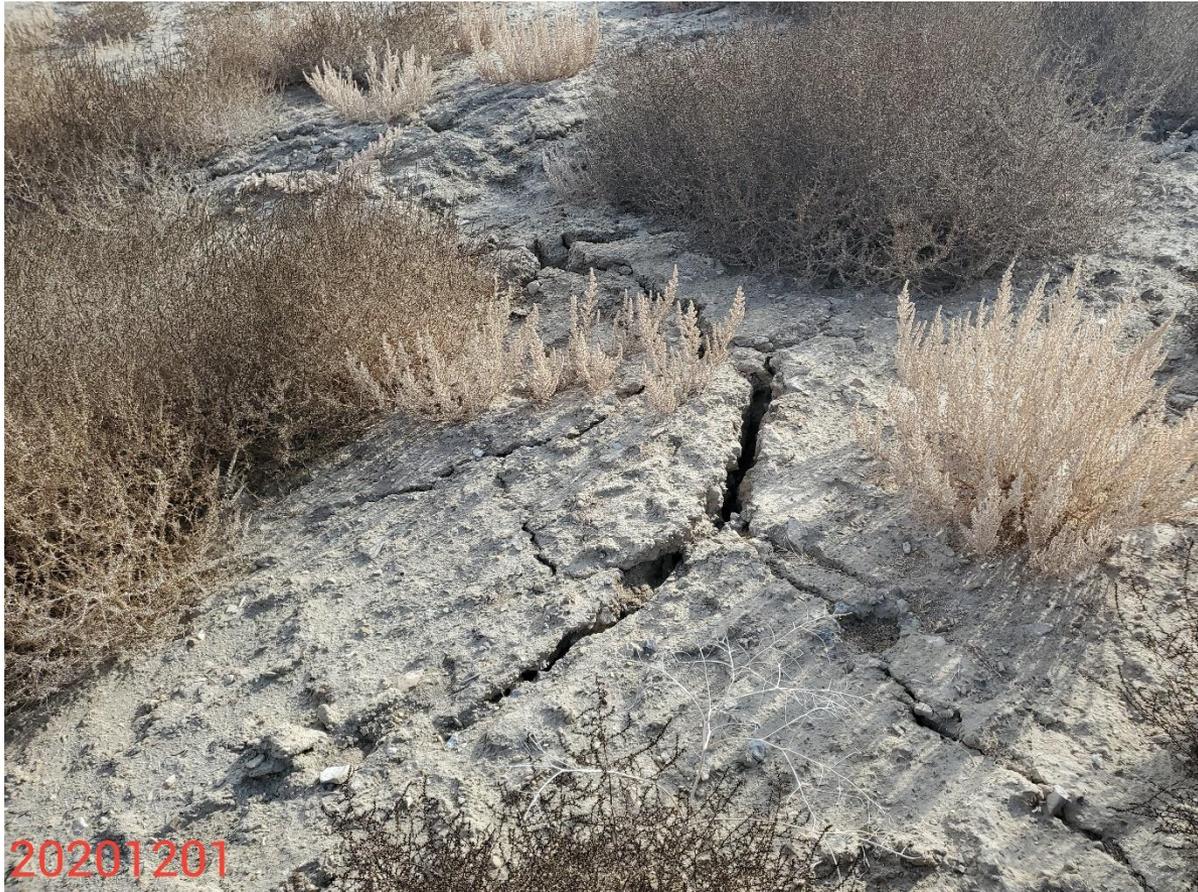
Photo 4: See comments under photo 3.

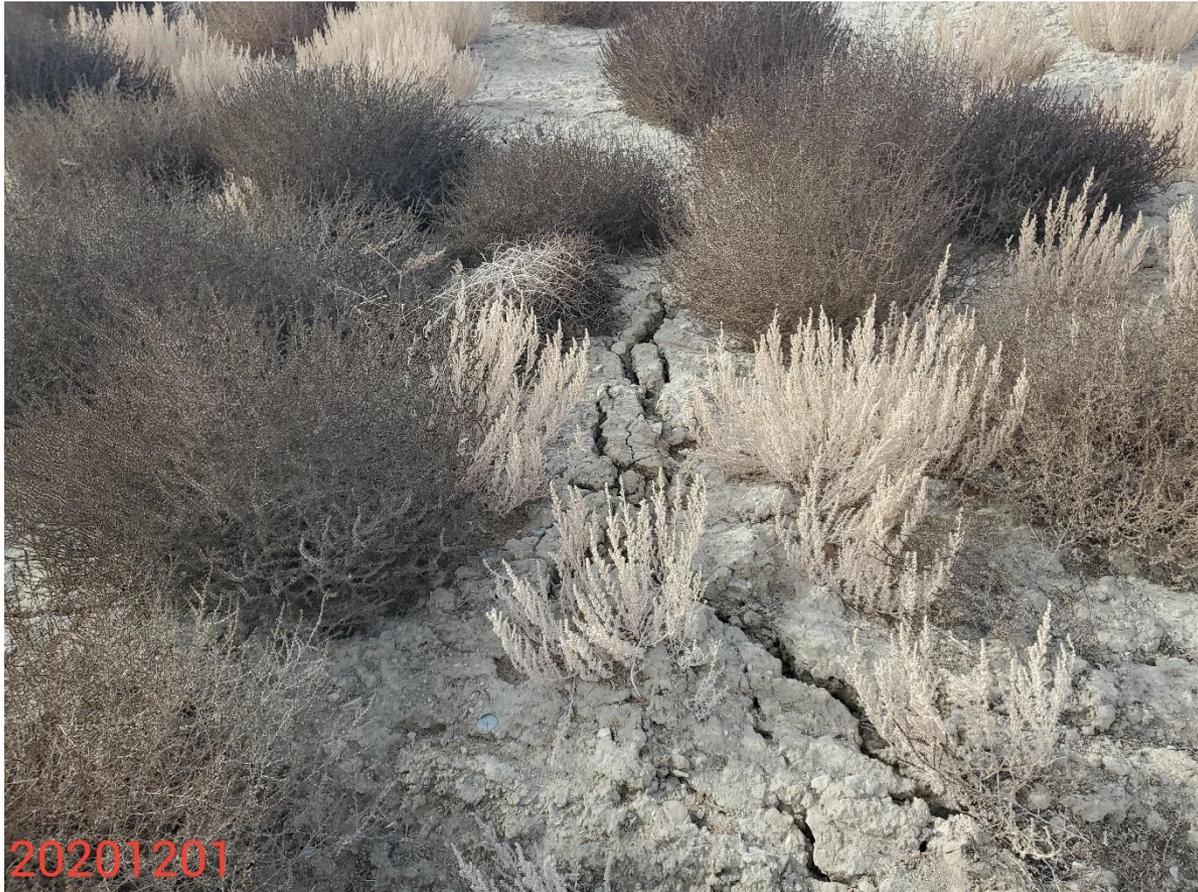
Photo 5: See comments under photo 3.

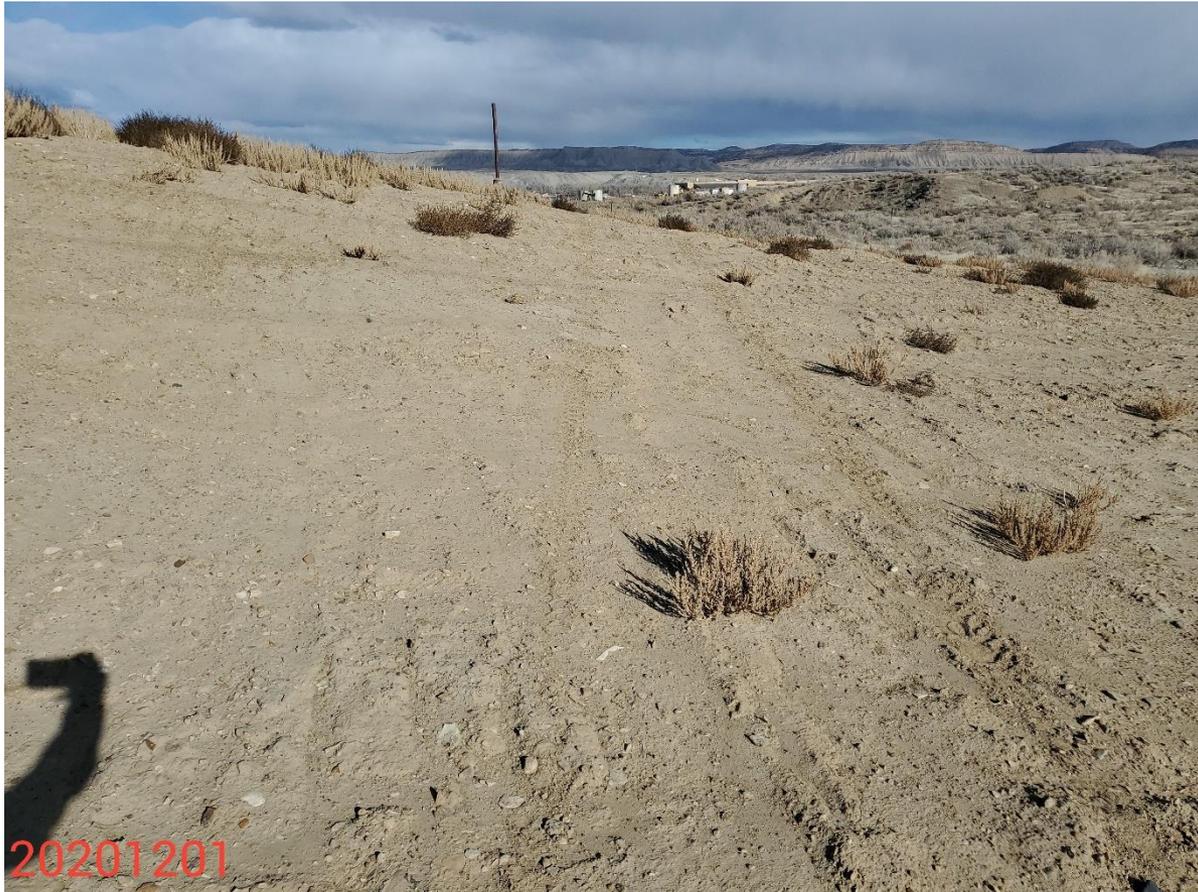
Photo 6: Photo taken from the Location. Photo shows vehicle travel on the reclamation area evident. Continued vehicle travel on Location not conducive to reclamation and may result in additional reclamation work required in order for site to meet 1004 standards.

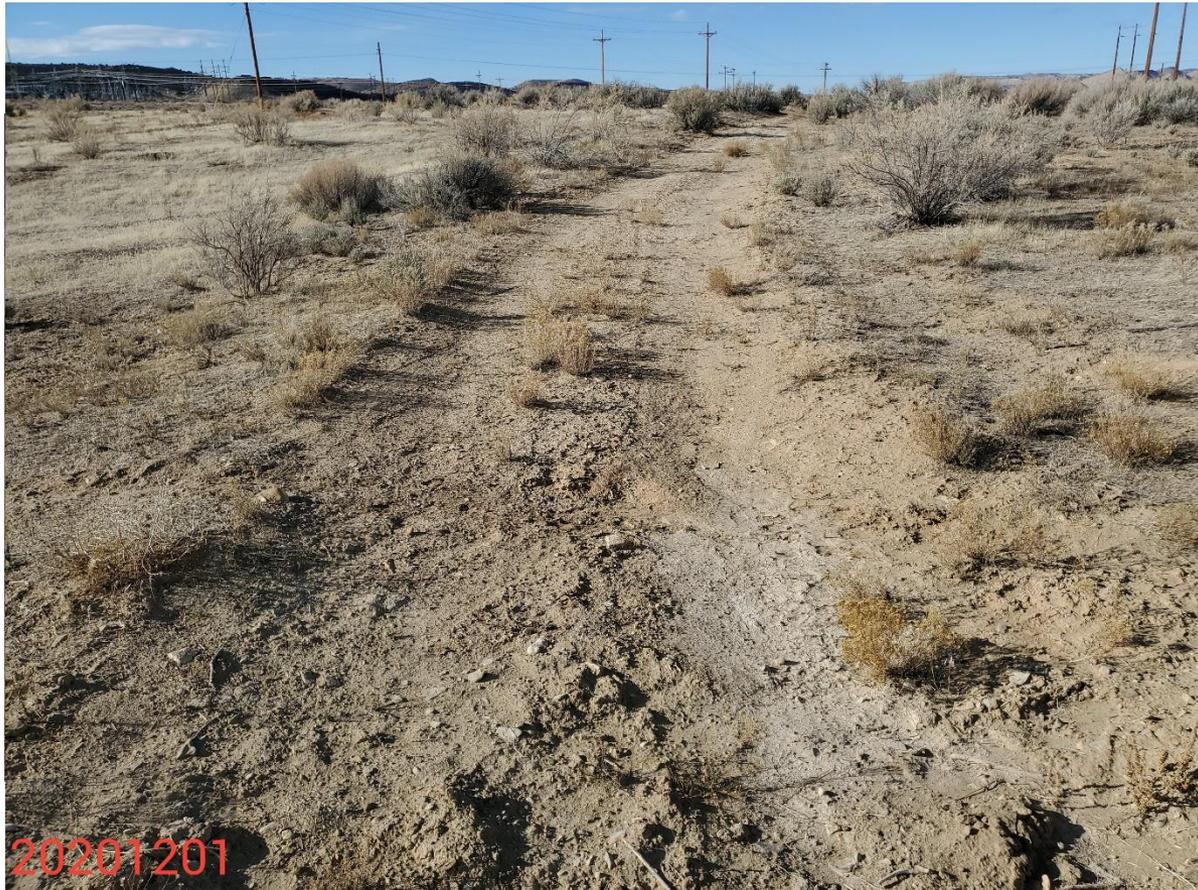
Photo 7: Photo shows access road west of the Location. Reclamation activities pursuant to Rule 1004.a has not been conducted including compaction alleviation.

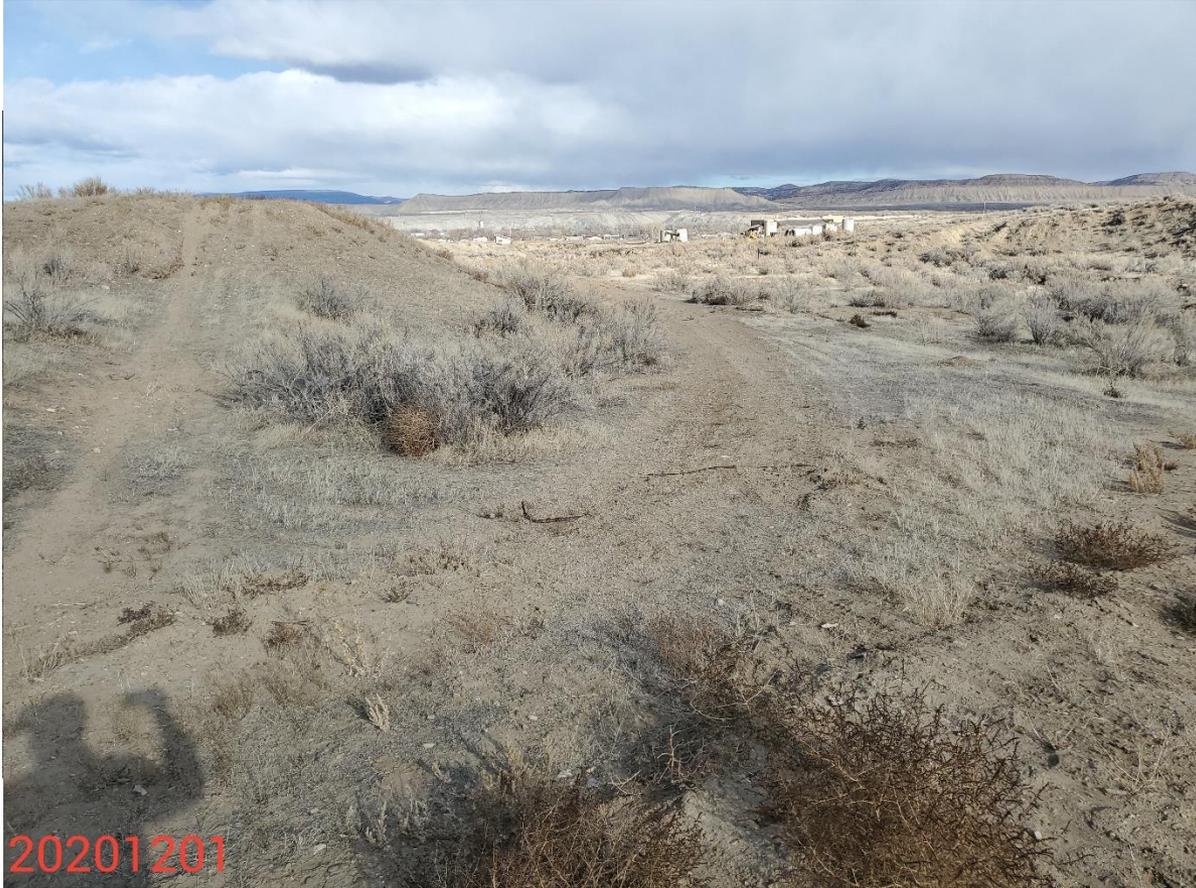
Photo 8: Photo shows access road north of the Location. Reclamation activities pursuant to Rule 1004.a has not been conducted including compaction alleviation.

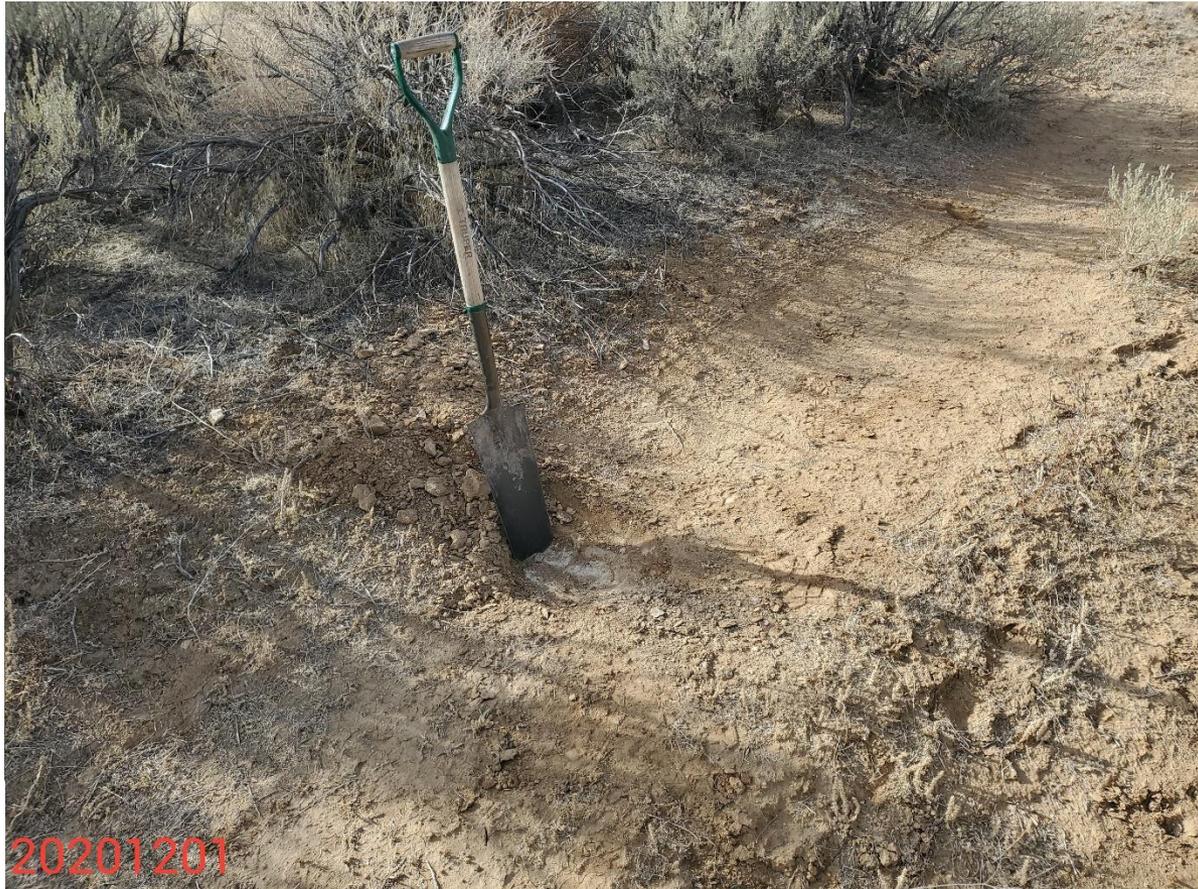
Photo 9: Photo taken from the access road. Photo shows a test pit on the access road to determine compliance with compaction alleviation requirements. Soils at the surface was fairly loose and easy to penetrate. Compaction zones were encountered ~2-3 inches subsurface. Reclamation of the access road has not been conducted in accordance with 1004 requirements.

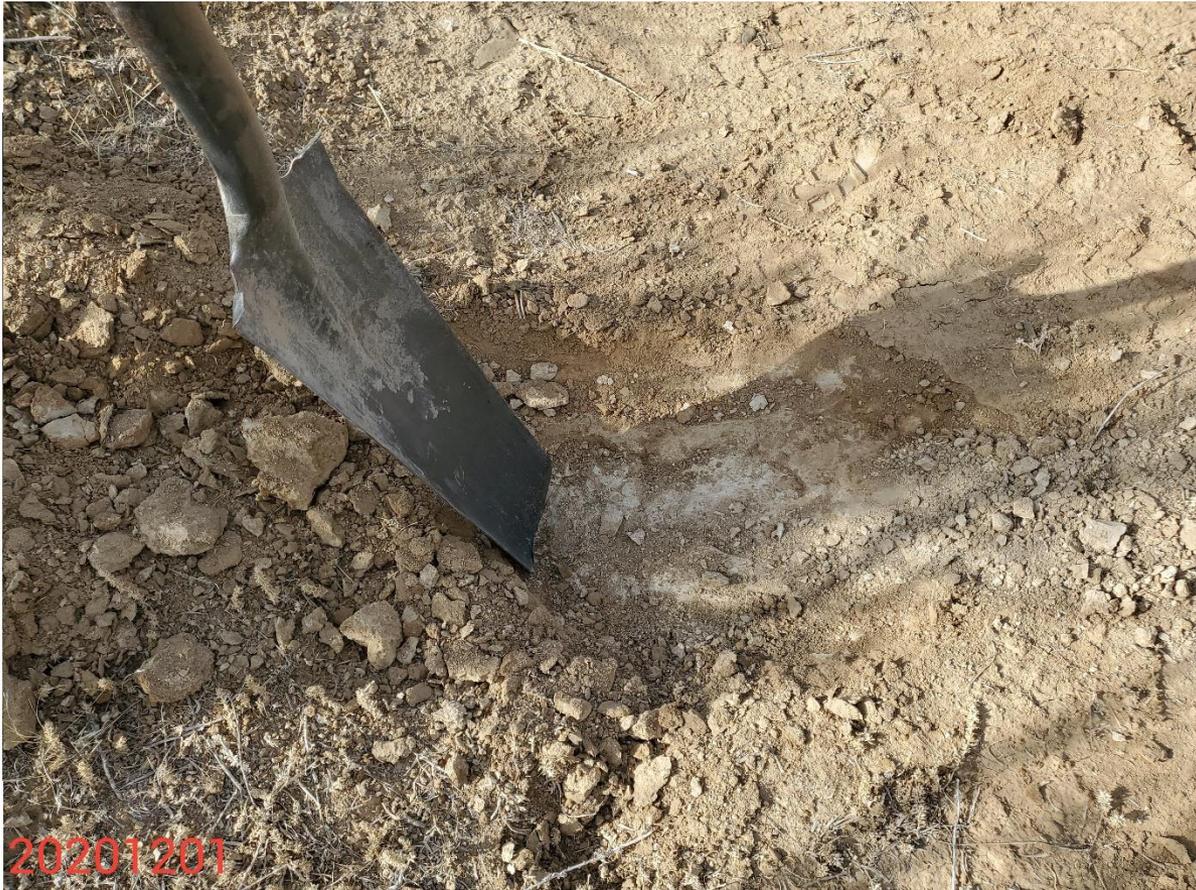
Photo 10: Continued from photo 9. Photo shows compacted soils exist ~2-3 inches subsurface.

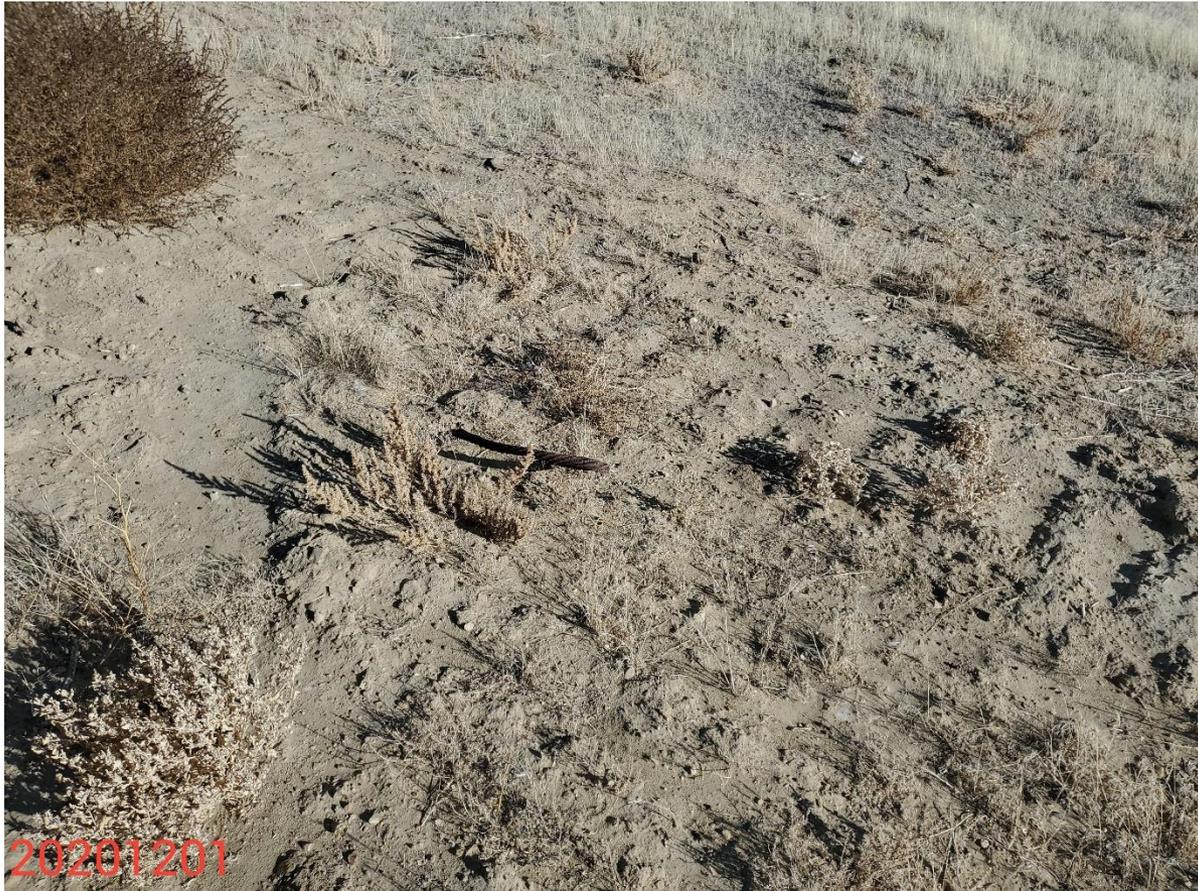
Photo 11: Photo taken from the east end of the Location. Photo shows cable debris remaining on the Location.

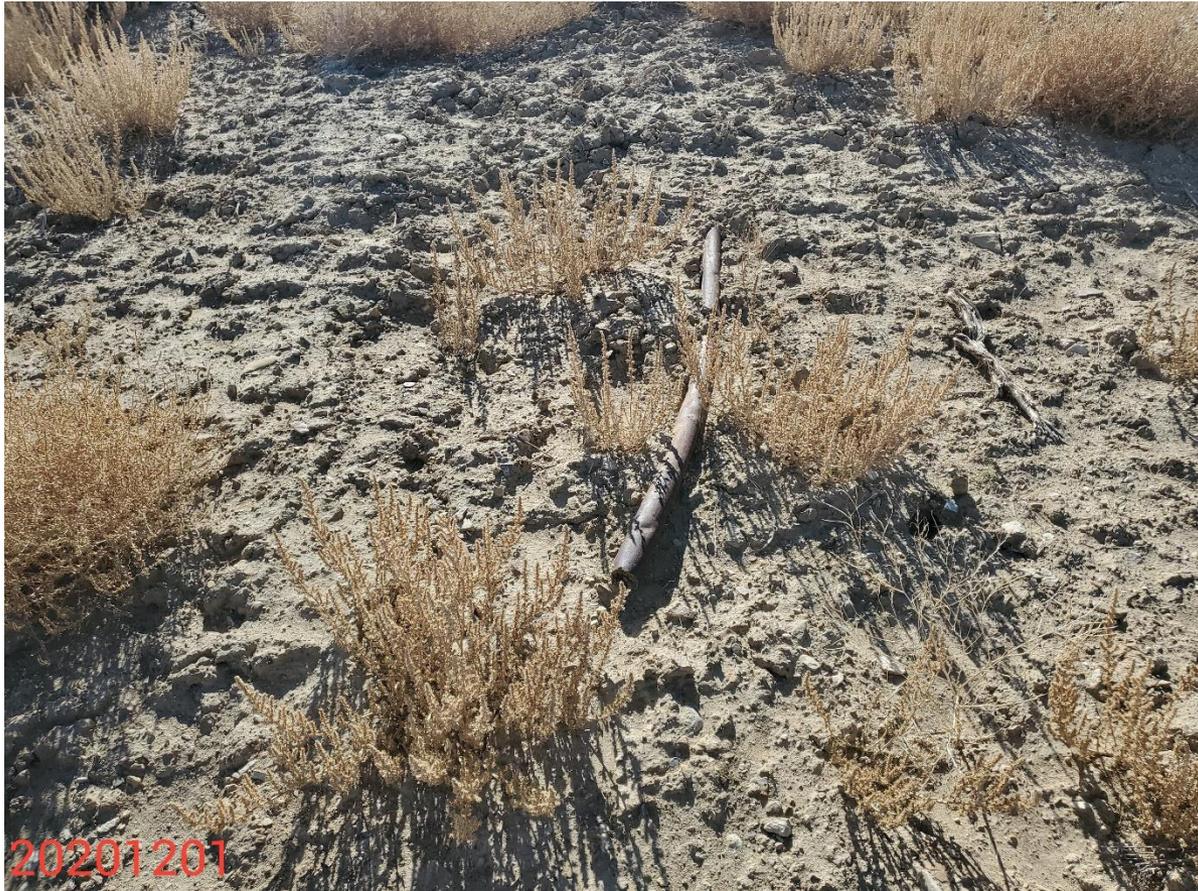
Photo 12: Photo taken from the west end of the Location. Photo shows pipe debris remaining on the Location.

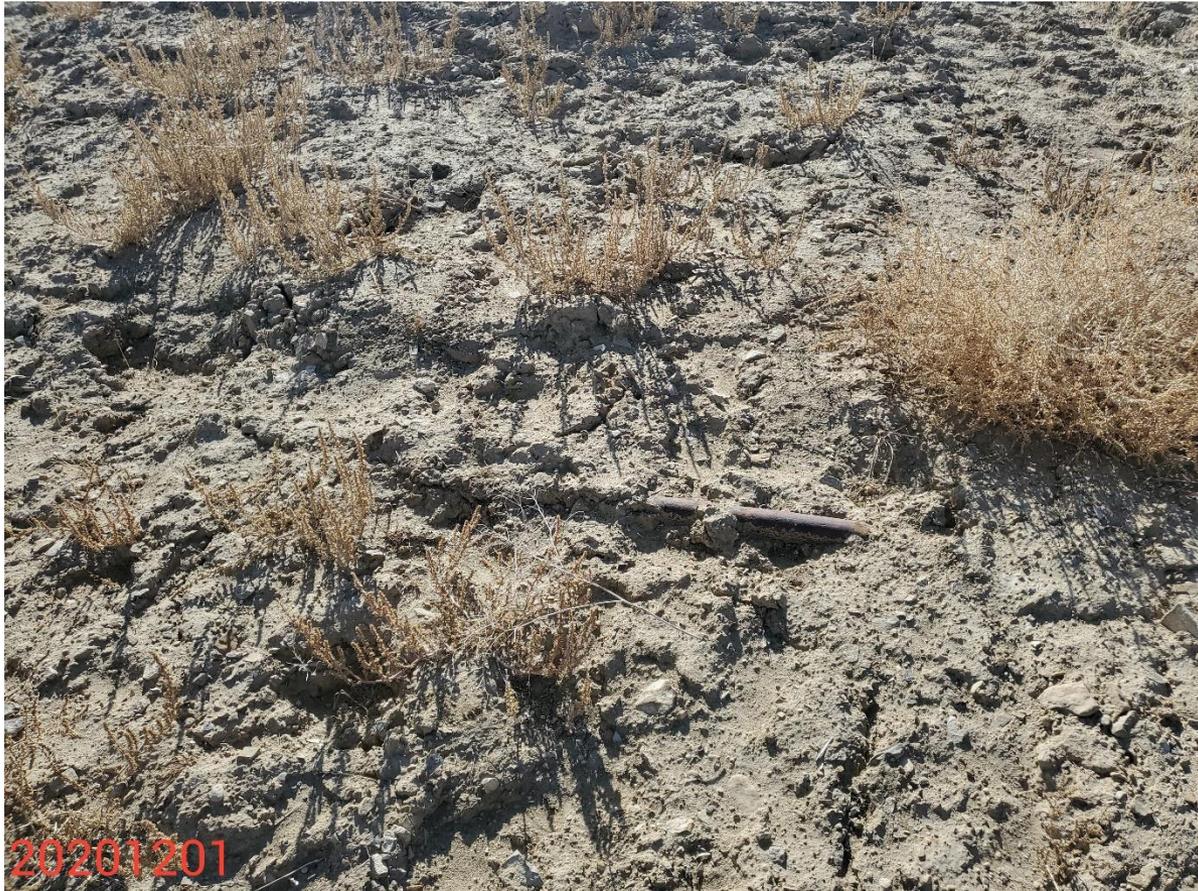
Photo 13: Photo taken from the west end of the Location. Photo shows pipe debris remaining on the Location.
