Inspection Photos
Location Name: Cascade Creek 697-09-61
Location ID: #335889
Inspection Date: December 4, 2020

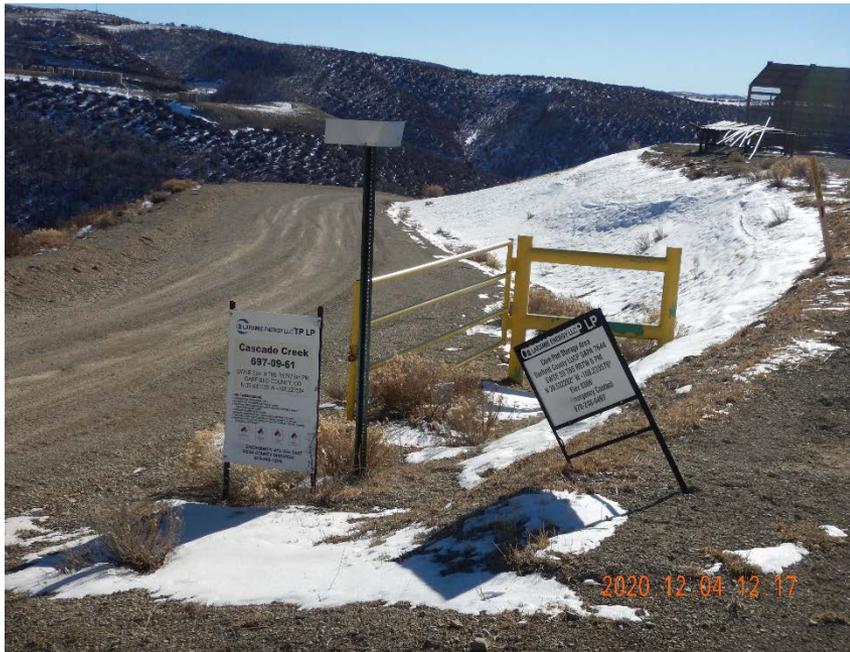
Photo #1 – Sign located at entrance to pad.

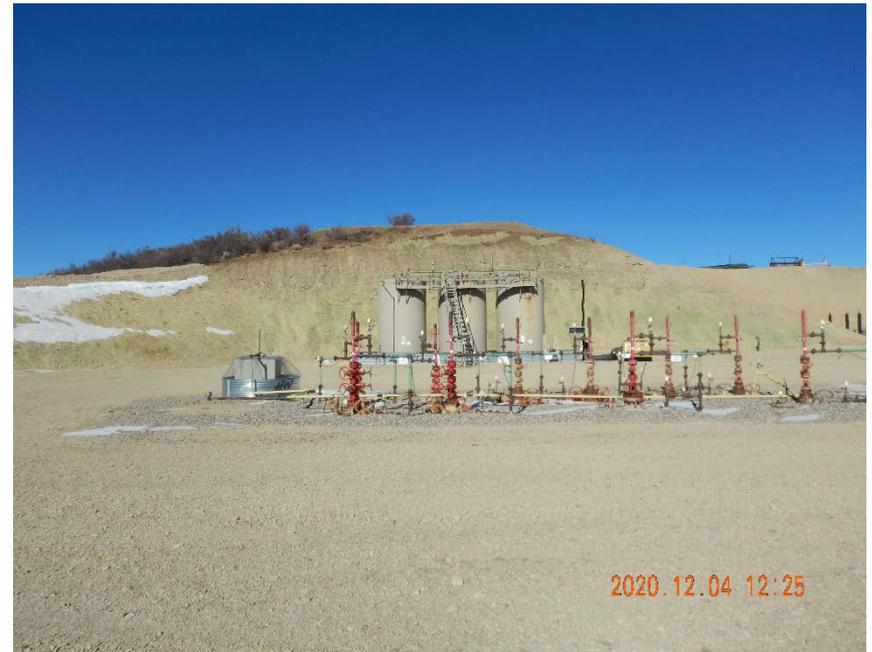
Photo #2 – View of wellheads and tank battery from south.

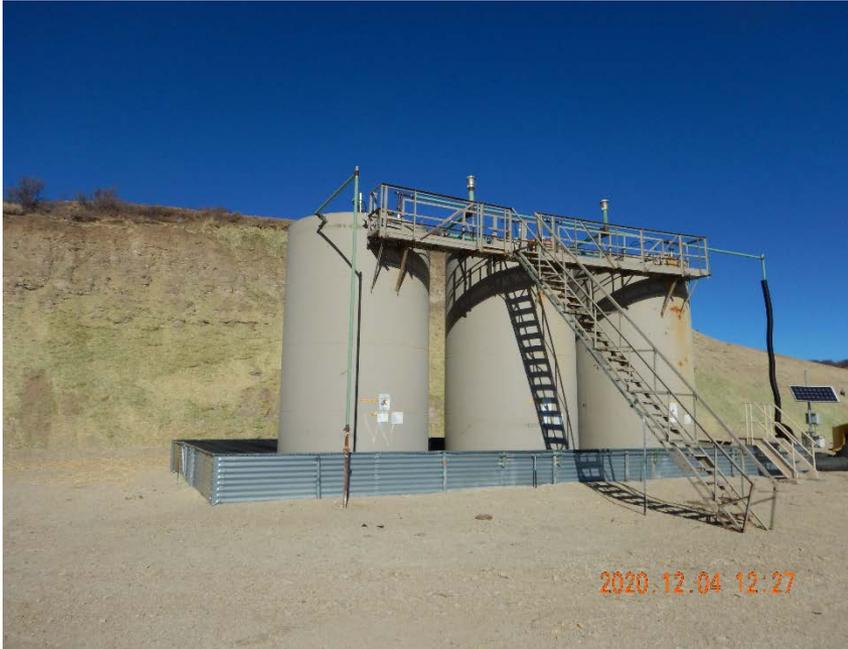
Photo #3 – View of tank battery from south.

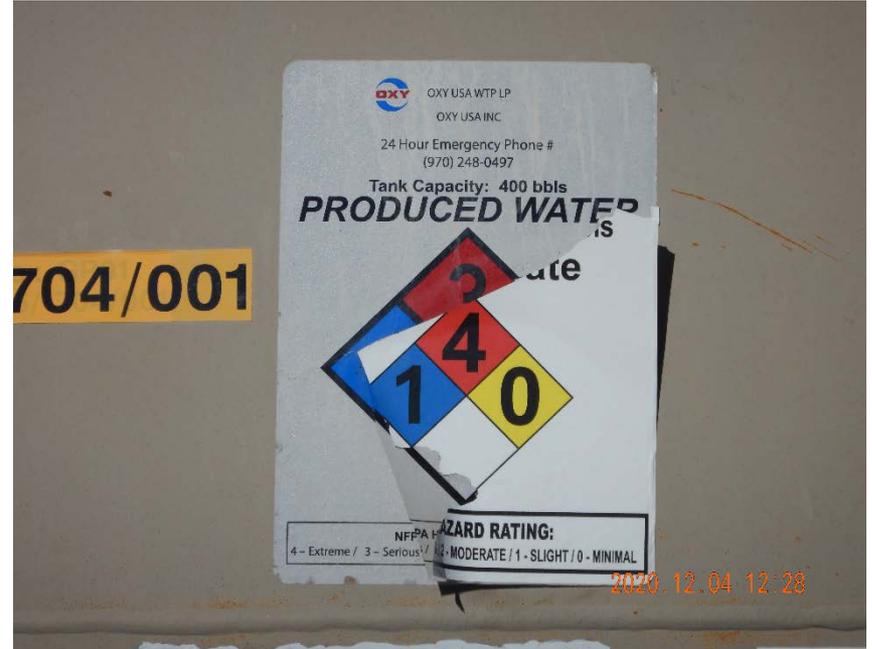
Photo #4 – Damaged NFPA placard on steel AST.

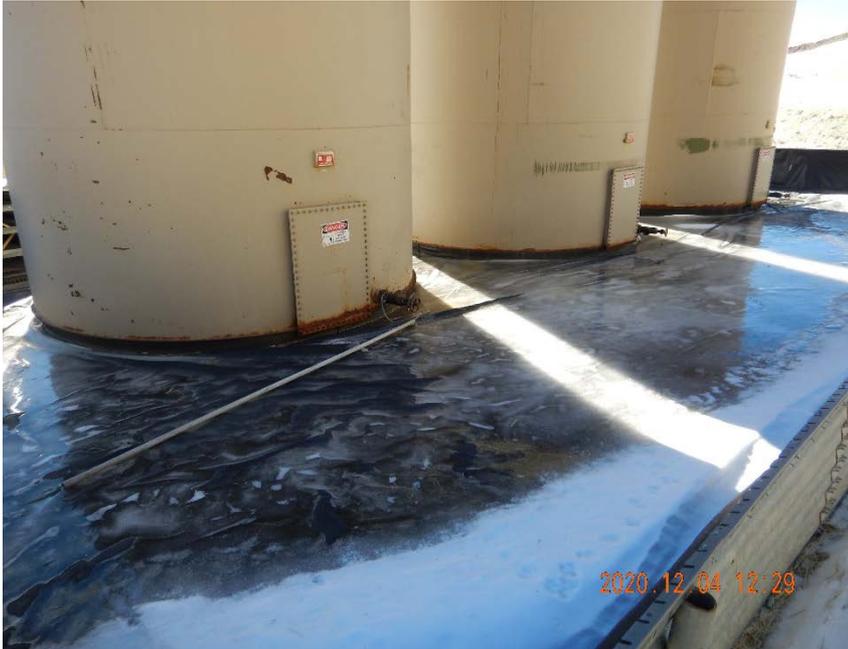
Photo #5 – Accumulation of ice inside of secondary containment area.

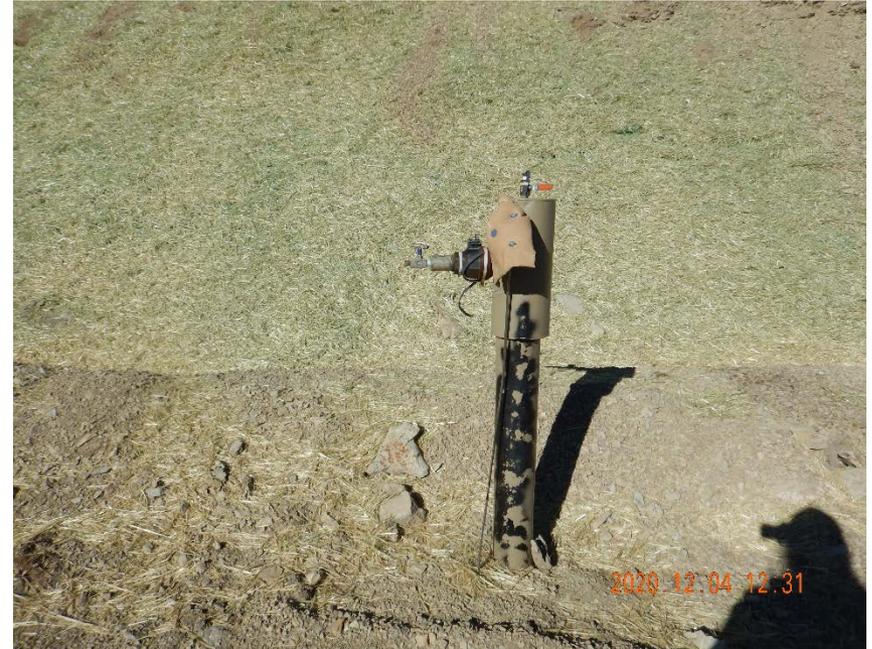
Photo #6 – Unmarked flowline riser located northeast of tank battery.

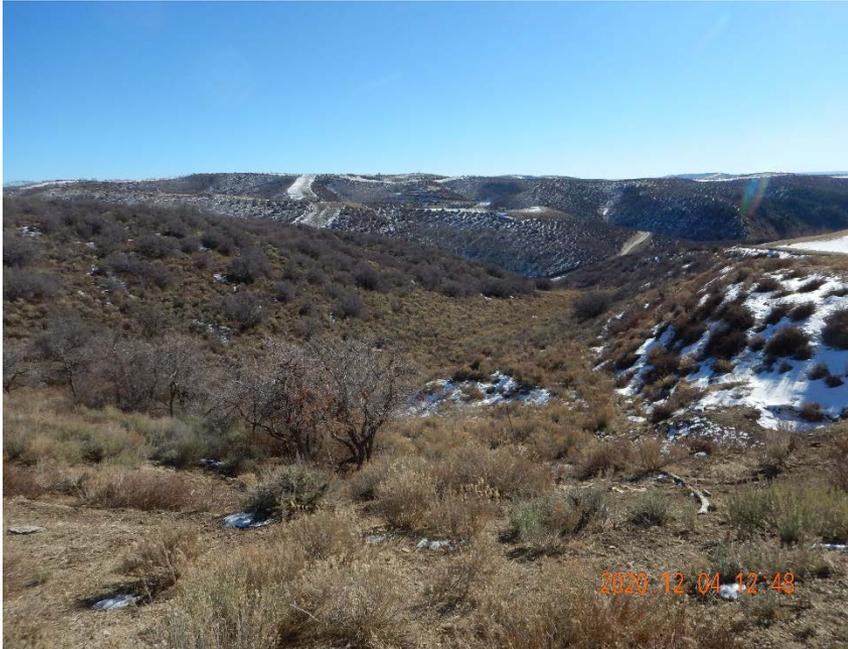
Photo #7 – Overview of unnamed creek located east of Cascade Creek 697-09-61 Pad, looking south.

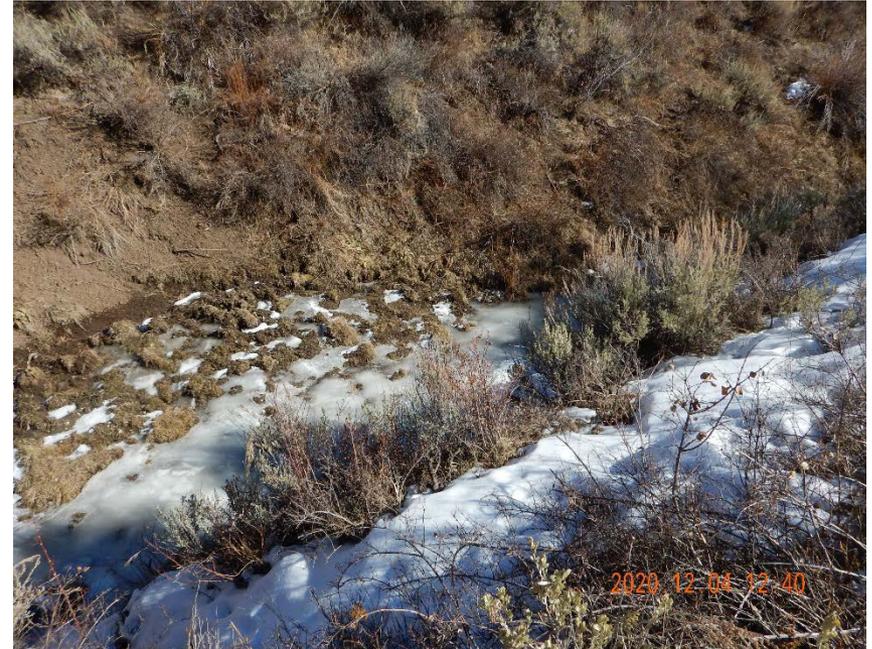
Photo #8 – Creek contained ice on inspection date.

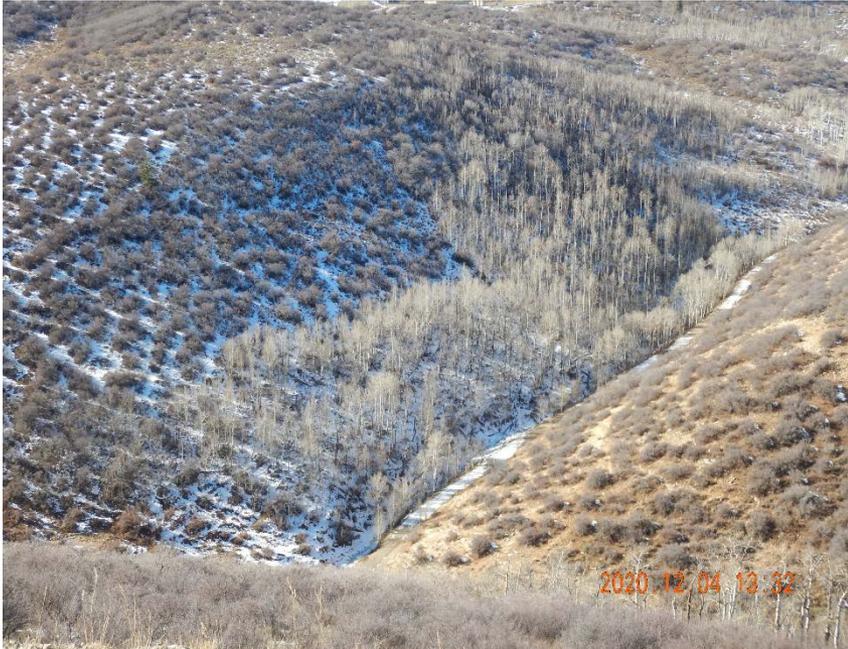
Photo #9 - Overview of unnamed creek located west of Cascade Creek 697-09-61 Pad, looking north.

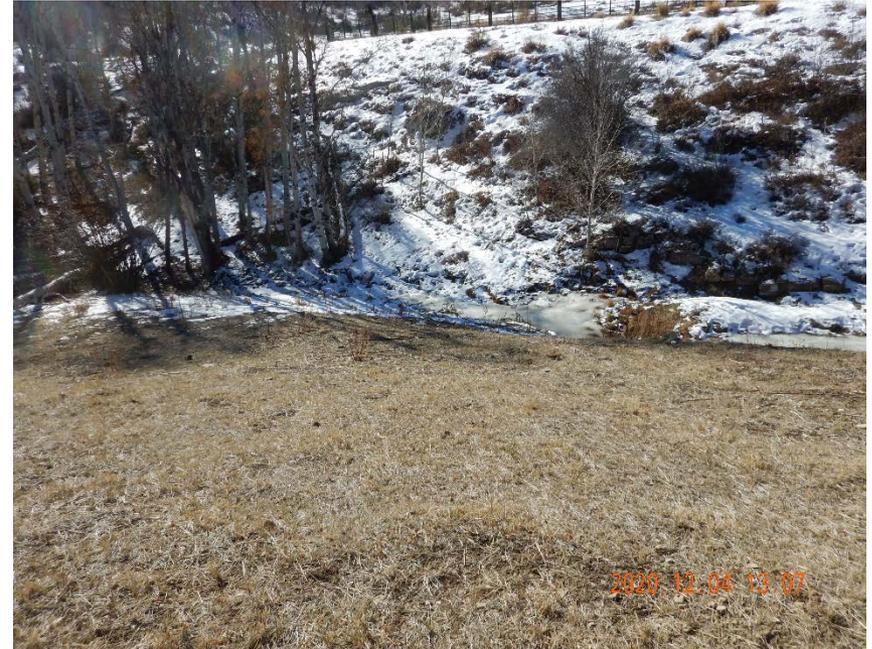
Photo #10 - Creek contained ice on inspection date.
