Inspection Photos

Operator: BP America
API: 067-08935
Date: 12/7/2020

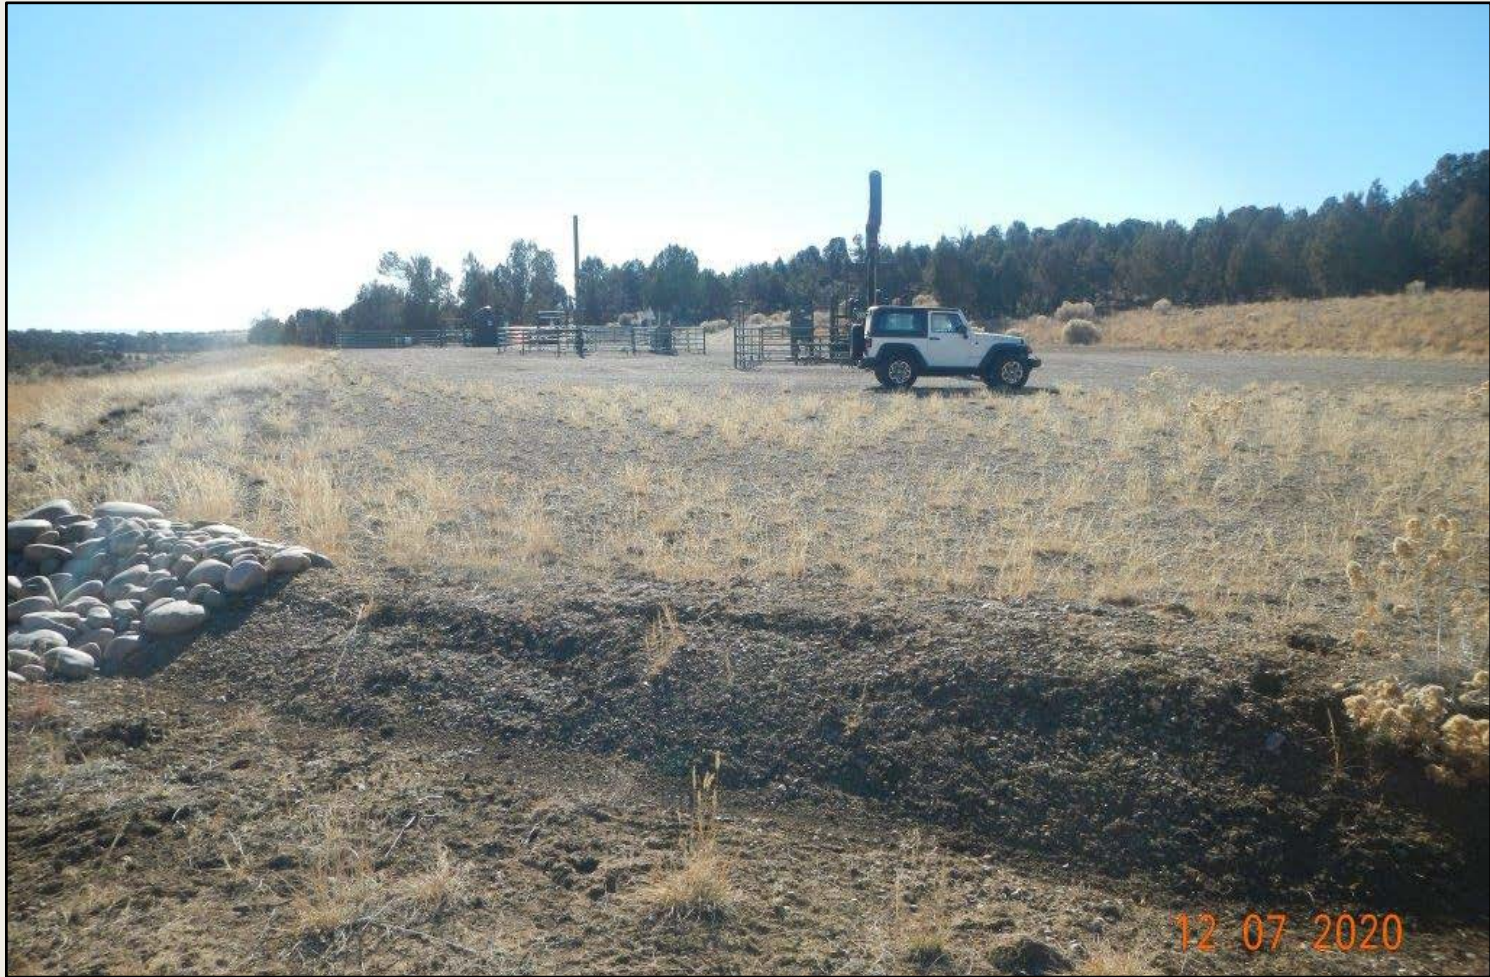
Photo 1. View of the project area from the northeastern corner facing center.

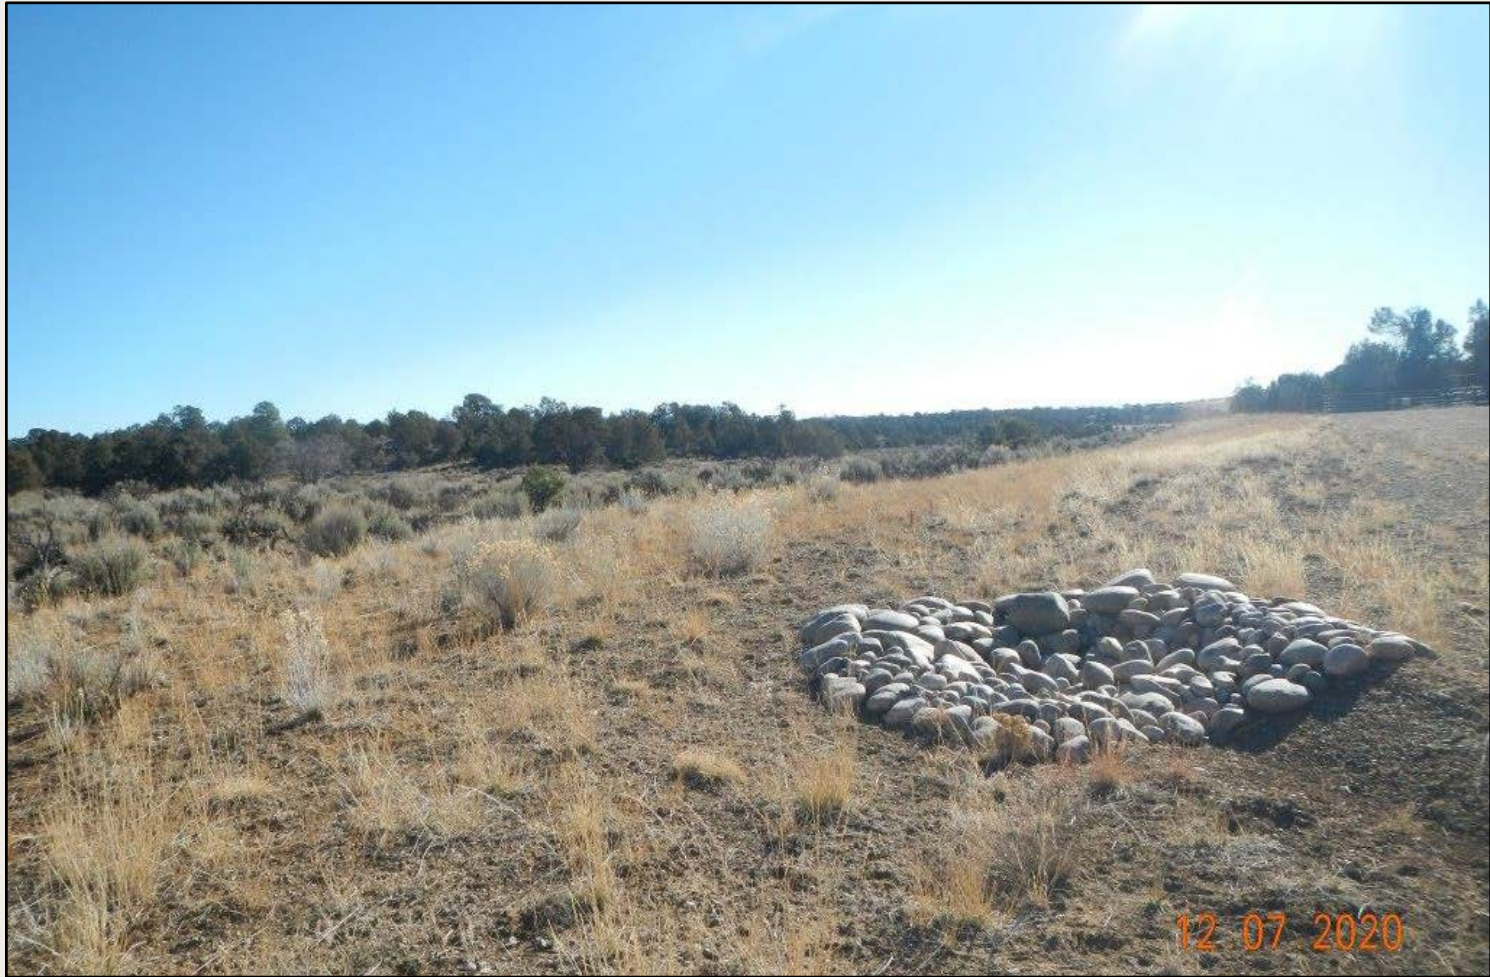
Photo 2. View of the eastern fill slope, facing southward. Revegetation is progressing with crested wheatgrass, western wheatgrass, intermediate wheatgrass, and sand dropseed.

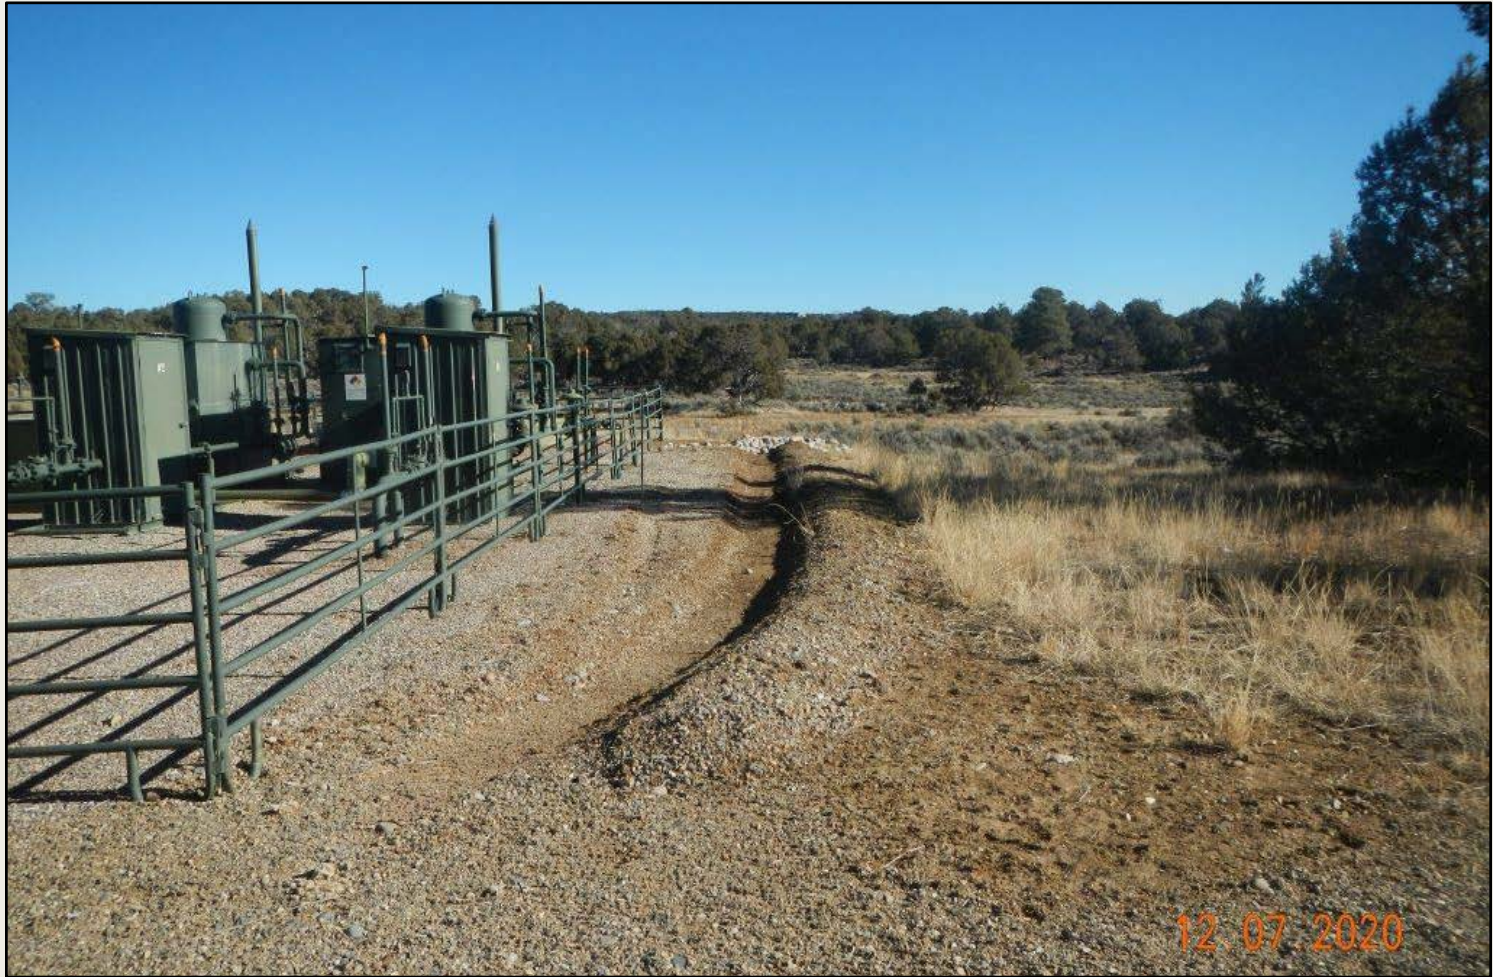
Photo 3. View of the southern project area facing eastward.

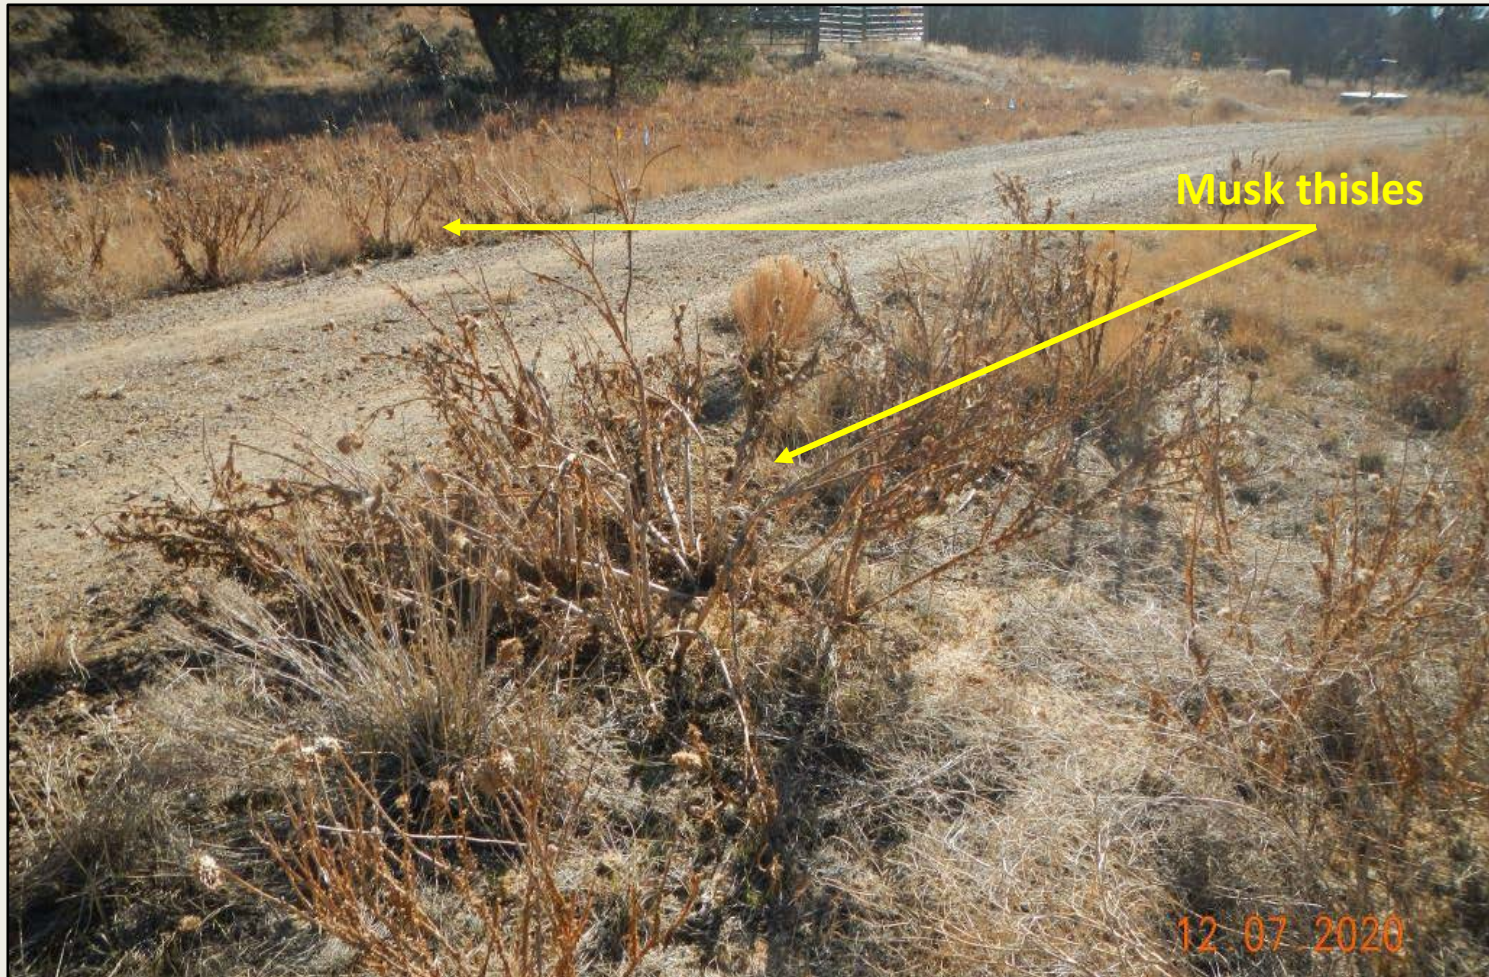
Photo 4. View of musk thistles along the access road. Approximately 200 individuals observed.

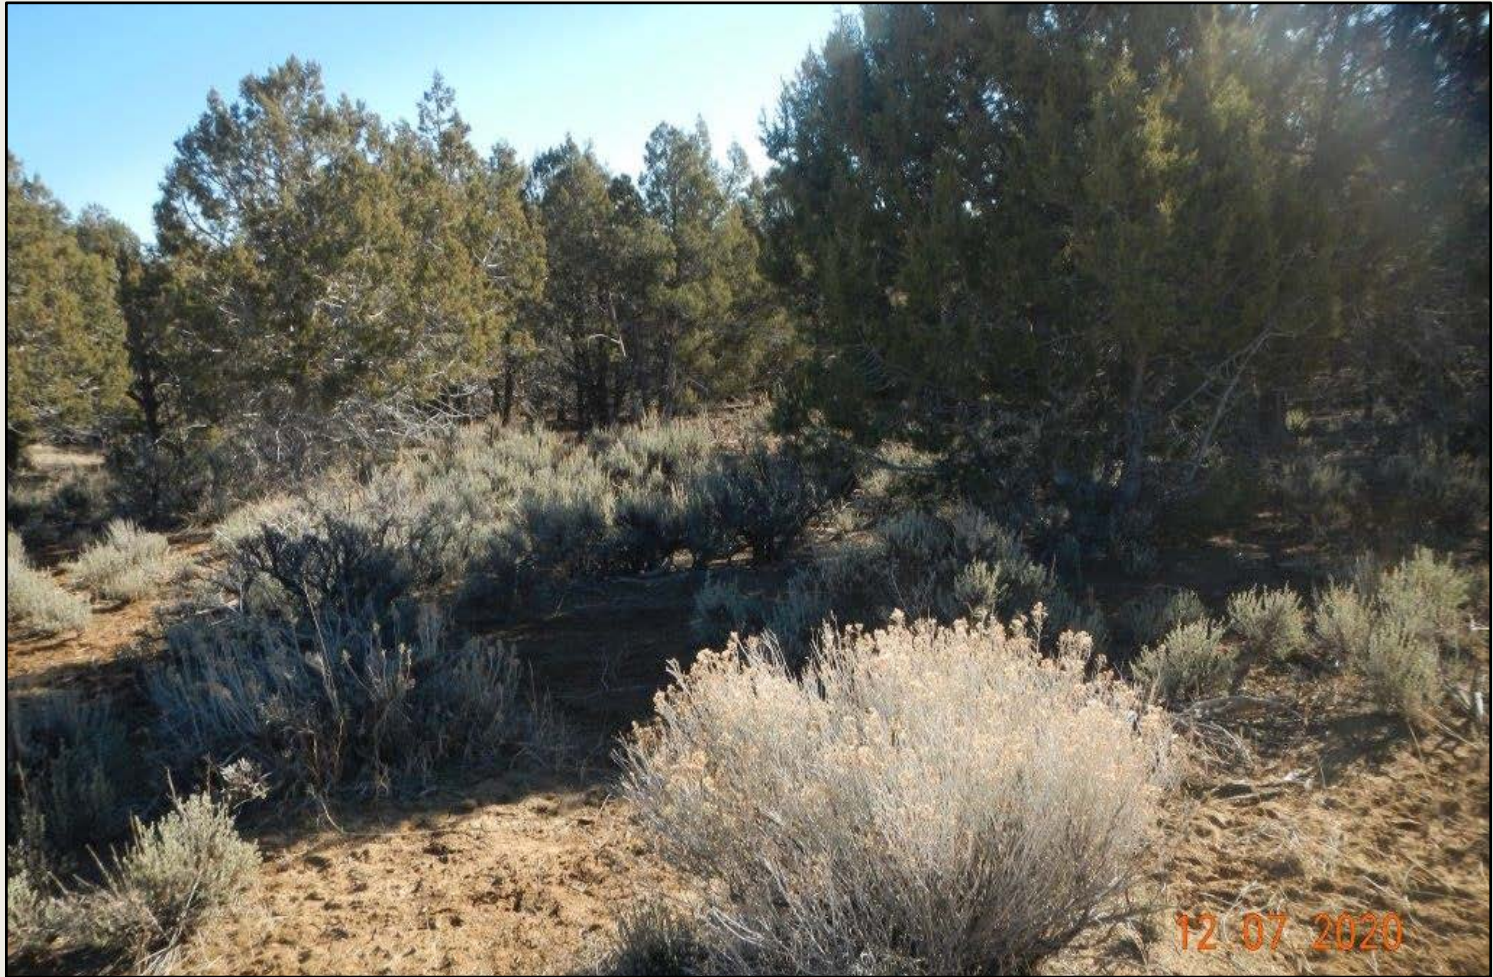
Photo 6. View of the reference area comprised of sagebrush shrubland and pinyon/juniper woodland with understory of squirreltail, blue grama, and penstemon spp.

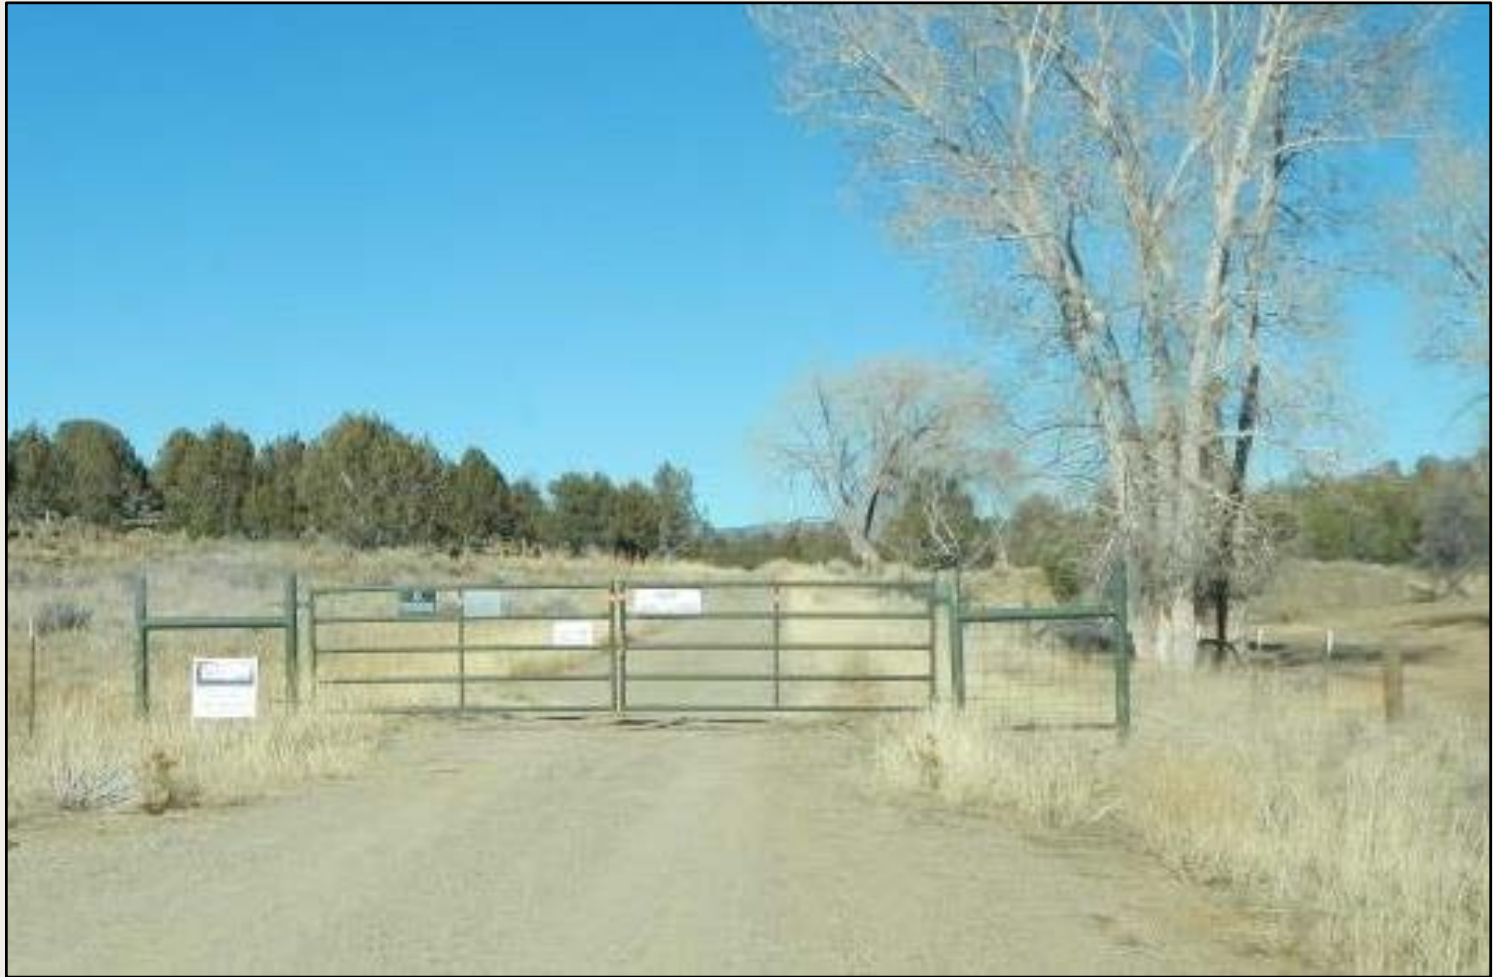
Photo 7. View of closed gate after leaving location.
