Inspection Photos

Location Name: MARALEX RESOURCES INC SOUTH SHALE RIDGE-68S98W /14NENE

Location ID: 324270

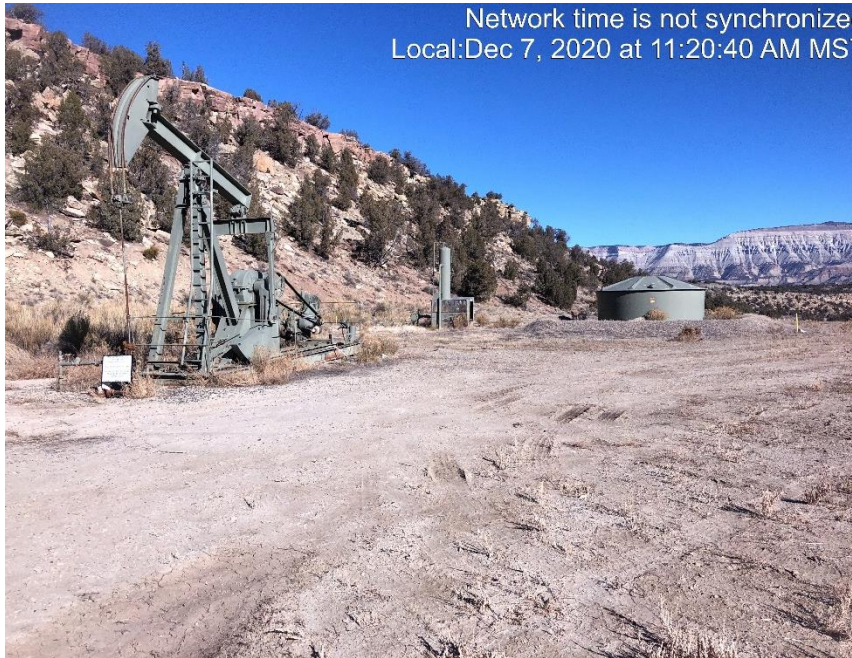
Photo #2403 from entrance to location.

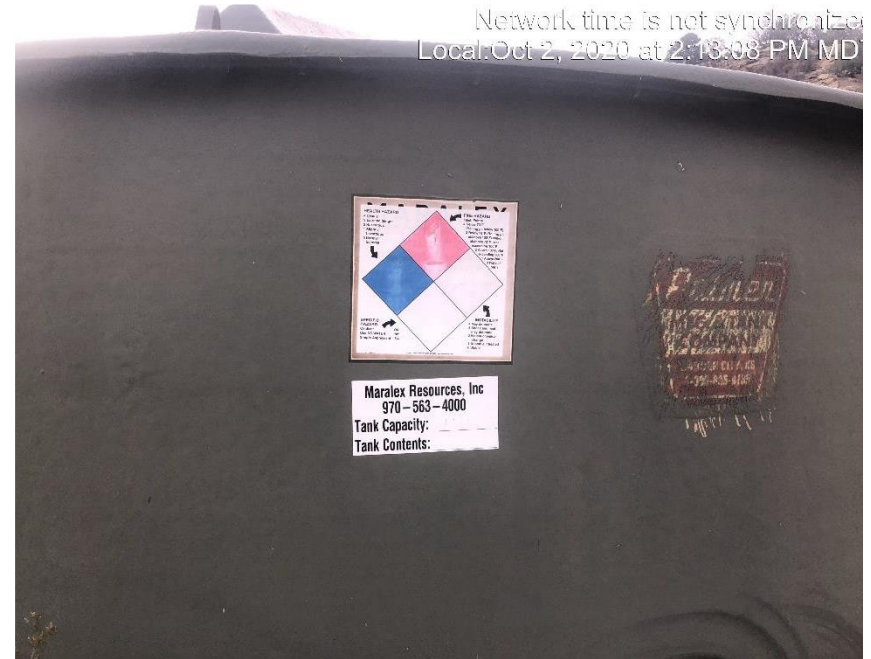
Photo #1976 from #699801876 inspection conducted on 10/2/20.

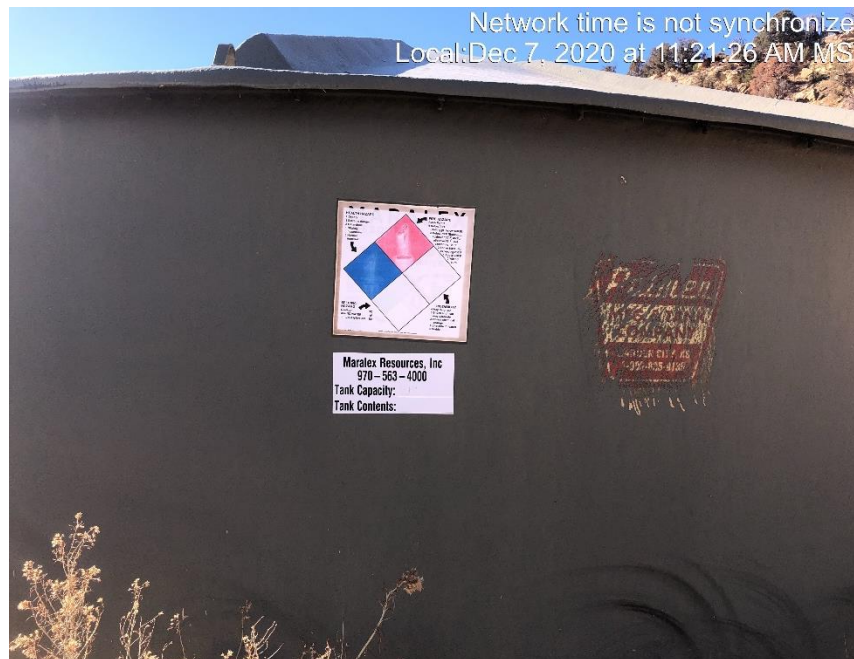
Photo #2404 Tank label weathered and not legible.

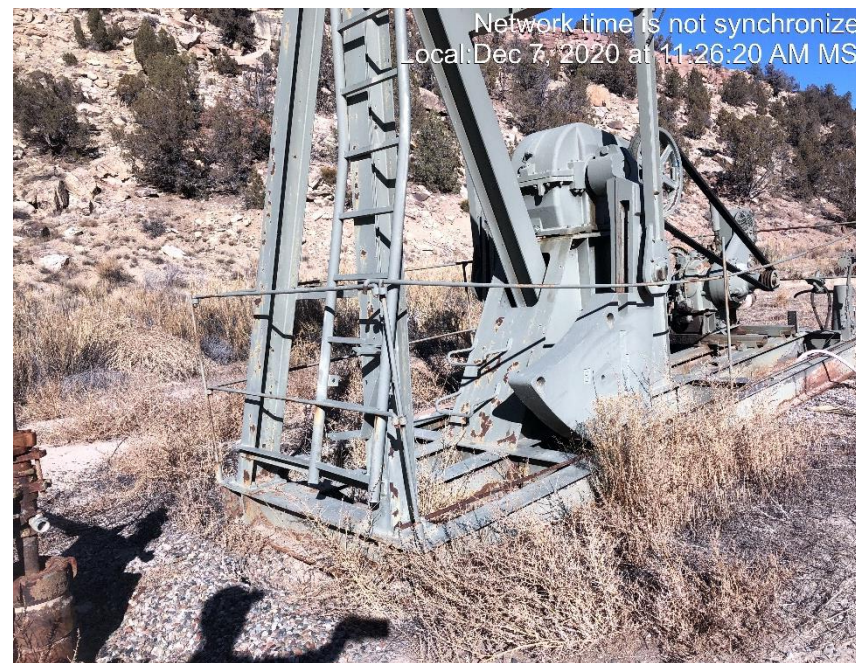
Photo #2405 Multiple places with debris and weeds on location.

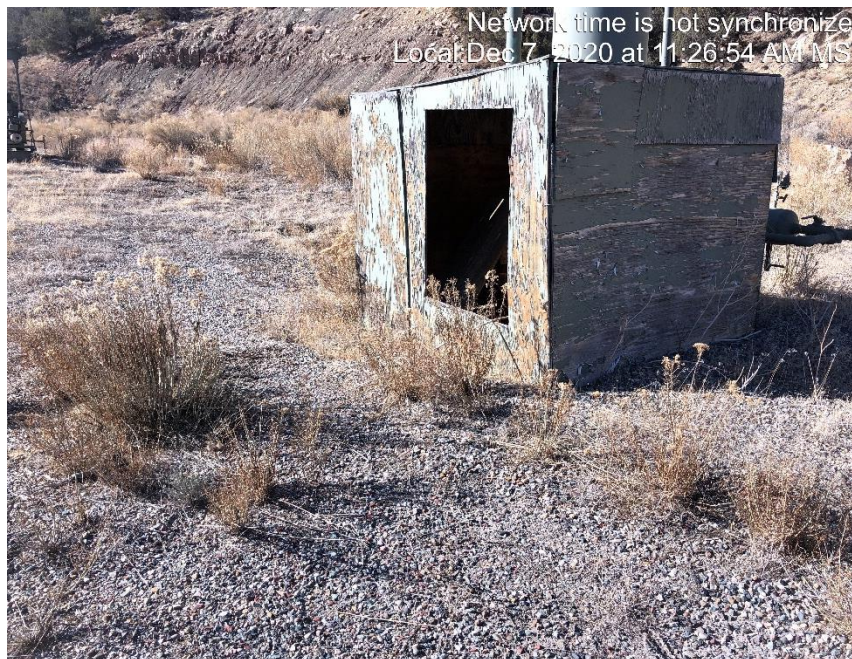
Photo #2406 Multiple places with debris and weeds on location.

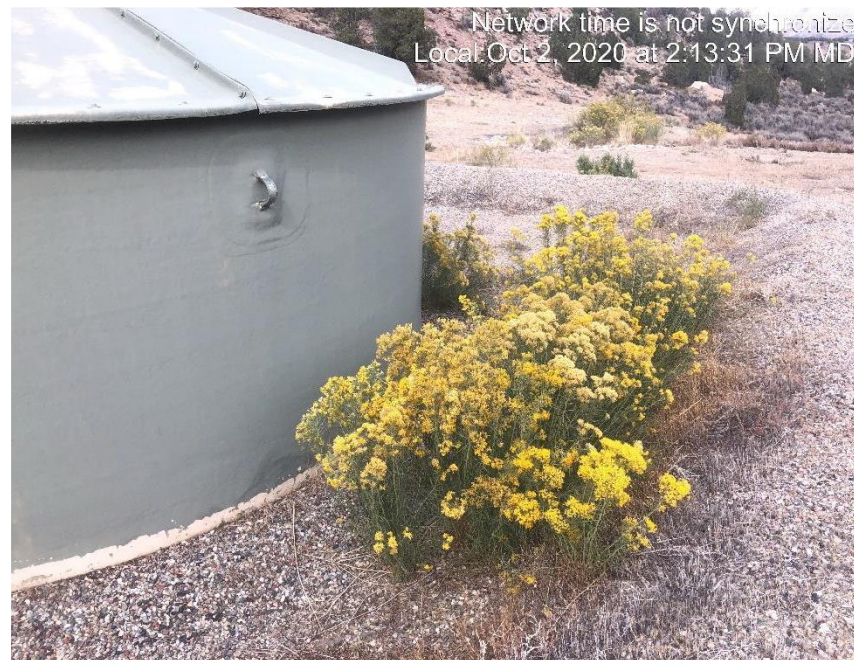
Photo #1977 from #699801876 inspection conducted on 10/2/20.

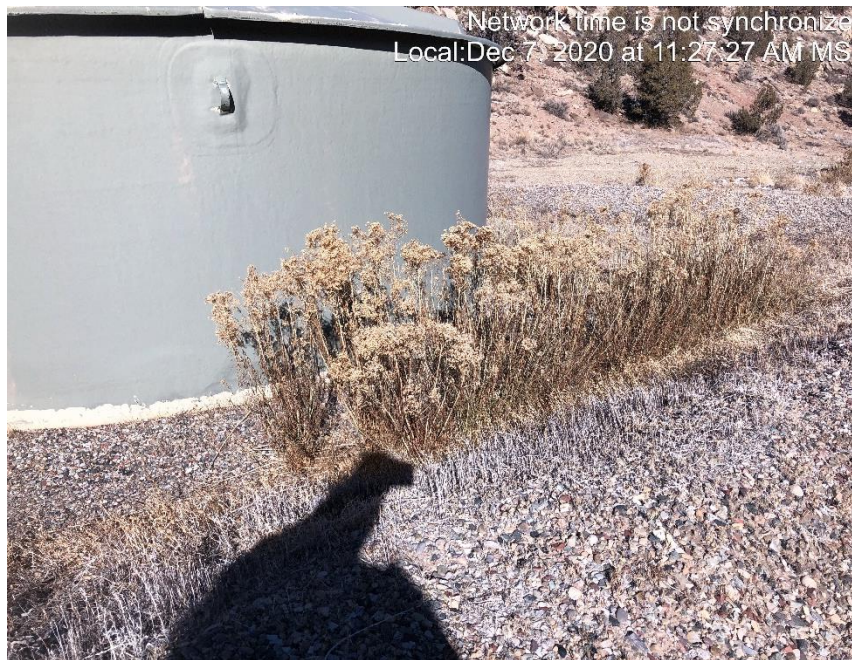
Photo #2407 Secondary containment not adequate weeds and debris inside tank containment.

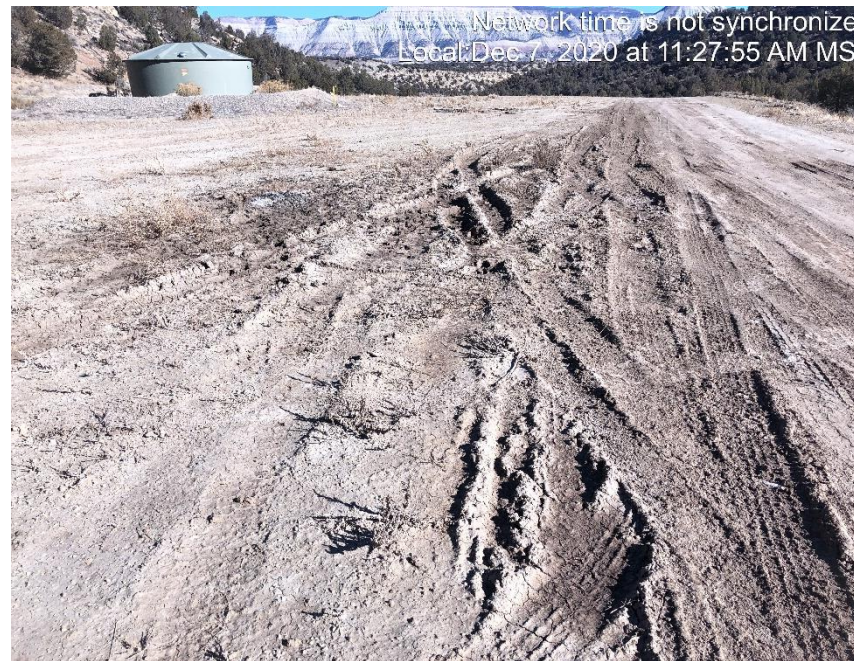
Photo #2408 Rutting occurring on location due to lack of stabilization.
