Inspection Photos
Operator: Simcoe
API: 067-09579
Date: 12/15/2020

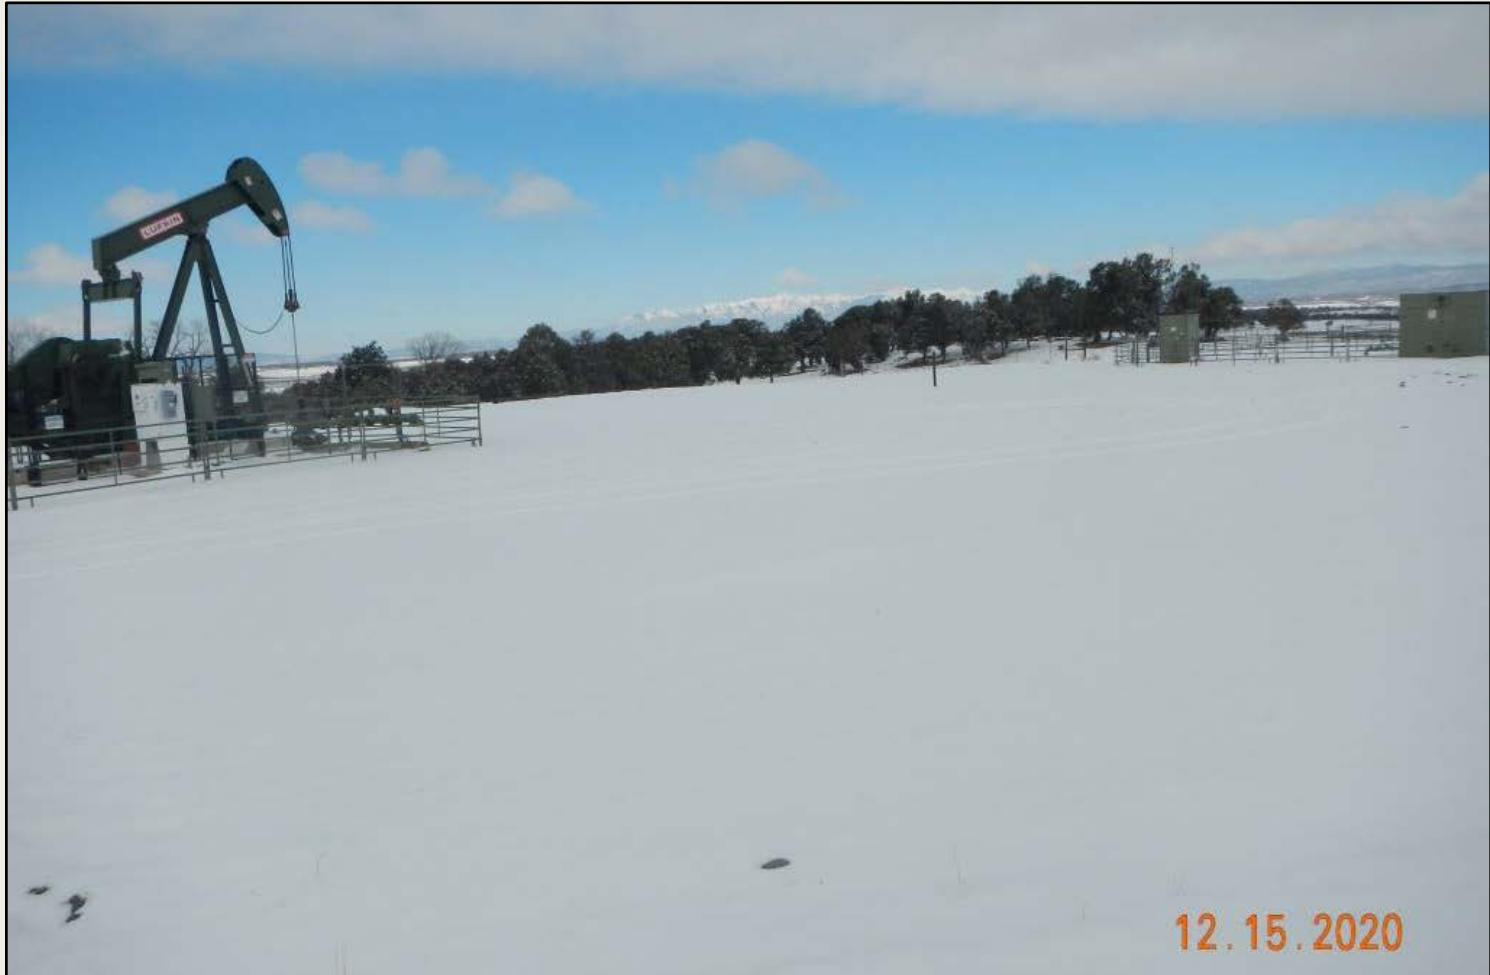
Photo 1. View of the project area from the southeastern corner facing center.

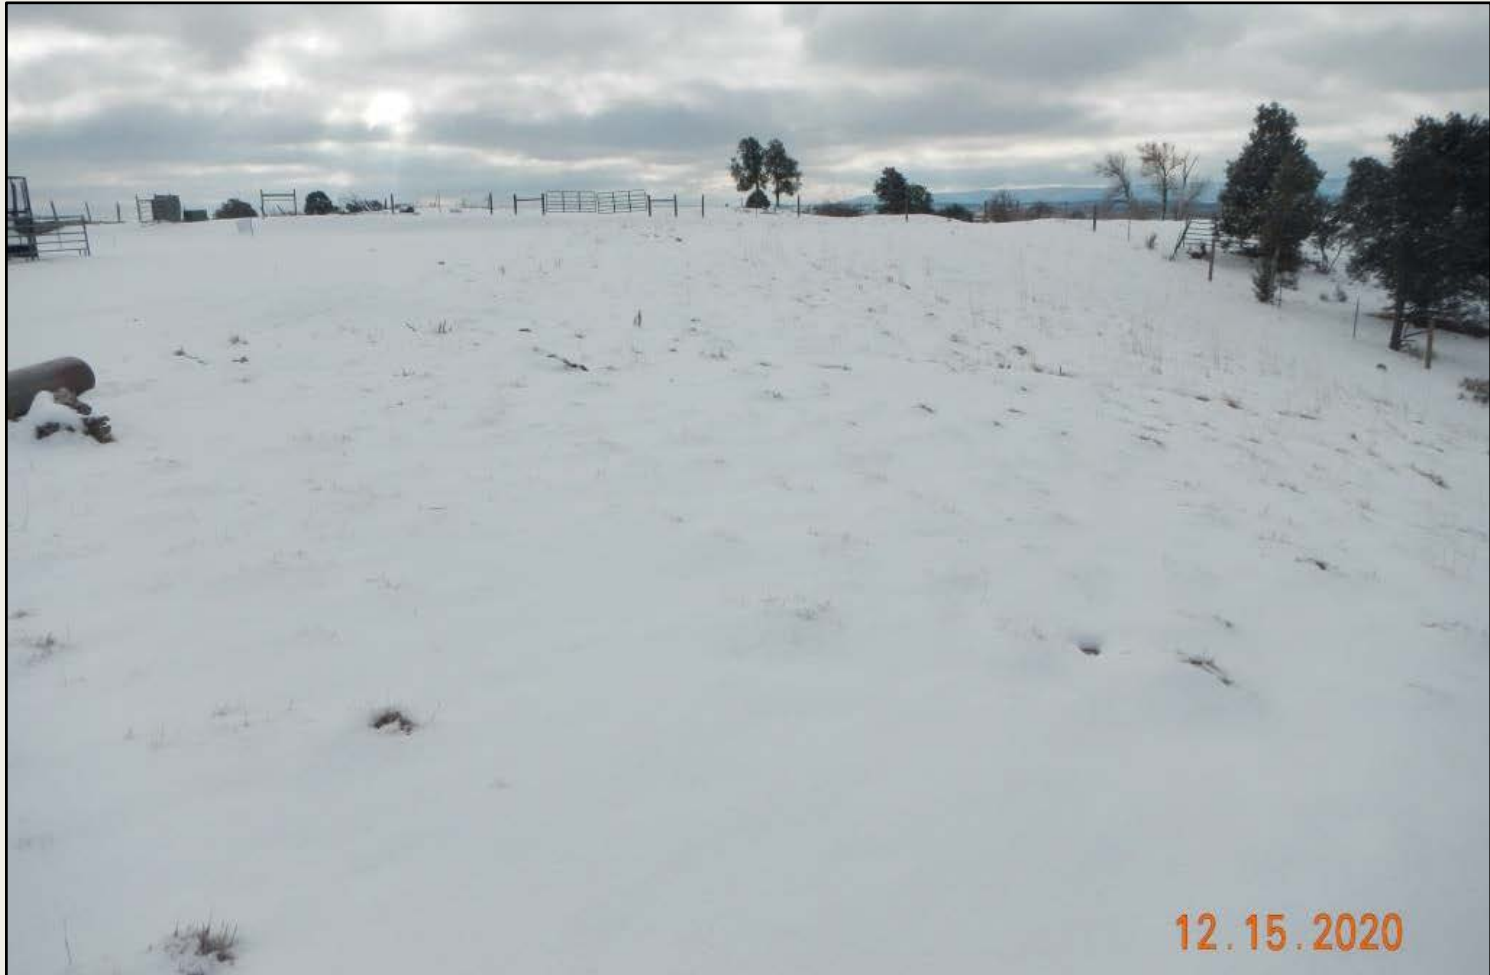
Photo 2. View of the western project area from the northwestern corner facing southward. Revegetation is largely snow covered and can be observed in a grazed condition beneath snow.

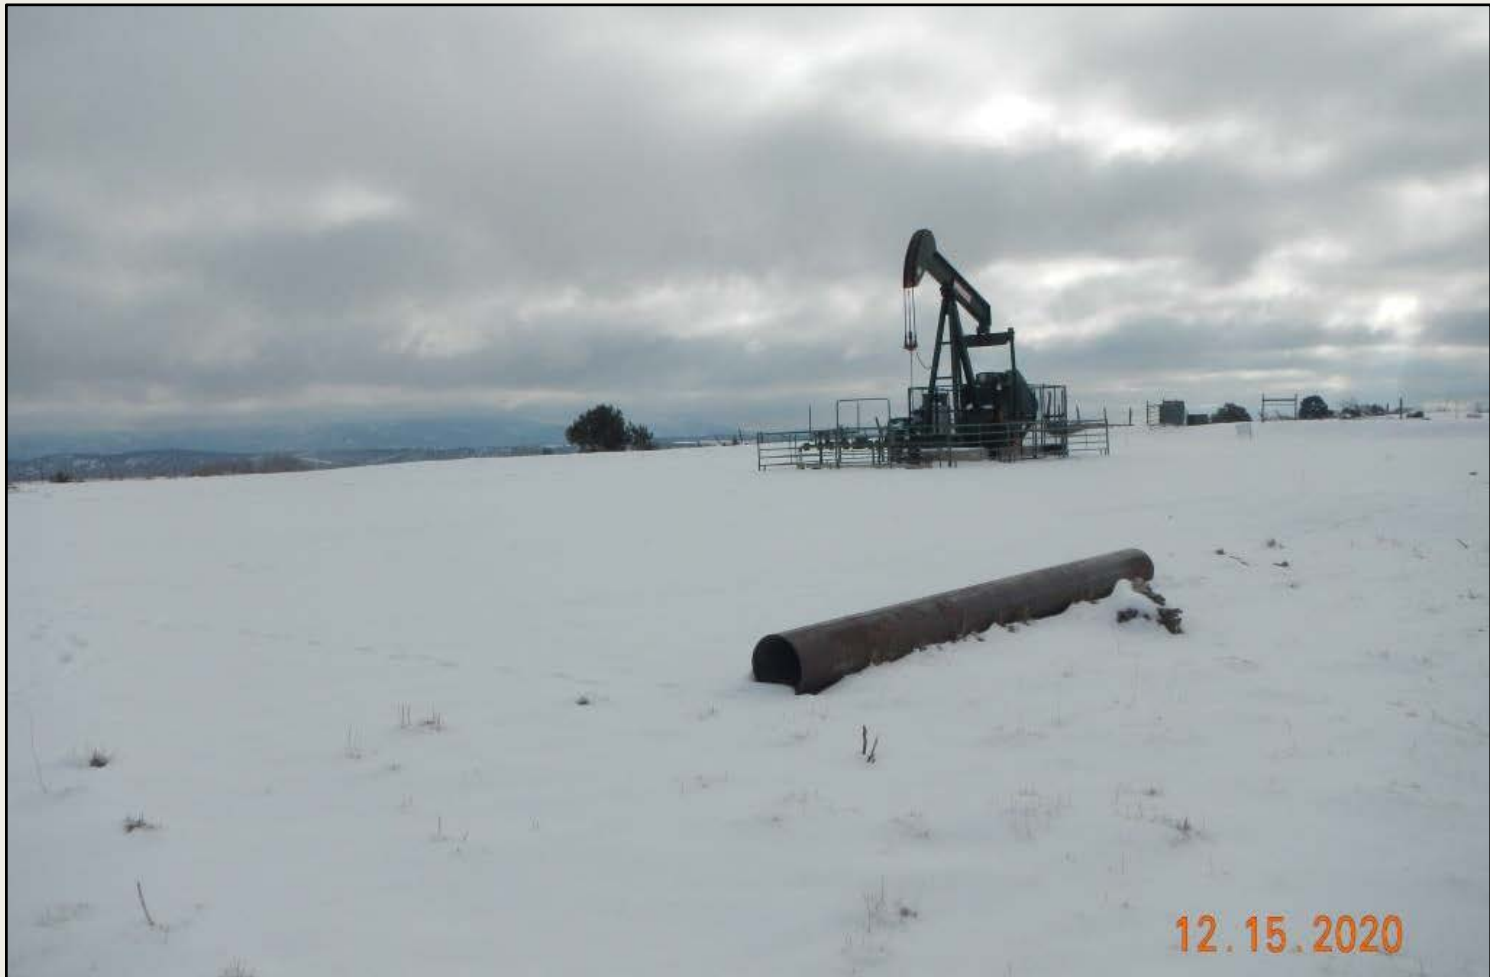
Photo 3. View of metal tube within the western project area.

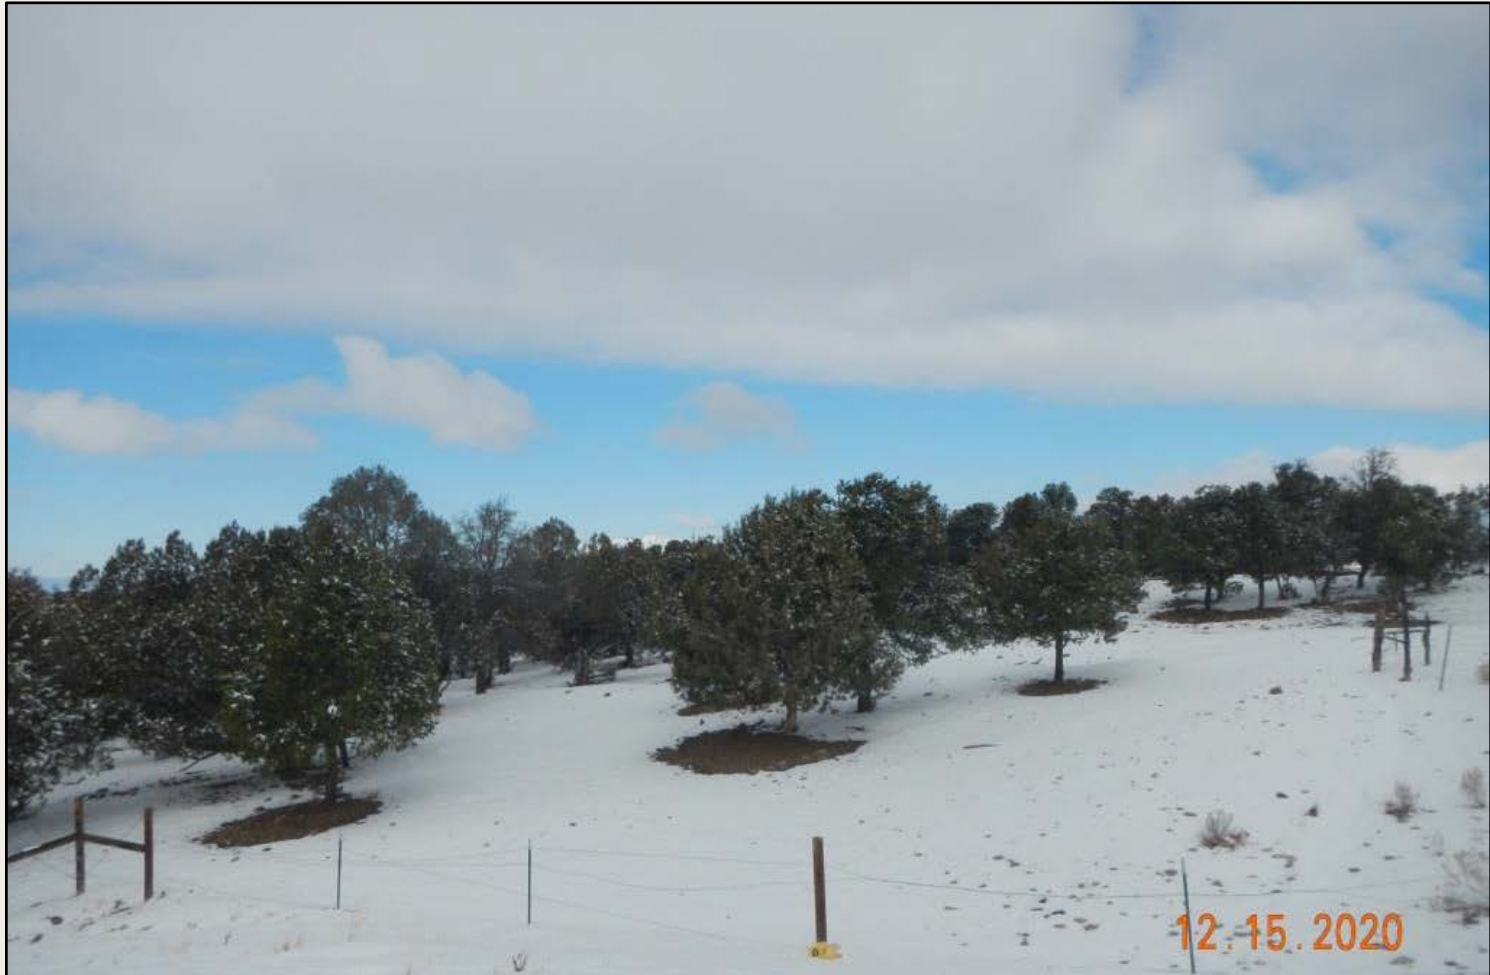
Photo 4. View of reference area comprised of pinyon and juniper woodland with sagebrush understory. Additional understory grasses and forbs are not observable due to snow cover.
