Inspection Photos

API: 043-06142

Operator: JAVERNICK OIL

Inspection Date: 12/16/2020

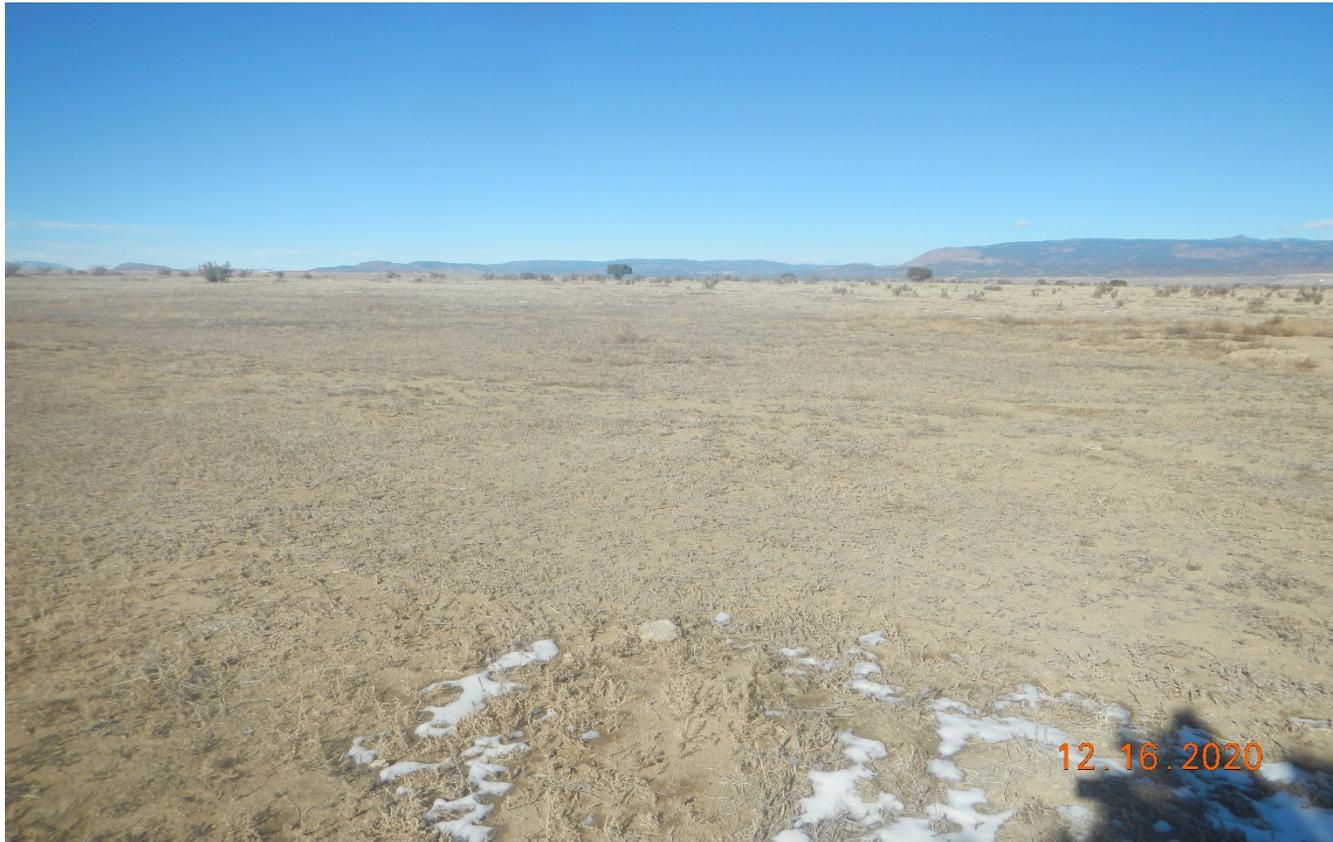
Photo 1. Facing north toward the location. The location has not established desirable vegetation cover.

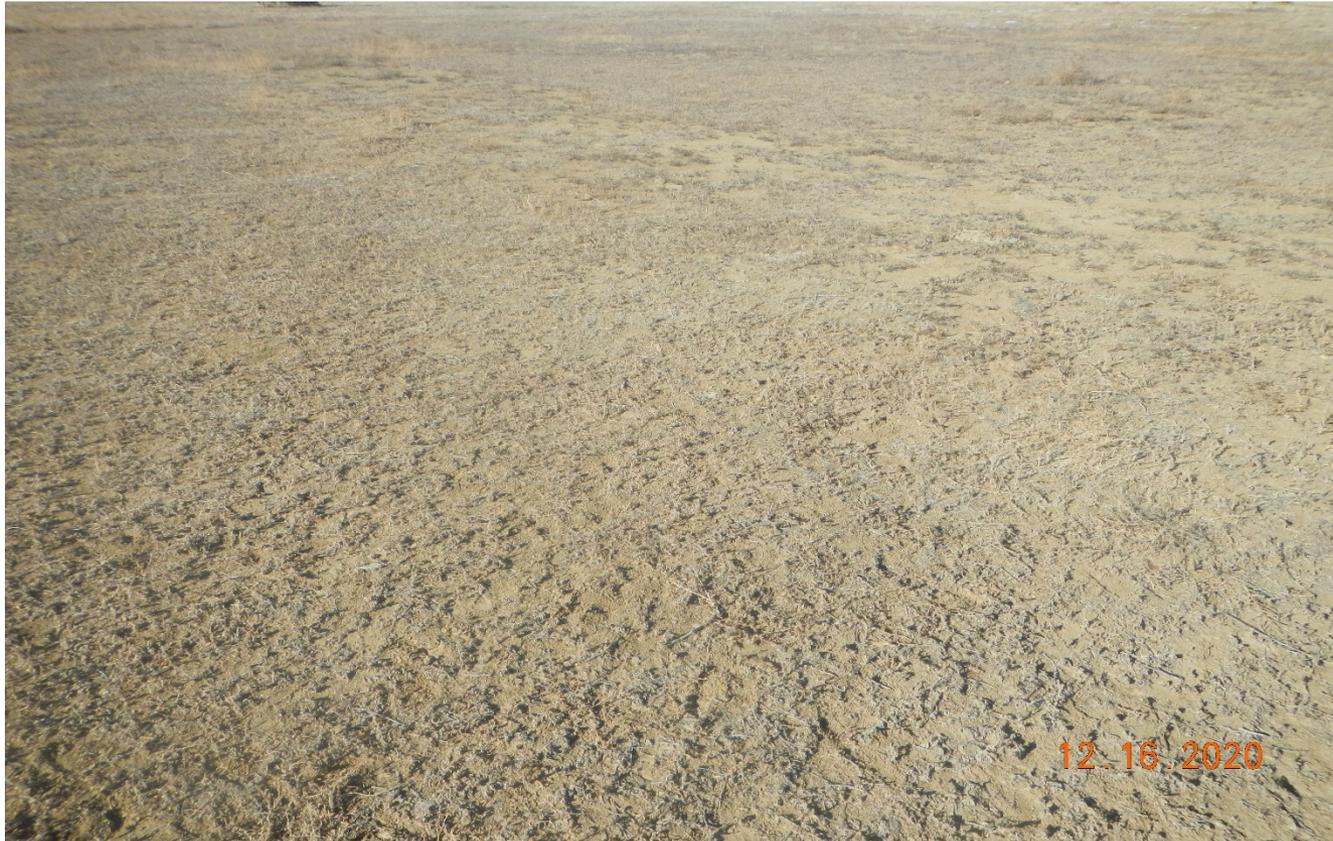
Photo 2. View of ground cover shows undesirable weeds (Kochia sp.) observed throughout the location.

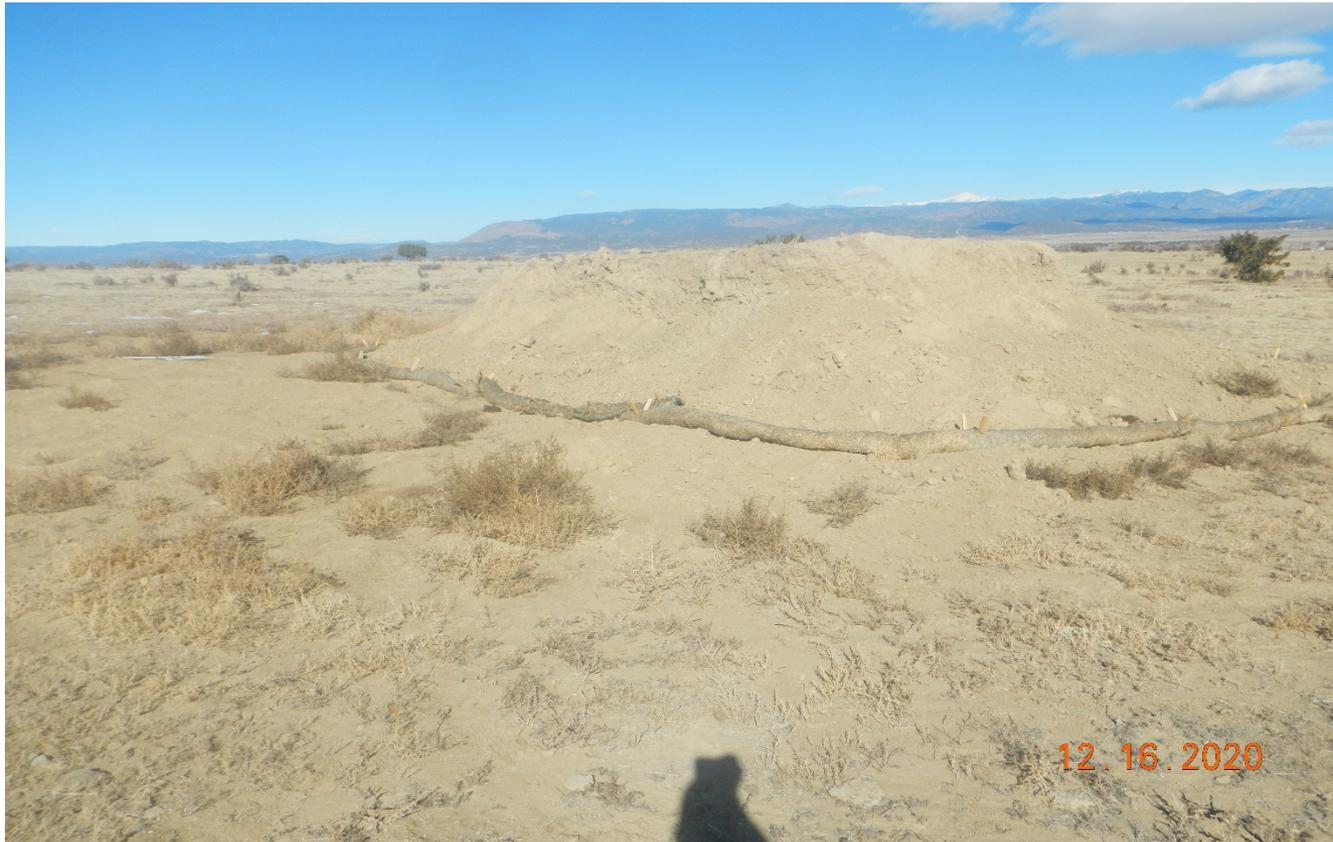
Photo 3. There is a soil pile that remains at the northwest side of the location. The soil pile needs to be replaced or removed. If soil is not from the location then the soil needs to be removed.

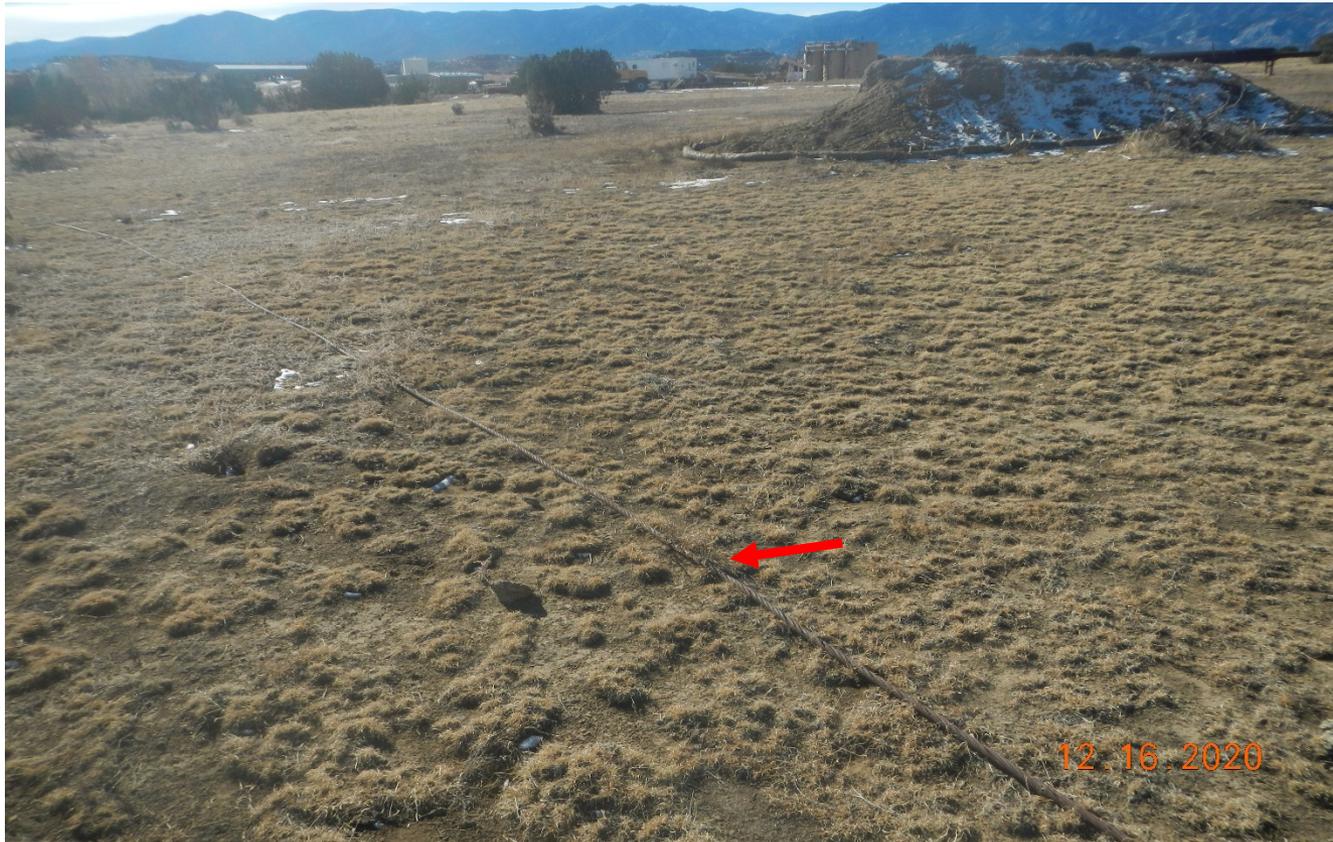
Photo 4. There is a metal cable at the east side of the location and soil pile.

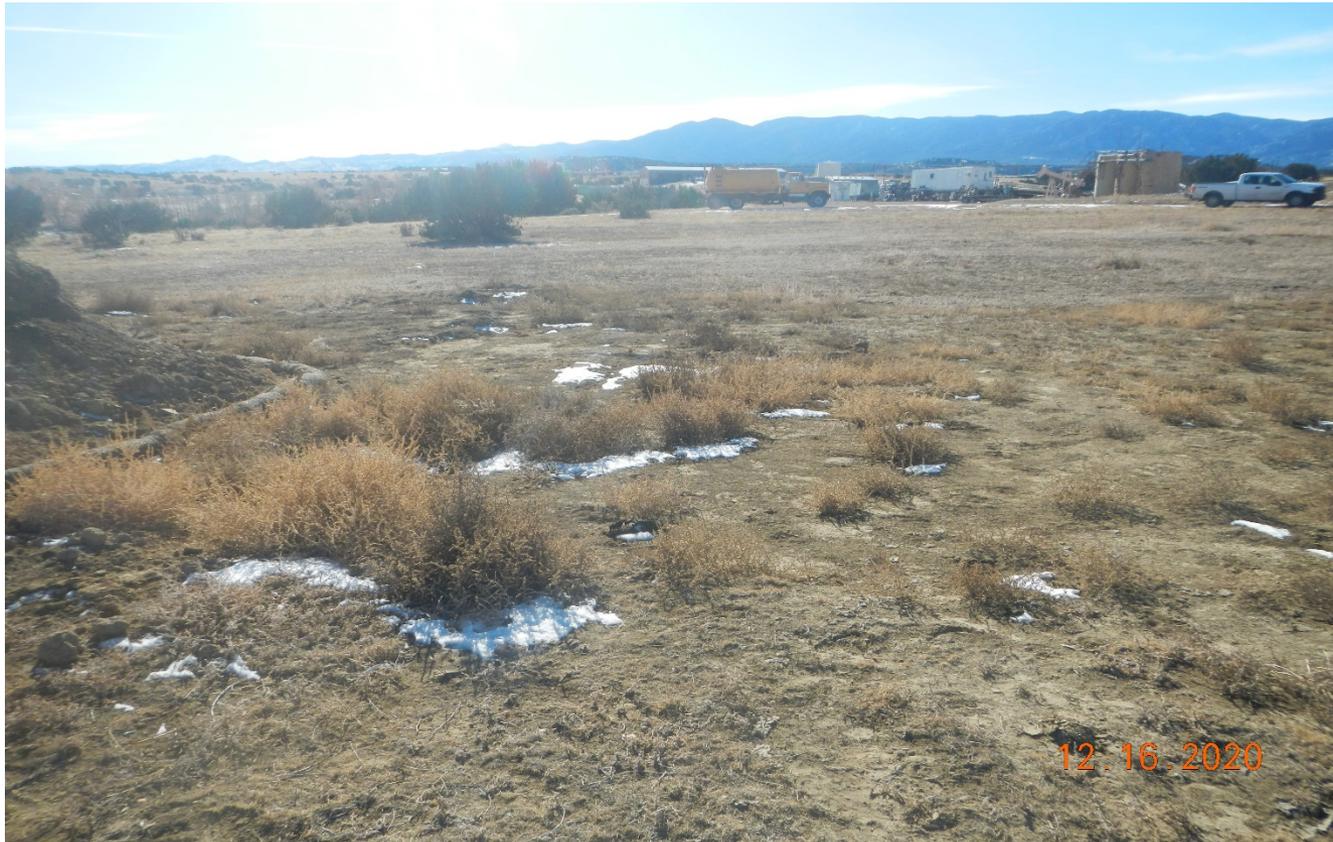
Photo 5. Facing south at the location. The location needs to be reclaimed and weeds need to be controlled.

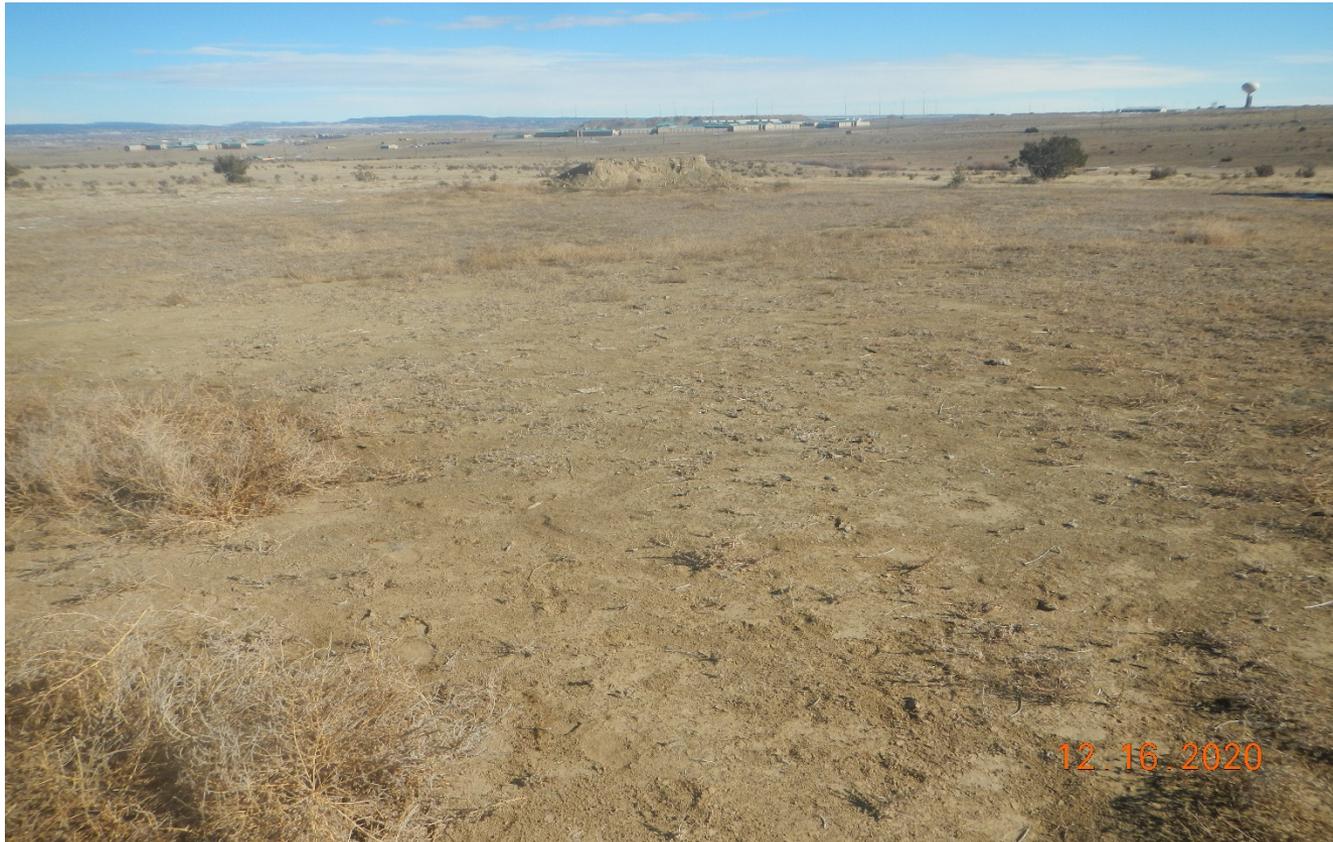
Photo 6. Facing east toward the location. The location needs to be reclaimed to establish vegetation reflective of the surrounding reference area.

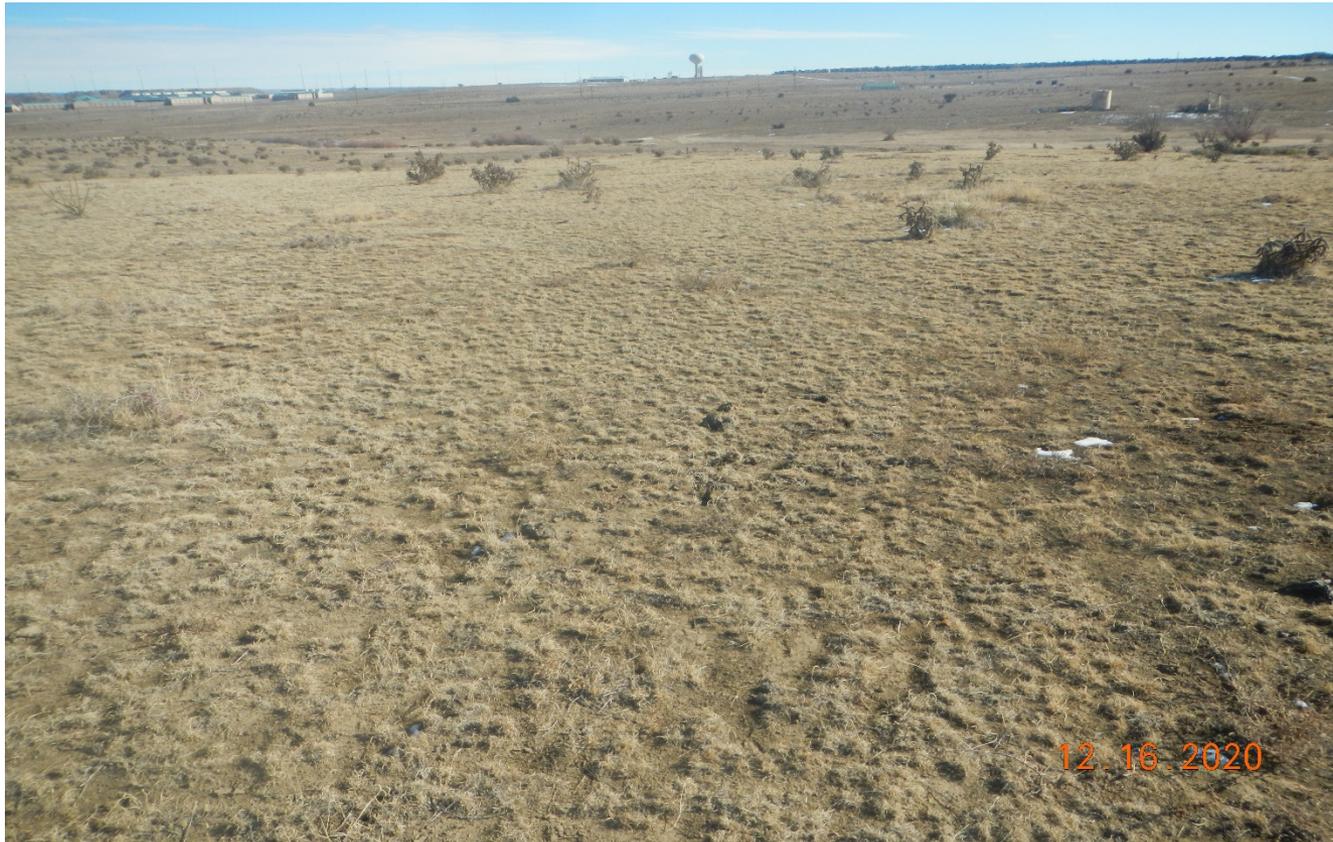
Photo 7. Facing east toward the surrounding reference area which consists of Blue grama grassland.
