Inspection Photos

12/8/2020

Operator: LARAMIE ENERGY LLC - 10433

Location ID: 424970

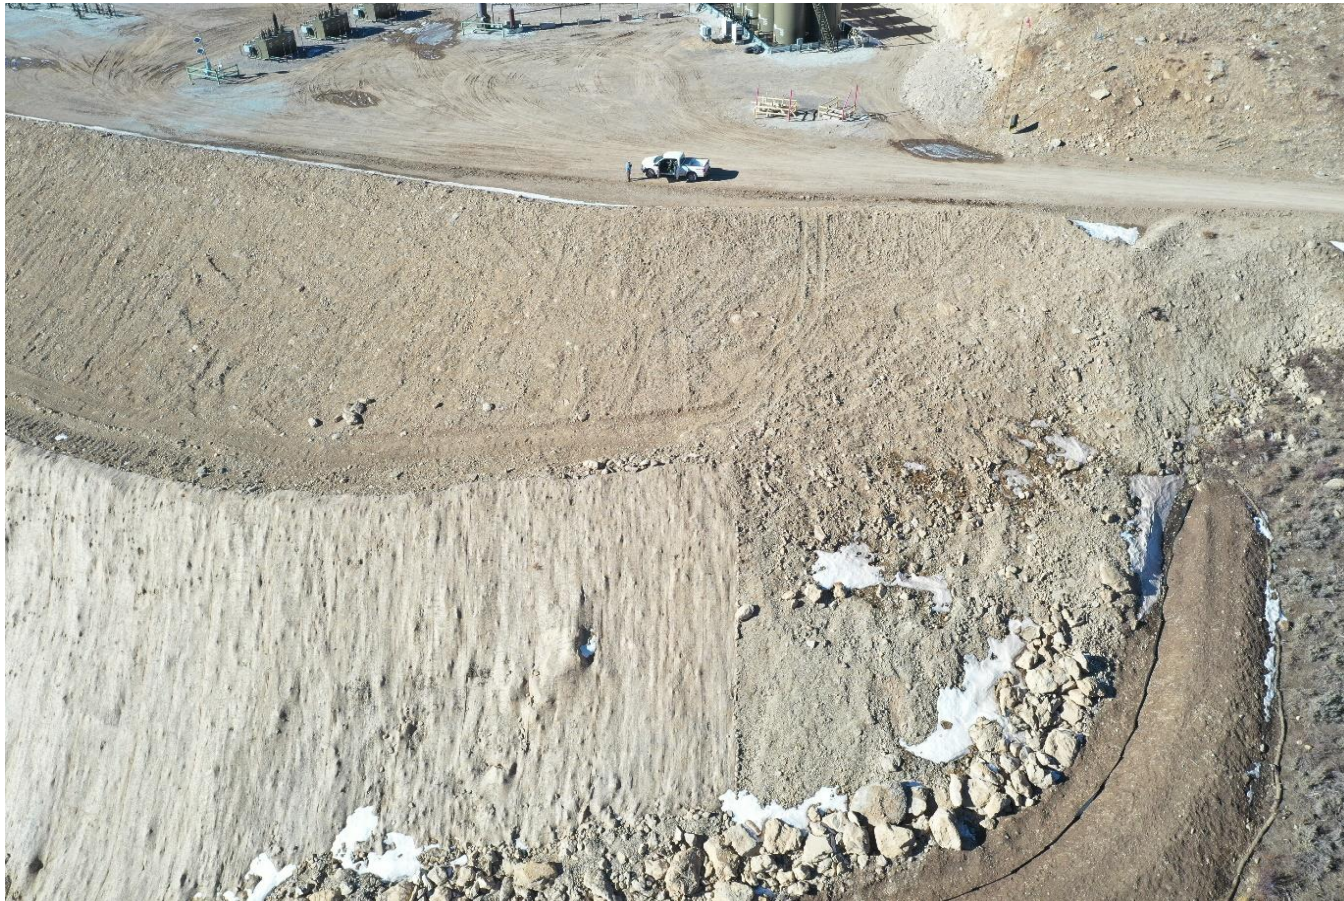
Photo 1: Photo taken with use of a sUAS. Photo taken from the east of the Location, facing west. Photo shows Operator installed erosion blankets on only a portion of the fill slopes. BMPs remain missing or insufficient to protect/stabilize slopes of the Location.

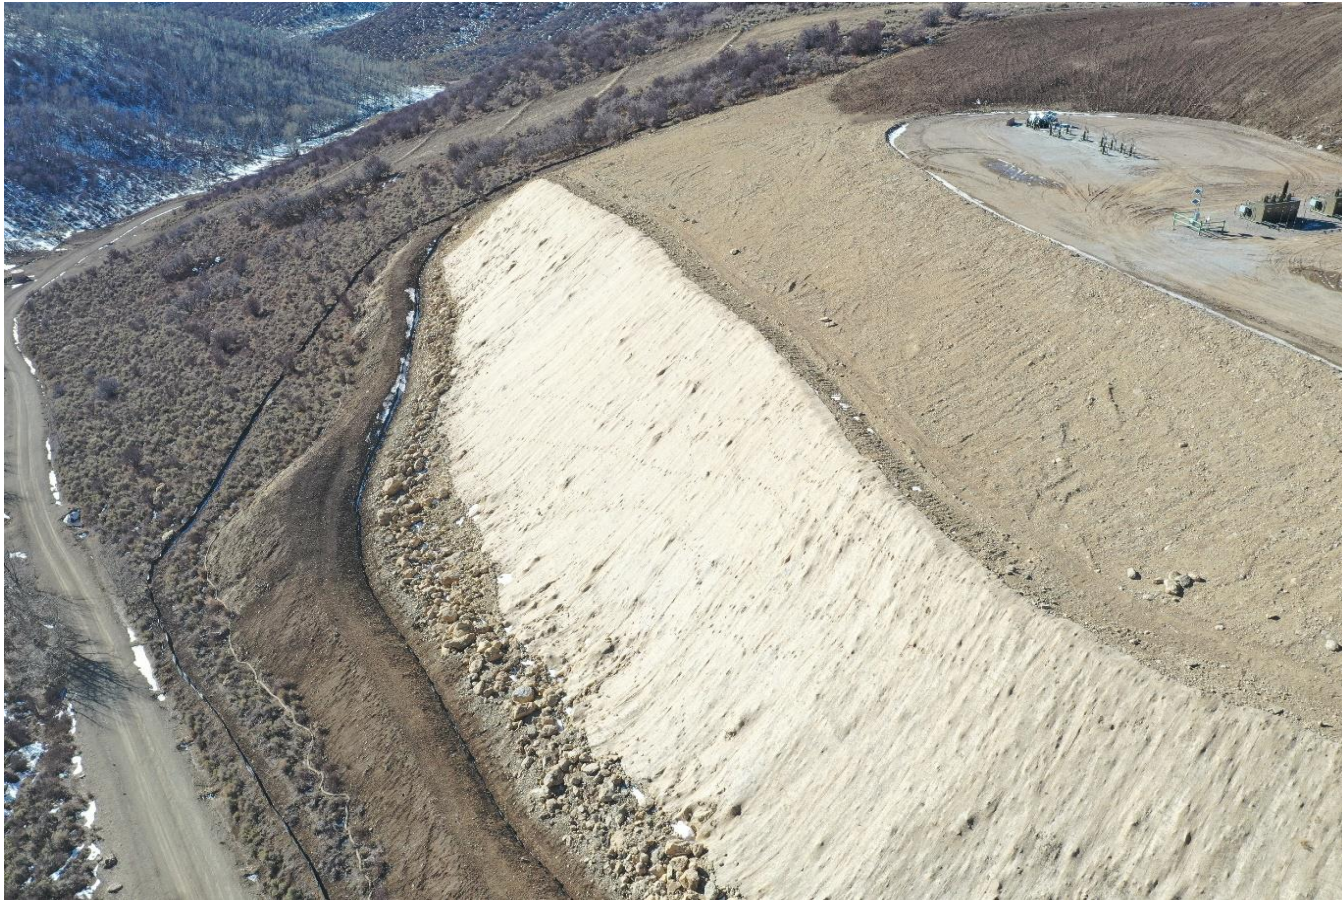
Photo 2: Photo taken with use of a sUAS. Photo taken from the east of the Location, facing south. Photo shows Operator installed erosion blankets on only a portion of the fill slopes. BMPs remain missing or insufficient to protect/stabilize slopes of the Location.

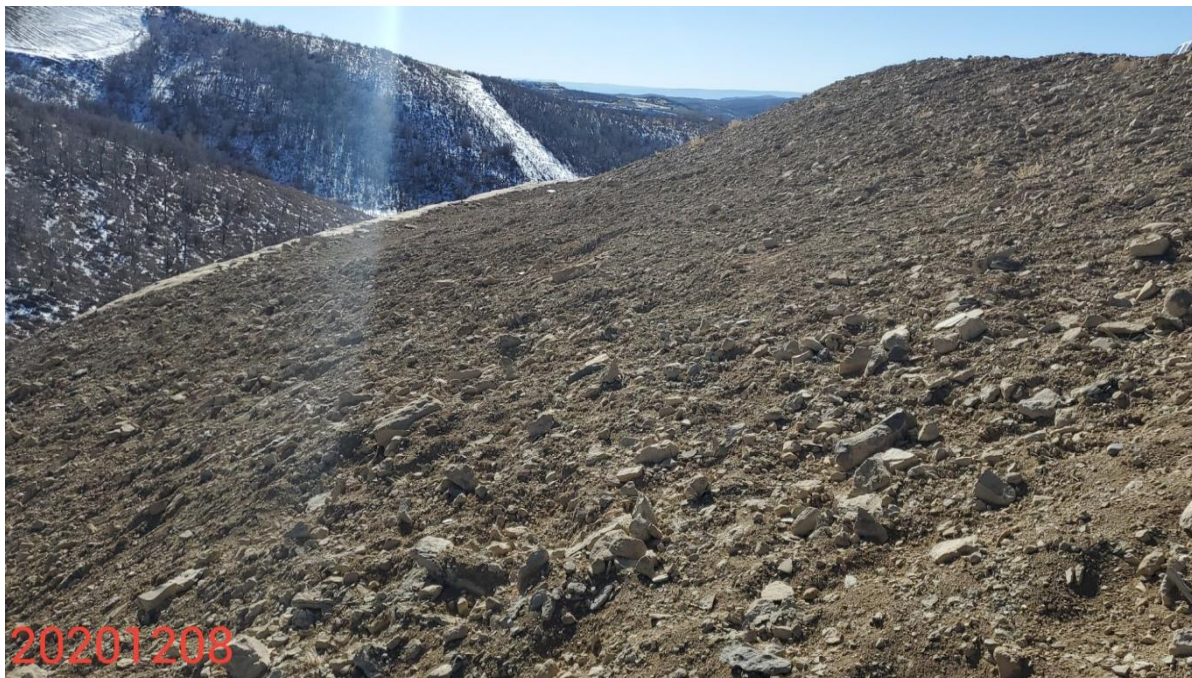
Photo 3: Photo taken from the northeast slopes of the Location, facing south. Photo shows BMPs remain missing or insufficient to protect/stabilize slopes of the Location.

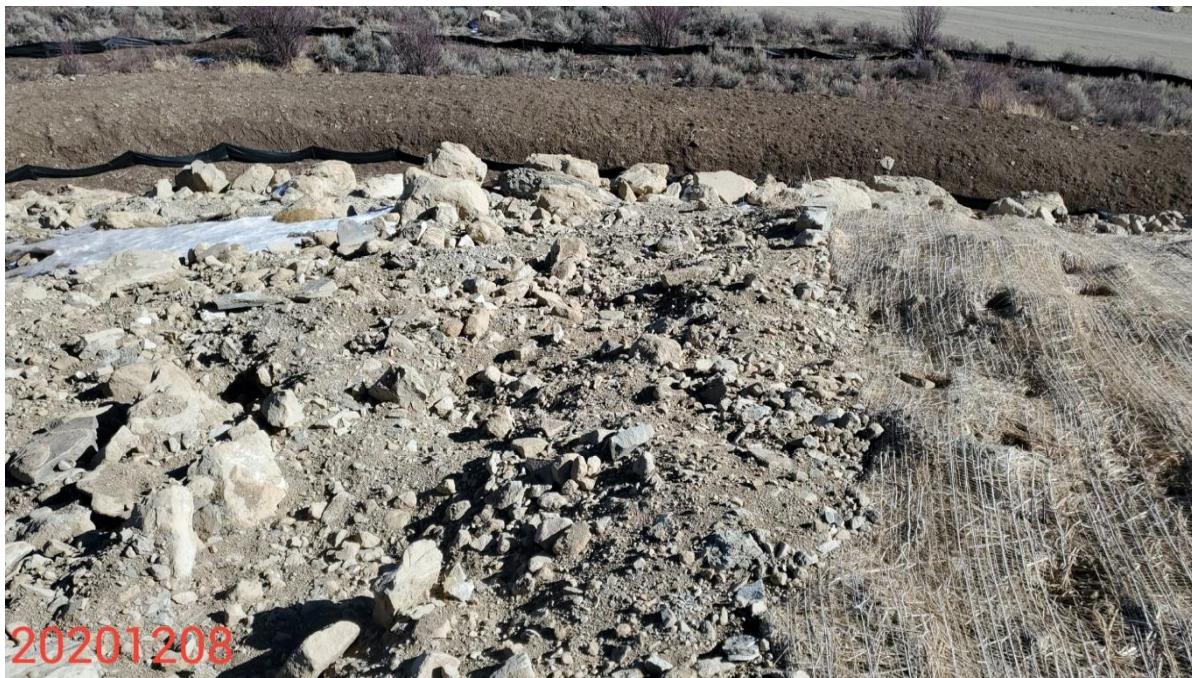
Photo 4: Photo taken from the east of the Location, facing east. Photo shows Operator installed erosion blankets on only a portion of the fill slopes. BMPs remain missing or insufficient to protect/stabilize slopes of the Location.

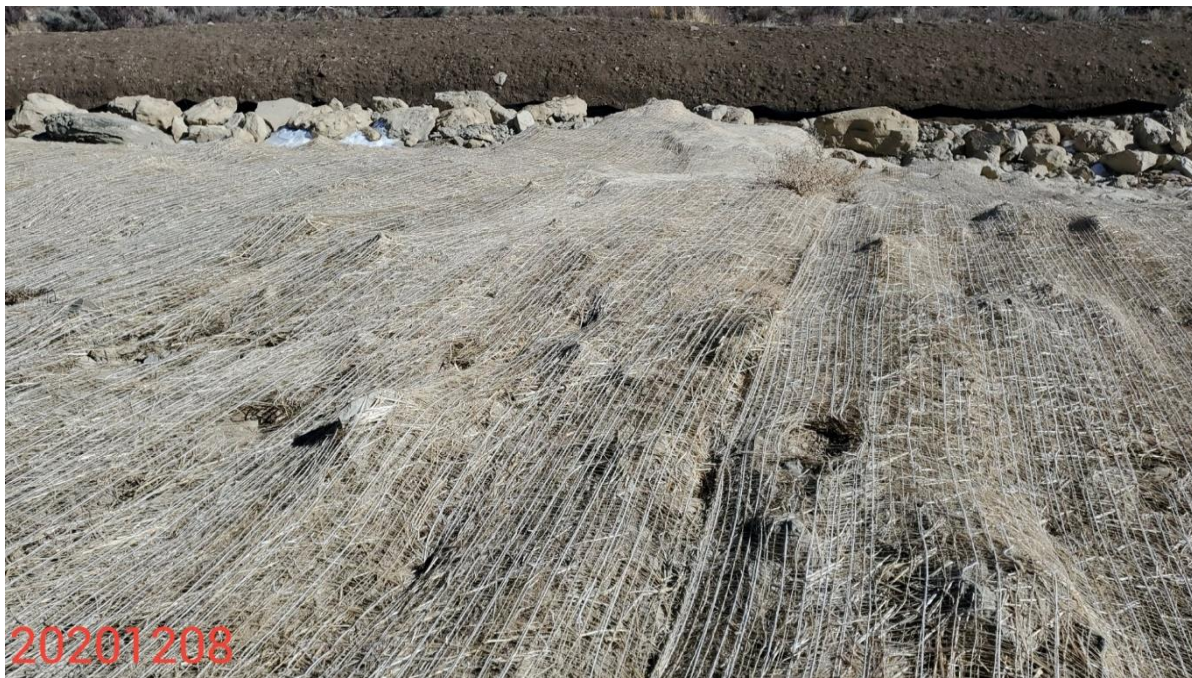
Photo 5: Photo taken from the east slopes of the Location, facing east. Photo shows BMPs do not appear to have uniform soil surface contact.

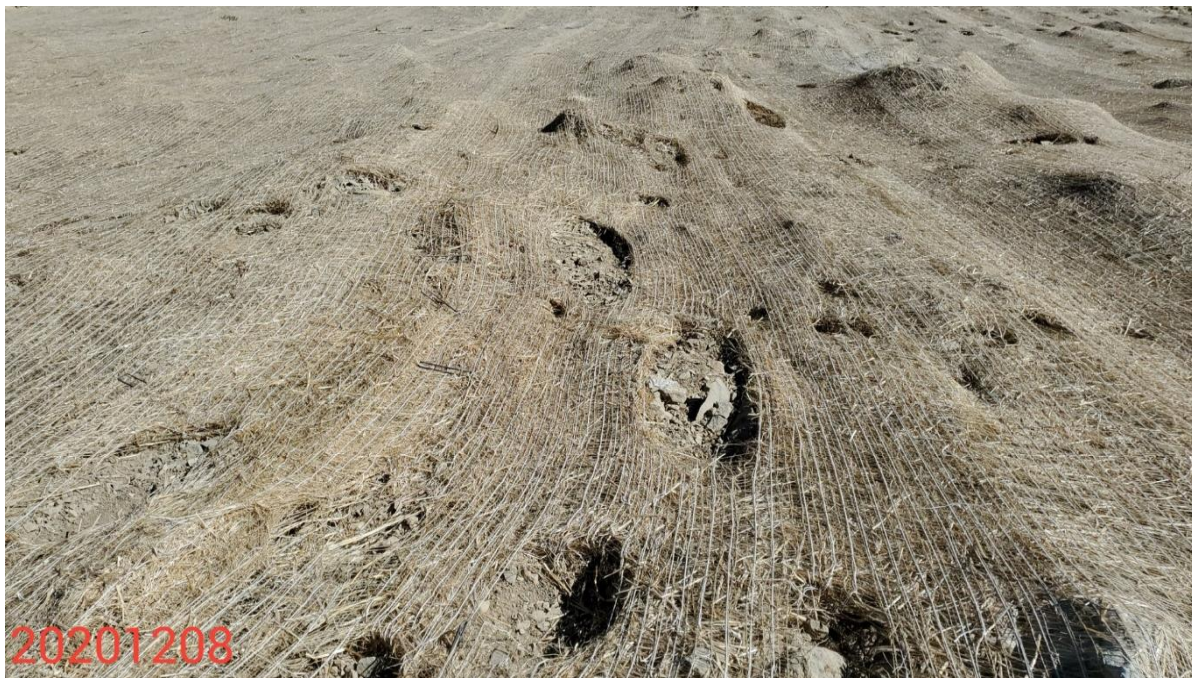
Photo 6: Photo taken from the east slopes of the Location, facing east. Photo shows BMPs do not appear to have uniform soil surface contact. Stakes also appear loose and are being pulled out. BMP also shows sign of degradation.

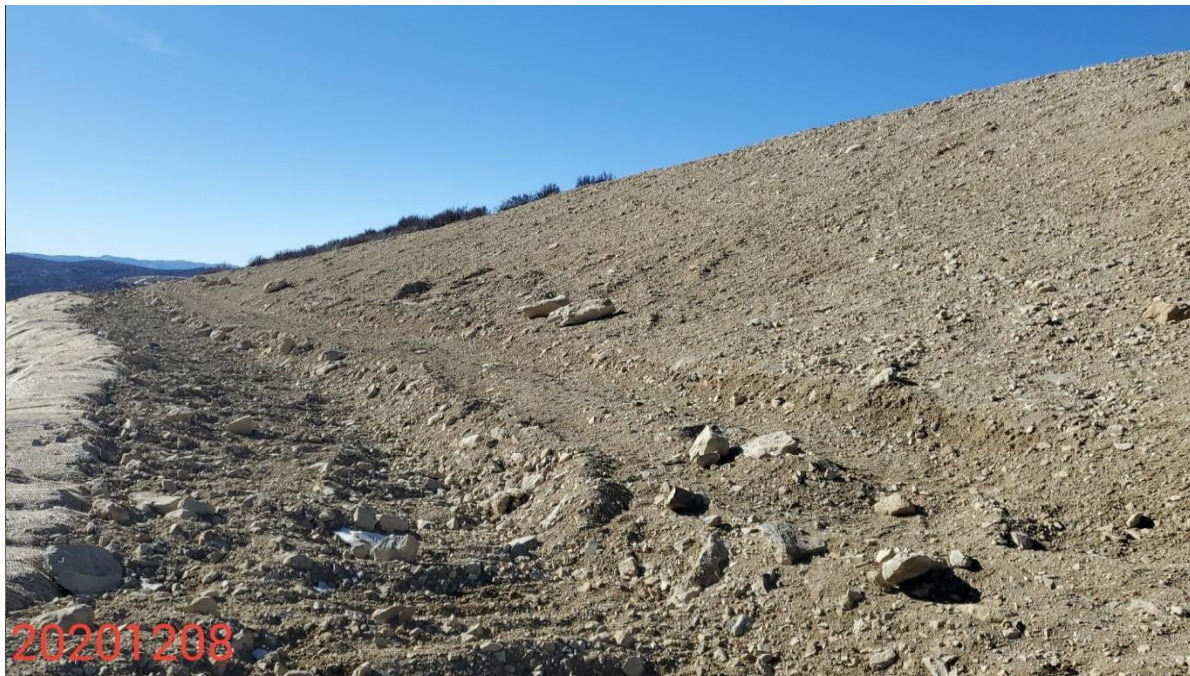
Photo 7: Photo taken from the east slopes of the Location, facing south. Photo shows BMPs remain missing or insufficient to protect/stabilize slopes of the Location.

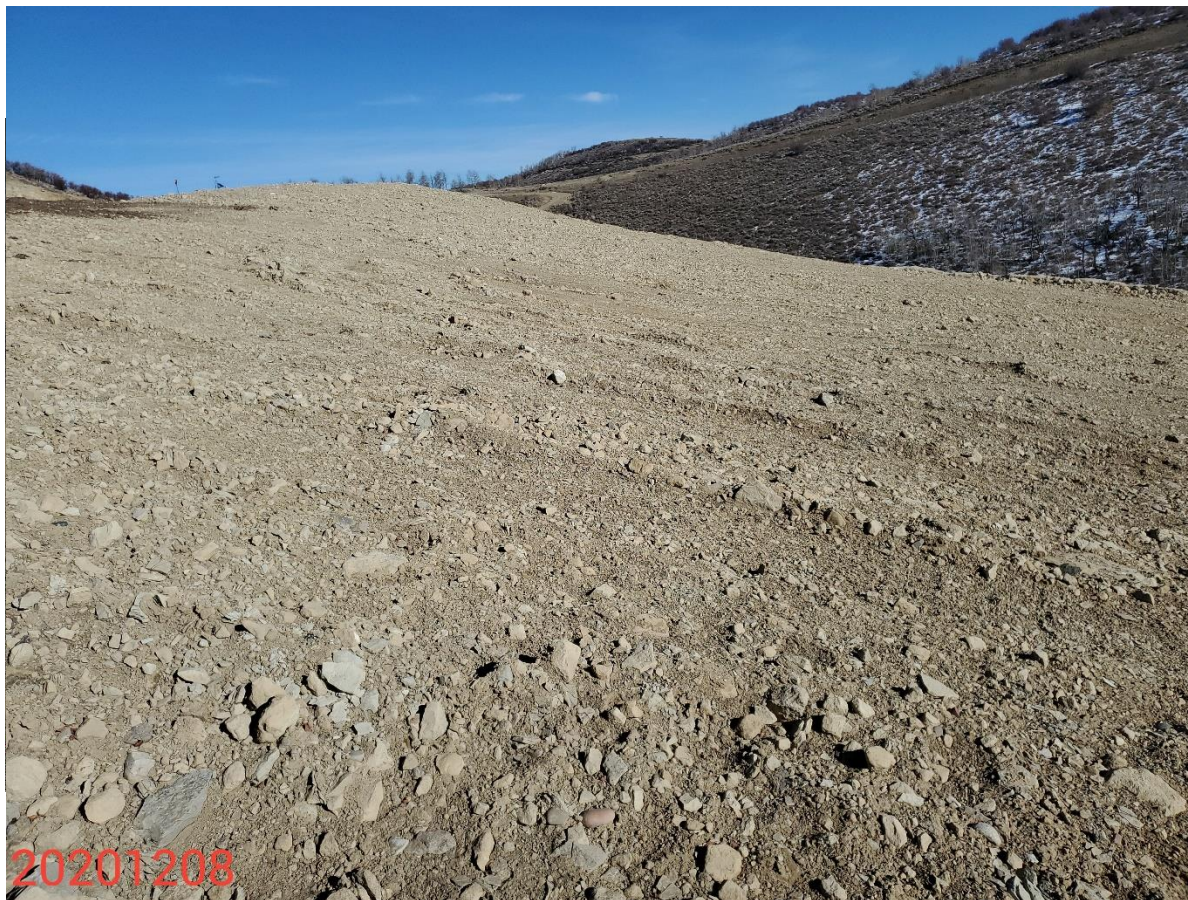
Photo 8: Photo taken from the southeastern areas of the Location, facing north. Photo shows BMPs remain missing or insufficient to protect/stabilize slopes of the Location.

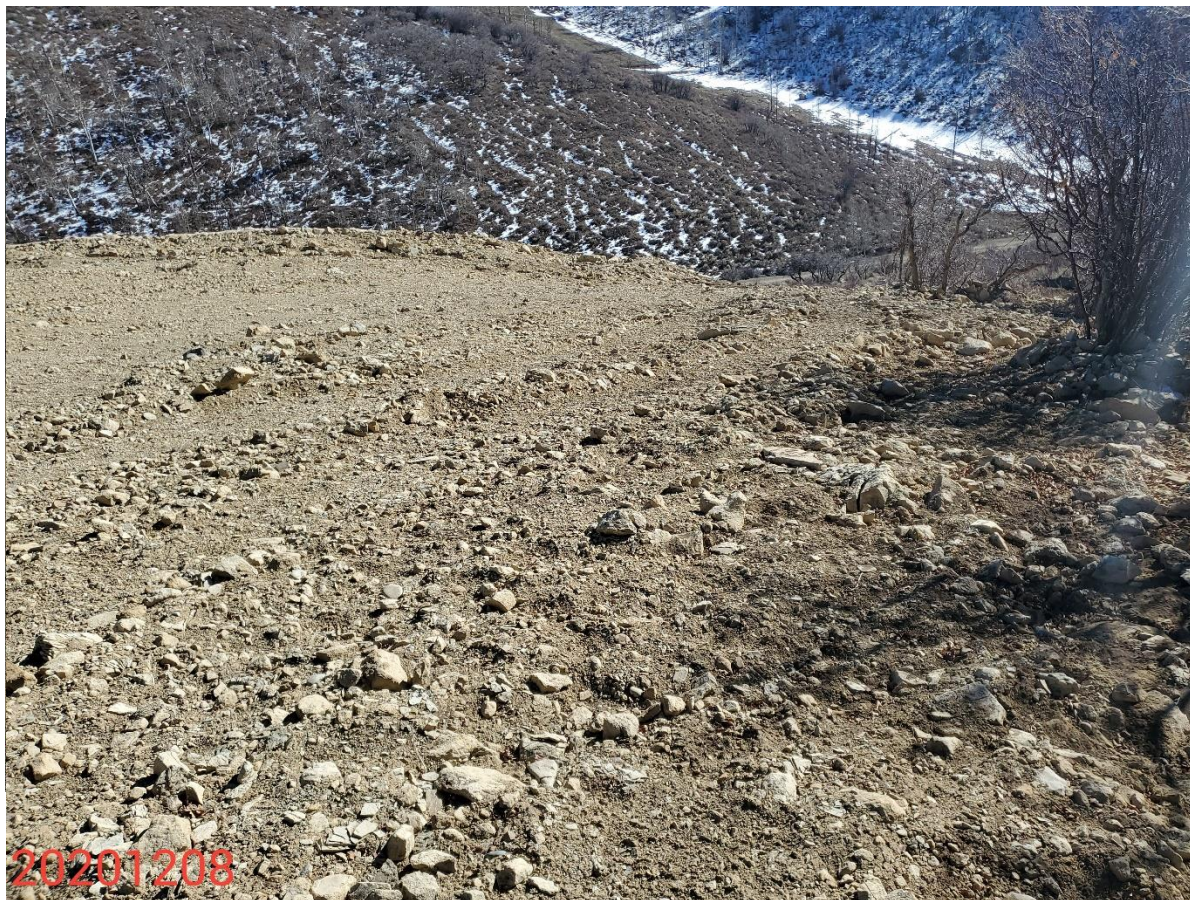
Photo 9: Photo taken from the southeastern areas of the Location, facing east. Photo shows BMPs remain missing or insufficient to protect/stabilize slopes of the Location.

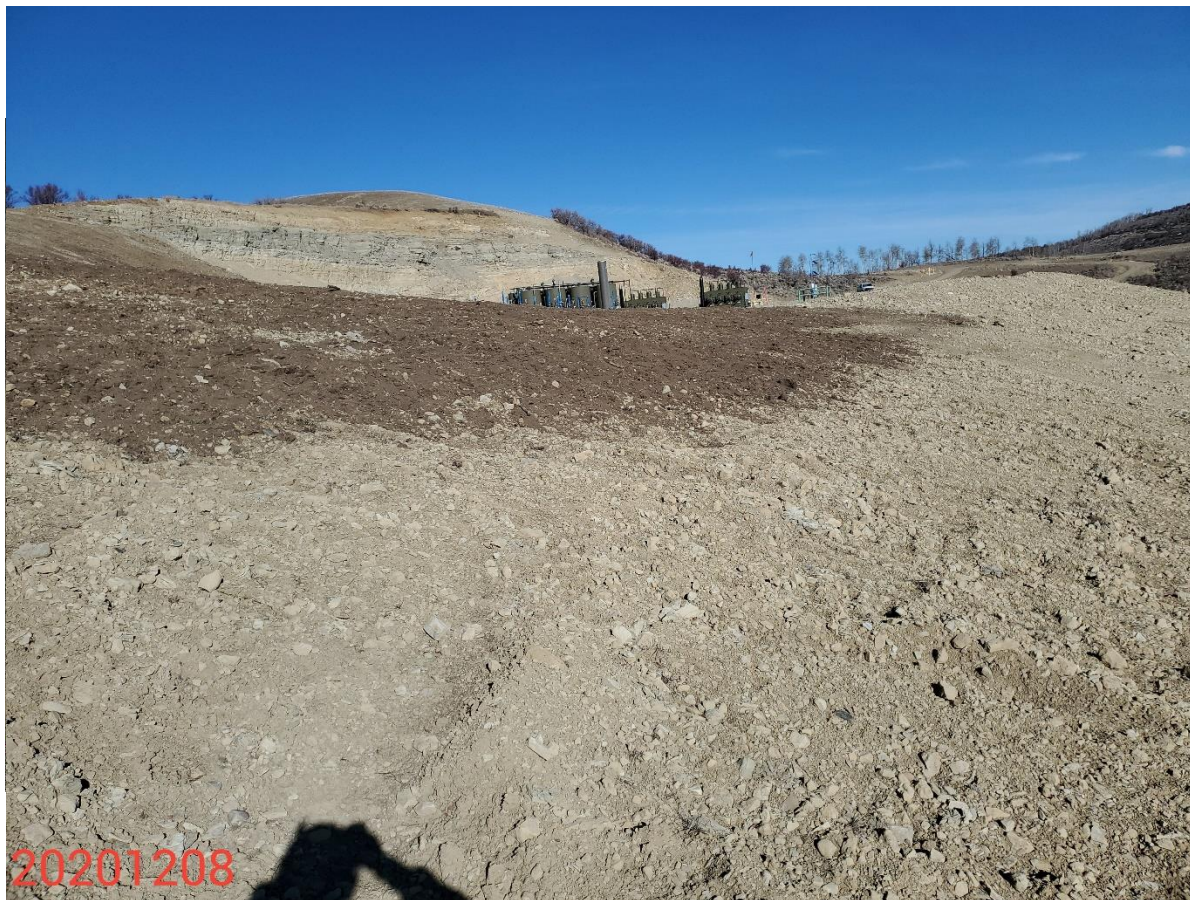
Photo 10: Photo taken from the southern areas of the Location, facing north. Photo shows BMPs remain missing or insufficient to protect/stabilize slopes of the Location.

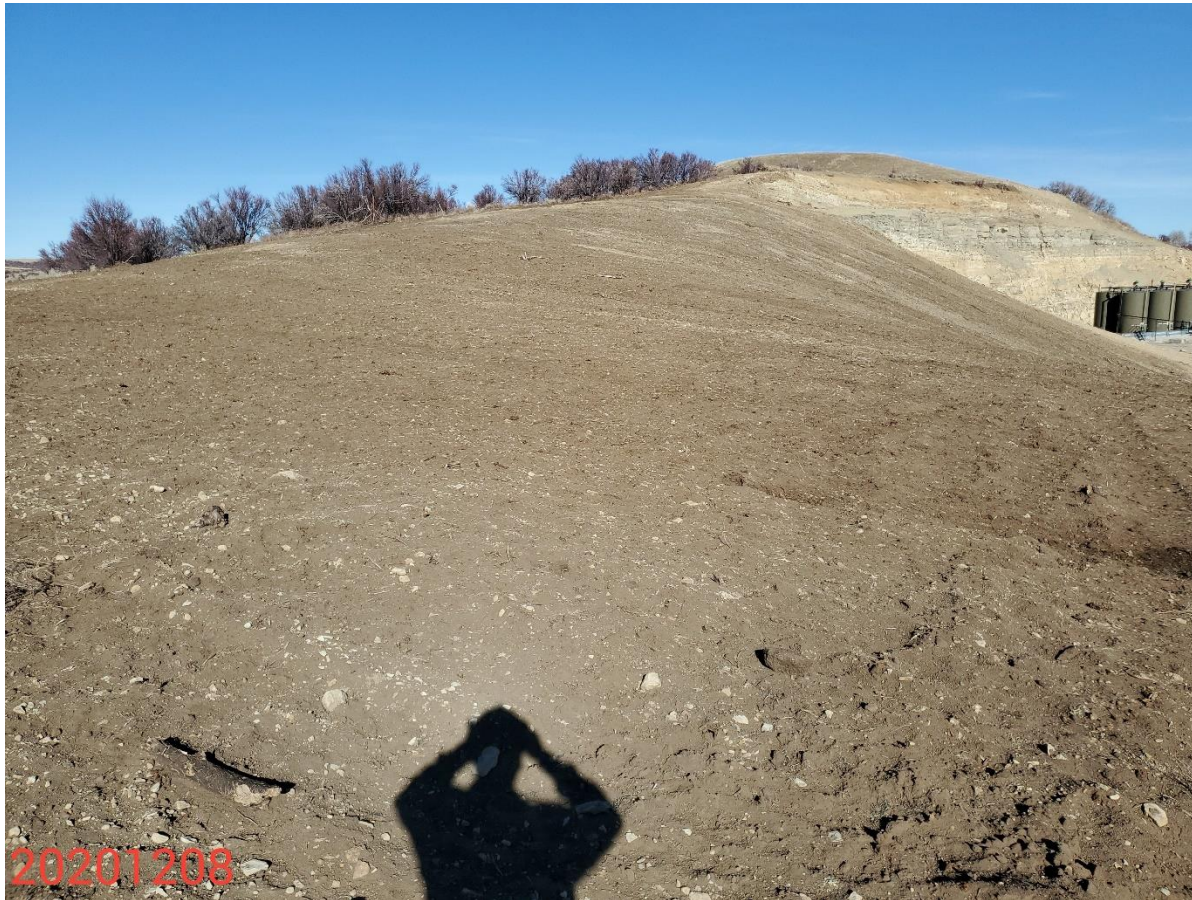
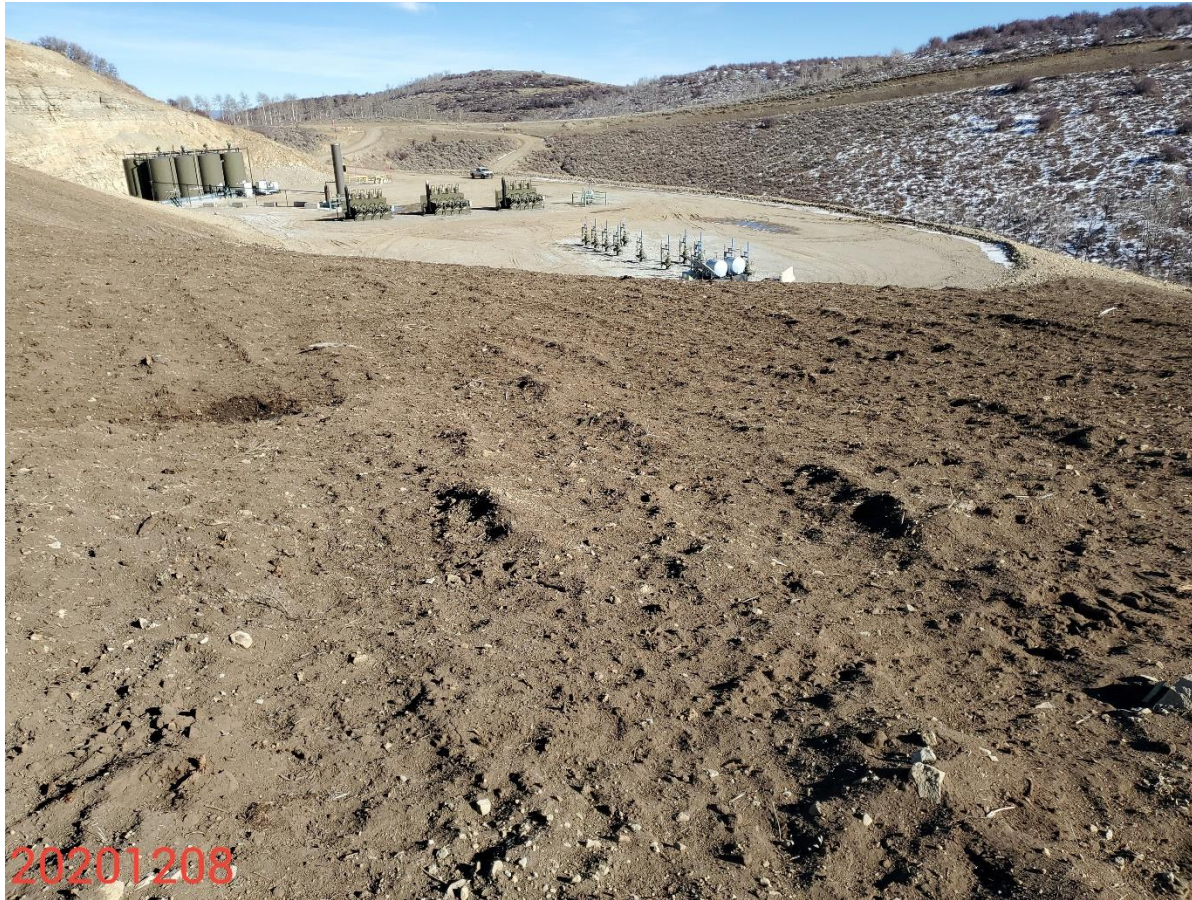
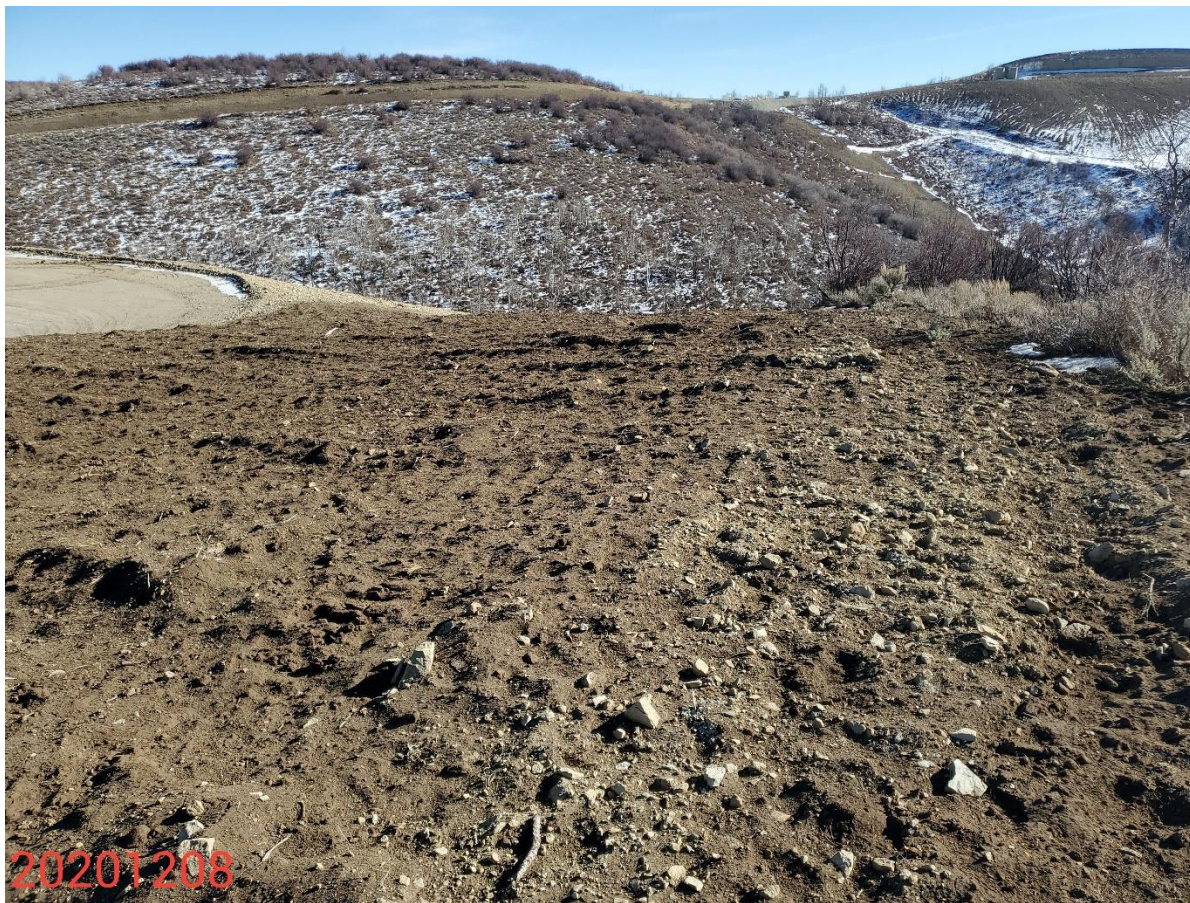
Photo 11: Photo taken from the southwest end of the Location, facing north. Photos 11-13 provide an overview of the Location from north, northeast to east. Photos show BMPs remain missing or insufficient to protect/stabilize slopes of the Location.

Photo 12: See comments under photo 11.

Photo 13: See comments under photo 11.

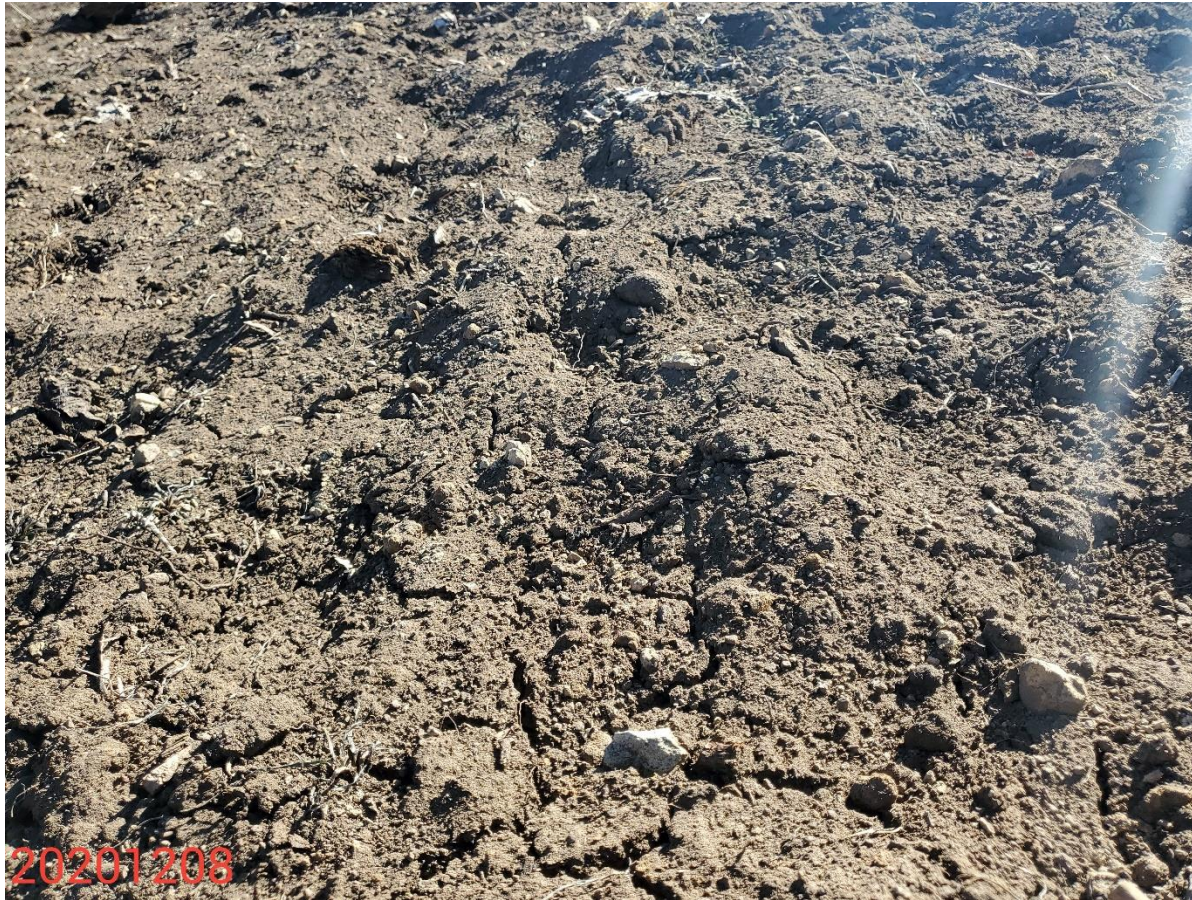
Photo 14: Photo taken from interim areas on the south end of the Location. Photo shows soil surface. Though interim reclamation activities including recontouring and regrading have been conducted, revegetation/seeding activities have not been conducted in accordance with Rule 1003.e.(2).

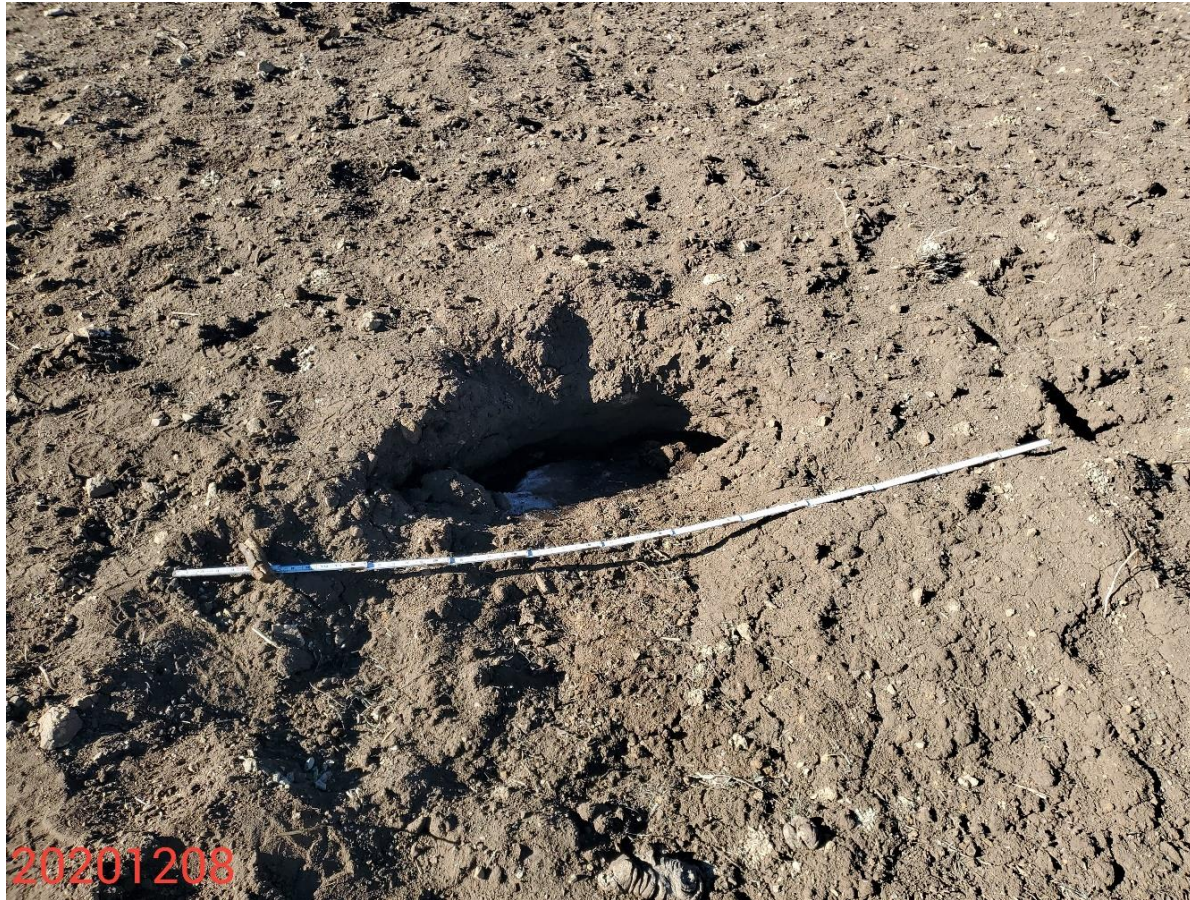
Photo 15: Photo taken from the southern interim areas of the Location. Photo shows cracking within the soils. Crack is currently ~3 feet wide, and 4 feet deep; Soil/Slope stabilization concerns remain evident. 6 foot measuring stick for reference.

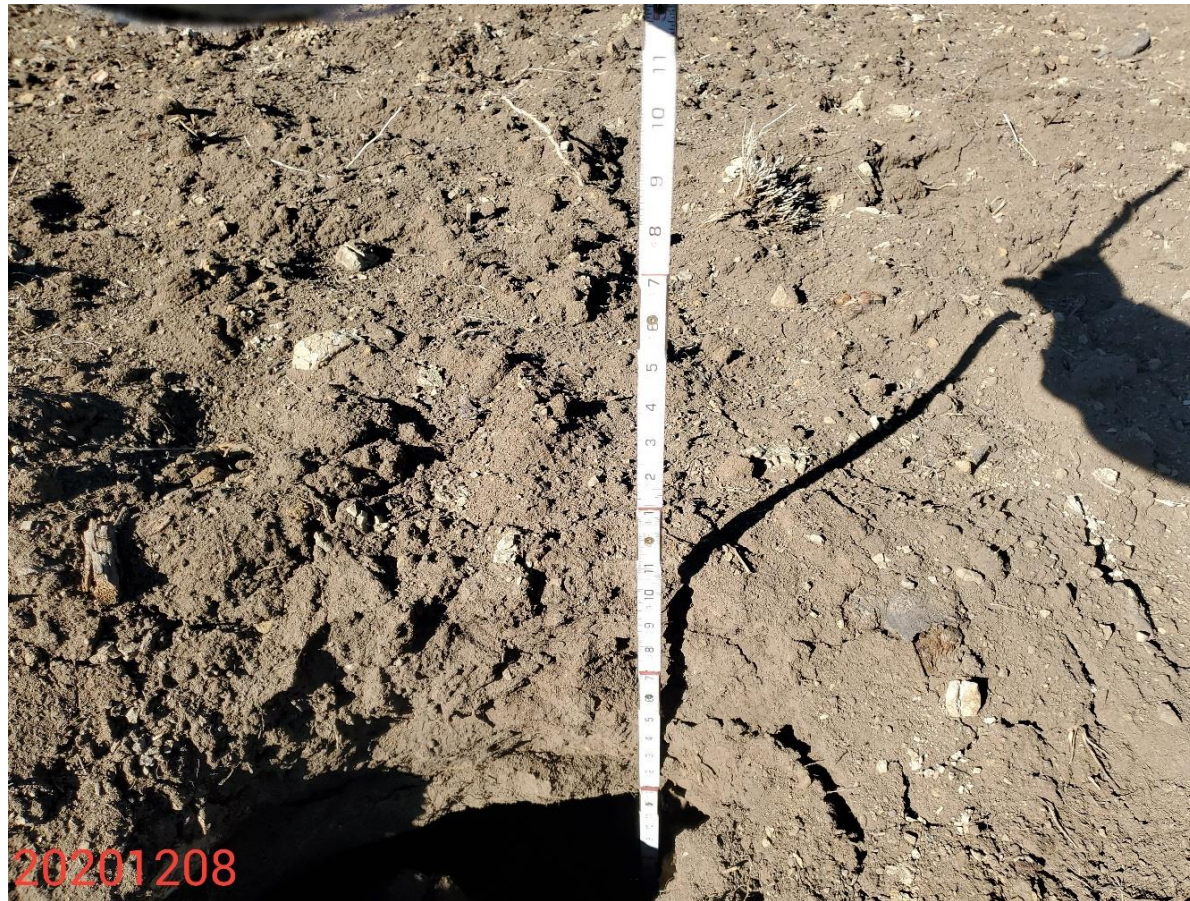
Photo 16: Continued from photo 15. Photo shows crack is ~4 feet deep; Soil/Slope stabilization concerns remain evident. 6 foot measuring stick for reference.

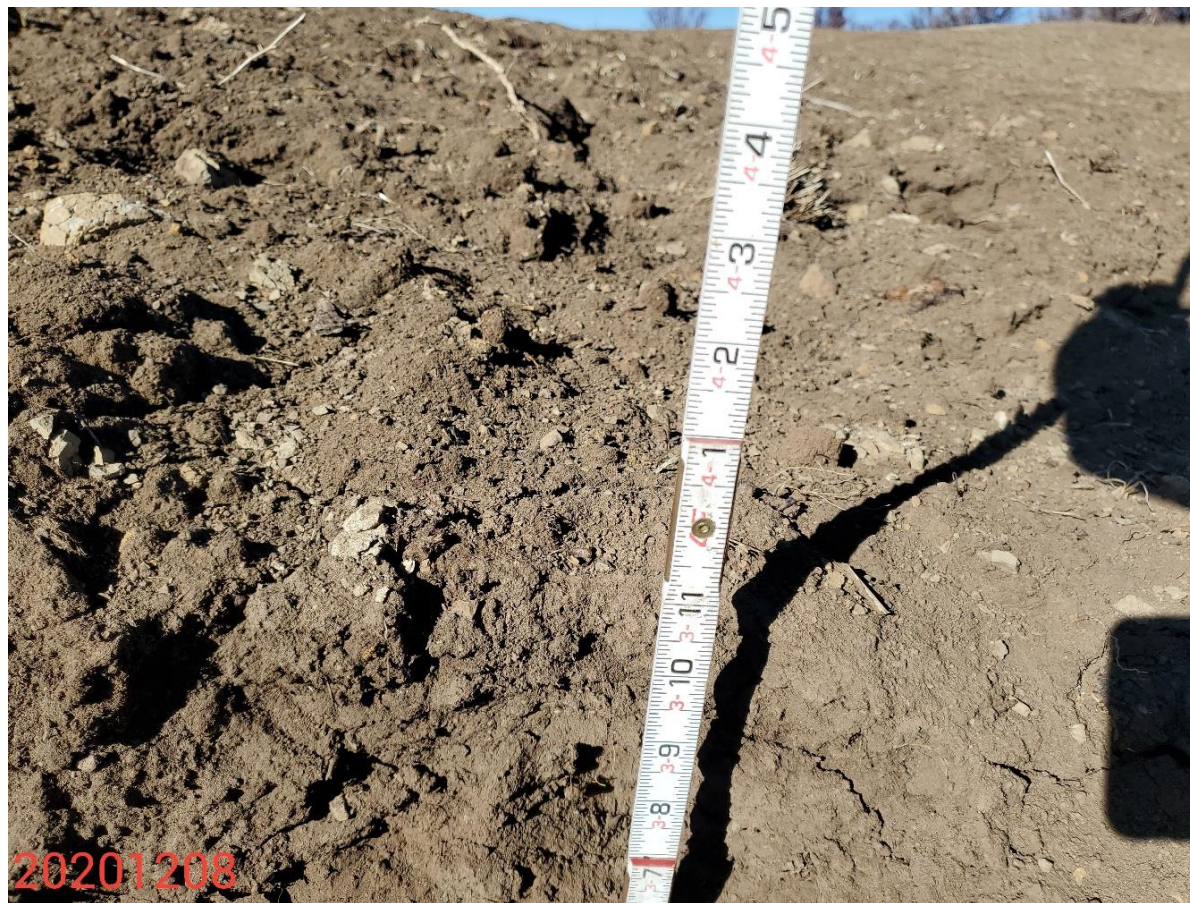
Photo 17: Continued from photo 15. Photo shows crack is ~4 feet deep; Soil/Slope stabilization concerns remain evident. 6 foot measuring stick for reference.

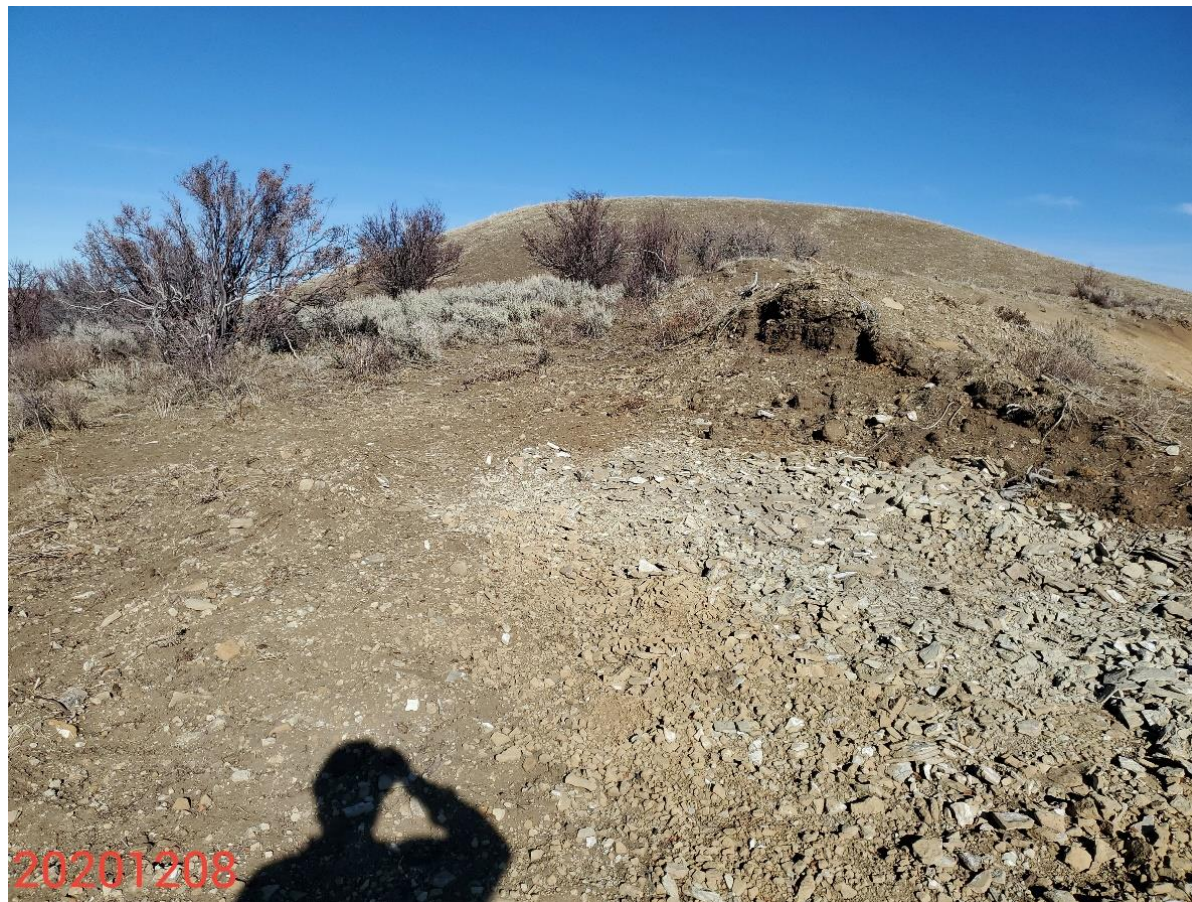
Photo 18: Photo taken from the northwest end of the Location, facing north. Photo erosion/head cutting evident on soil berms/stockpiles on the northwest end of the Location. BMPs remain missing or insufficient to protect/stabilize slopes/soils

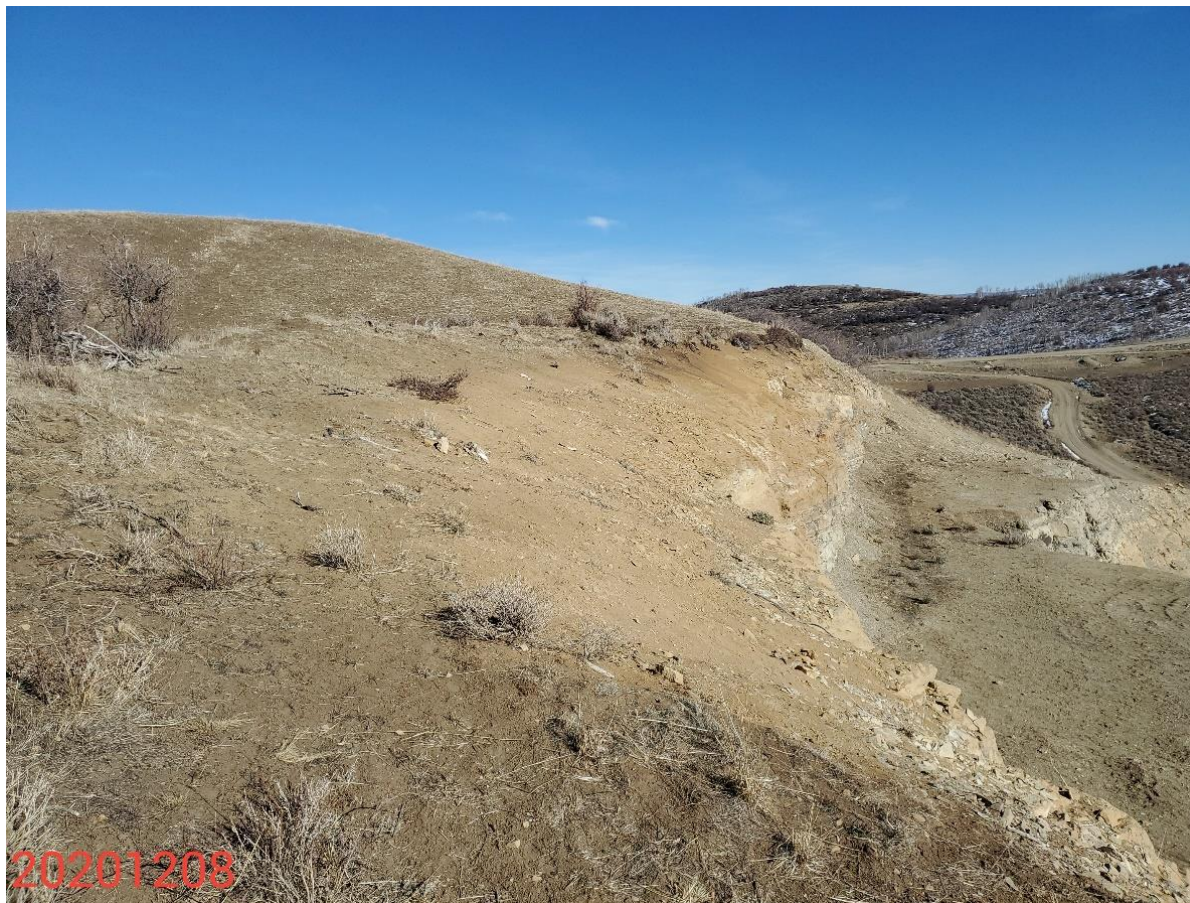
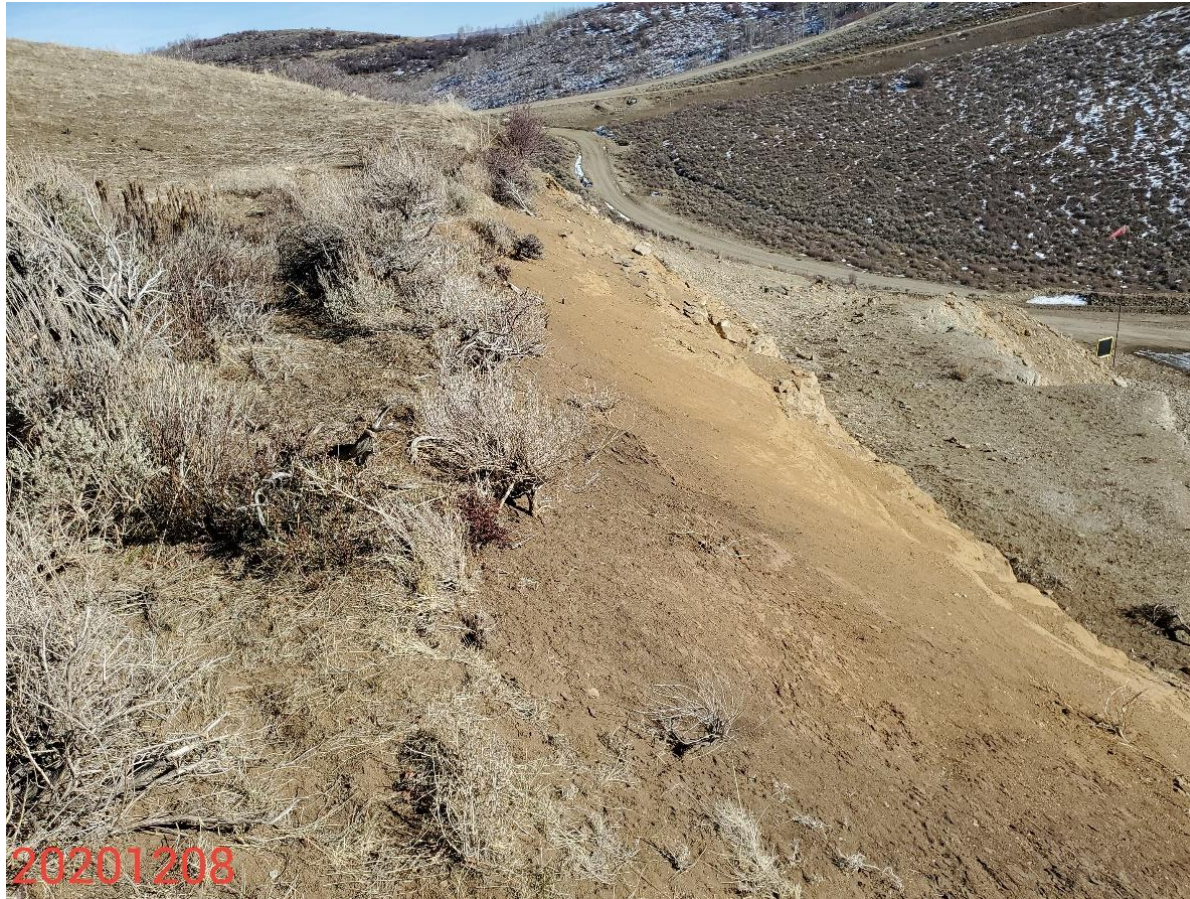
Photo 19: Photo taken from the northwest end of the Location, facing northeast. Photo shows BMPs remain missing or insufficient to protect/stabilize slopes/soils

Photo 20: See comments under photo 19.

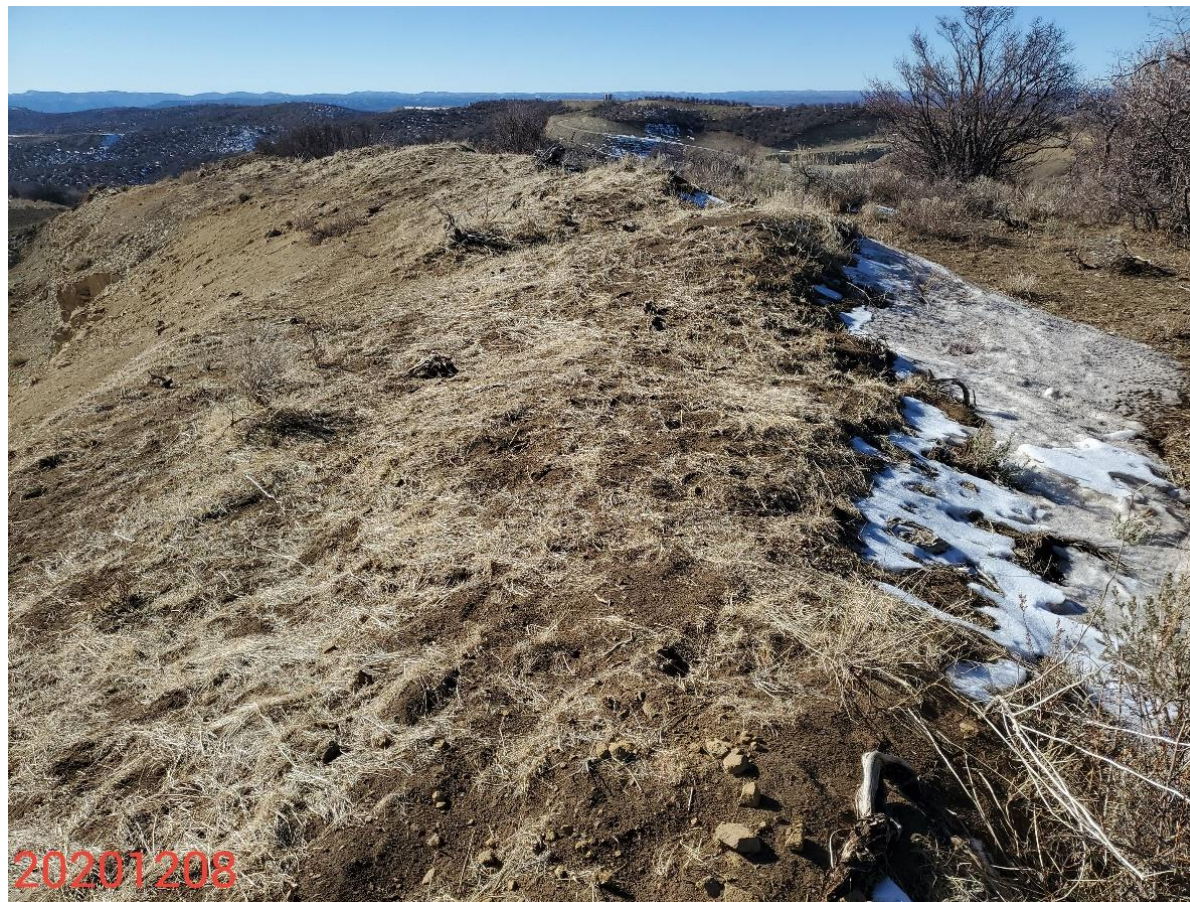
Photo 21: Photo taken from the northwest end of the Location, facing south. Photo erosion/head cutting evident on soil berms/stockpiles on the northwest end of the Location. BMPs remain missing or insufficient to protect/stabilize slopes/soils.
