Inspection Photos

12/8/2020

Operator: LARAMIE ENERGY LLC - 10433

Location ID: 424970

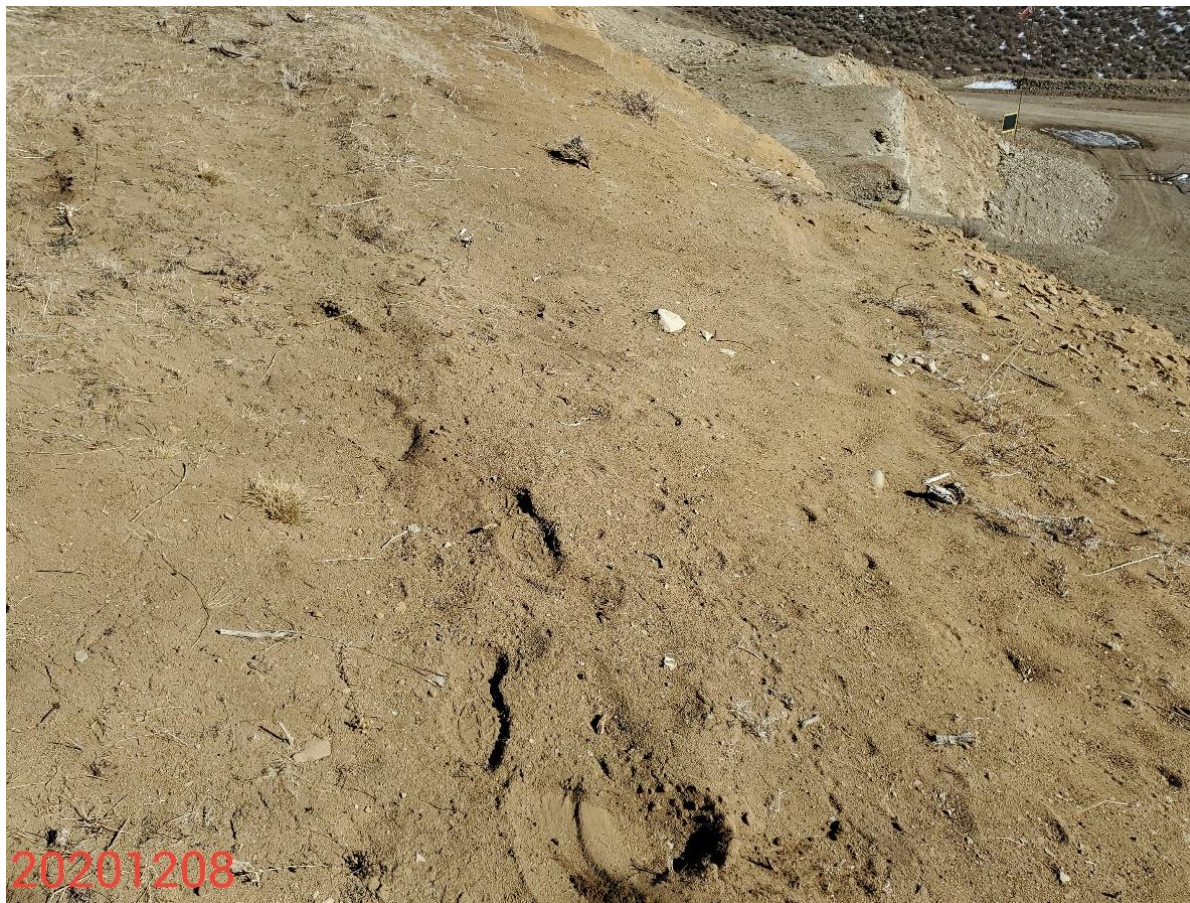
Photo 22: Photo taken from the northwest end of the Location, facing northeast. Photo shows BMPs remain missing or insufficient to protect/stabilize slopes/soils.

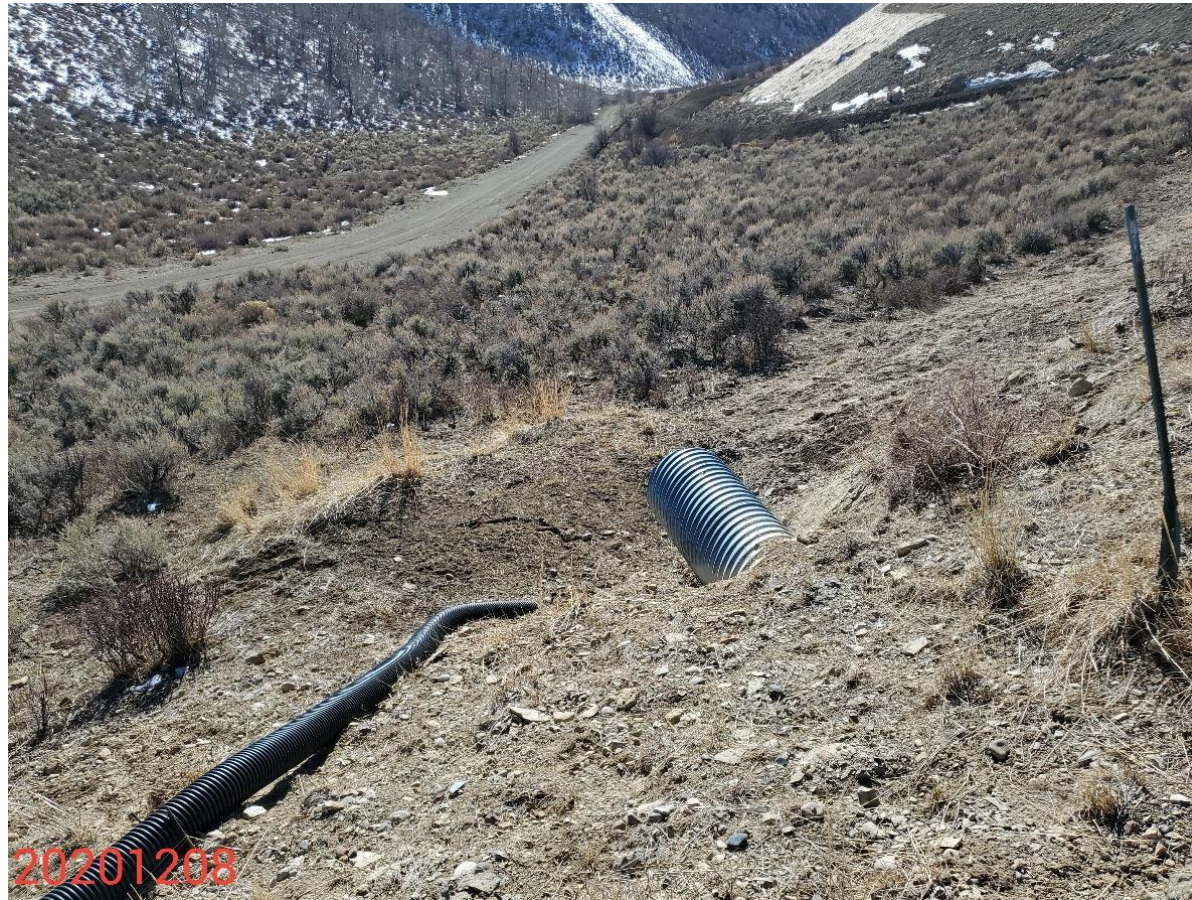
Photo 23: Photo taken from the access road north of the Location, facing southeast. Photo shows culvert and pipe. BMPs missing inlet/outlet protection and armoring in accordance with good engineering practices.

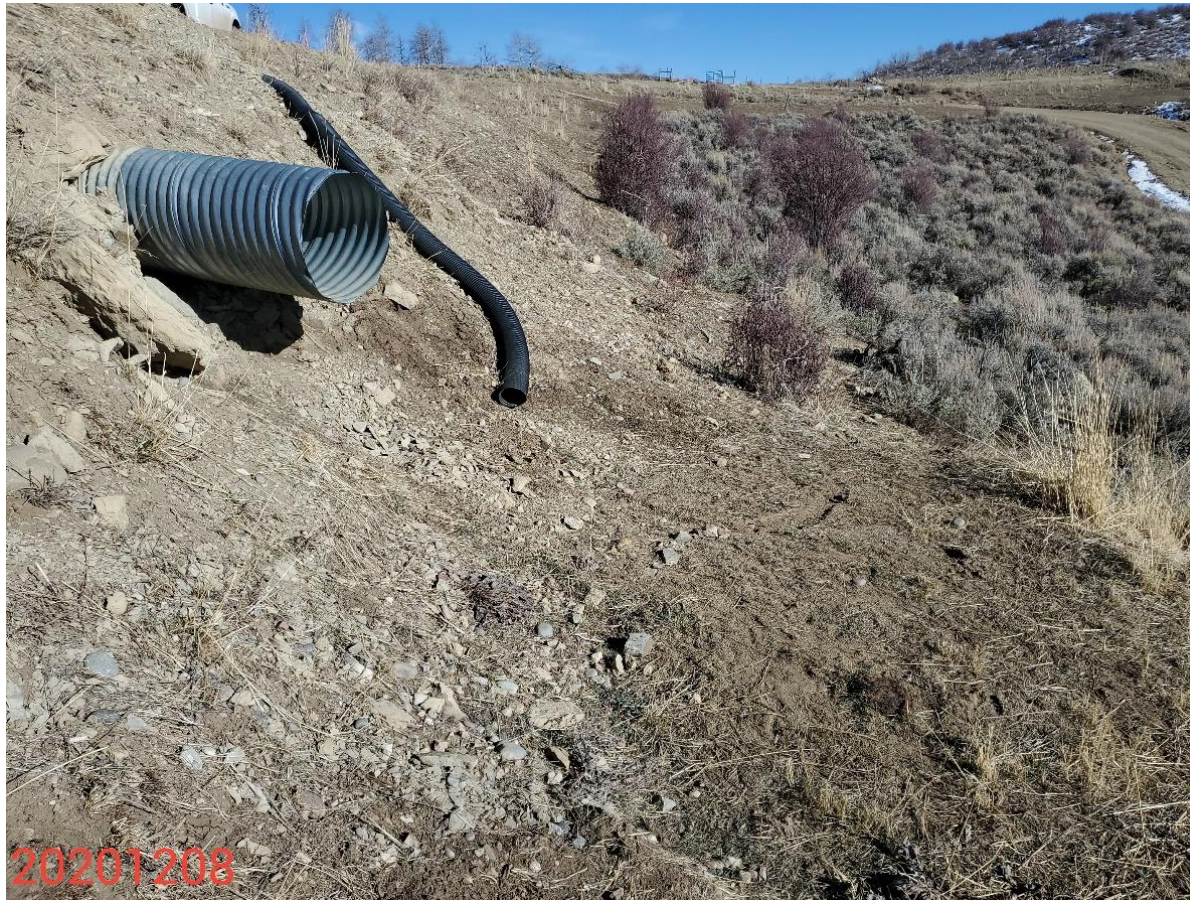
Photo 24: Photo taken from the access road north of the Location, facing north. Photo shows culvert and pipe. BMPs missing inlet/outlet protection and armoring in accordance with good engineering practices.
