# Inspection Photos

Operator: Enduring Resources  
API: 067-09614  
Date: 12/22/2020

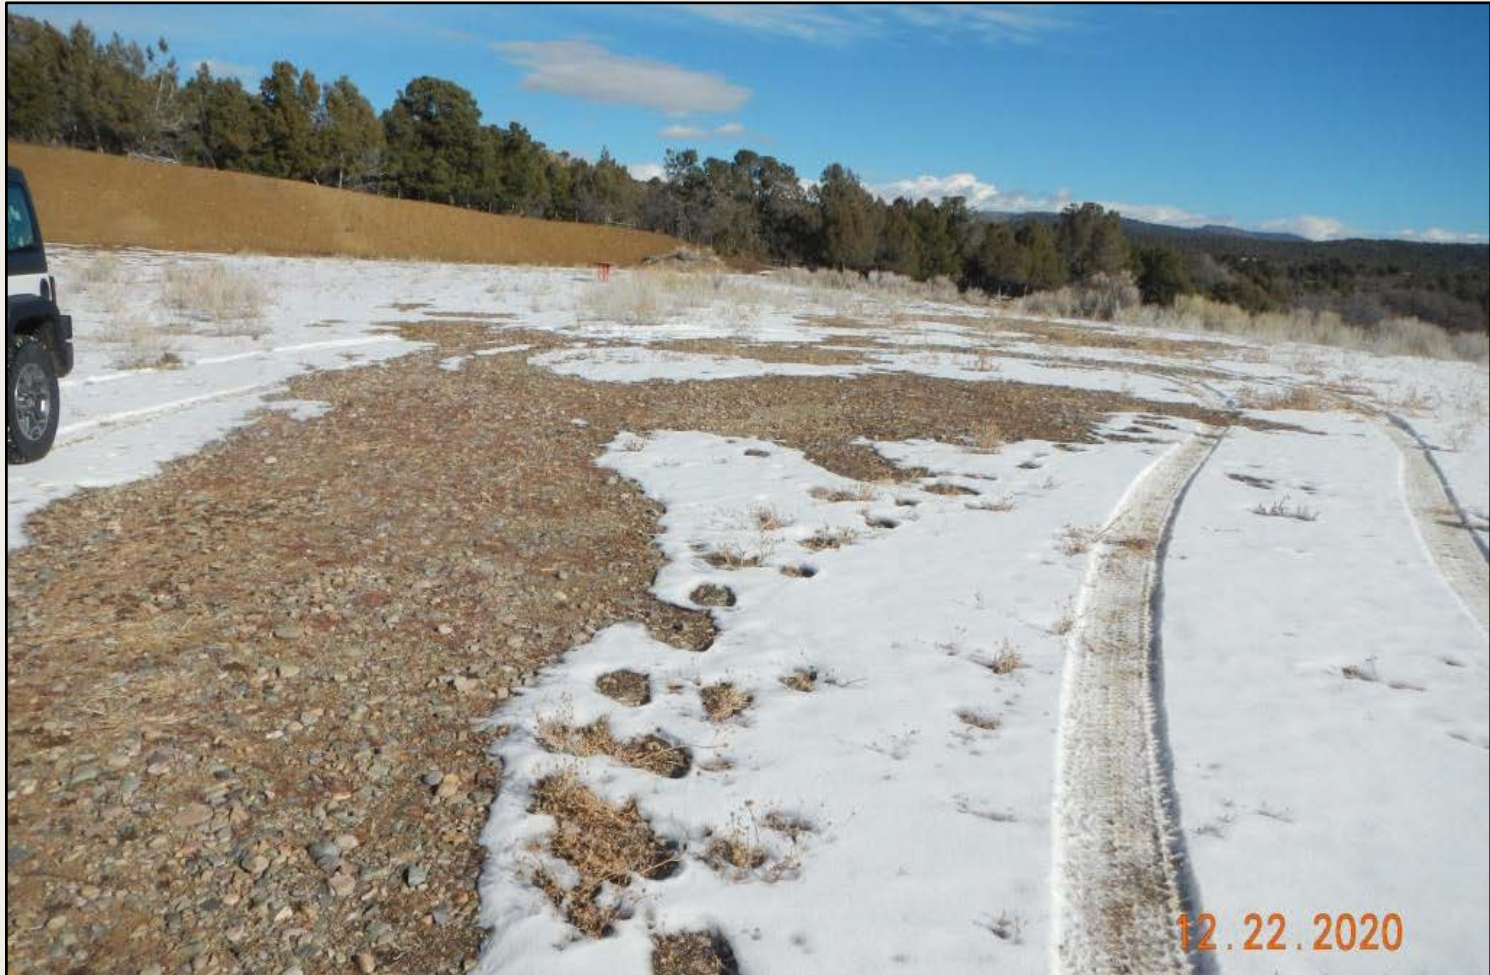
Photo 1. View of the project area from the well pad entrance facing center.

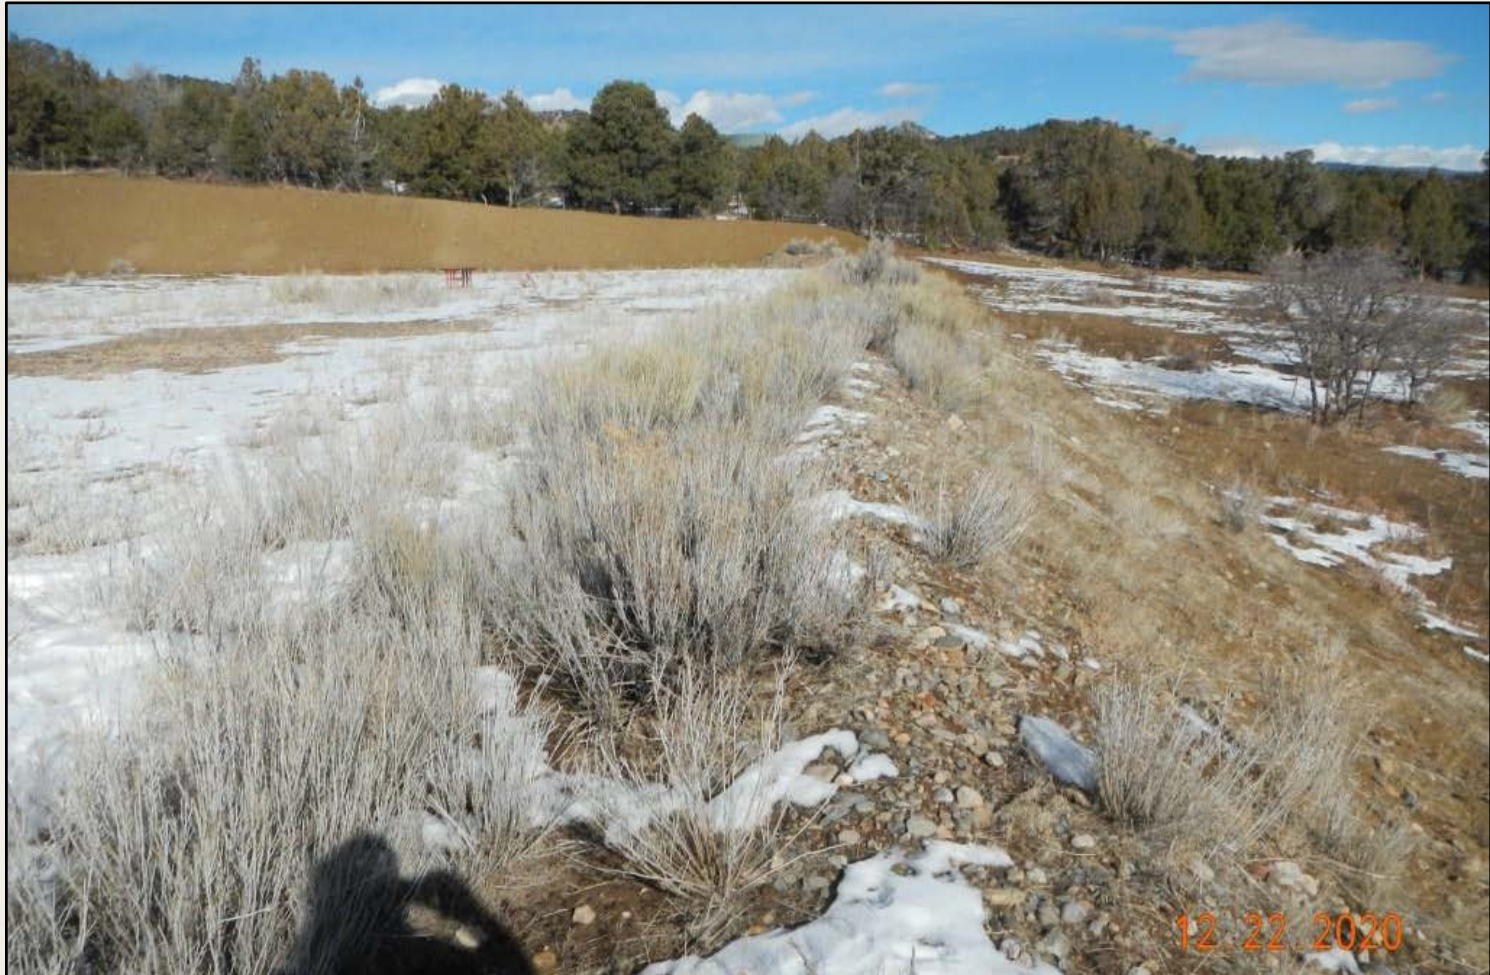
Photo 2. View of the eastern fill slope from the southeastern corner facing northward. Some desirable vegetation observable through snow, although thorough assessment was not conducted.

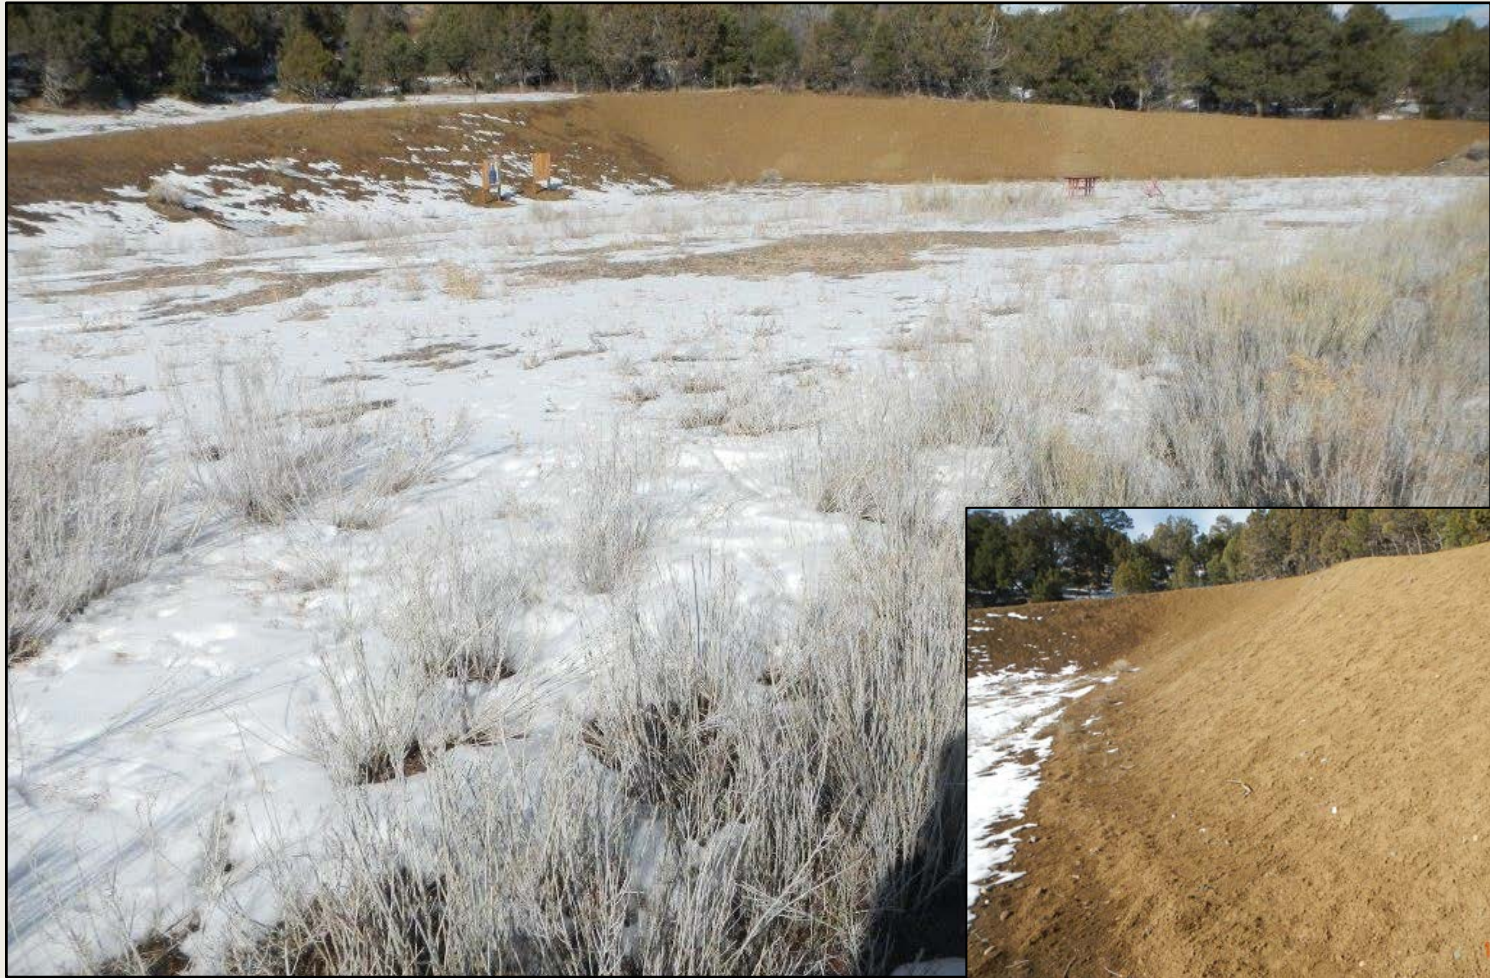
Photo 3. View of project area from the southeastern corner facing center. Inset shows a closeup of cut-slope. Little desirable vegetation. Per Condition of approval for variance, operator needs to establish vegetation and stabilize cut-slopes.

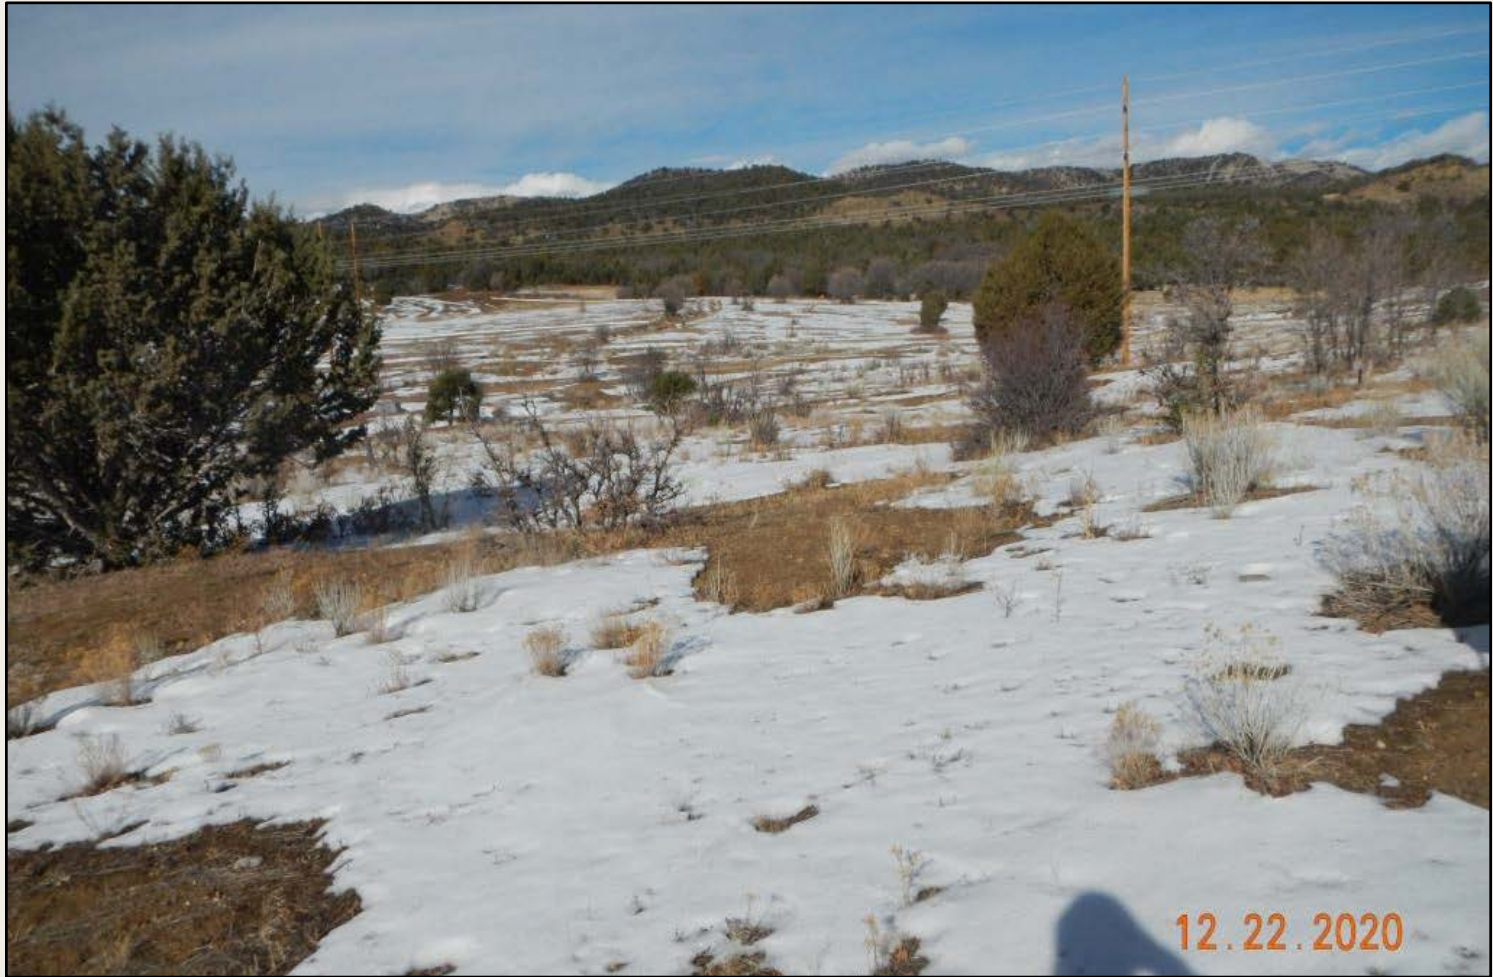
Photo 4. View of reference area comprised of open pinyon and juniper woodland with gambel oak, rubber rabbitbrush, snakeweed, and Indian ricegrass.
