Inspection Photos

API: 009-06081

Operator: DOVER ATWOOD CORPORATION

Inspection Date: 12/29/2020

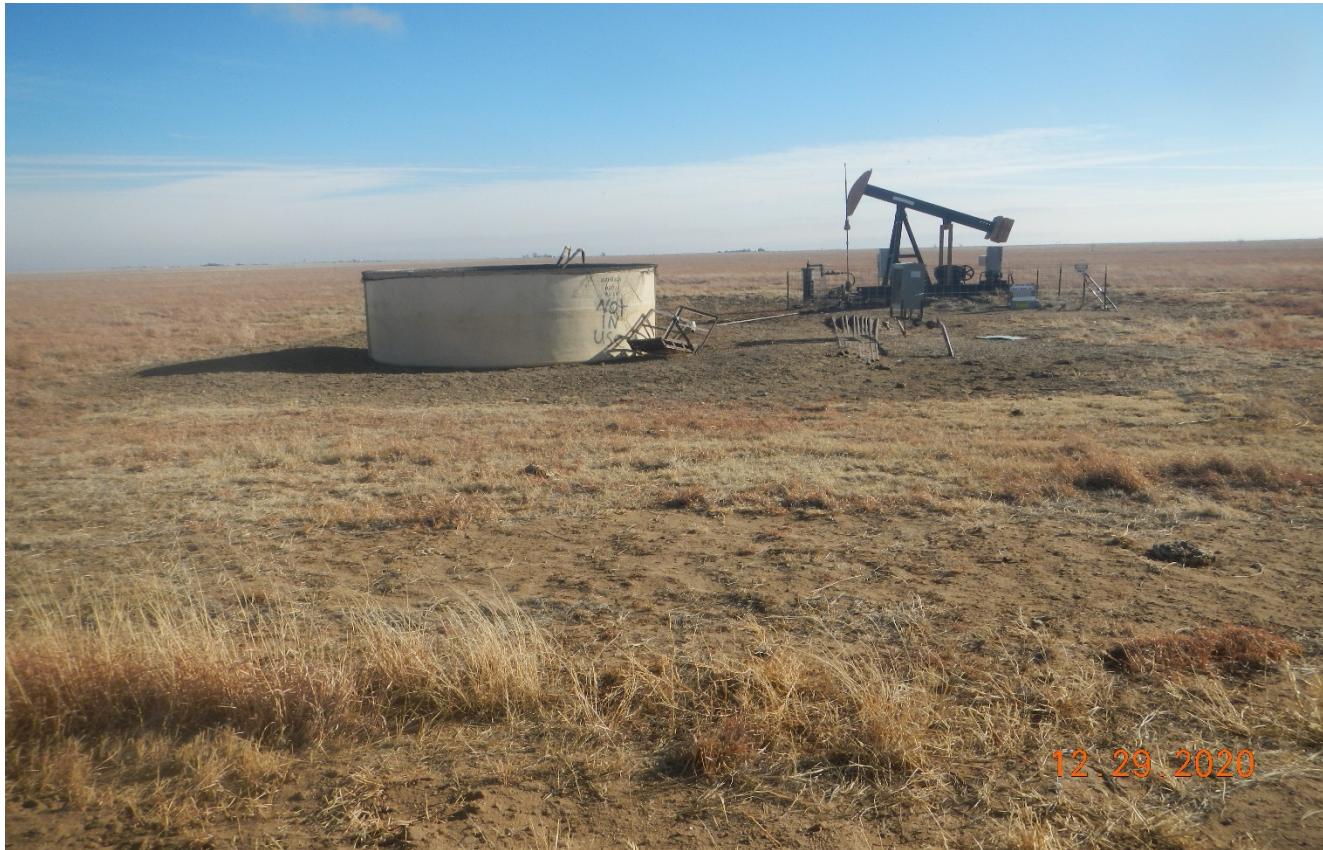
Photo 1. Facing west toward the location..

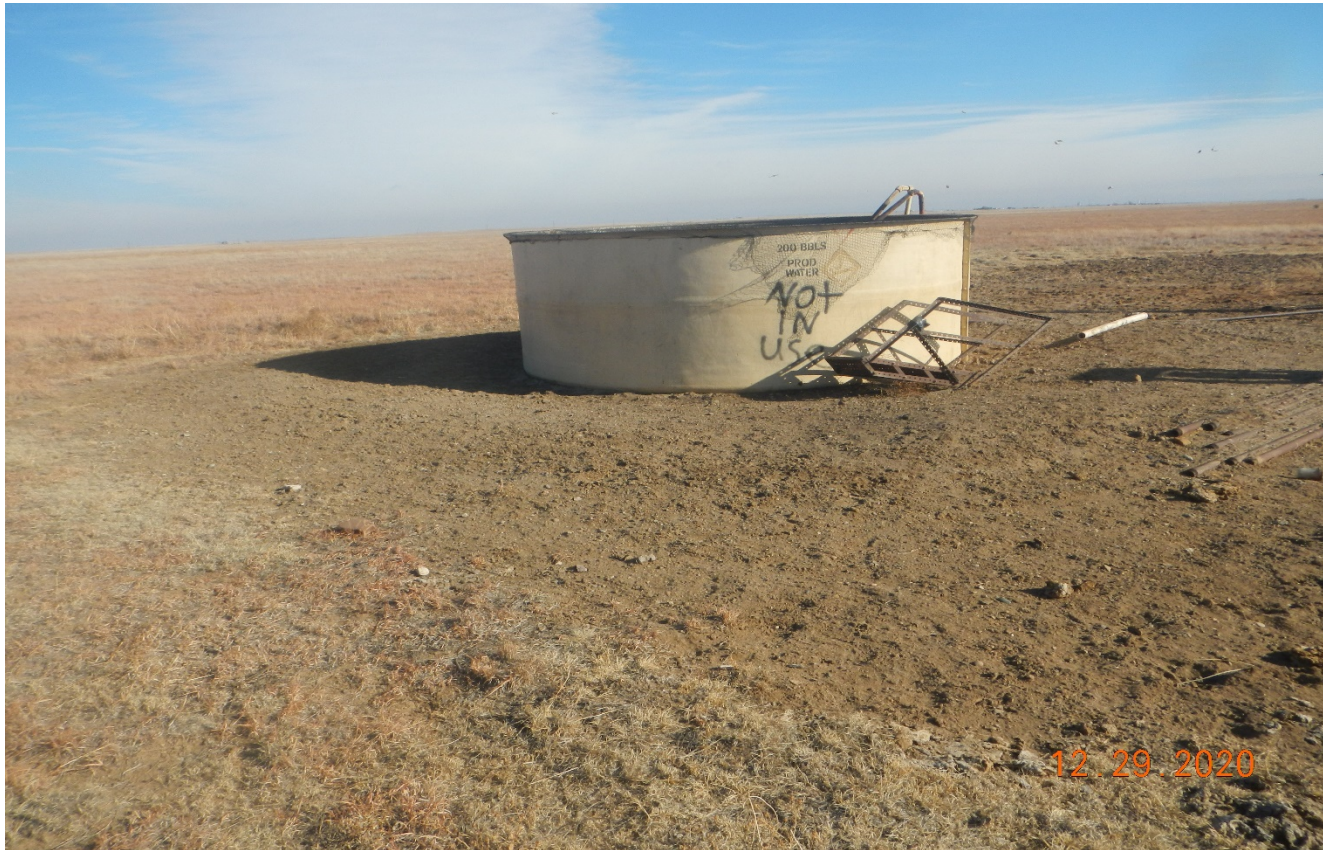
Photo 2. The tank is marked as not in use. Unused equipment must be removed. Additionally the berm around the tank is insufficient.

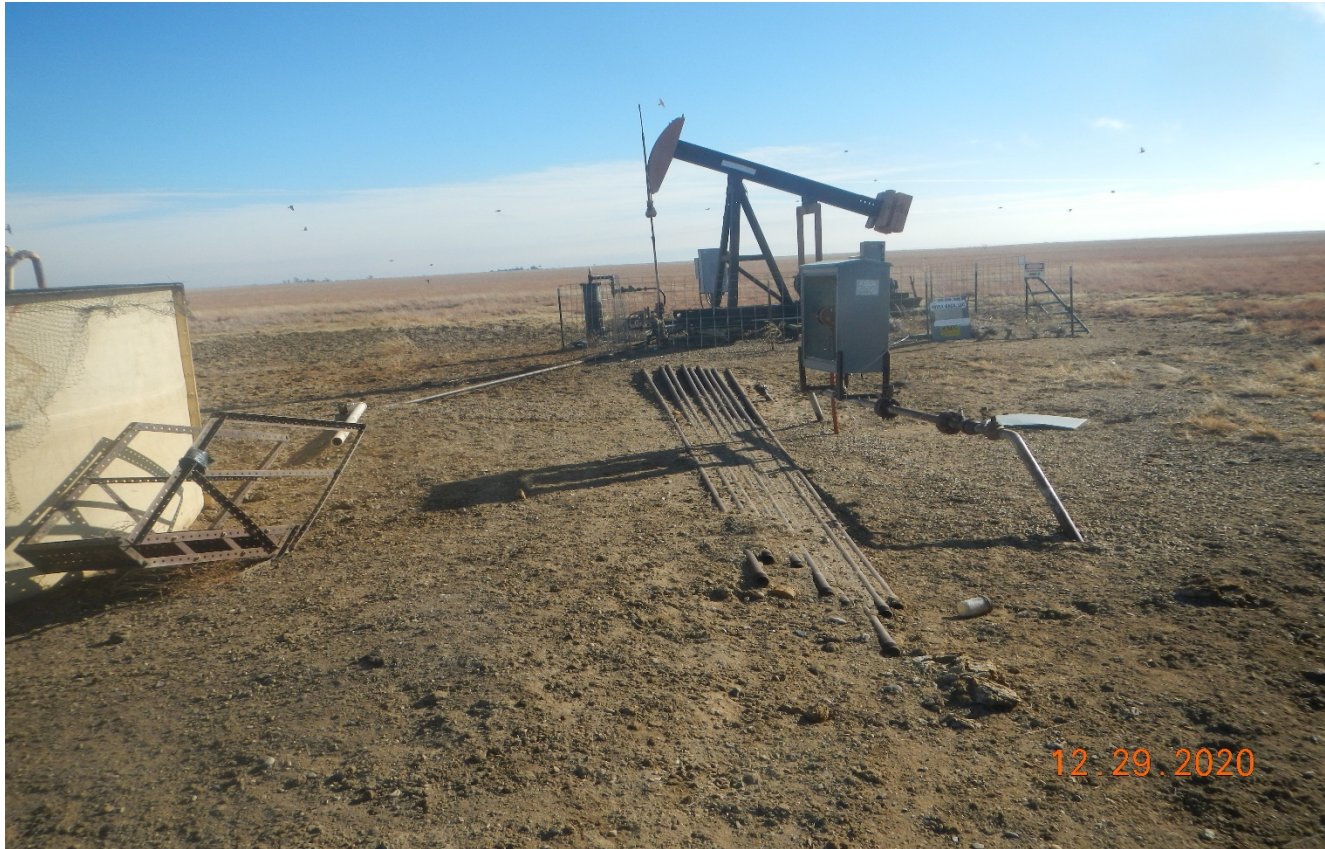
Photo 3. There is unused pipe laying at the location partially buried in dirt. Unused equipment must be removed.

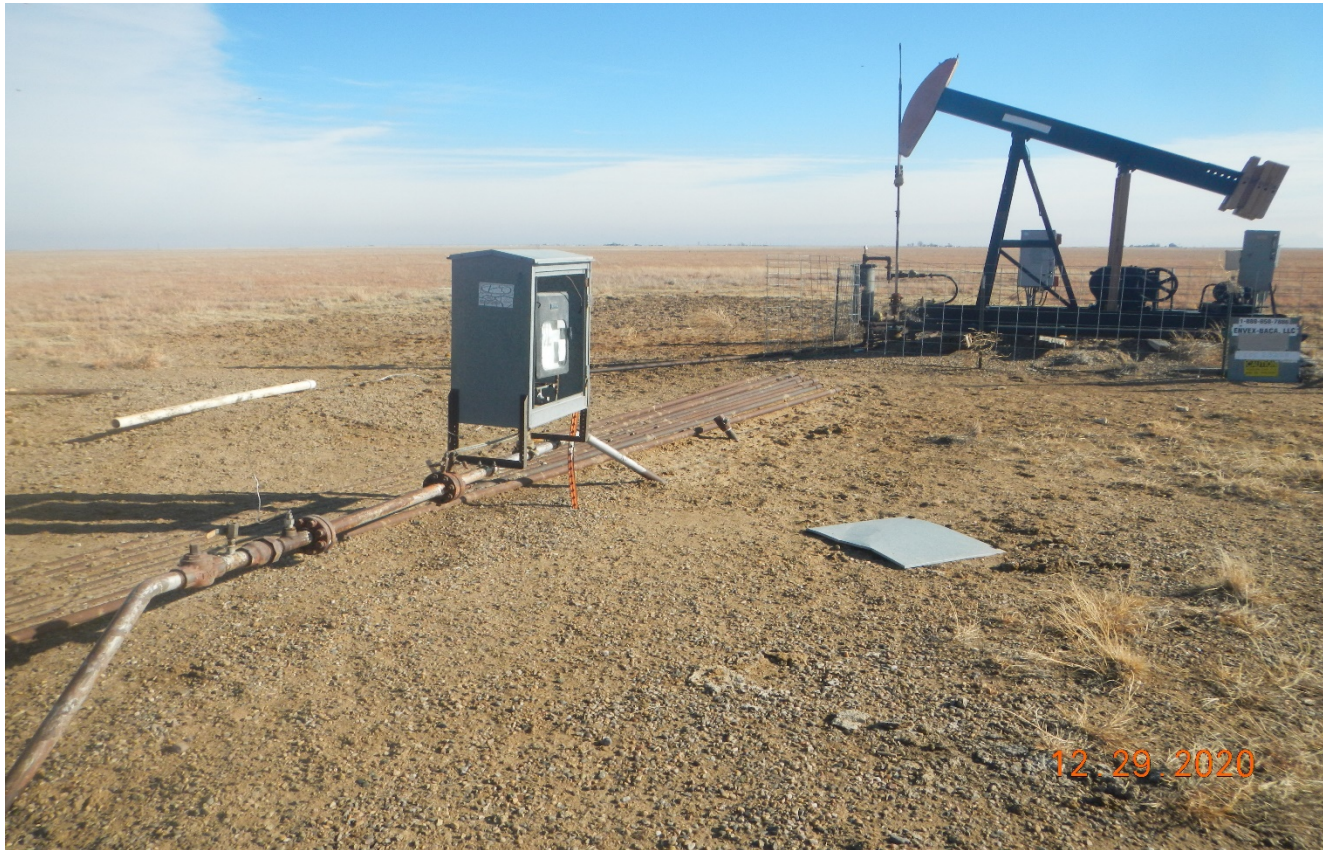
Photo 4. The cover on the meter has fallen off and needs to be repaired.

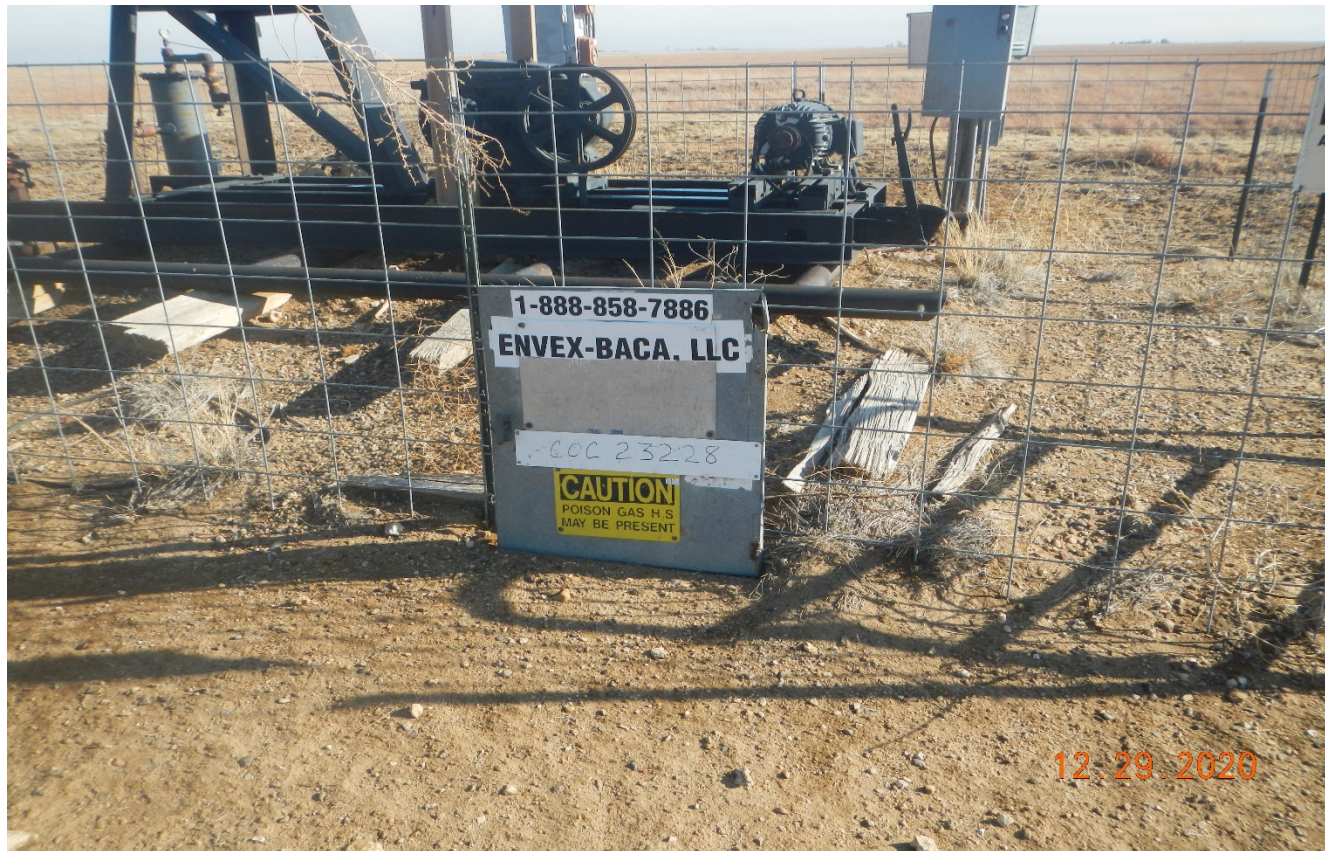
Photo 5. The well sign does not comply with 210.b.

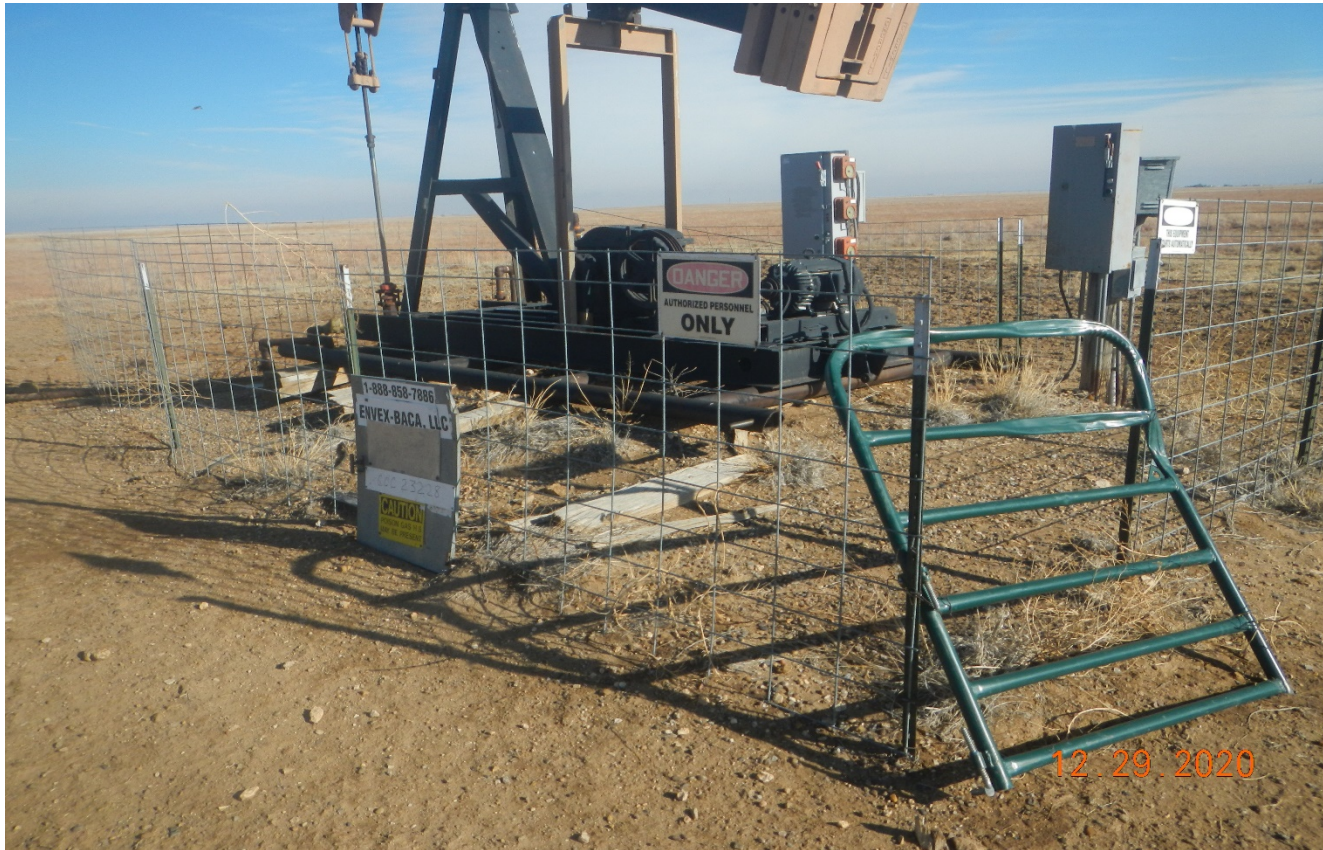
Photo 6. The gate on the fence around the pumpjack is not maintained. Fence around the pumpjack needs maintenance.
