Inspection Photos

API: 009-05117

Operator: TINDALL OPERATING COMPANY

Inspection Date: 12/29/2020

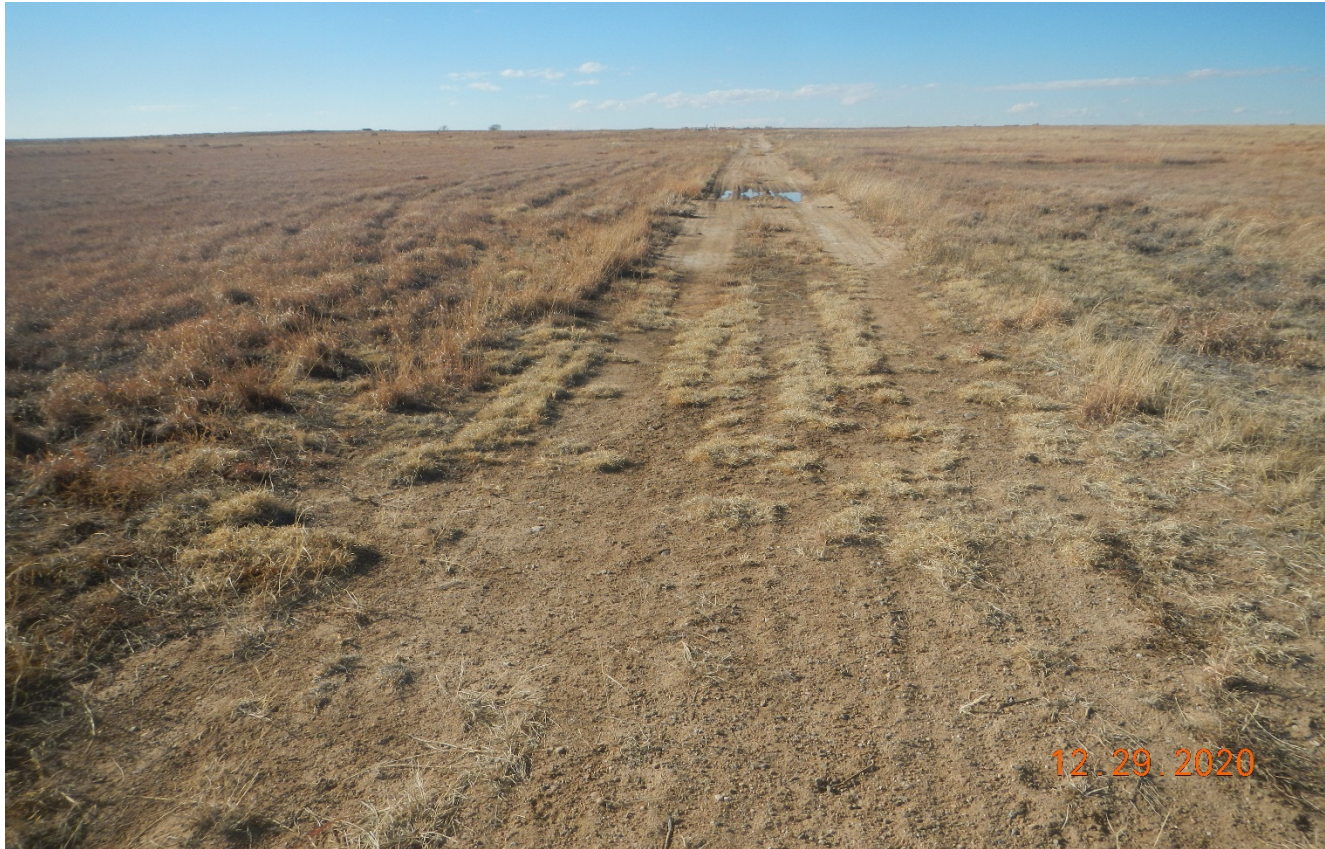
Photo 1. Facing west toward the access road. It appears the road may have been seeded however. It does not appear the road was decompacted by cross ripping to 18 inches.

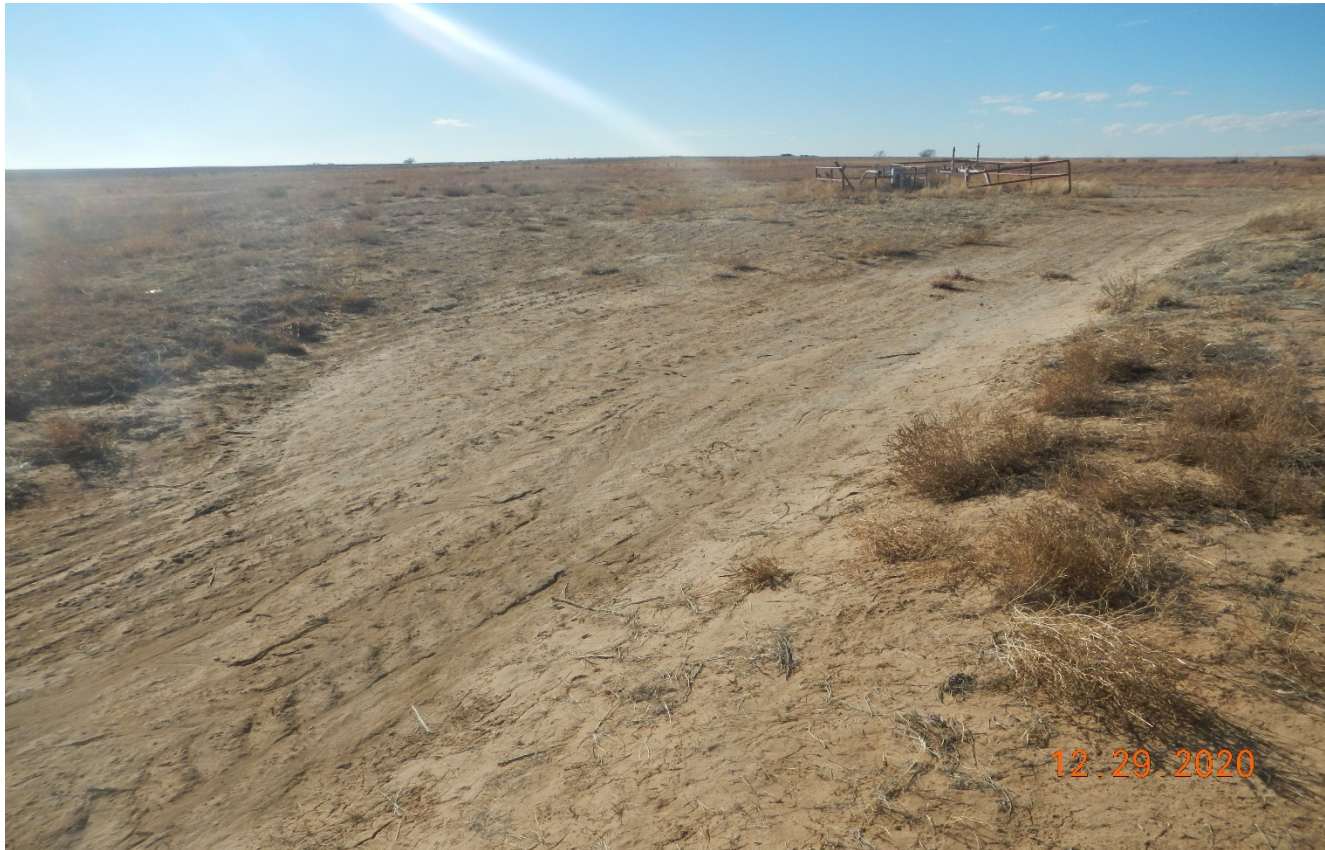
Photo 2. Facing southwest toward the location. The location has areas with no vegetation growth.

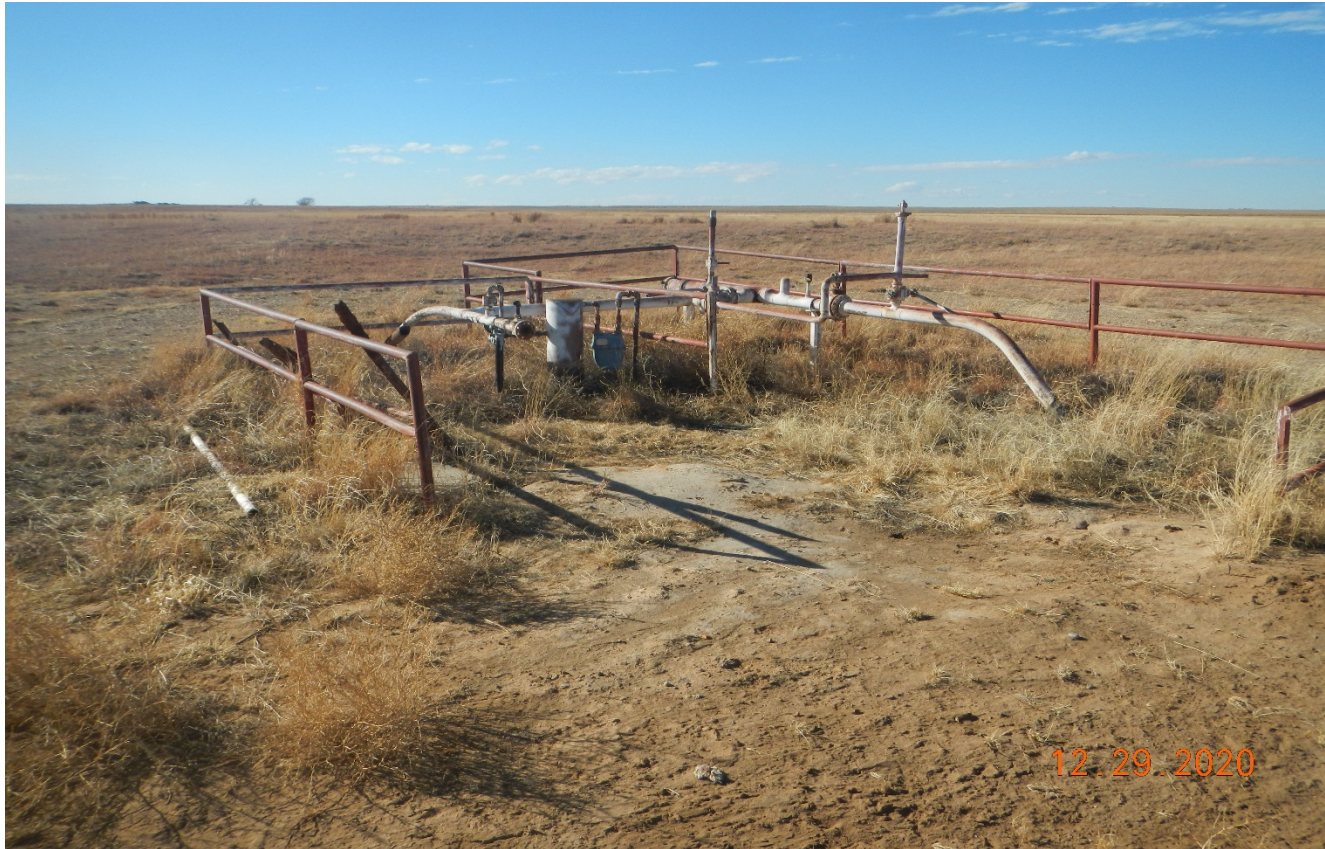
Photo 3. There is pipe risers and equipment that remain at the location. All equipment should have been removed within 3 months of abandonment.

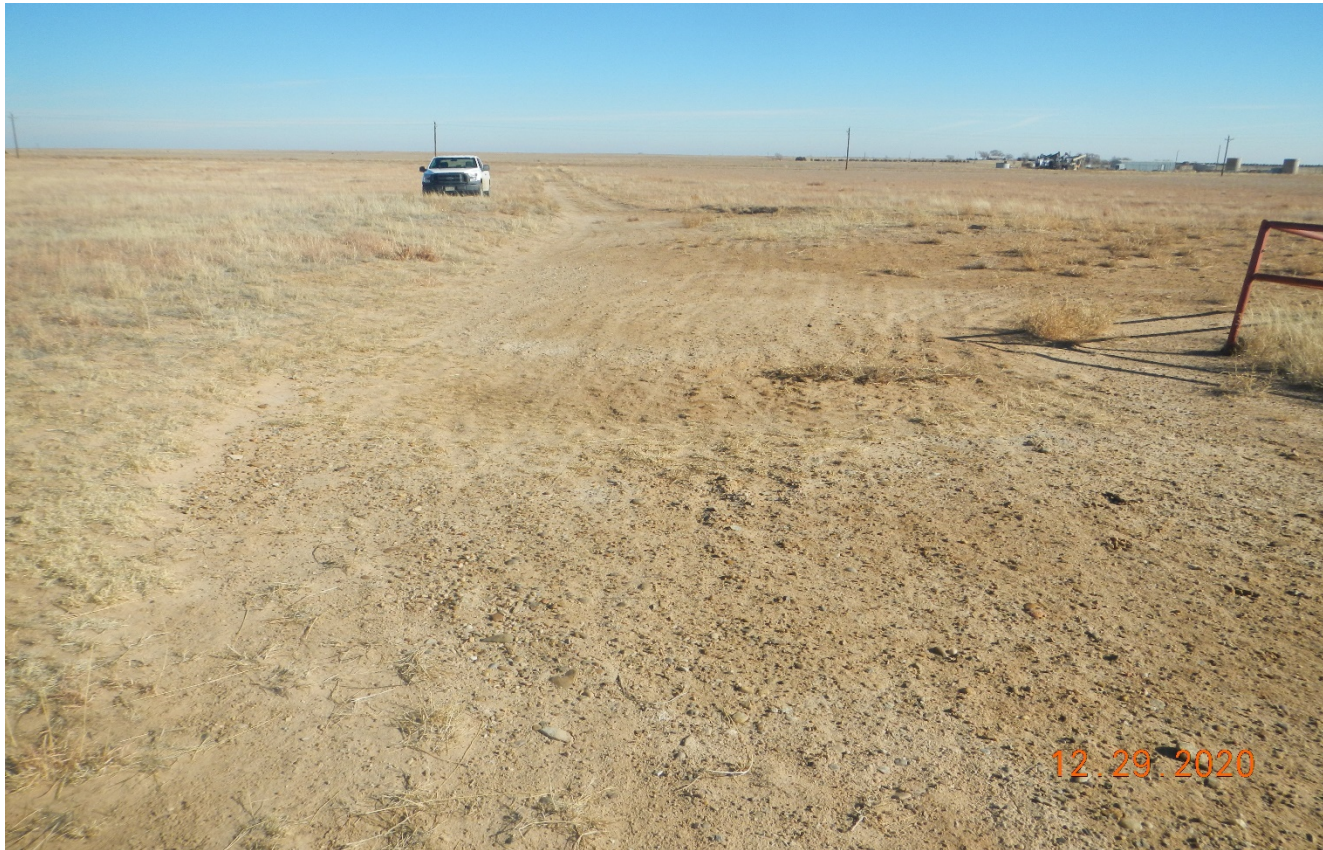
Photo 4. Facing east toward the location. It appears the road may have been seeded however. It does not appear the location was decompacted by cross ripping to 18 inches.
