**COLORADO**  
Oil & Gas Conservation  
Commission  
Department of Natural Resources

**A.C. McLaughlin JR 11**

**API: 05-103-05577**

**Inspection: 700404802**

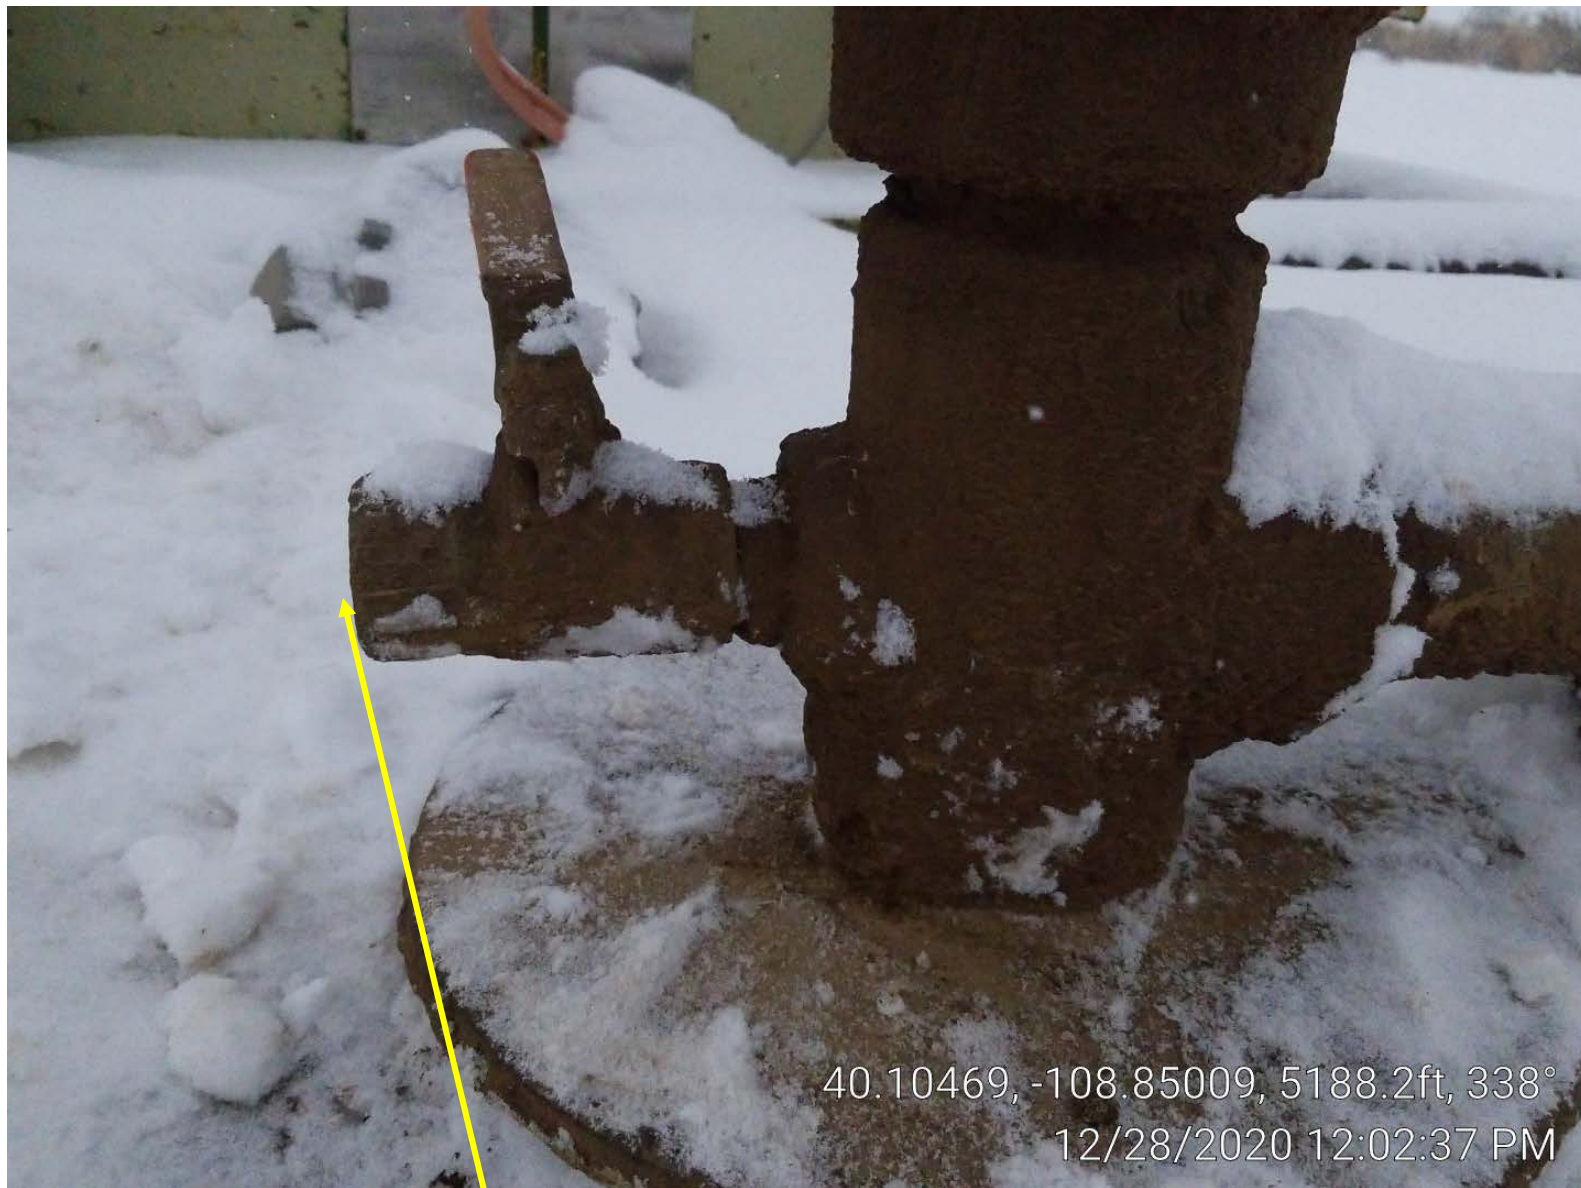
**Photo 4. Well. Gas leak.**
