**Inspection Photos**  
**Location Name: Champlin 78 Amoco B 1**  
**Location ID: 319896**

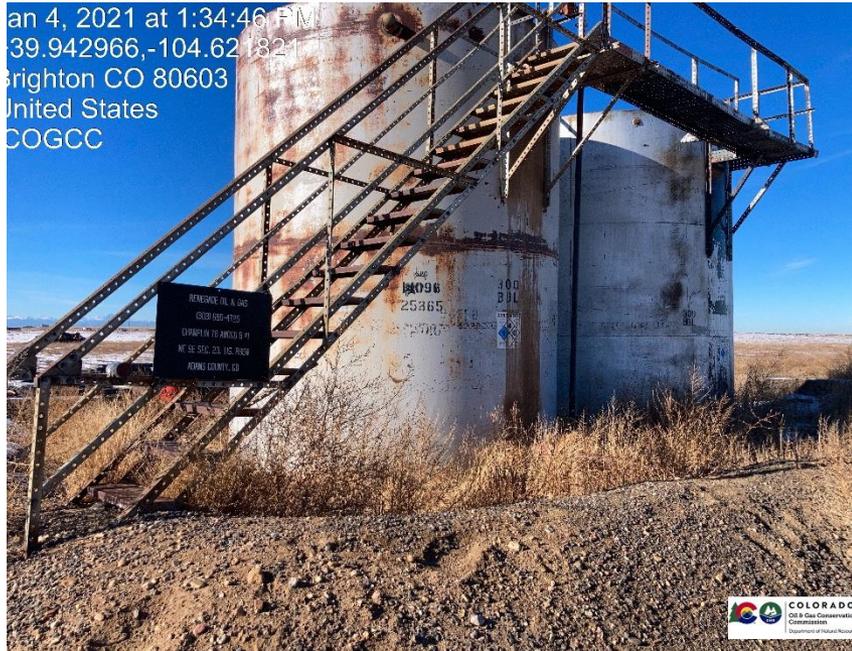
**Pic 1 weeds**

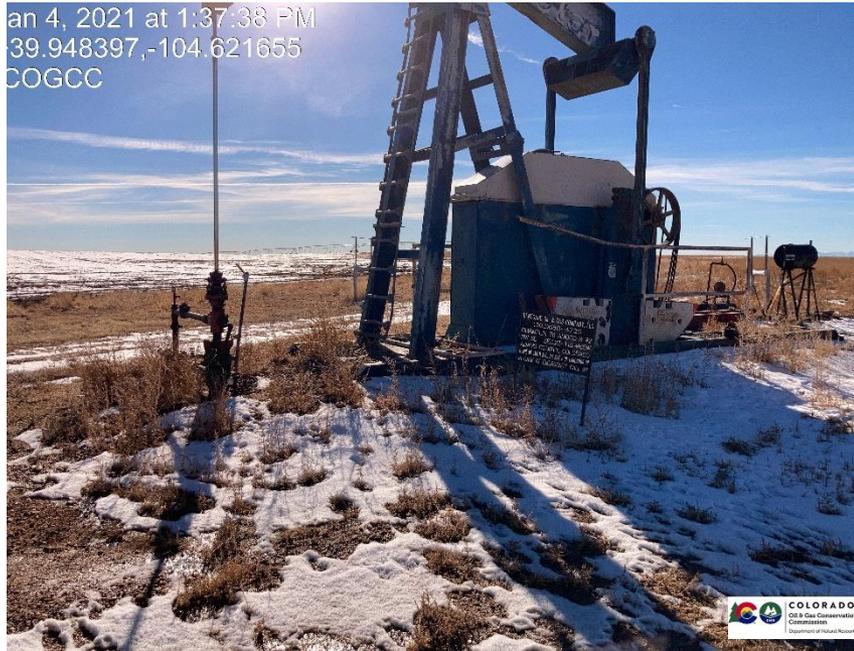
**Pic 3 weeds around pump jack**

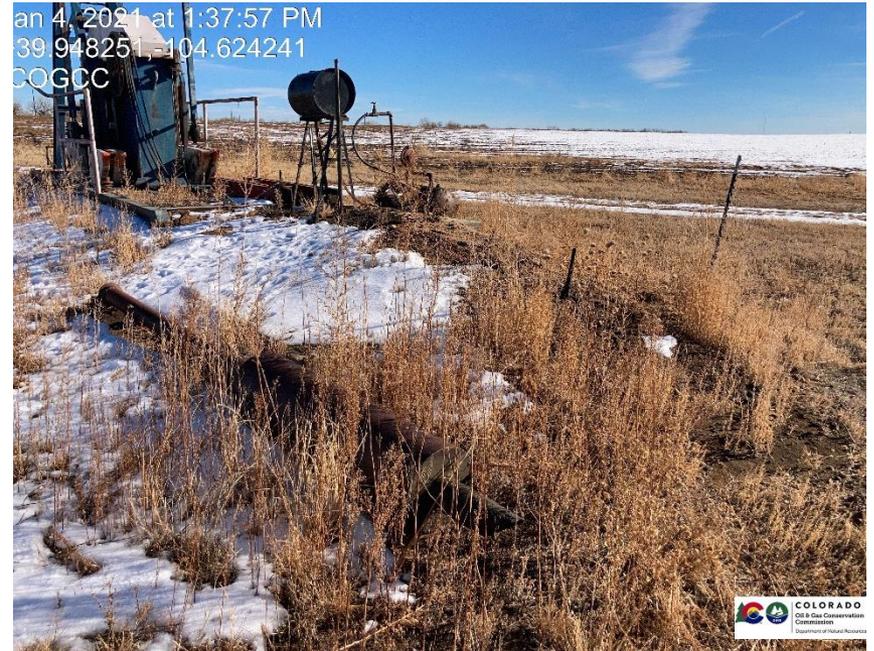
**Pic 4 stained soil / weeds / no BMP under chemical tank**

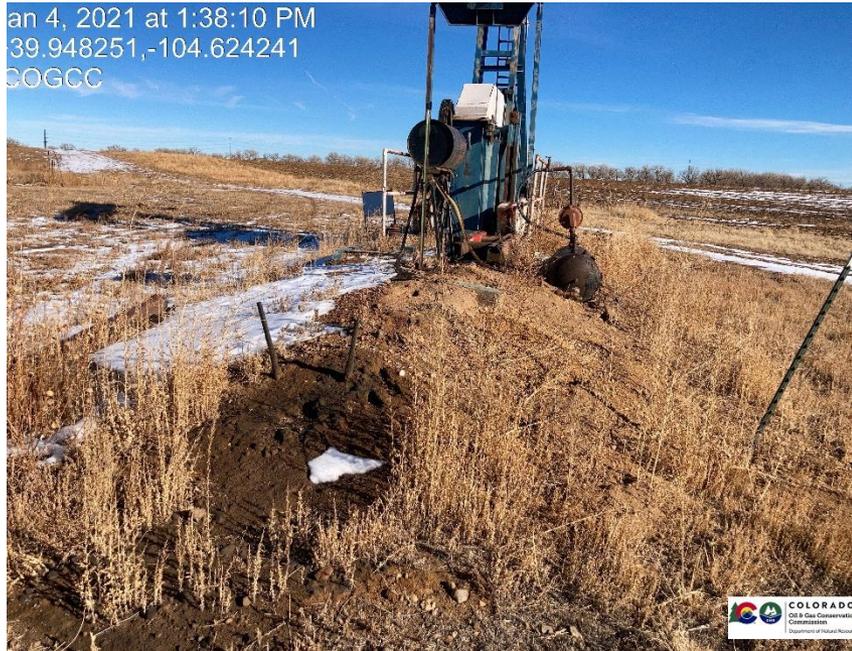
**Pic 5 stained soil / no BMP under chemical tank/ weeds**

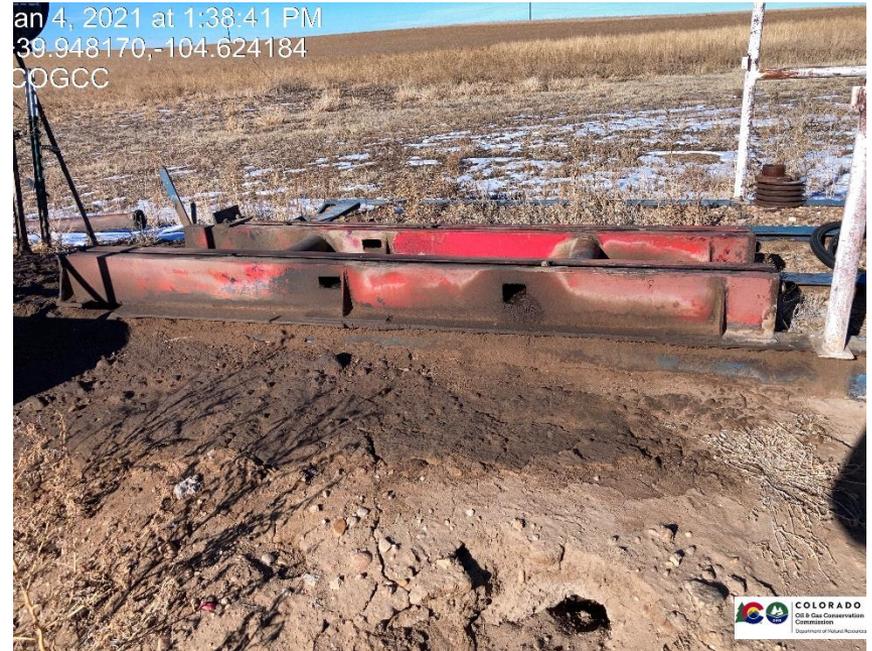
**Pic 6 stained soil**

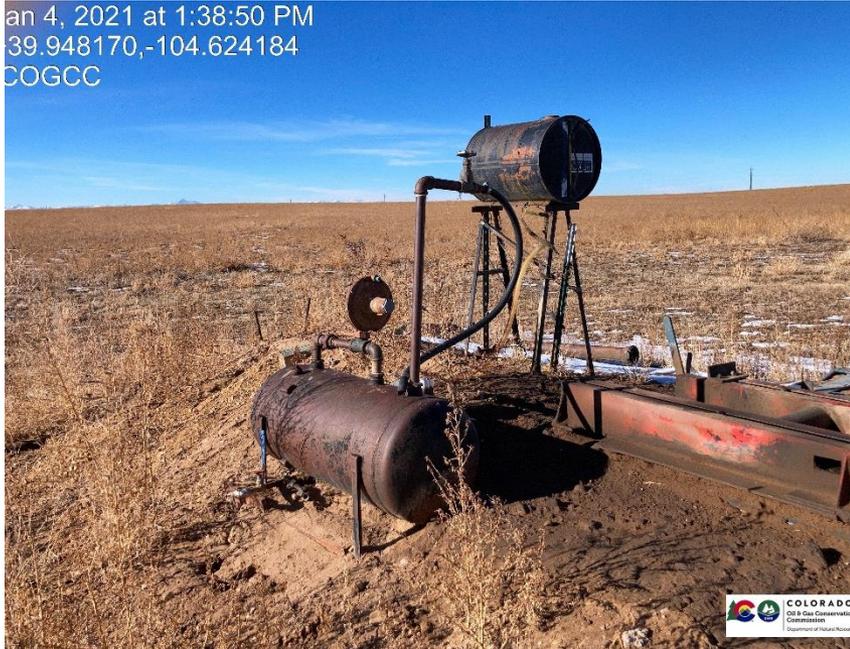
**Pic 7 stained soil / no BMP under chemical tanks / weeds**
